***Final Feasibility Study Report  
for Interim Action Work Plan  
Custom Plywood Site  
Anacortes, Washington***

***Prepared by Hart Crowser  
under Direction and Contract with  
Washington State  
Department of Ecology  
under Agreement with  
GBH Investments, LLC***

***September 2011  
17330-27***

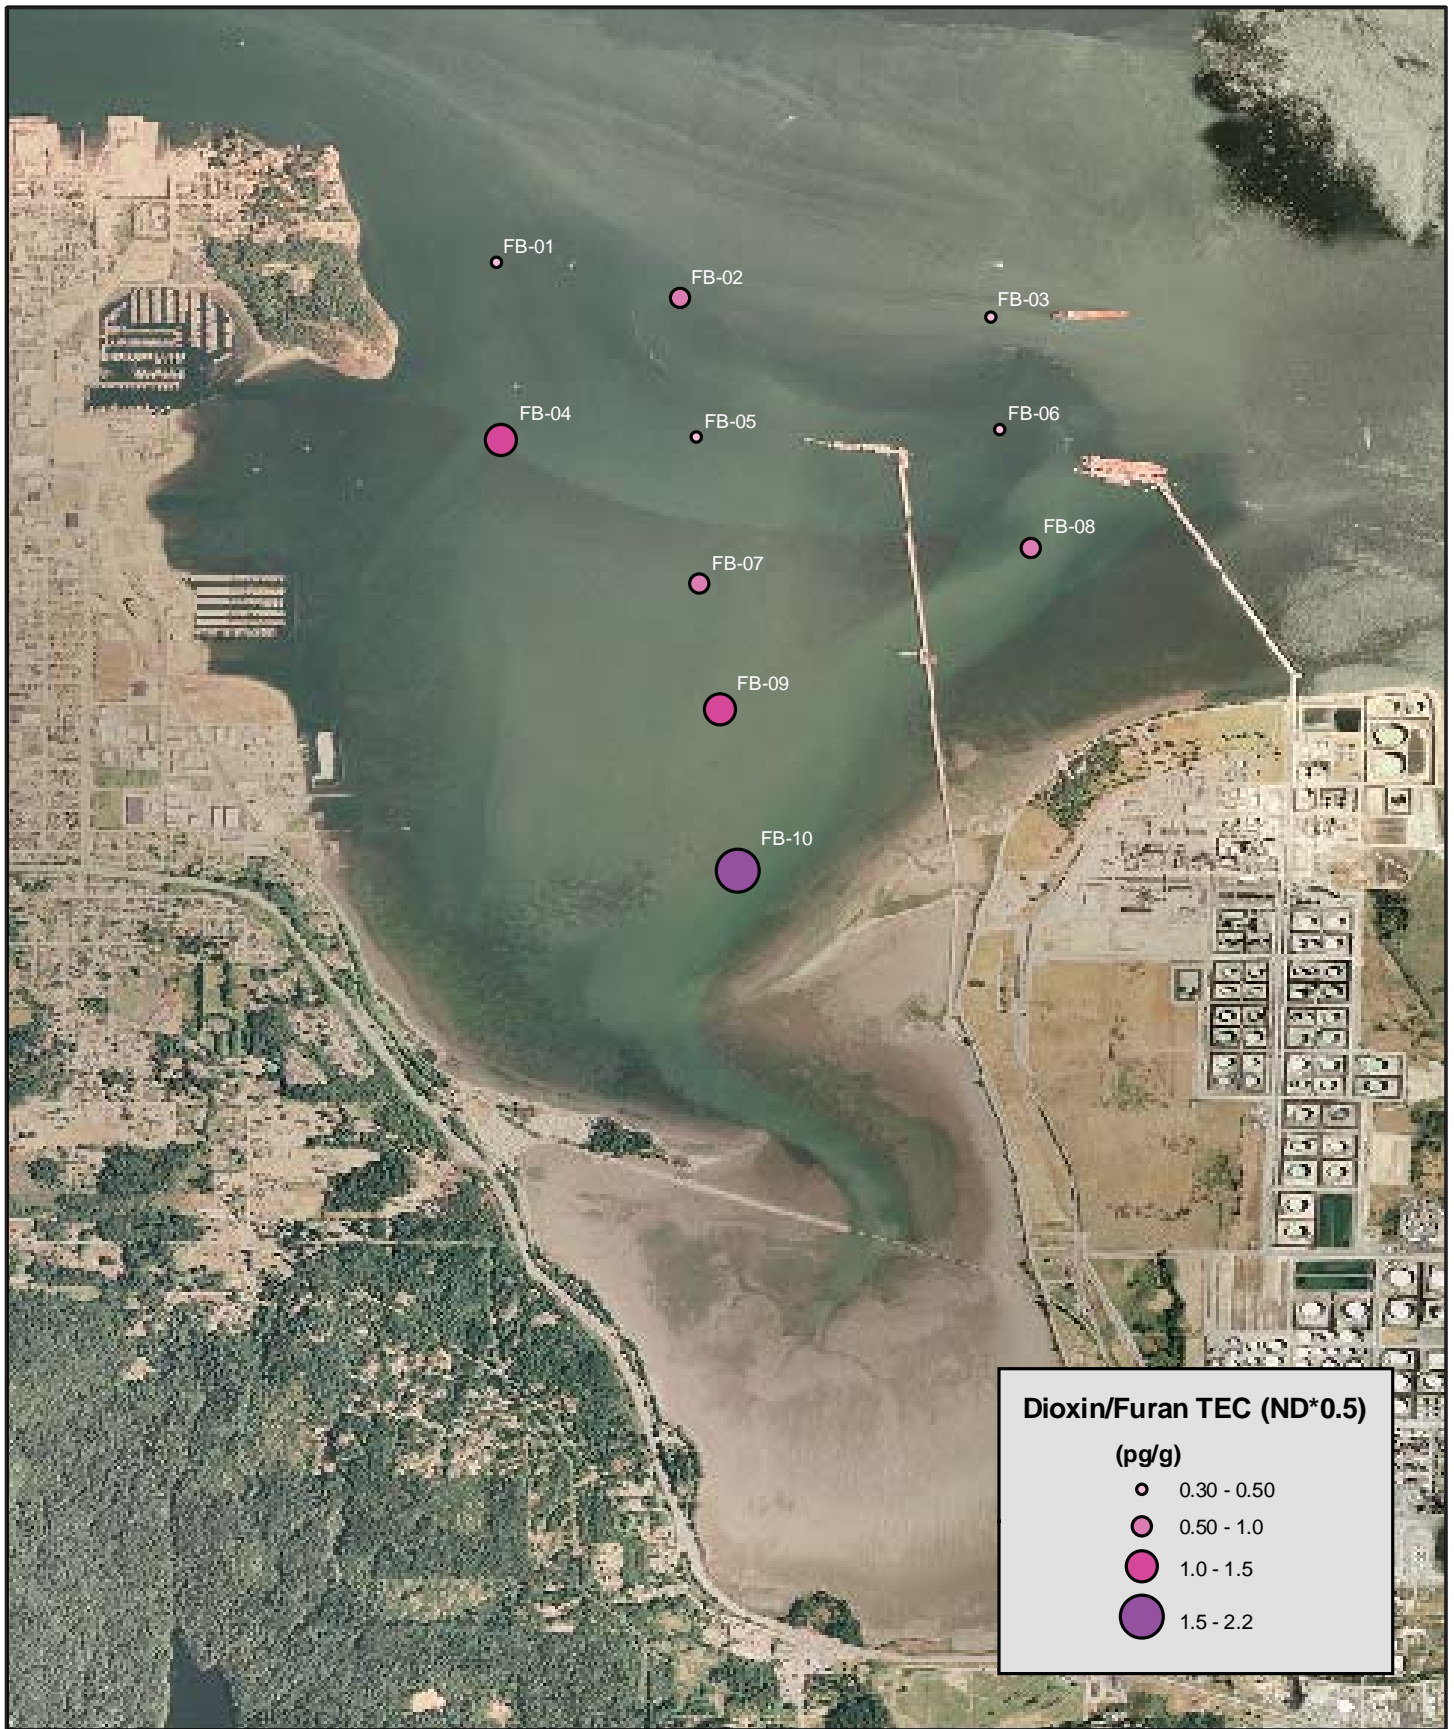
Figure 3-7. Dioxan/Furan TECs of Fidalgo Bay Background Locations

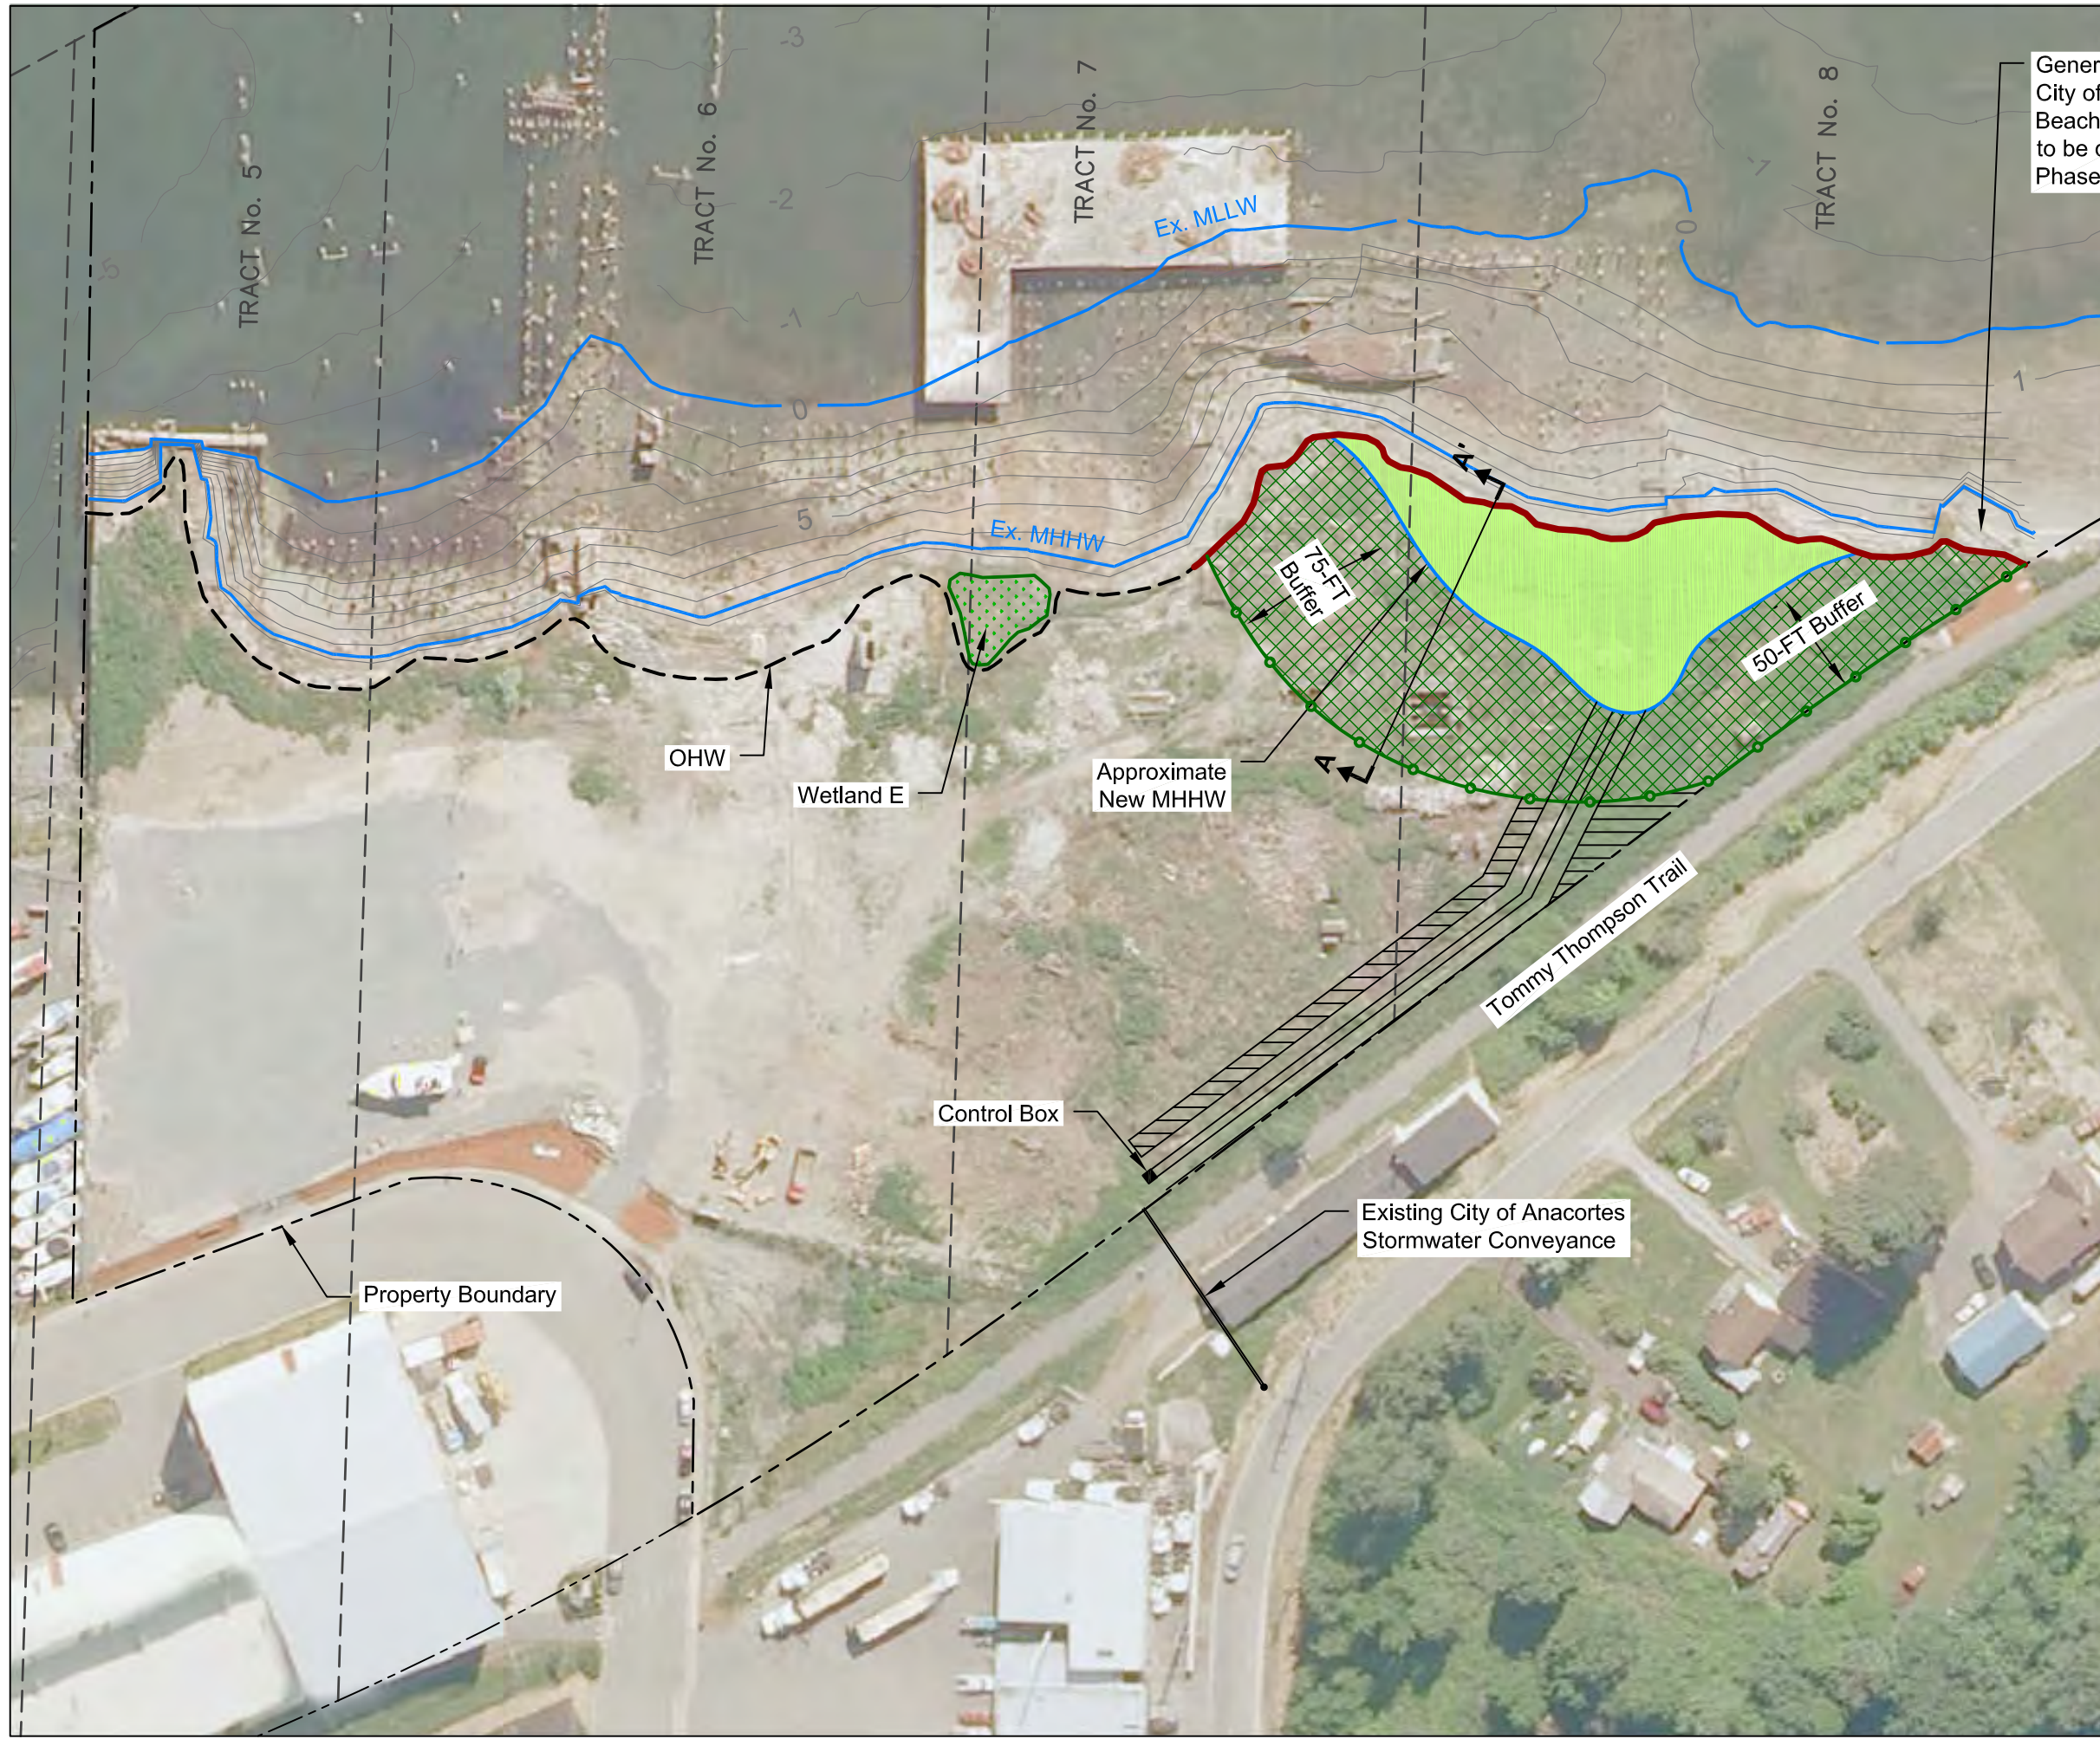
General Area of Future City of Anacortes Public Beach Access Facility, to be developed during Phase II Aquatic Cleanup

- Estuarine Wetland (12,050 sf)
- Buffer (26840 sf)
- Swale and Conveyance
- Temporary Fencing and Barrier Plantings
- Temporary Shoreline Berm
- Stormwater Plantings
- Cross Section Location and Designation

**Note:** See Figure 4 for stormwater conveyance and swale details.

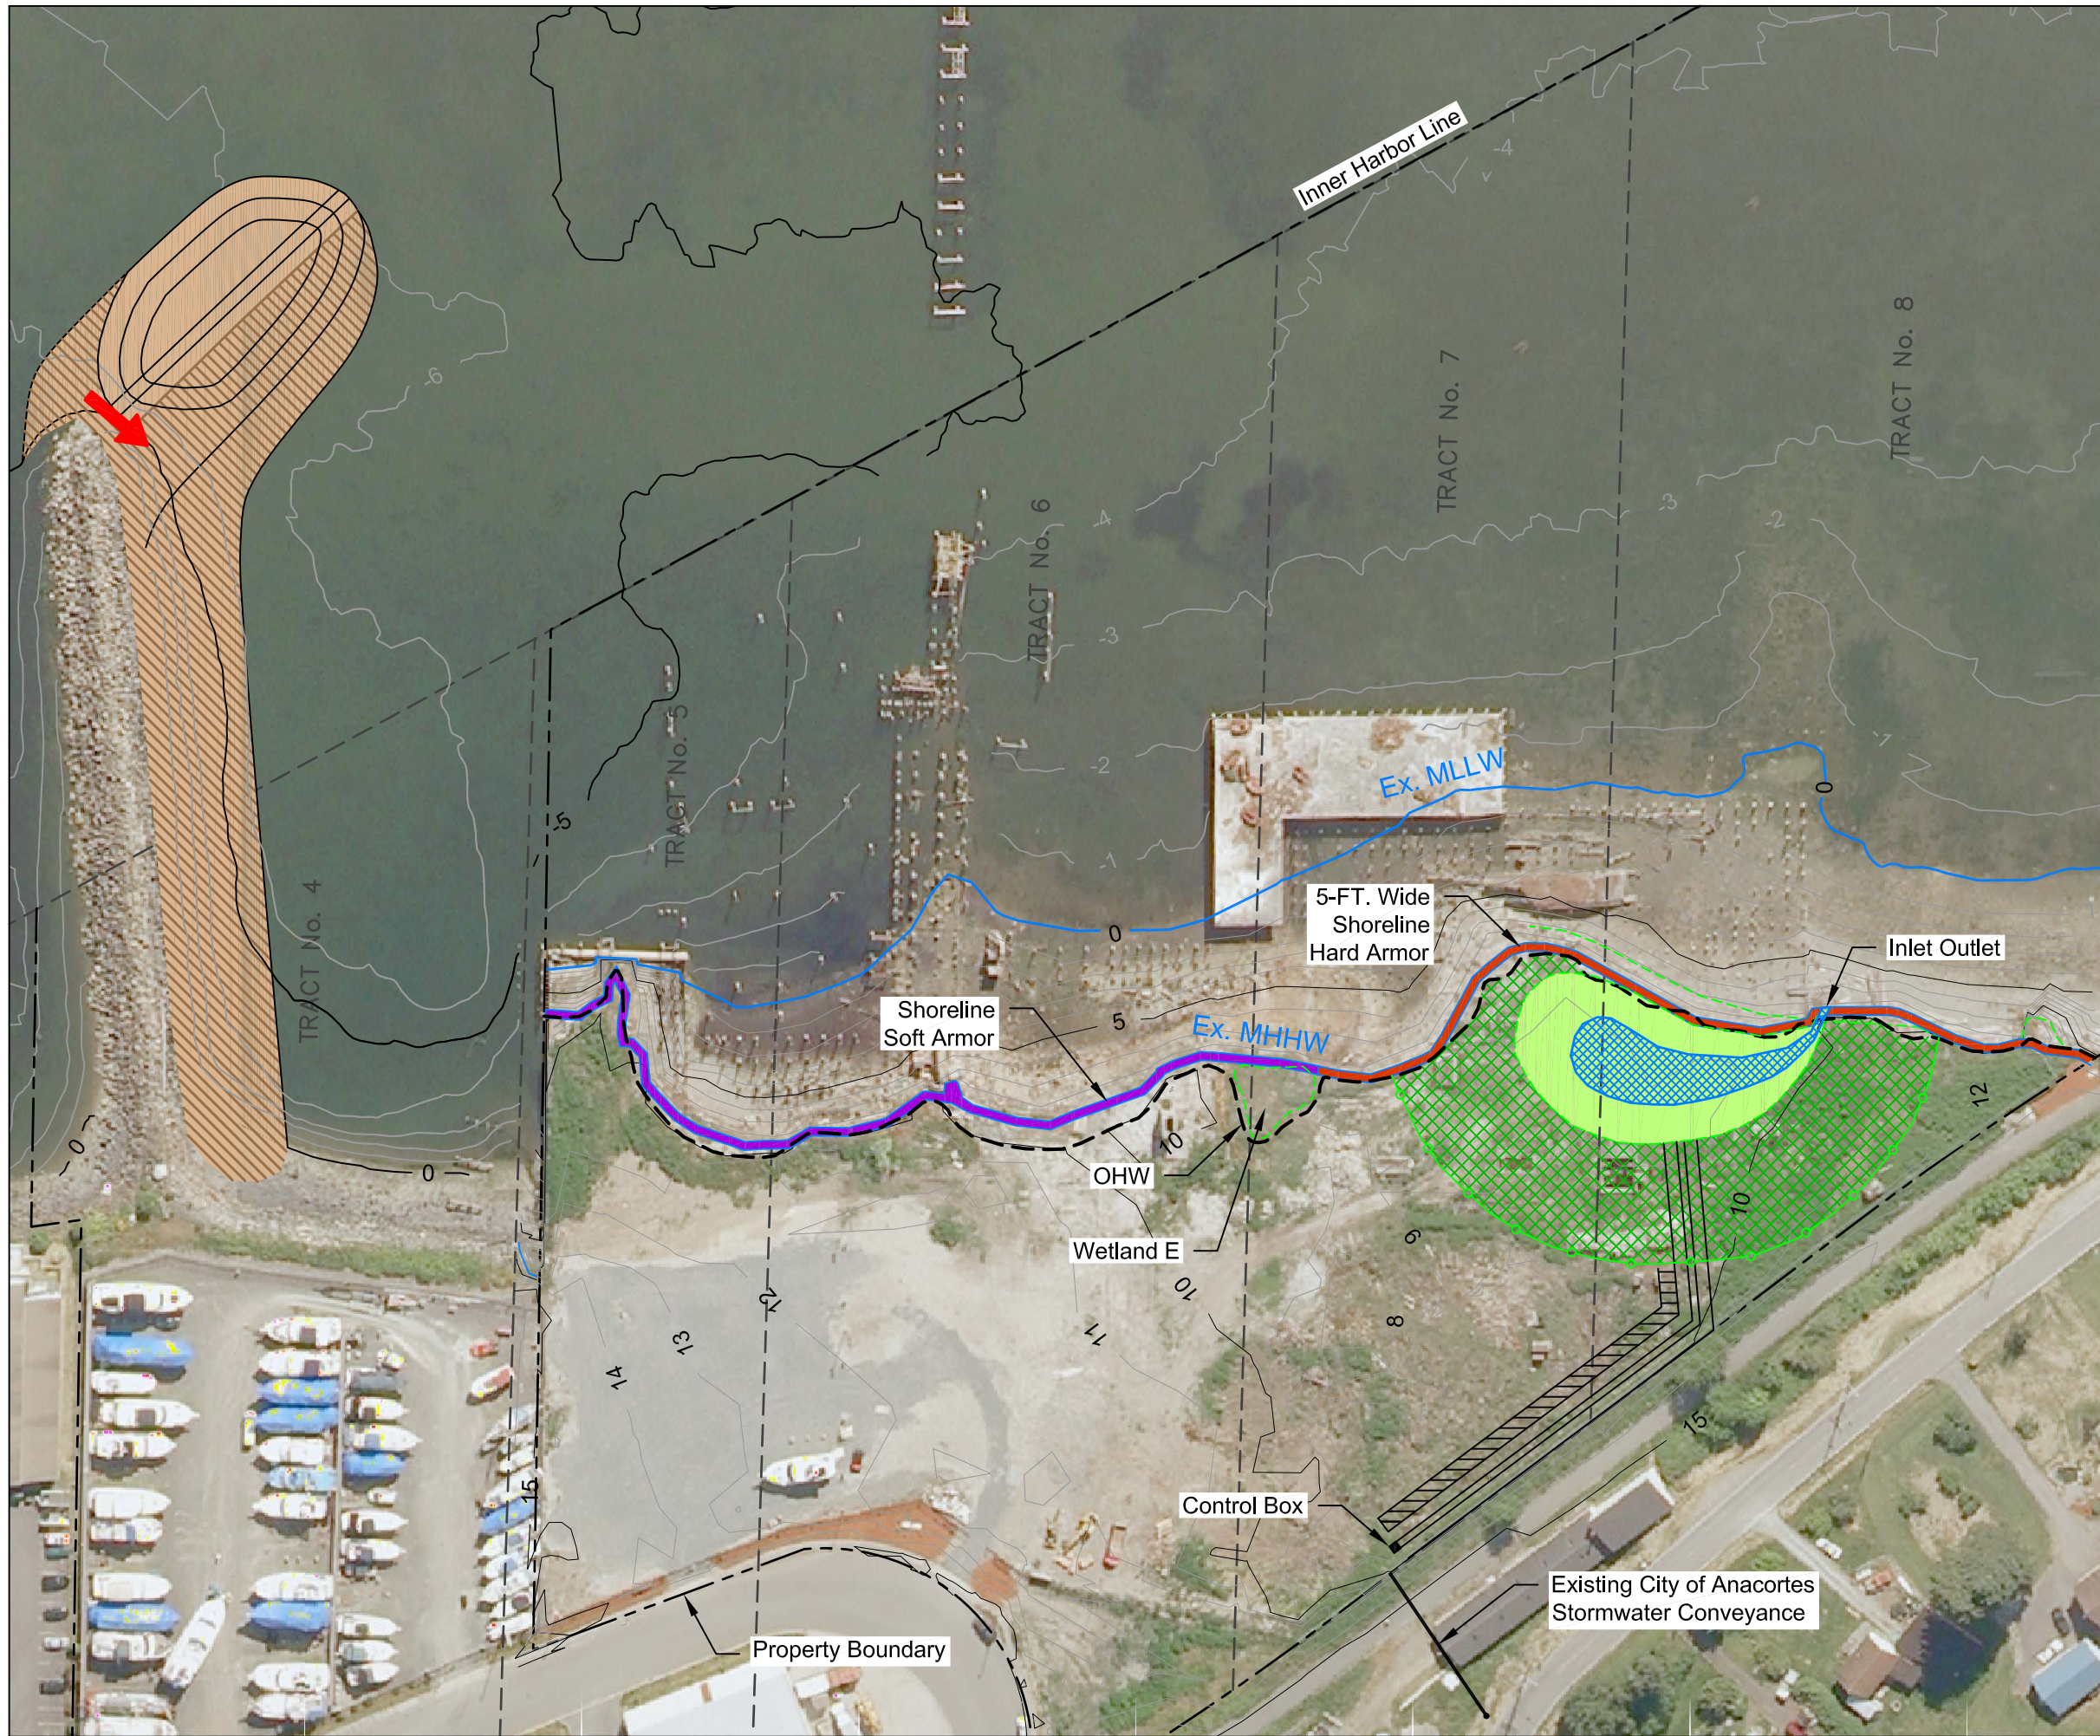
- Estuarine Wetland (12,305 sf)
- Buffer (26,840 sf)
- Jetty Extension Materials
- Habitat Mix
- Swale and Conveyance
- Temporary Fencing and Barrier Plantings
- Stormwater Plantings
- Juvenile Salmonid Corridor

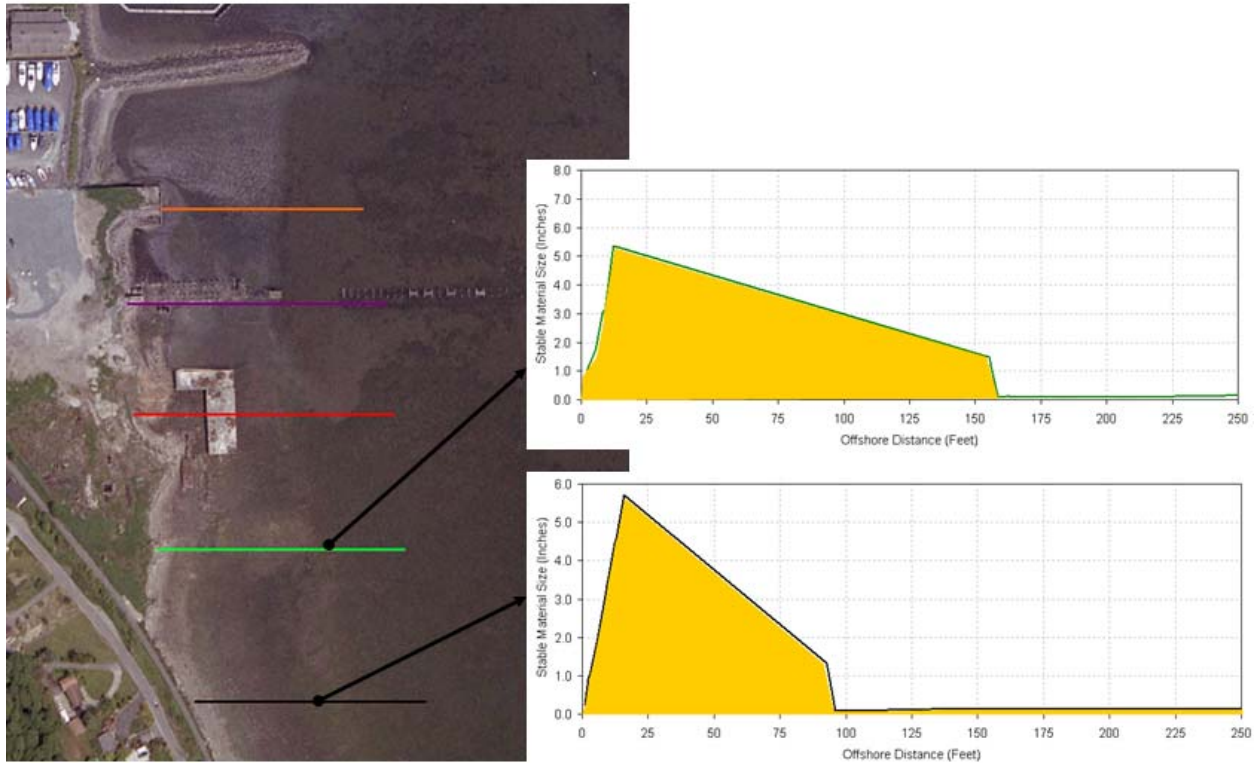
**Figure 2. Computed size of material at different transects along the shoreline resulted from the 25-year return period condition for MLLW and MHHW**
