MEMORANDUM

Project No.: 150323

Re: UST Closure and Remediation Report – Snohomish County Fire Station #22, 20510
Damson Road, Lynnwood, WA

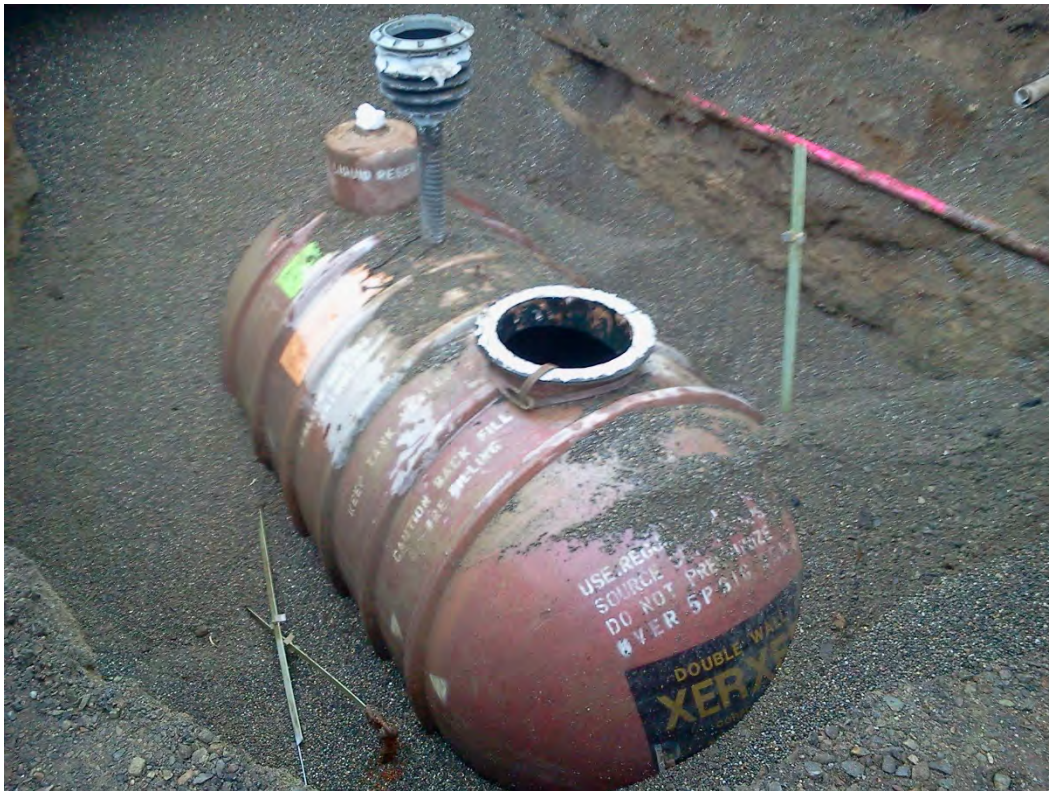
Photo 001 – October 2, 2015

Looking east-southeast at the 3,000-gallon double-wall fiberglass UST in the excavation, surrounded by pea gravel.

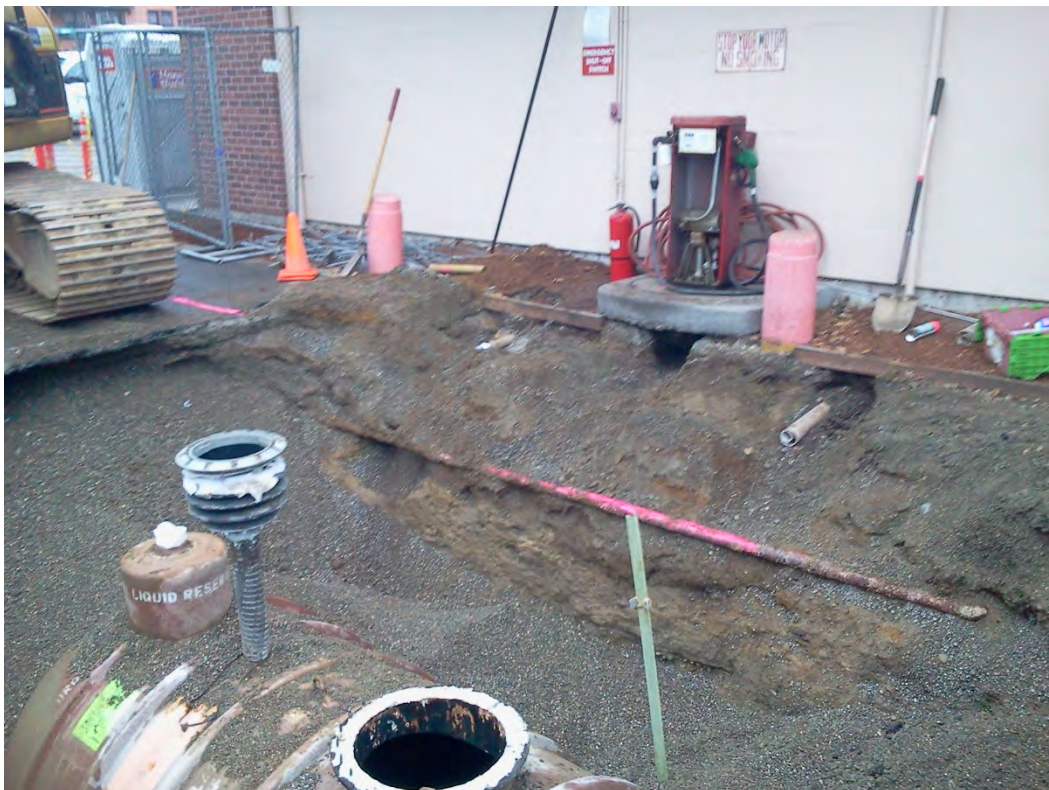
Photo 002 – October 2, 2015

Looking southeast at the UST system, including the dispenser and fuel lines adjacent to the north wall of Fire Station #22.

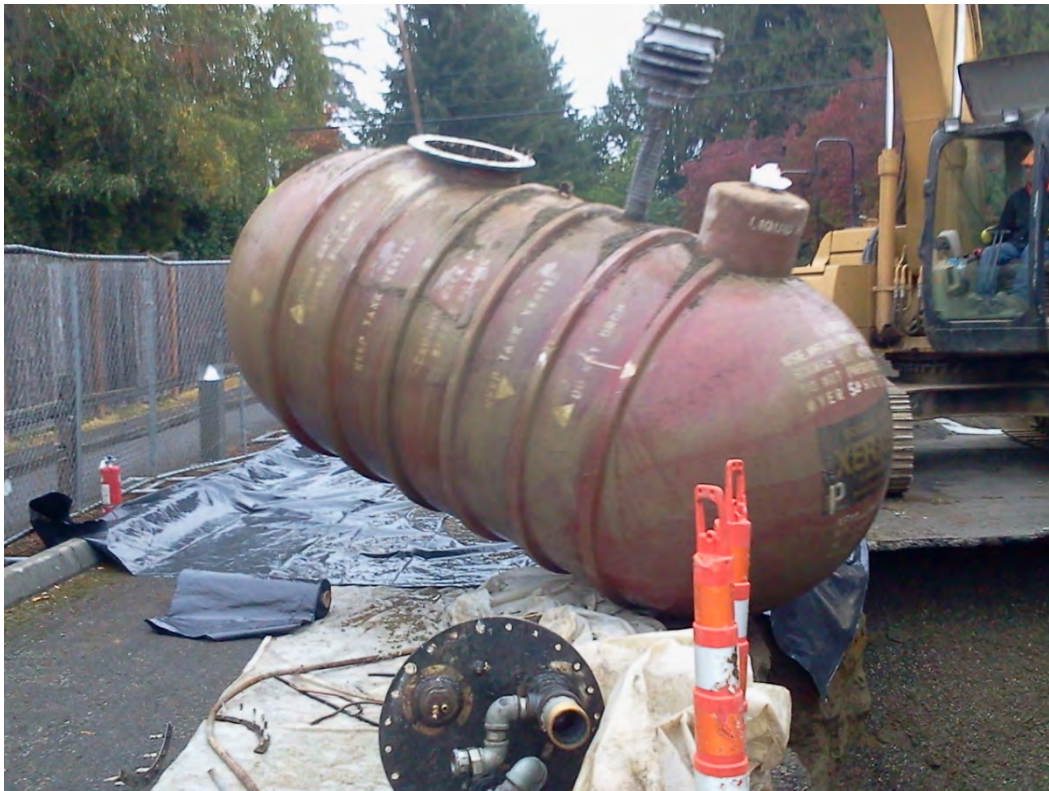
Photo 003 – October 2, 2015

Looking east as the UST is being removed from the excavation and placed on plastic and secured.

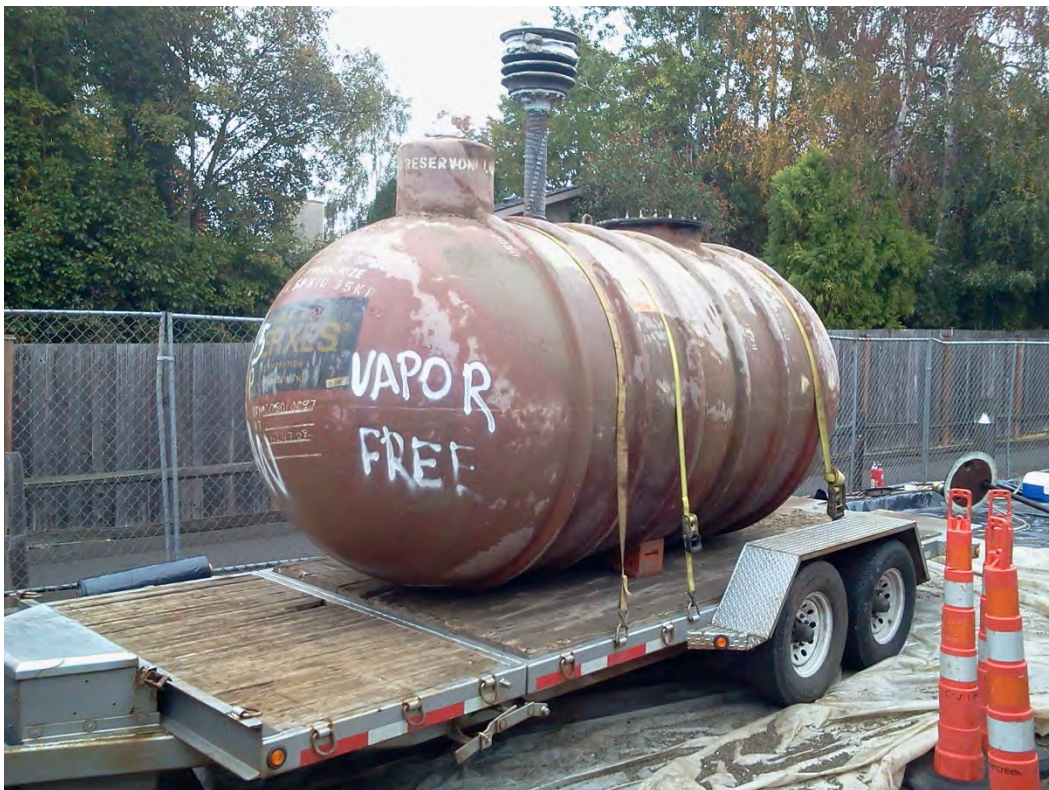
Photo 004 – October 2, 2015

Looking northeast at the UST loaded on a flatbed trailer for hauling to a disposal facility.

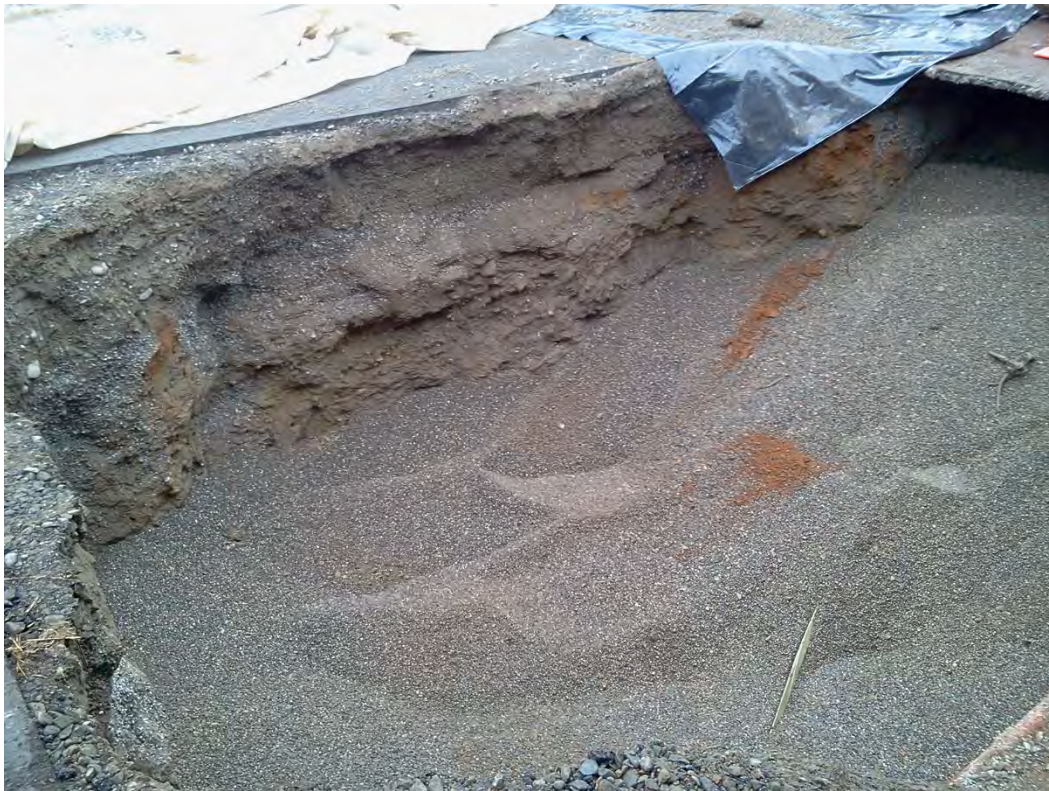
Photo 005 – October 2, 2015

During removal of the UST from the subsurface, evidence of petroleum-impacted soil was not observed (no odors, and photo-ionization detector (PID) readings of 0.0 parts per million [ppm]). Following removal from the subsurface, the tank was inspected for holes and/or signs of corrosion. The tank appeared to be in good condition with no evidence of holes or corrosion. A concrete slab was encountered at the base of the excavation and was left in place.

Looking northeast at the north wall of the UST excavation (a concrete slab remains below the pea gravel; soil samples were collected from edges of concrete slab).

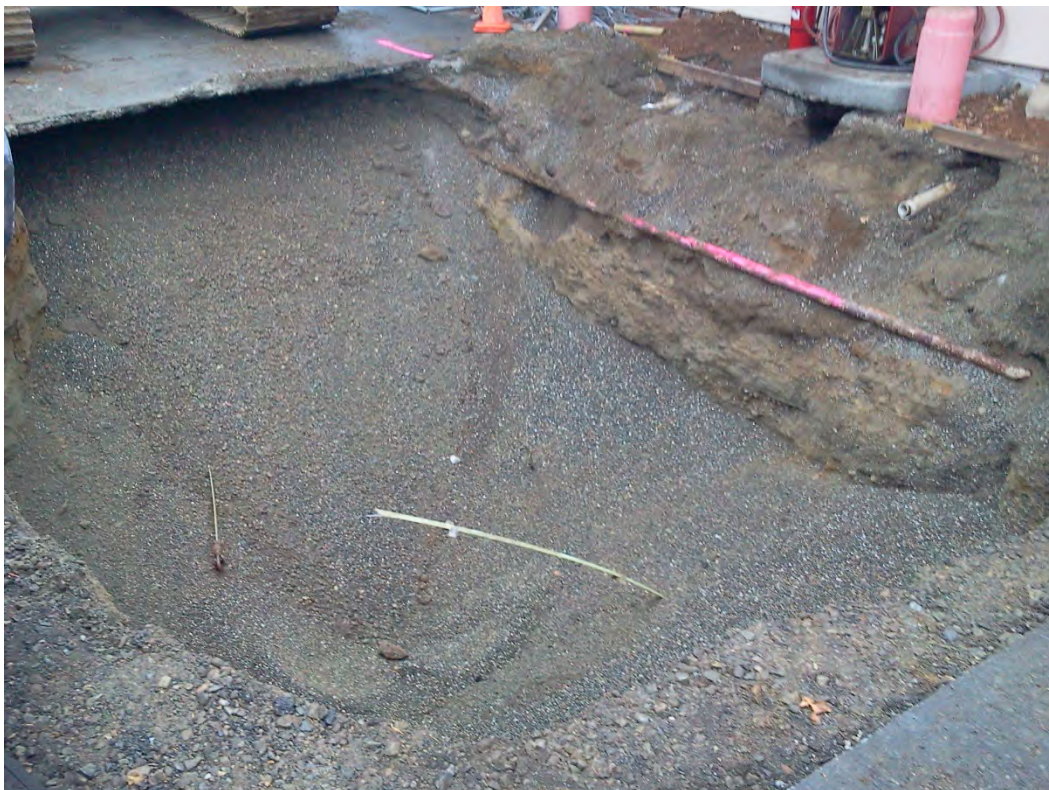
Photo 006 – October 2, 2015

Looking southeast at the south wall of the UST excavation (a 2" water line is marked in pink paint).

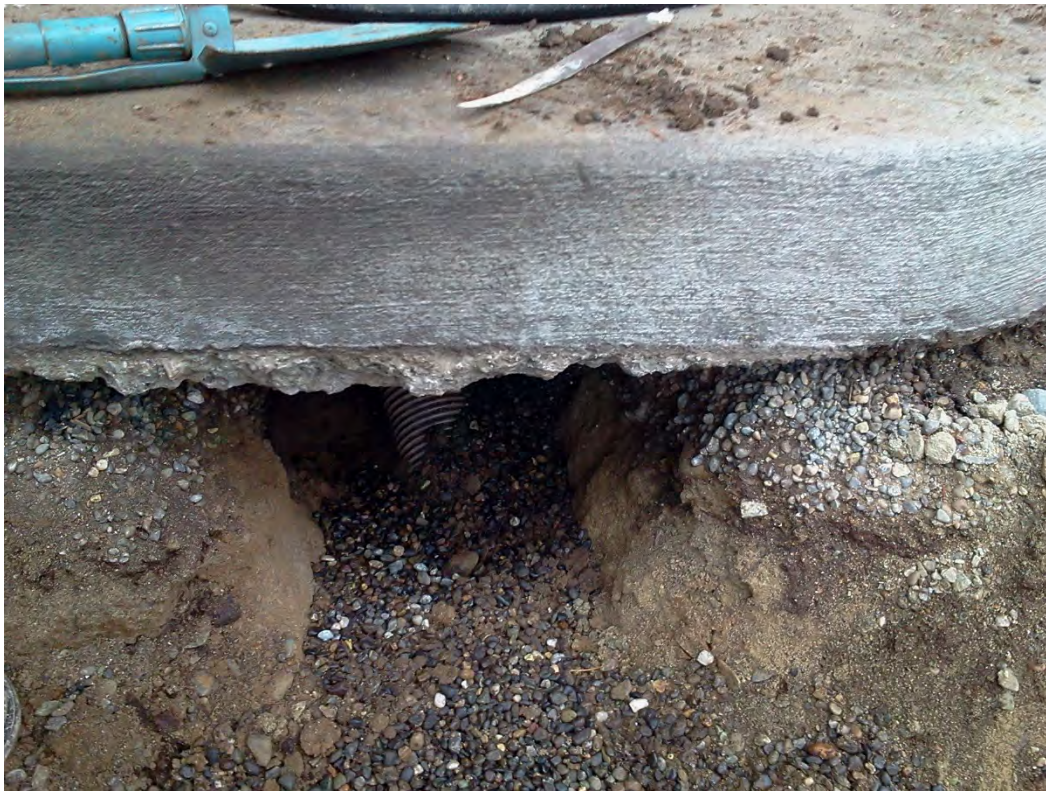
Photo 007 – October 2, 2015

Evidence of petroleum-impacted soil was observed below the fuel dispenser located approximately 15 feet south of the UST location (petroleum odor in soil and a PID reading of 37 ppm). One soil sample was collected below the former dispenser (DISP-100215-FL-01; Figure 3), submitted to F&B, and analyzed for: diesel- and oil-range TPH using NWTPH-Dx; benzene, toluene, ethylbenzene and xylenes (BTEX) using EPA Method 8021B; and polycyclic aromatic hydrocarbons (PAHs) using EPA Method 8270D SIM. The soil sample collected from below the dispenser indicated a diesel-range TPH concentration of 19,000 mg/kg, above the MTCA Method A cleanup level of 2,000 mg/kg for unrestricted land use. Several PAHs were detected in the sample, but the concentrations were below respective MTCA soil cleanup levels for unrestricted use.

Looking south below the fuel dispenser location where petroleum-impacted soil was observed, south of the UST excavation area.

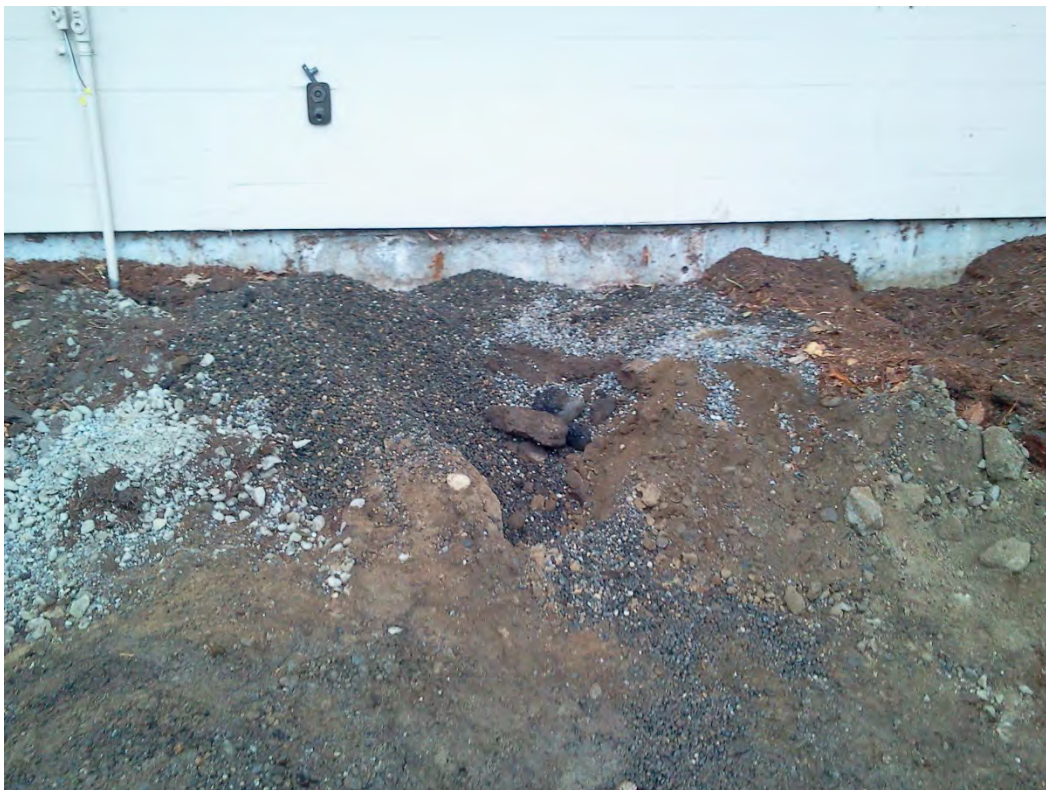
Photo 008 – October 8, 2015

Looking south at the former dispenser location where petroleum-impacted soil was encountered, prior to excavation.

Following removal of the dispenser and its small concrete pad, petroleum-impacted soil was excavated from below the former dispenser on October 8, 2015. The excavation of impacted soil was monitored using olfactory senses and a PID. Initial PID readings ranged from 30 to 40 ppm and dissipated as the excavation progressed. Soil from the perimeter and base of the final excavation indicated no petroleum odors, and the PID readings were 0.0 ppm. The dimensions of the final impacted soil excavation at the former dispenser were approximately 8 feet long by 6 feet wide by 4.5 feet deep. Following removal of the petroleum-impacted soil, confirmation soil samples were collected from the perimeter and base of the impacted soil excavation, submitted to F&B and analyzed for: diesel- and oil-range TPH using NWTPH-Dx; BTEX using EPA Method 8021B; and PAHs using EPA Method 8270D SIM.

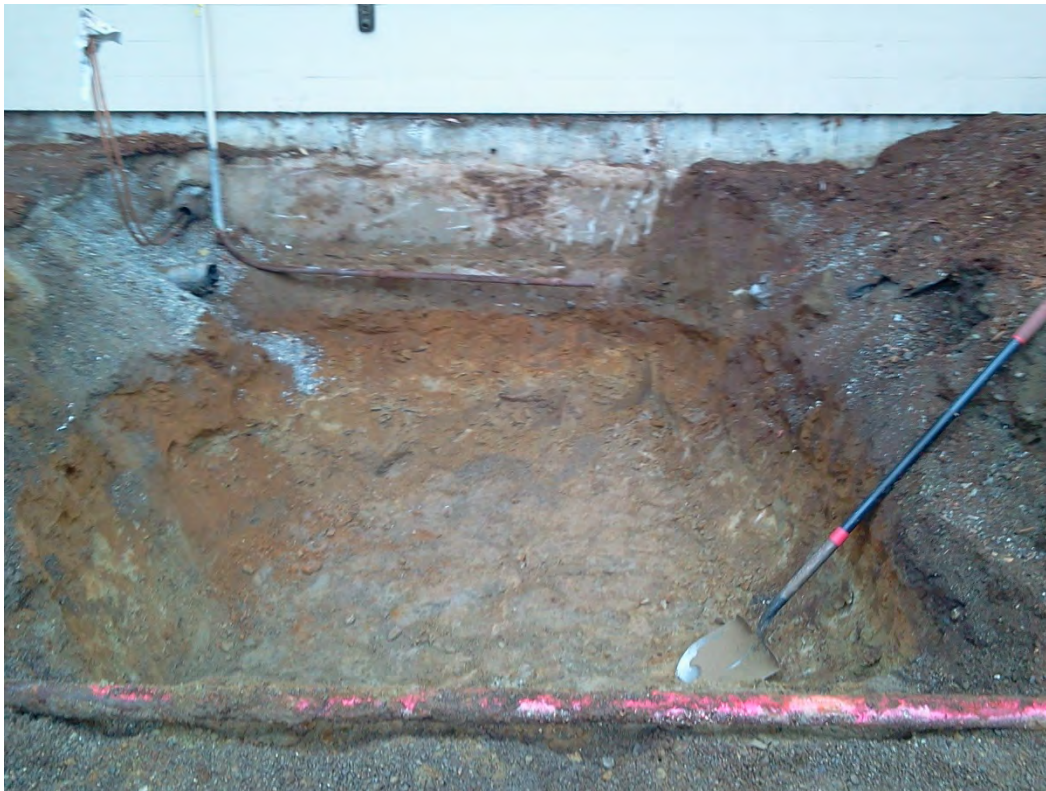
Photo 009 – October 8, 2015

Looking south at the excavation area (7'Wx8'Lx4.5'D) to remove the petroleum-impacted soil that was observed below the former dispenser location.

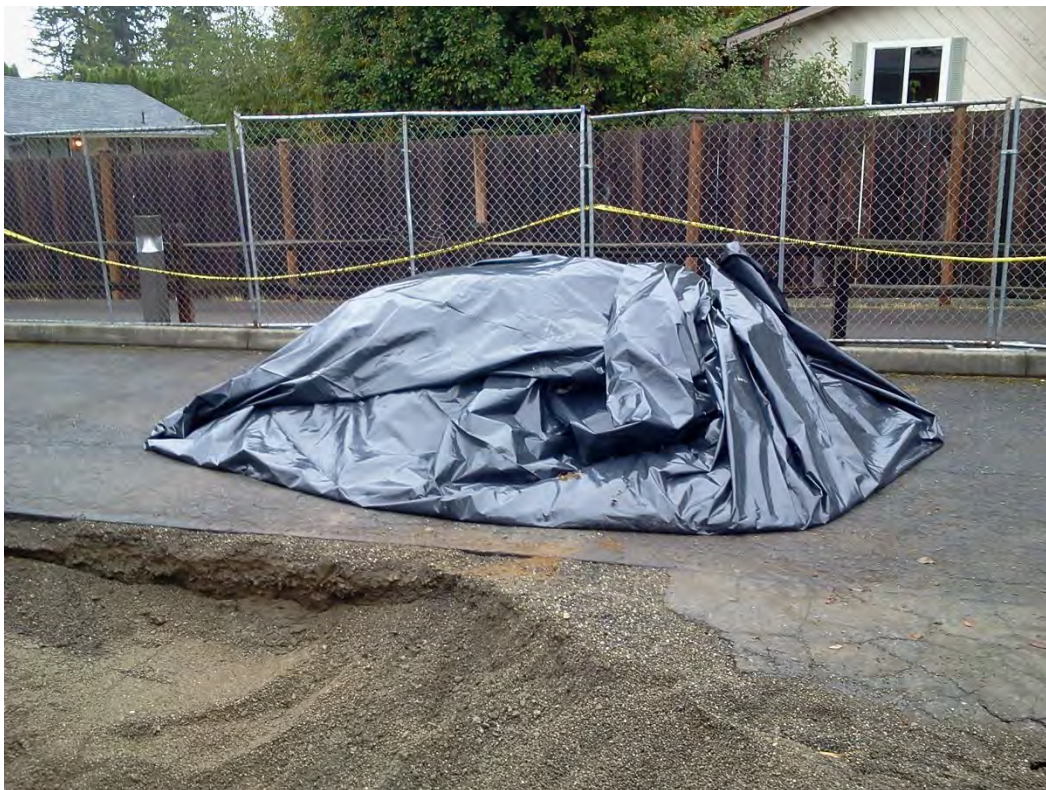
Photo 010 – October 8, 2015

Looking north at ~8 tons of petroleum-impacted soil placed on and covered with plastic. The soil was eventually hauled to Cemex for disposal.

The petroleum-impacted soil (8.03 tons) removed from the excavation below the former dispenser was hauled to the CEMEX USA soil remediation facility in Everett, Washington, for thermal treatment and disposal on October 13, 2015. A copy of the weight ticket documenting soil disposal is included in Appendix A.
