**REMEDIAL INVESTIGATION
LOPEZ VILLAGE MARKET
214 LOPEZ ROAD
LOPEZ ISLAND, WASHINGTON**

**FACILITY SITE ID# 87787992
VCP# NW2372**

September 23, 2011

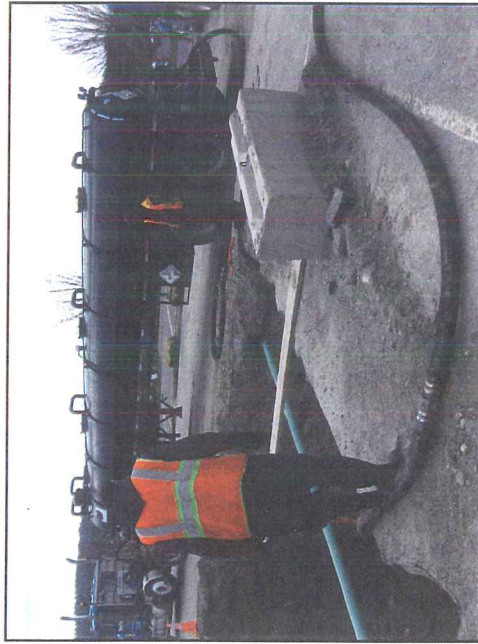
Photograph 3. A view to the south of MarVac Services removing pit water from the western tank pit prior to excavation of PCS.

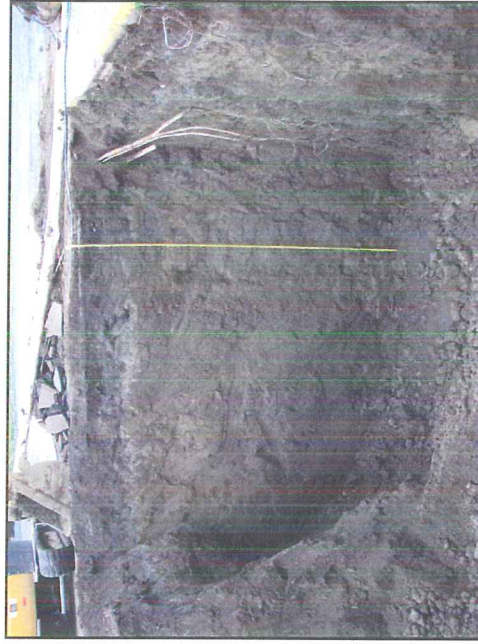
Photograph 4. A view to the west looking at the western tank pit west sidewall. Note the dry silt and no evidence of groundwater recharge.

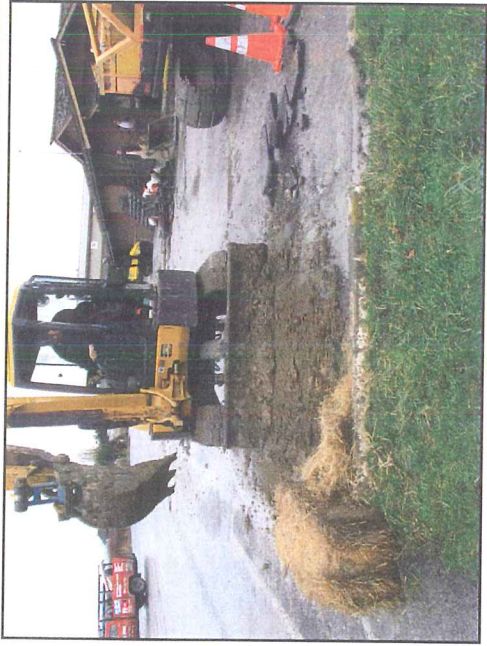
Photograph 5. A view to the northeast from the southwest corner of the subject property looking at the location of Test Pit #10.

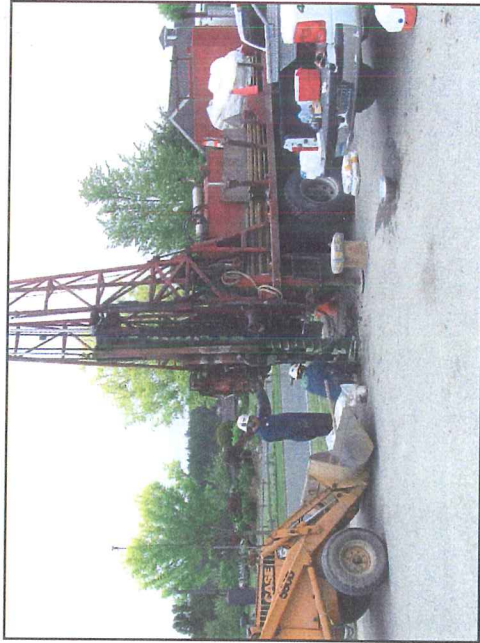
Photograph 7. A view to the southwest looking at the well installation process for monitoring well MW-3.

MW-3 was also drilled to 30 feet bgs and the well was installed using a 20 foot screen length (screened from 10 to 30 feet bgs). The well was checked for water for over 1 hour and remained dry until the geologist left the site. Two weeks later when the site was visited to develop the wells the depth-to-water in well MW-3 was 5.25 feet bgs, again indicating that groundwater exists under confined or semi-confined conditions at the site.
