**Final
Remedial Investigation/Feasibility Study
Volume I: Remedial Investigation Report**

R.G. Haley Site
Bellingham, Washington

for
City of Bellingham

February 1, 2016

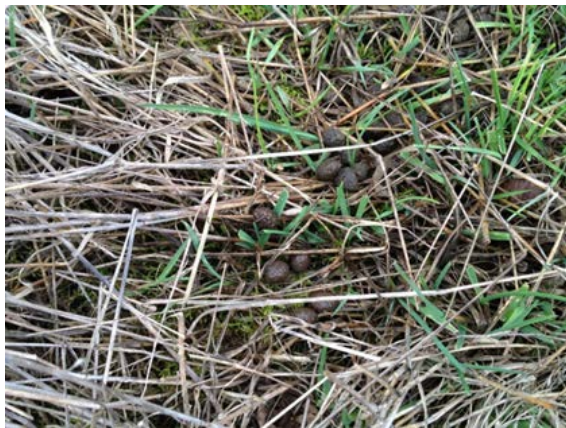
Deer scat

Wildlife observed at the Site during the November 2012 upland survey included dark-eyed juncos, glaucous-winged gulls, bufflehead, and double-crested cormorants. Deer scat and hoof prints were observed throughout the upland. The remains of a bird (scattered feathers and limb parts) were observed in one area. No evidence of vole runways or shallow burrows was observed. Similarly, no evidence of habitat use by shrews was observed (signs of habitat use by shrews can be difficult to find; however, shrews often co-exist with voles and make use of voles' runways). On previous visits to the Site, Canada geese and harbor seals were observed in Bellingham Bay adjacent to the upland.

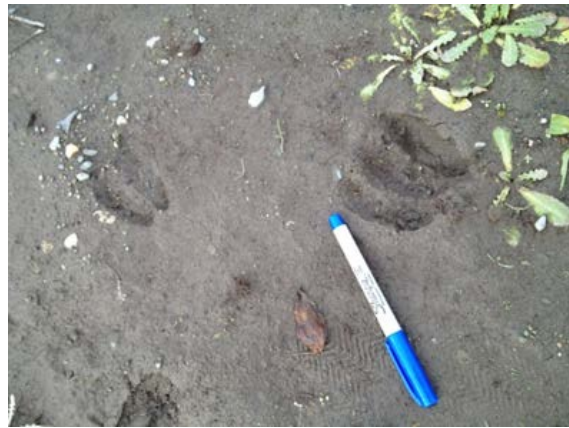
Deer hoof prints

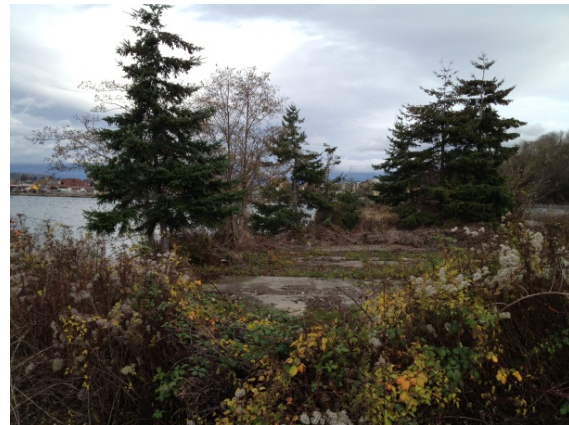
Marine Riparian Area: blackberry and small trees.

A marine riparian area approximately 90 to 100 feet wide exists along the upland shoreline bank. Vegetation within this marine riparian area consists of red alder, black cottonwood, Douglas-fir, Scotch broom, Himalayan blackberry, common tansy, and common mullein. The majority of the marine riparian area is dominated by grasses and weedy herbaceous species (e.g., tansy), with patches of native trees and non-native shrubs. Immediately southwest of the sheet pile barrier, ten Douglas-fir and four red alder trees
