**Total Petroleum Hydrocarbon Results for Surface Sediment**

R.G. Haley Site Bellingham, Washington

**Total Petroleum Hydrocarbon Results for Subsurface Sediment** R.G. Haley Site Bellingham, Washington GEOENGINEERS Figure 6-45

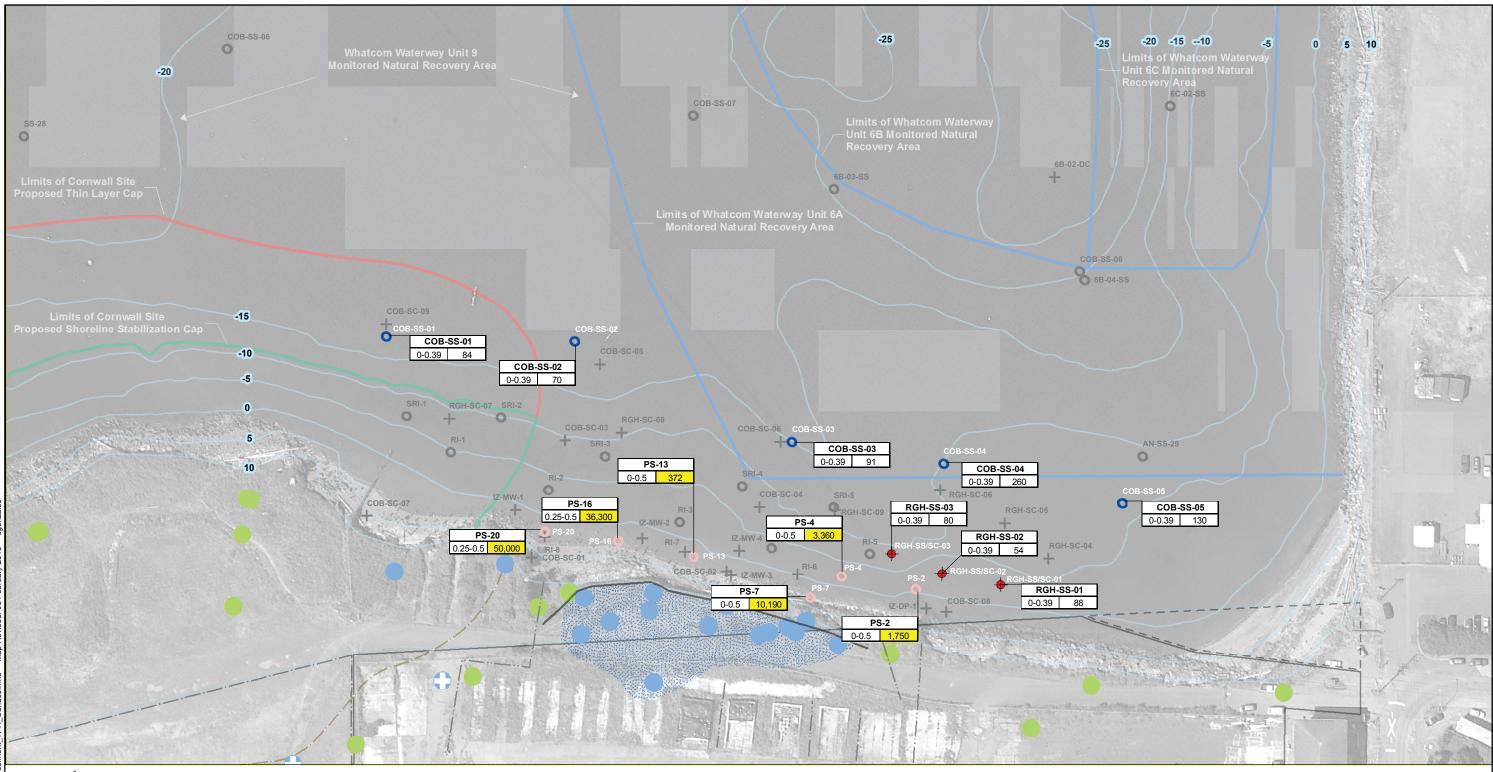
### Total Petroleum Hydrocarbon Results

U indicates chemical not detected

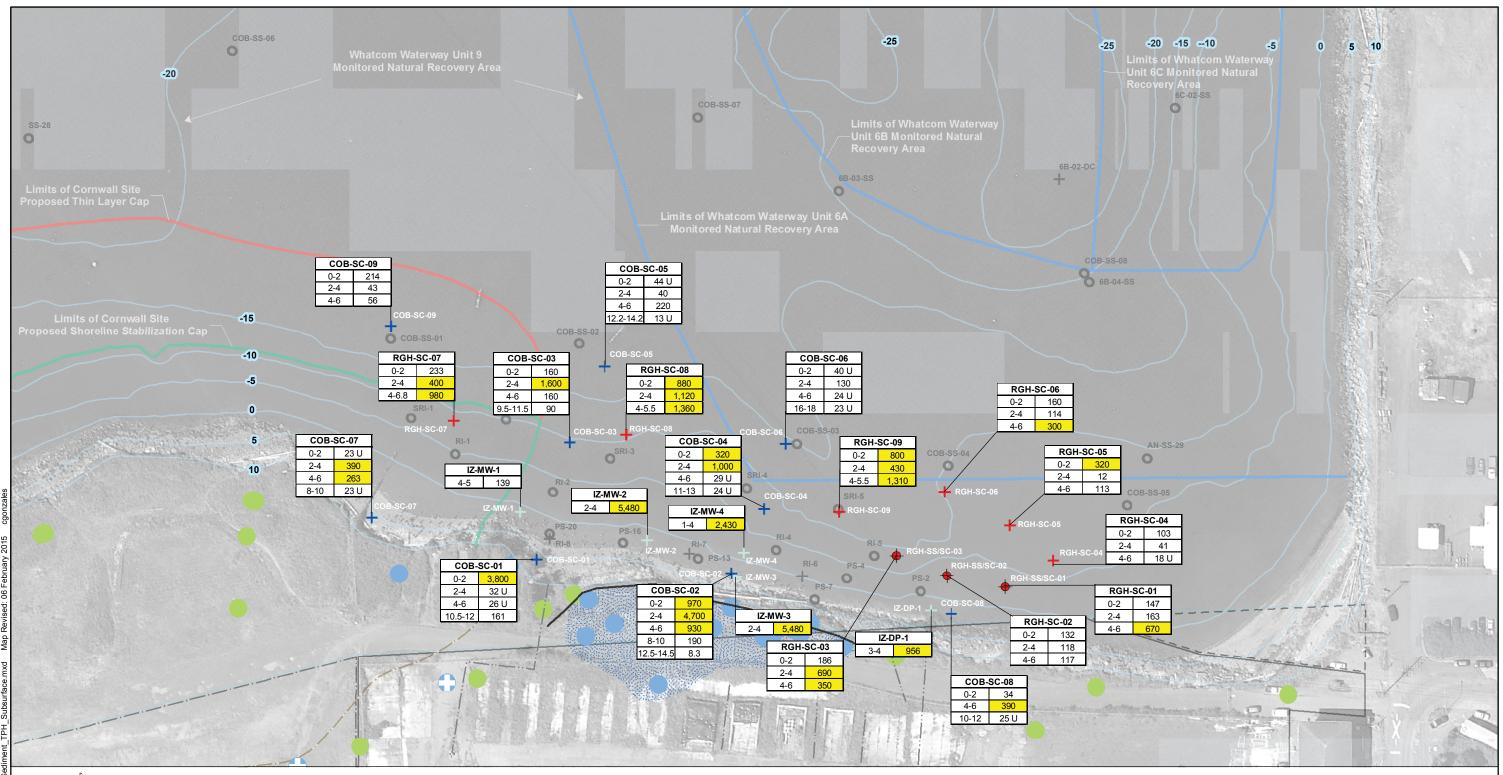
Indicates exceedance of 260 mg/kg screening level

U indicates chemical not detected at identified detection limit

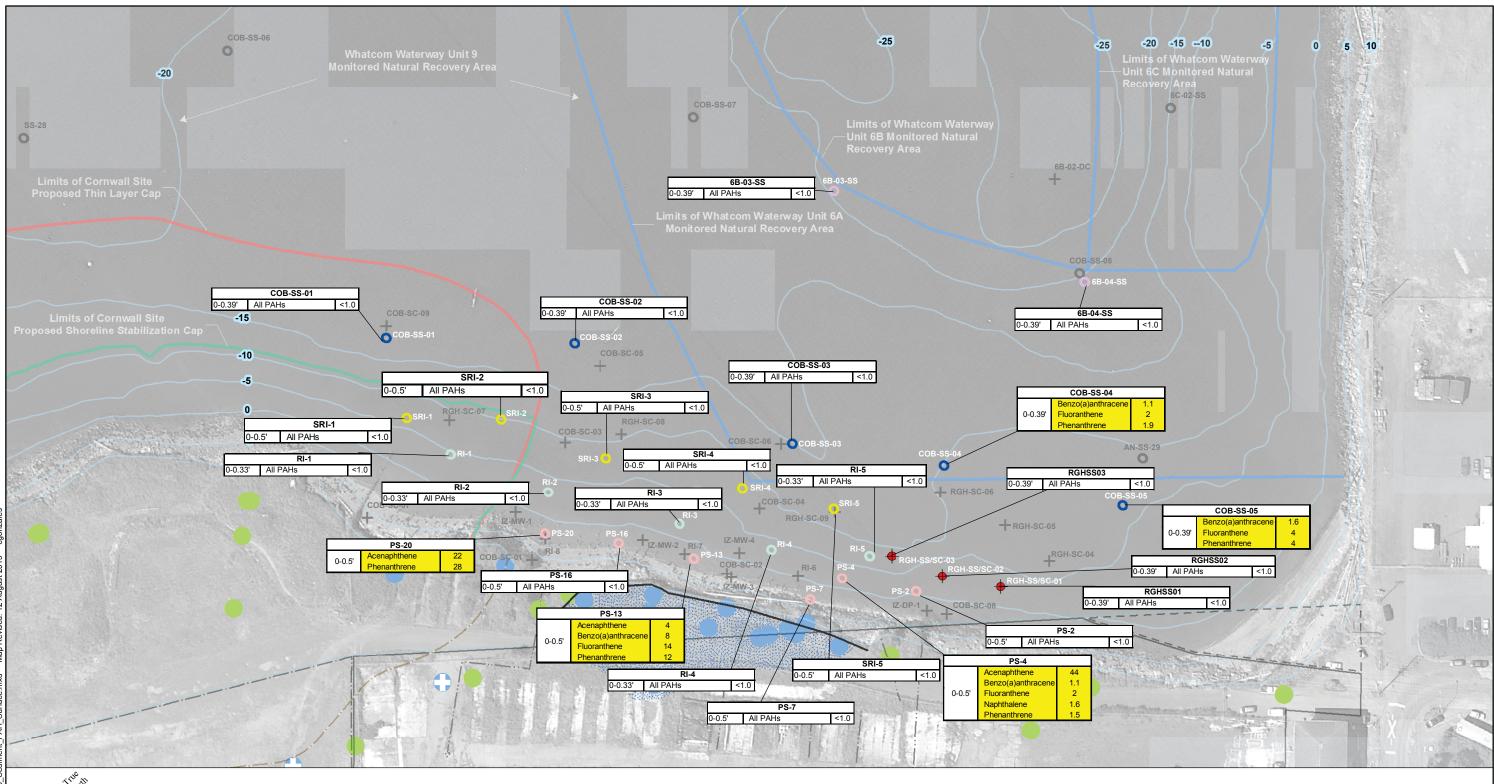
Exceedance factors calculated relative to SCO or LAET, depending on sample organic carbon content.

Results for individual compounds are shown only for IHSs with EF > 1.0

Polycyclic Aromatic Hydrocarbon IHSs Results for Surface Sediment R.G. Haley Site Bellingham, Washington

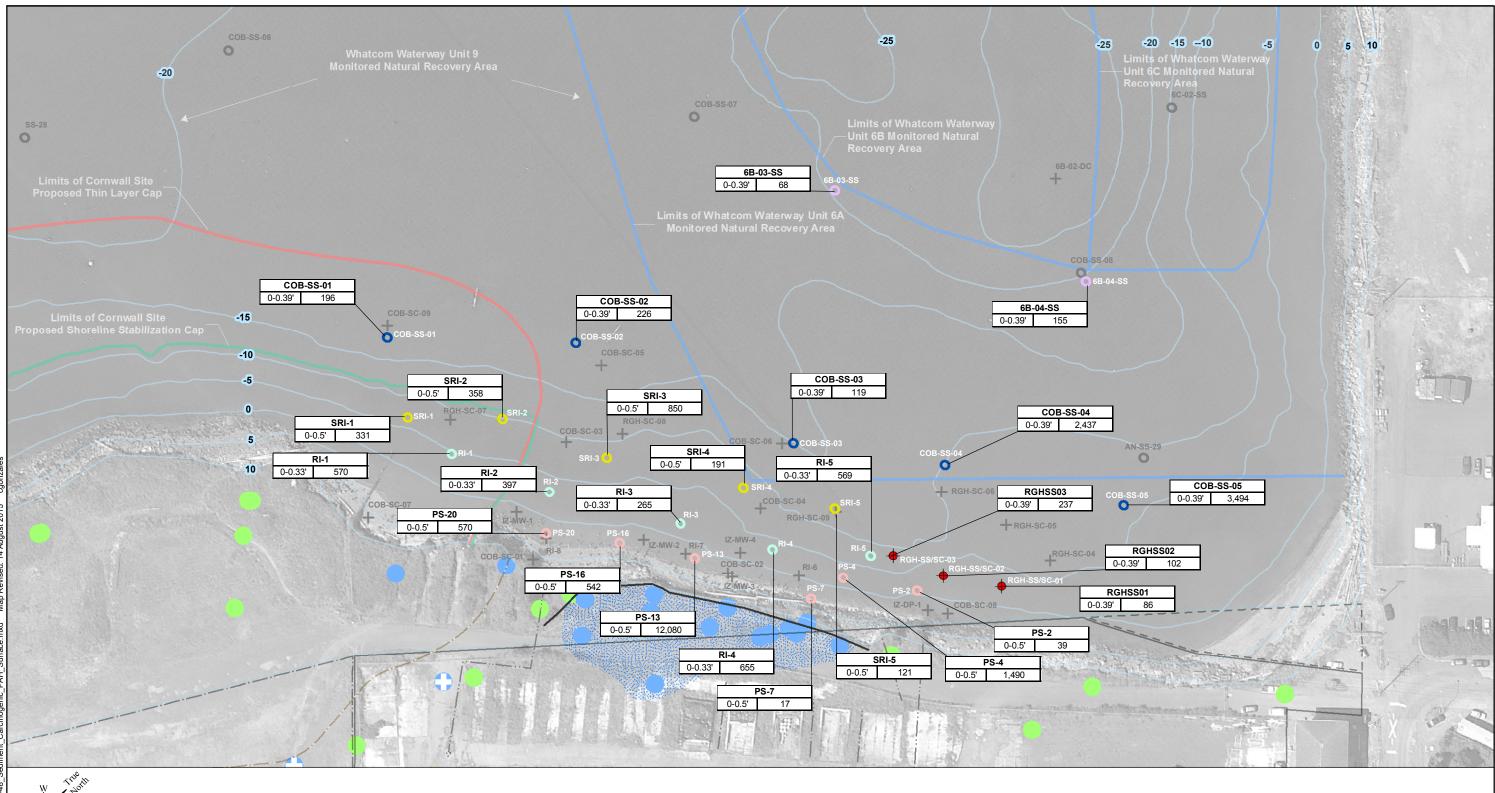
as the toxic equivalent (TEQ) of benzo(a)pyrene

Natural background (21 µg/kg)

was used as screening level

Carcinogenic Polycyclic Aromatic Hydrocarbon **TEQ Results for Surface Sediment**

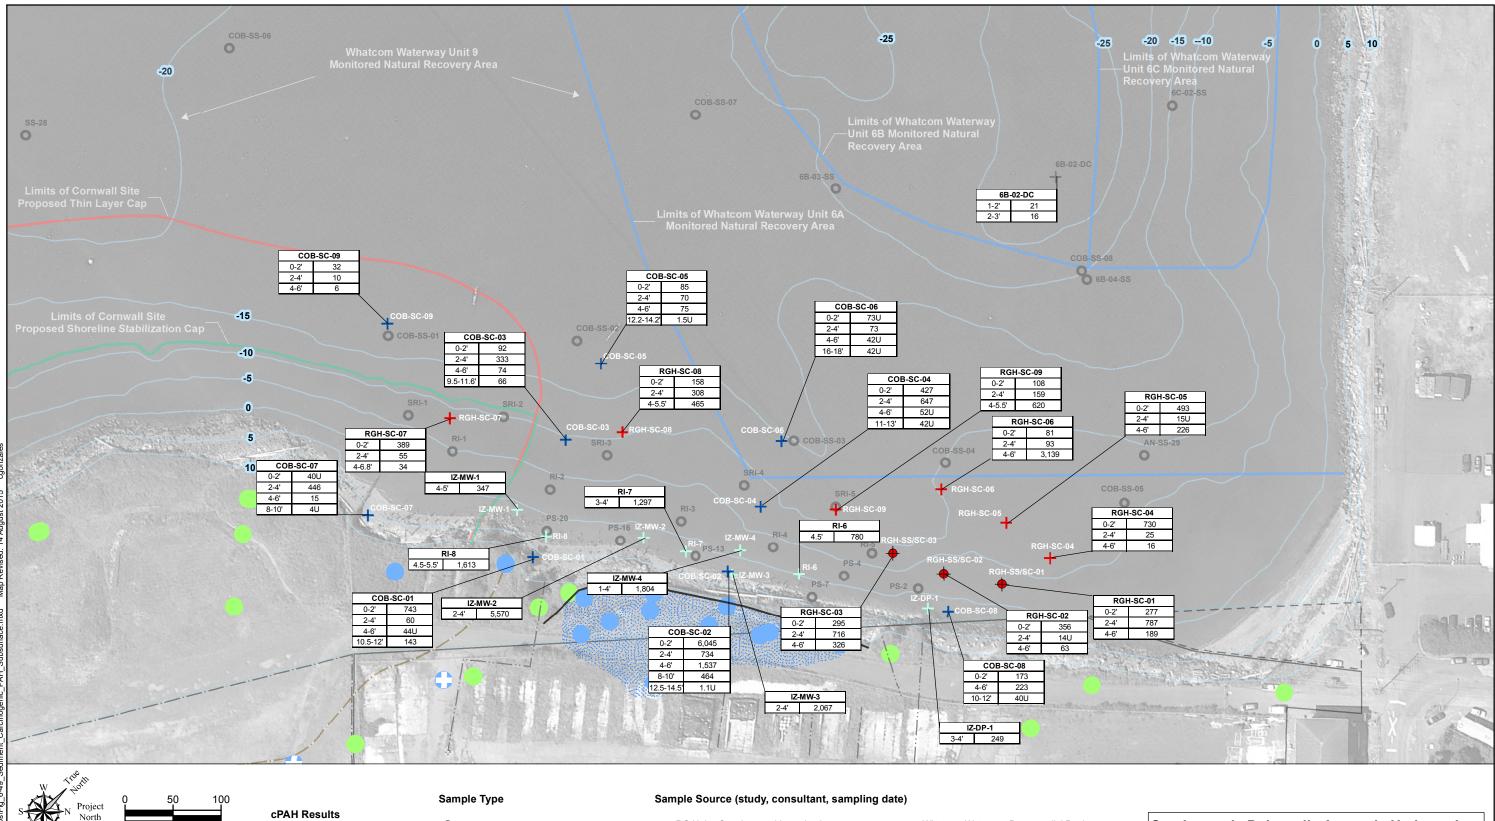
as the toxic equivalent (TEQ)

Natural background (21 µg/kg)

was used as screening level

Carcinogenic Polycyclic Aromatic Hydrocarbon **TEQ Results for Subsurface Sediment**

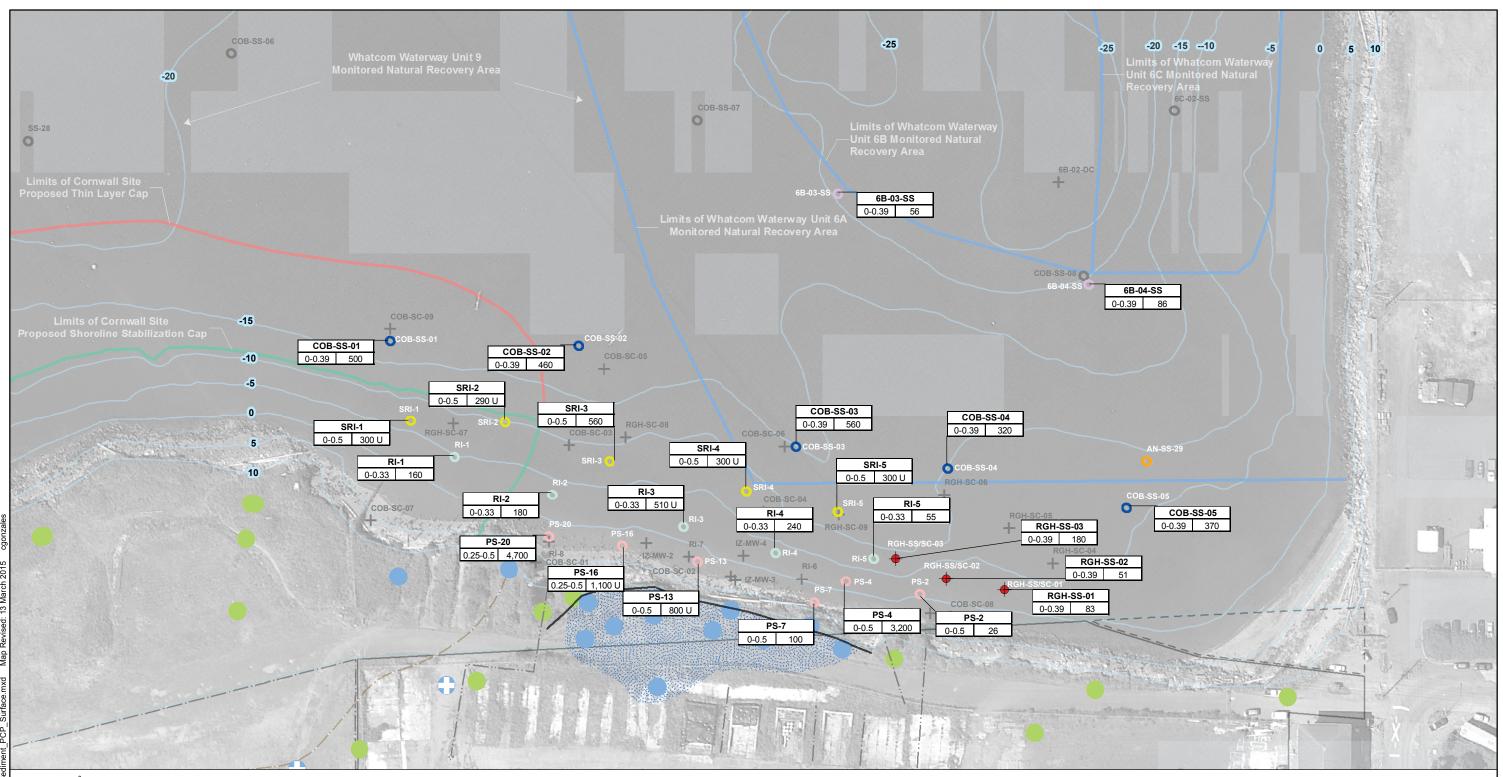
### Pentachlorophenol Results

PQL (100 µg/kg) was used as the

screening level

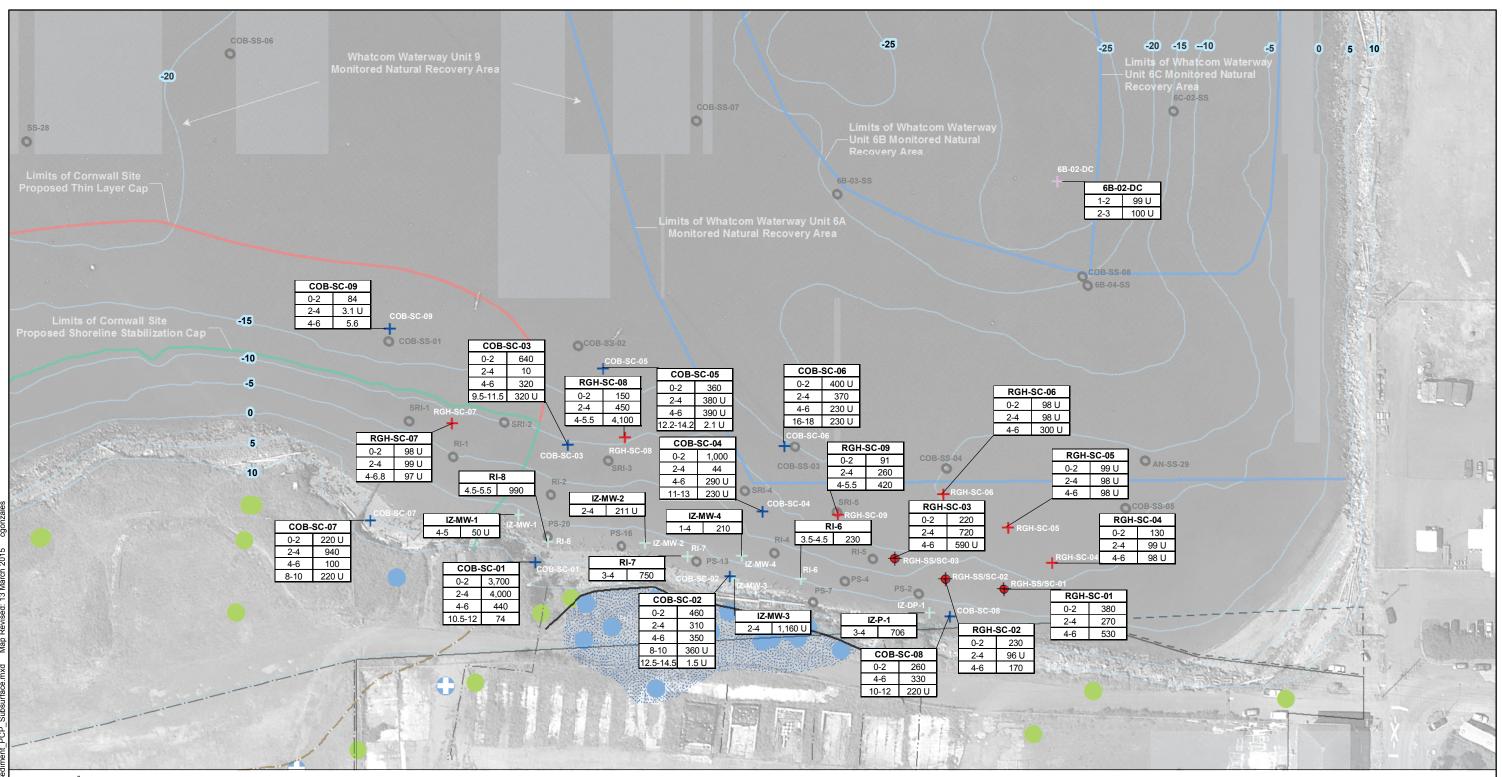
### Pentachlorophenol Results

U indicates chemical not detected at identified detection limit PQL (100 µg/kg) was used as the

screening level

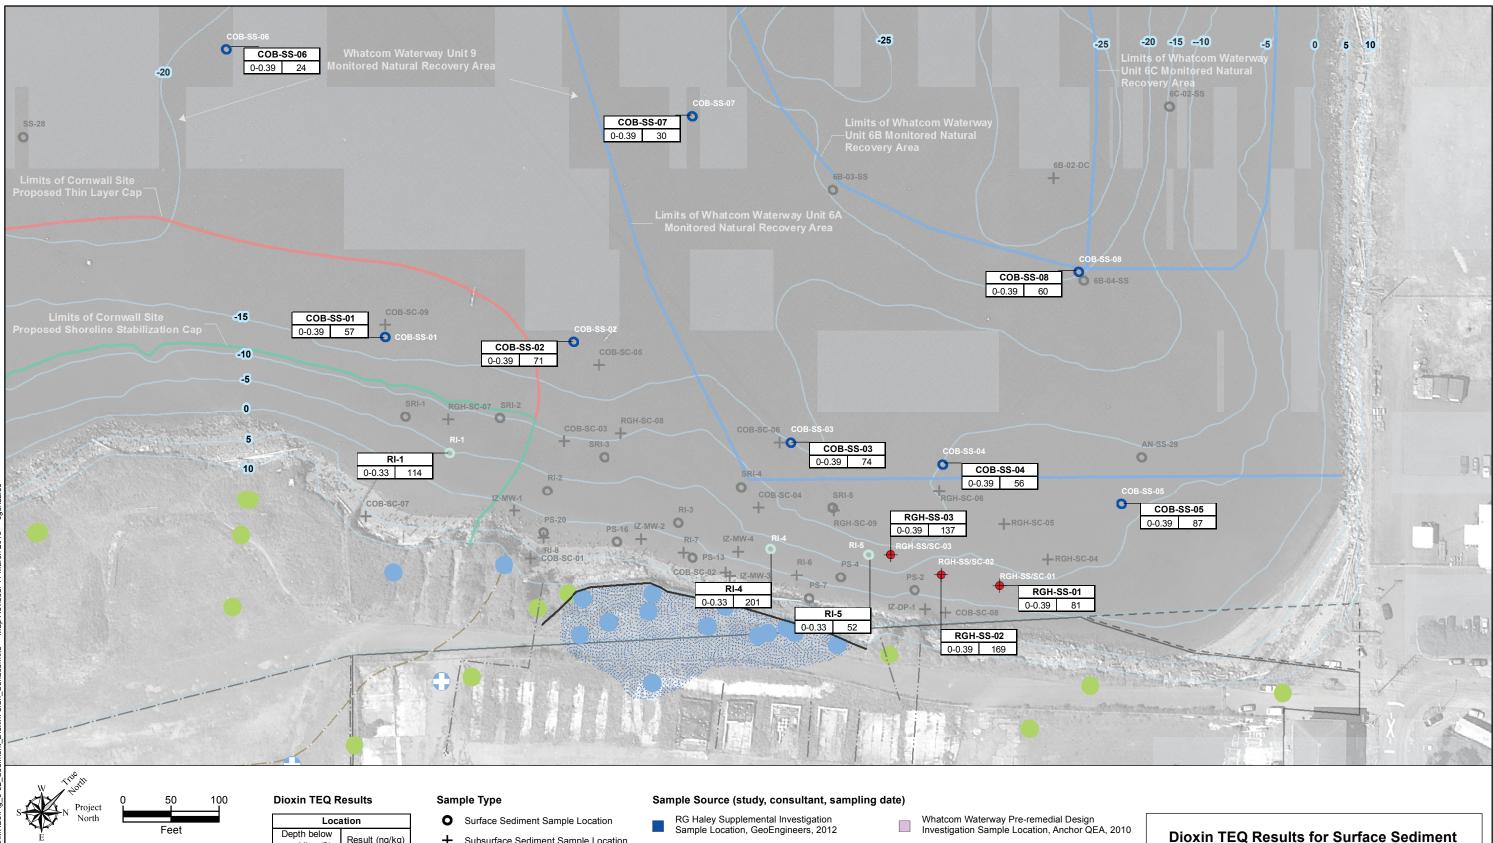
Natural background (4 ng/kg)

was used as screening level

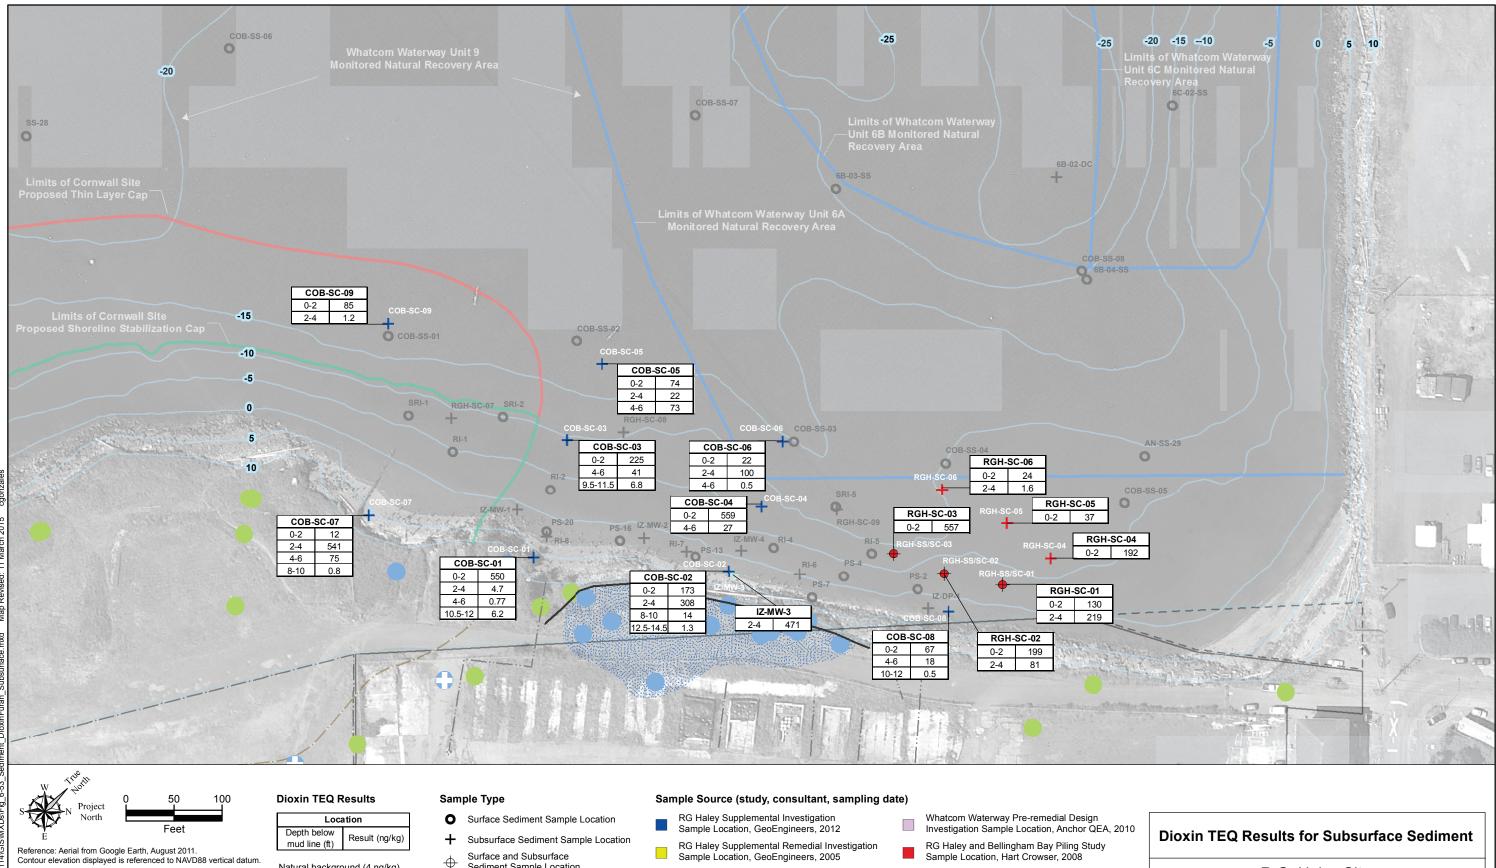
- Natural background (4 ng/kg)

was used as screening level

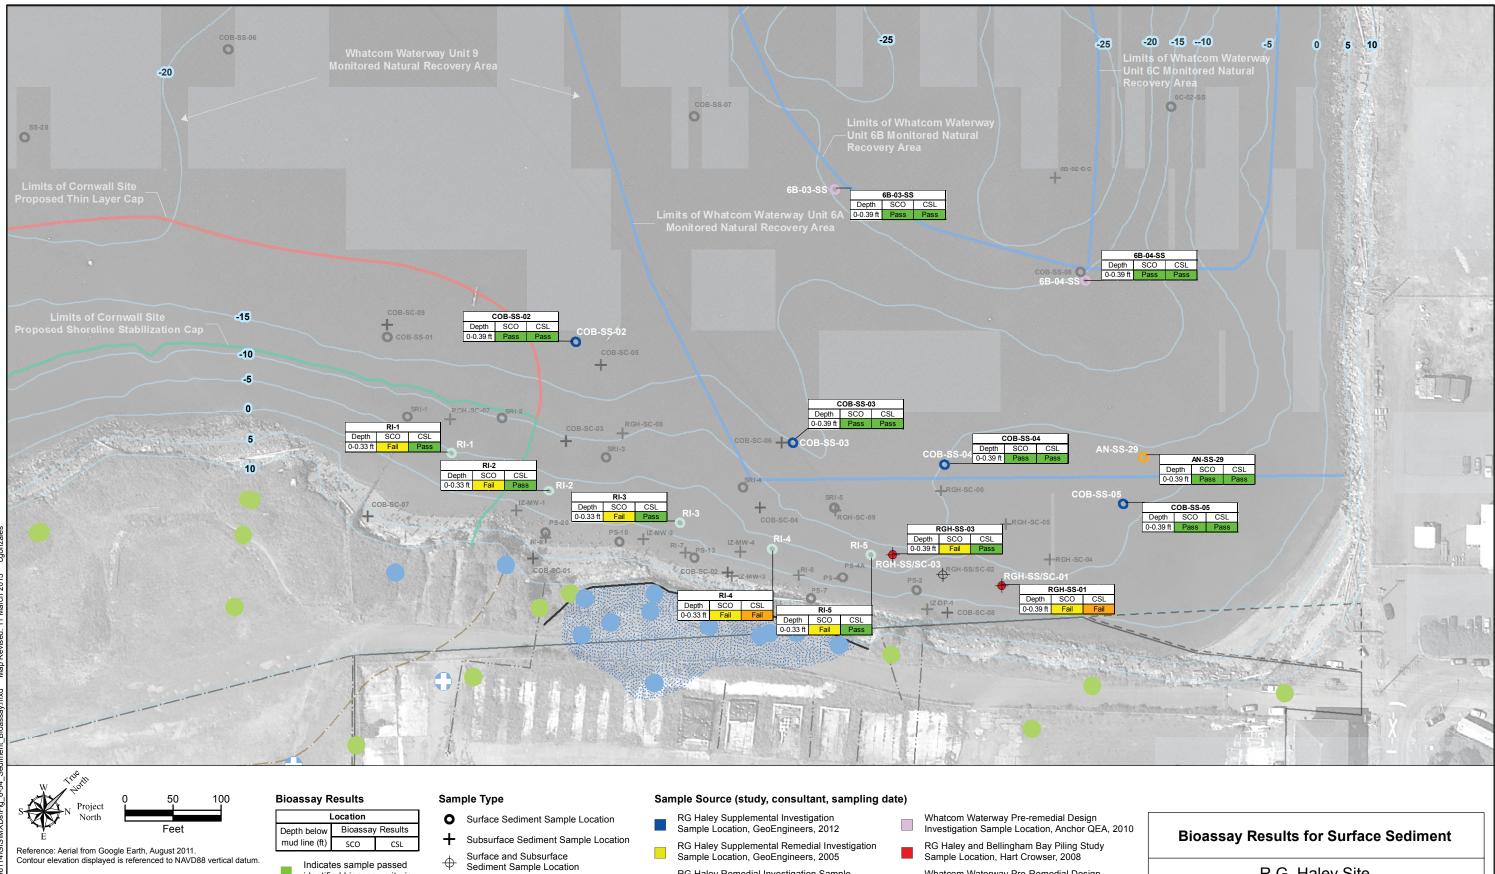
- identified bioassay criteria
- Indicates exceedance of SCO bioassay criteria Indicates exceedance of
- CSL bioassay criteria

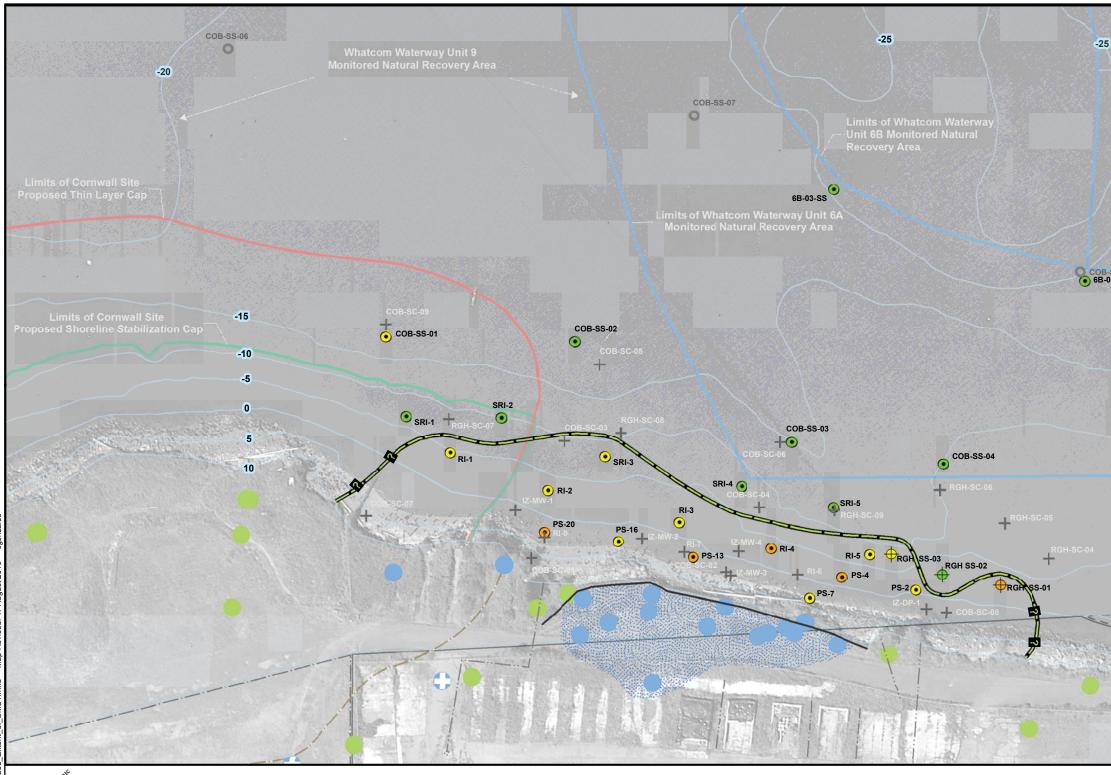
### Sediment Sample Results

- Exceeds CSL/2LAET Chemical or Biological Criterion for One or More Site Contaminants
- Exceeds SCO/LAET Chemical or Biological Criterion for One or More  $\bigcirc$ Site Contaminants
- Meets SMS Benthic Criteria for Site Contaminants
- Estimated boundary of sediment exceedances for SMS benthic chemical and/or toxicity criteria

2	Key						
-55-08 04-55	- P		te					
		Conta	minant					
		Concentrations Exceed SMS?		Biological Test Results				
	Sample ID	SCO	CSL	SCO	CSL	Final		
	PS-2	Yes	No			SCO		
	PS-4	Yes	Yes			CSL		
	PS-7	Yes	No			SCO		
	PS-13	Yes	Yes			CSL		
	PS-16	Yes	No			SCO		
	PS-20	Yes	Yes			CSL		
	RI-1	No	No	Fail	Pass	SCO		
	RI-2	No	No	Fail	Pass	SCO		
	RI-3	No	No	Fail	Pass	SCO		
	RI-4	No	No	Fail	Fail	CSL		
AN-SS-29	RI-5	No	No	Fail	Pass	SCO		
COB-SS-05	SRI-1	No	No			Pass		
	SRI-2	No	No			Pass		
	SRI-3	Yes	No			SCO		
	SRI-4	No	No			Pass		
	SRI-5	No	No			Pass		
	RGH-SS-01	No	No	Fail	Fail	CSL		
	RGH-SS-02	No	No			Pass		
	RGH-SS-03	No	No	Fail	Pass	SCO		
	/ 6B-03-SS	No	No	Pass	Pass	Pass

- 6B-04-SS	No	No	Pass	Pass	Pass		
	COB-SS-01	Yes	No			SCO		
	COB-SS-02	Yes	No	Pass	Pass	Pass		
hard and	COB-SS-03	Yes	No	Pass	Pass	Pass		
A P SSILL AN ARTEN	COB-SS-04	Yes	Yes	Pass	Pass	Pass		
	COB-SS-05	Yes	Yes	Pass	Pass	Pass		
	AN-SS-29	No	No	Pass	Pass	Pass		
Marthurson and a grander 1	=No Data/	= No Data/Not Tested						
1000 C	SCO = sedime	SCO = sediment cleanup objective						
	CSL = cleanu	CSL = cleanup screening level						
		SMS = Sediment Management Standards
