Historical Reference Materials

Former R.G. Haley Site
Bellingham, Washington

R.G. Haley Site: Commentary regarding Historical Evidence and Recommendations for Future Work

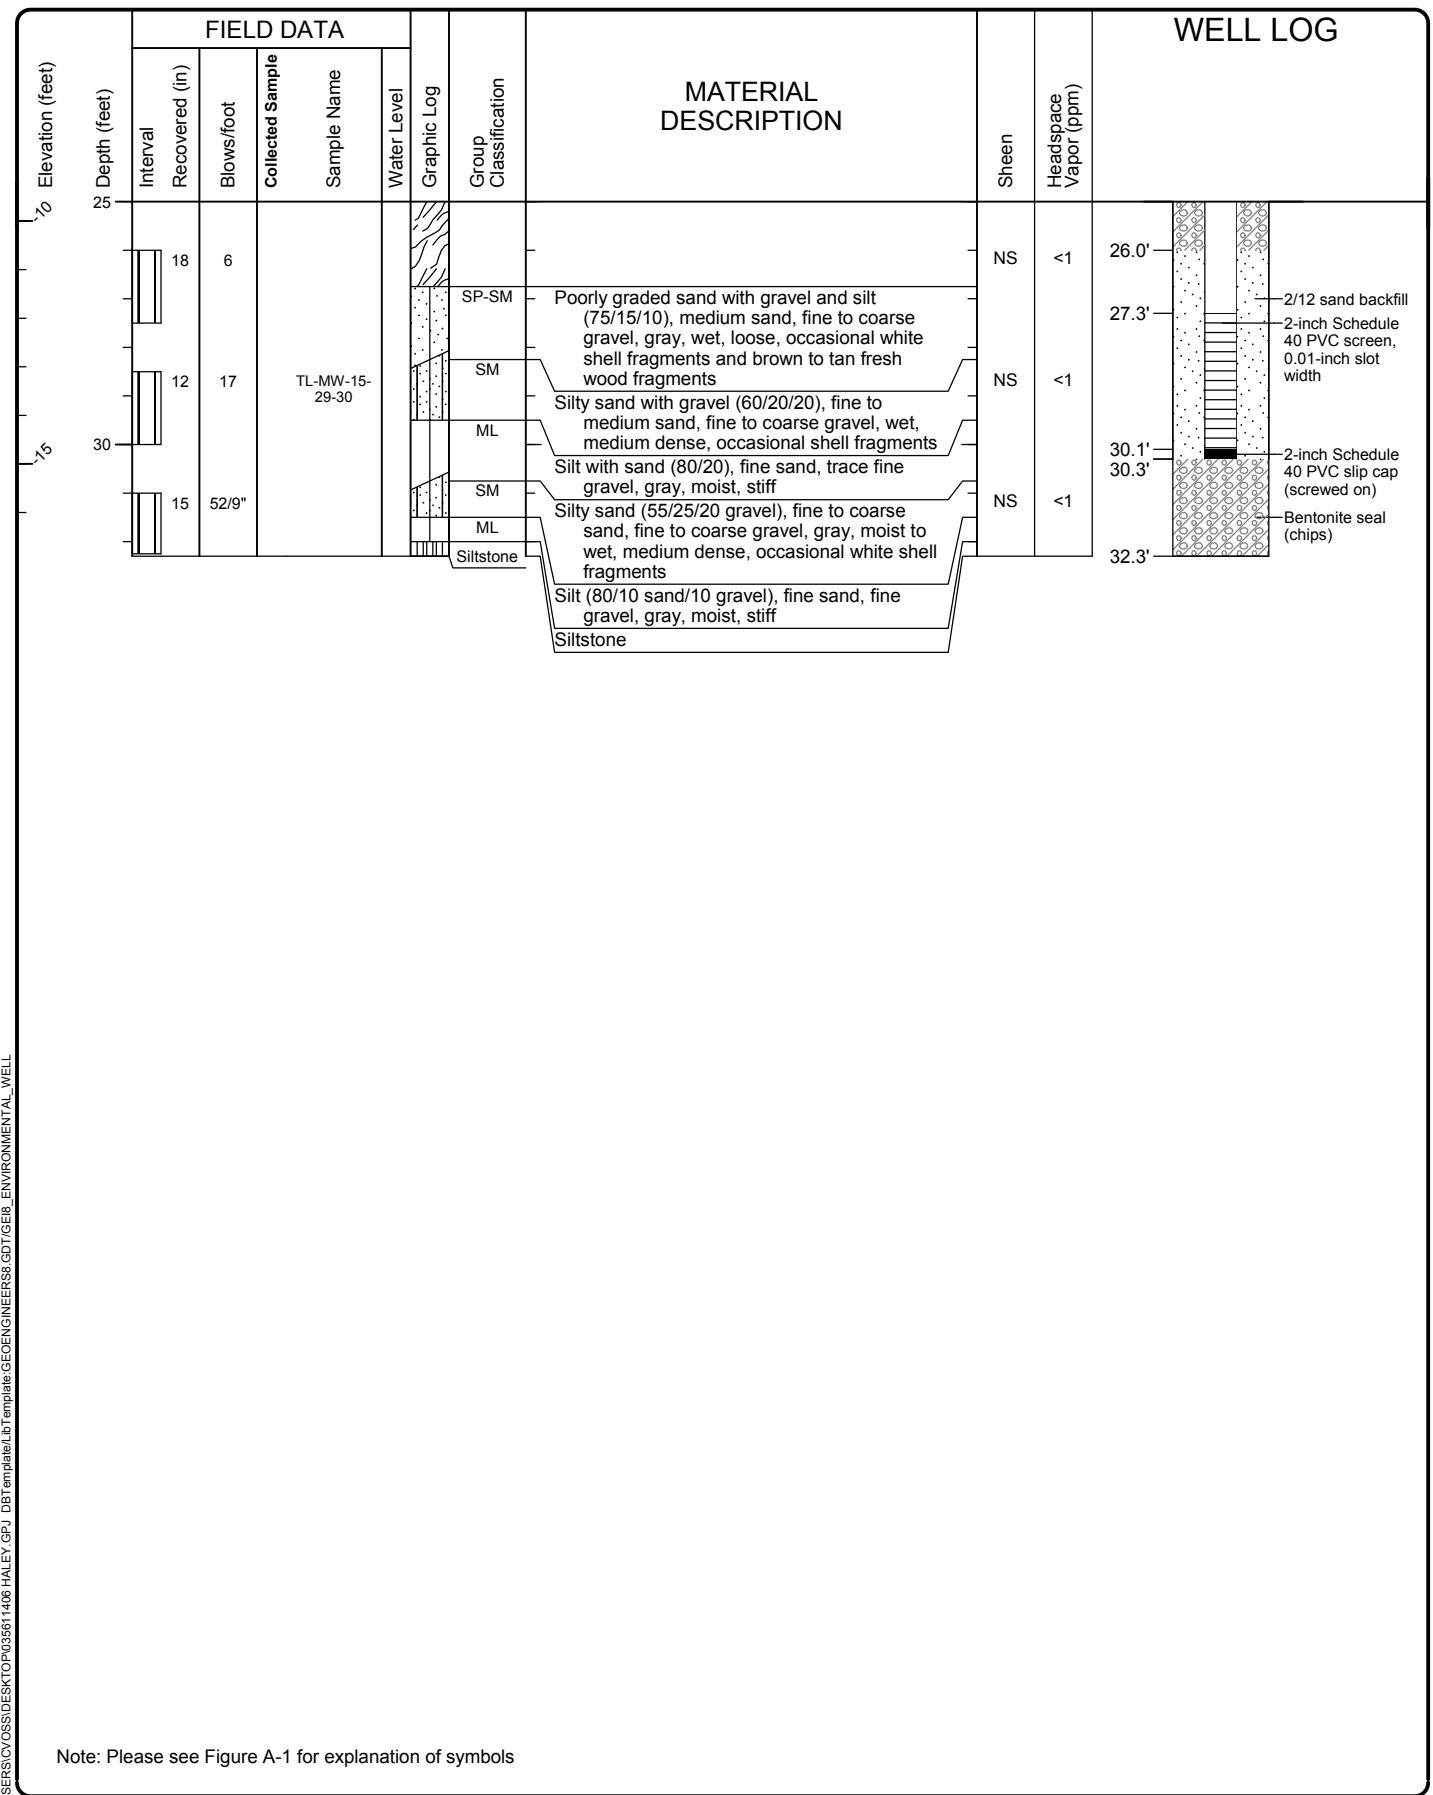
Start Drilled	End 6/28/2012	Total Depth (ft)	33.3	Logged By RNM Checked By CEB	Driller	Cascade Drilling, L.P.	Drilling Method	Hollow-stem Auger
Hammer Data	300 (lbs) / 30 (in) Drop	Drilling Equipment	Truck-mounted CME 75				DOE Well I.D.: BHE 979 A 2 (in) well was installed on 6/28/2012 to a depth of 32.7 (ft).	
Surface Elevation (ft) Vertical Datum	13.53 NAVD88	Top of Casing Elevation (ft)	12.99				Groundwater Date Measured	Depth to Water (ft) Elevation (ft)
Easting (X) Northing (Y)	639409.89 1240016.04	Horizontal Datum	NAD83/98				6/28/2012	6.0 7.5
Notes:	Auger Data: 4½-inch I.D.

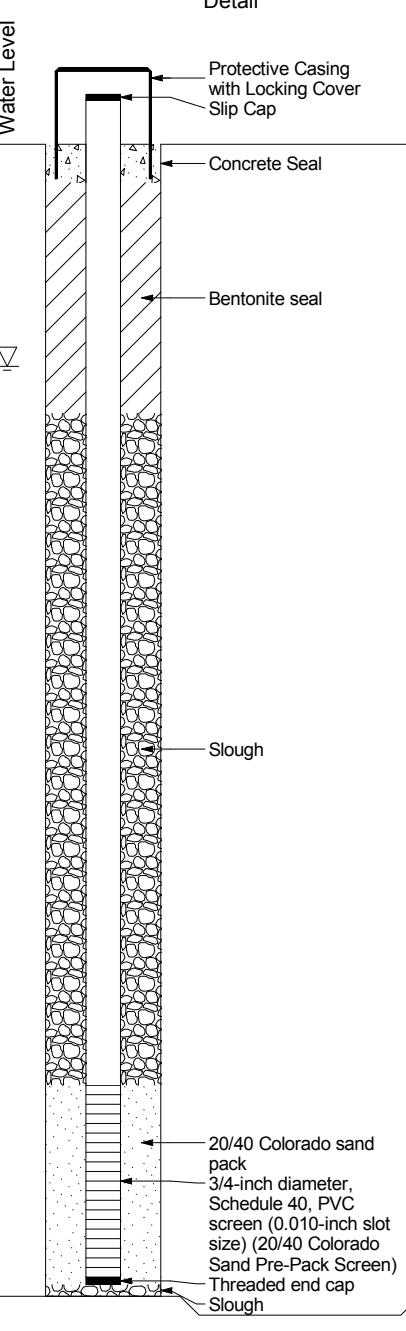
30	S-7	i4					- Drilling More Difficult 16 to 24 Feet - (No Recovery 16 to 30 Feet)	
35							Difficult to interpret fill/native contact. Bottom of well screen set at 30 feet as per Ecology recommendation.	
Boring Completed 07/18/12 Total Depth of Boring = 30.0 ft.								
Notes: 1. Stratigraphic contacts are based on field interpretations and are approximate. 2. Reference to the text of this report is necessary for a proper understanding of subsurface conditions. 3. Refer to "Soil Classification System and Key" figure for explanation of graphics and symbols. 4. Generalized log of MW-11D and MW-11S is shown here.								
CORNWALL LANDFILL SUPPLEMENTAL RI BELLINGHAM, WA								
Log of MW-11D								
Figure B-1

The diagram illustrates the borehole structure and its components. It shows a vertical borehole with various layers of soil and rock. Key features labeled include:

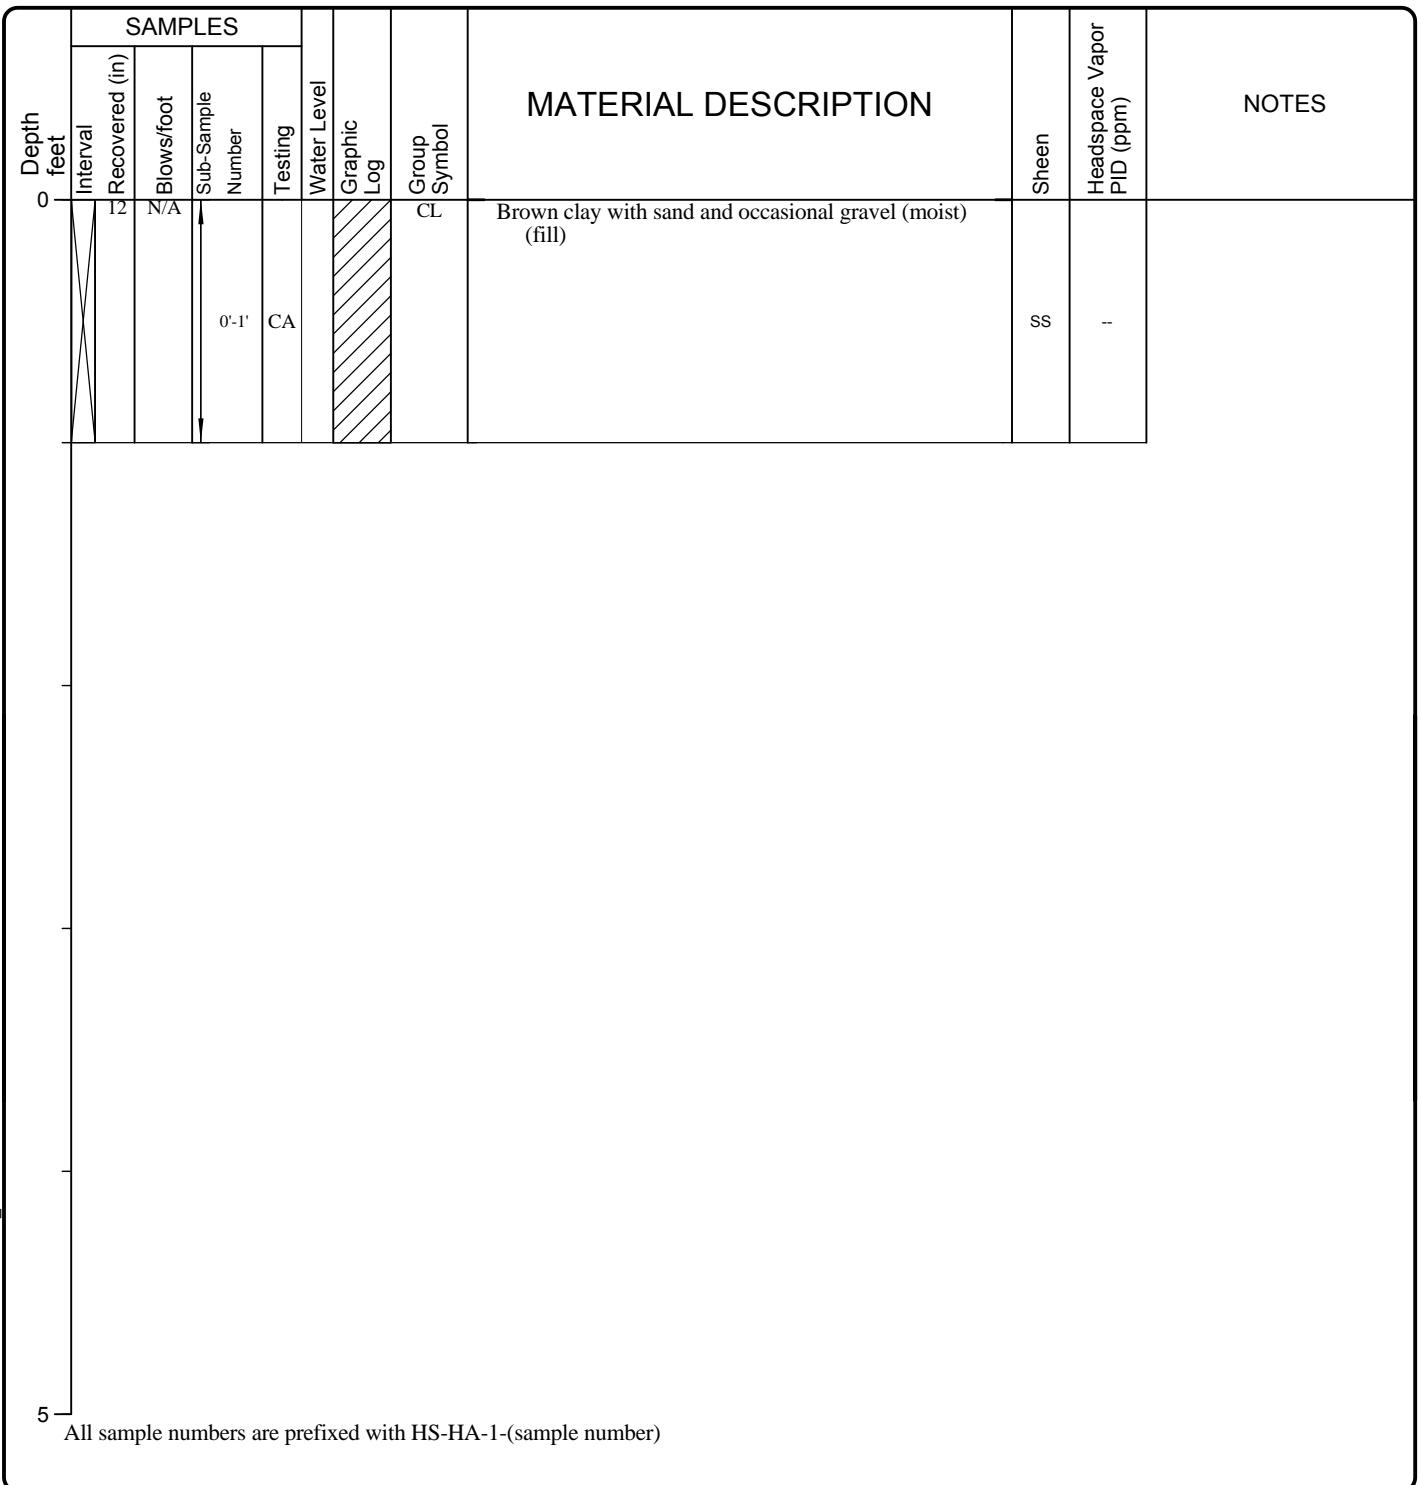
LOG OF HAND BORING HS-HA-1

Date(s) Drilled	06/14/2004 - 06/14/2004	Logged By	RMB	Checked By	BES
Drilling Contractor	N/A	Drilling Method	Hand Auger	Sampling Methods	Grab
Auger/Bit Data	3"	Hammer Data	N/A	Drilling Equipment	Stainless Steel
Total Depth (ft)	1	Surface Elevation (ft)	Not Measured	Groundwater Level (ft. bgs)	Not Encountered
Vertical Datum	City	Datum/ System	N/A N/A	Easting(x): Northing(y):

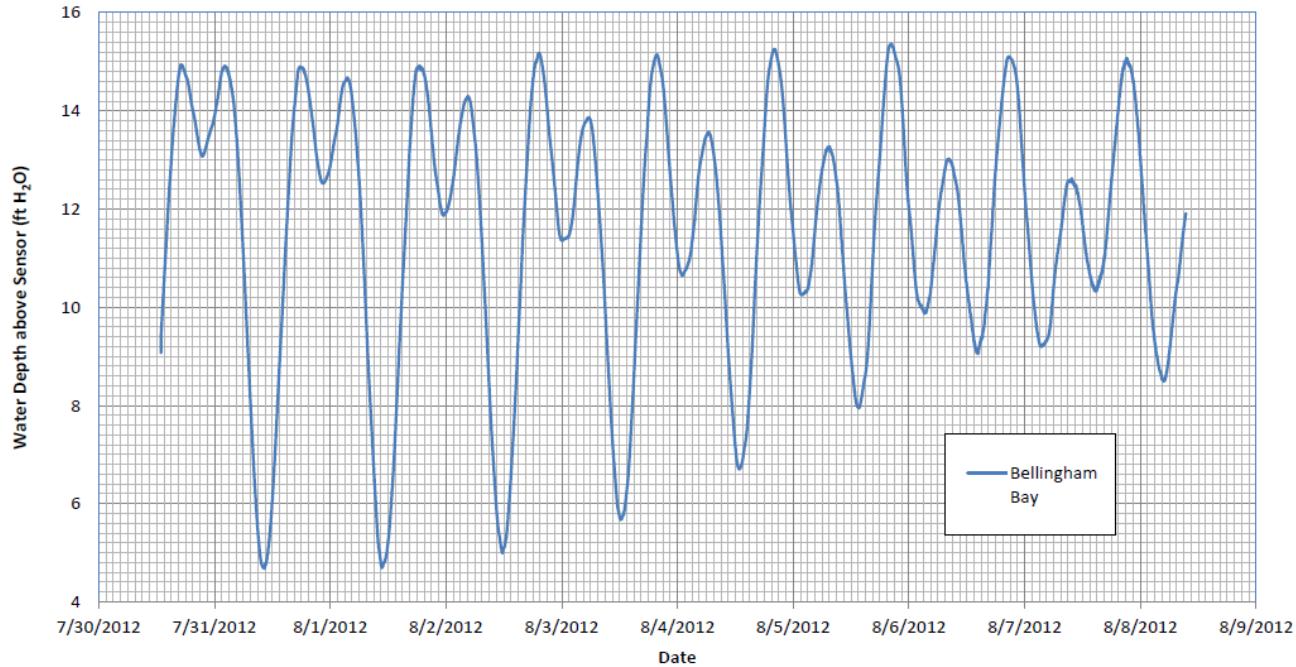
a) Tide Cycles Recorded in Bellingham Bay
