October 18, 2010

Re: Revised Phase II Environmental Site Assessment
Ridgefield Rail Overpass Project
Ridgefield, Washington
1161-01

Phase II Environmental Site Assessment
Ridgefield Rail Overpass Project
Ridgefield, Washington

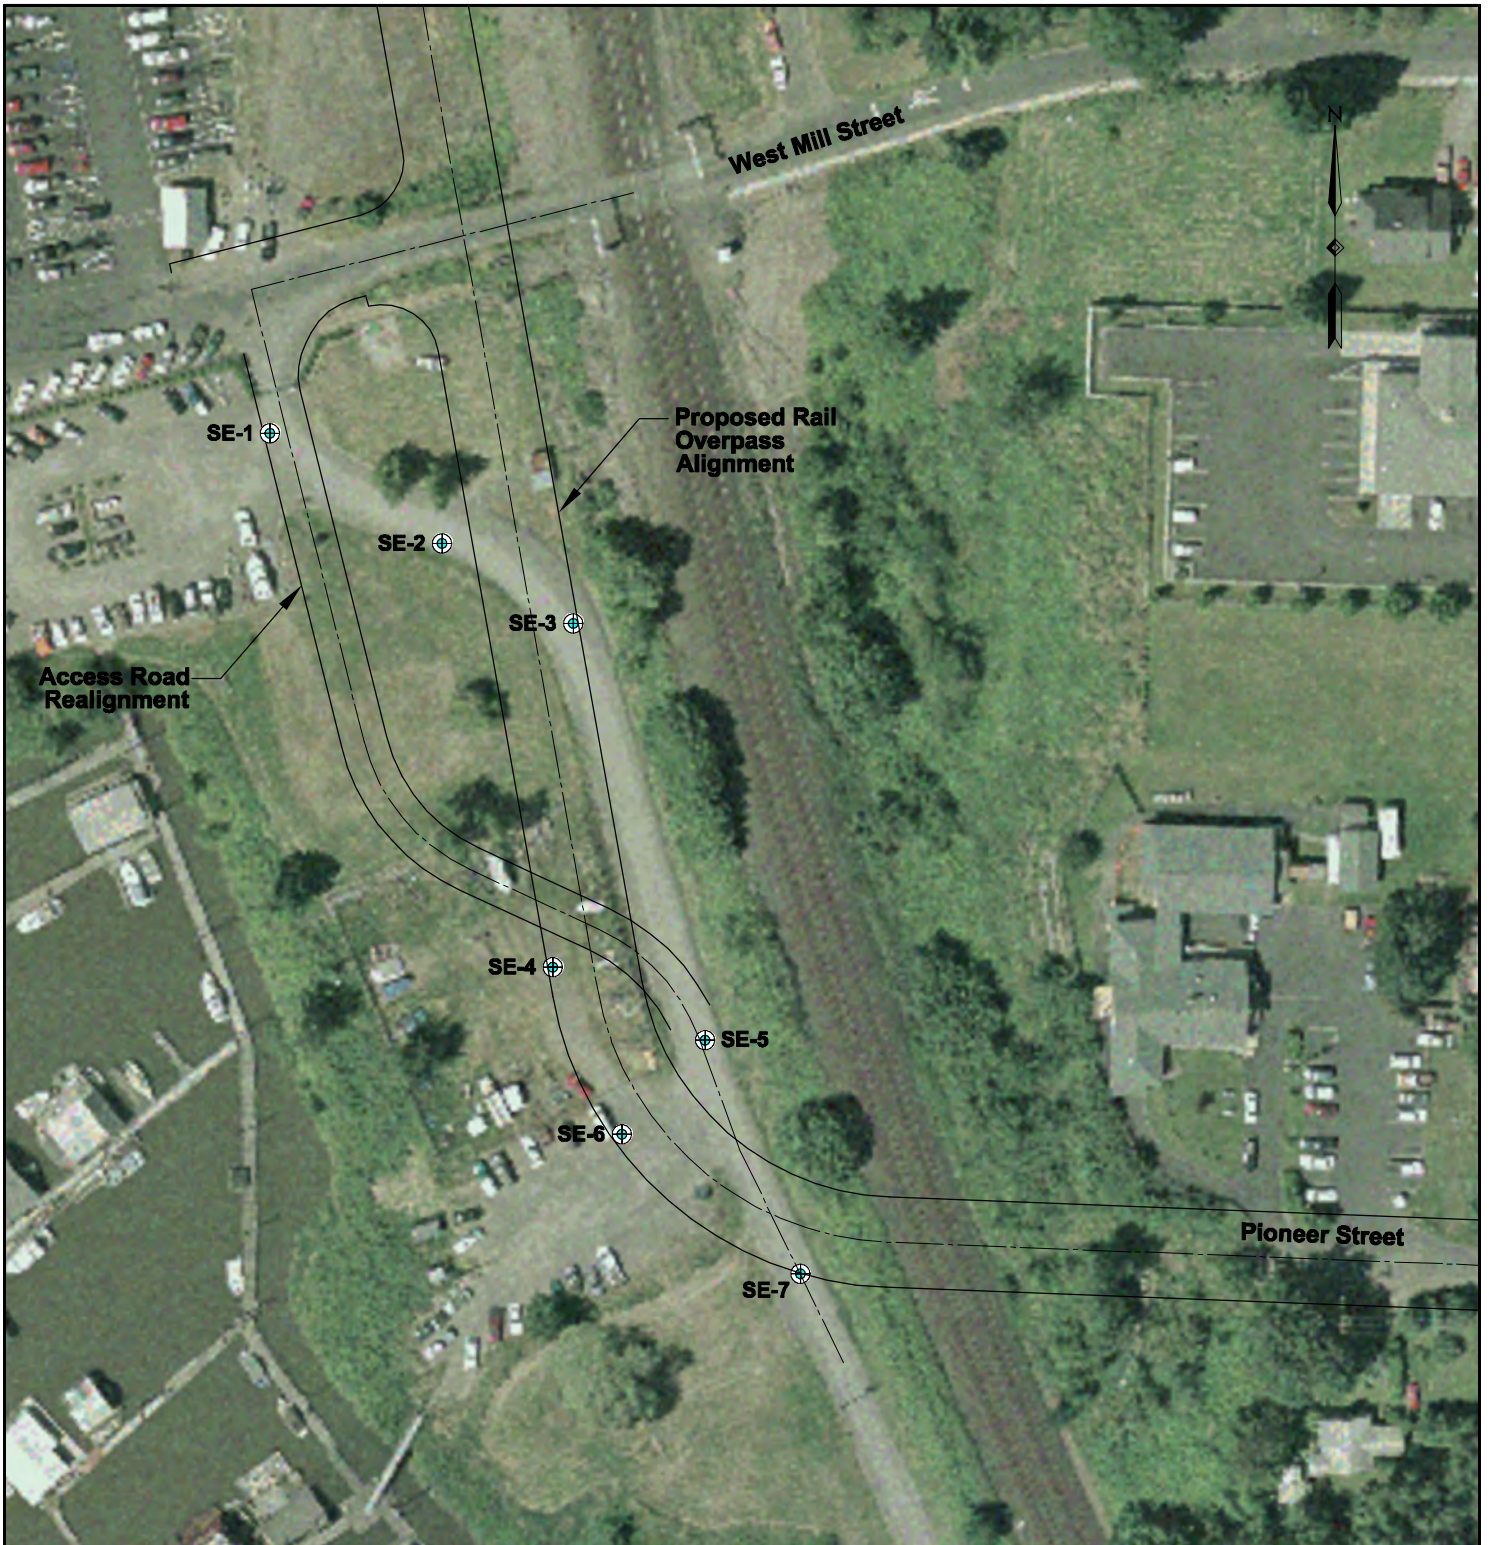
2

SE-1 Soil Exploration Location

Note: Base map prepared from an AutoCAD file provided by Jacobs (2007) and an aerial photograph from Seamless.usgs.gov (2007).

Site Exploration Plan

Based on the 2006 evaluations of the proposed alignments, the current selected alignment is as follows (Figure 2):

- Approach via Pioneer Street;
- Bridge over the railroad, turning northward to parallel the railroad (and intersecting the gravel road), and reaching current grade on the north portion of the current marina property; and
- At-grade roadway the remainder of the distance to the Port of Ridgefield.
