SITE CLEANUP CONFIRMATION  
INVESTIGATION

At the  
**HIGHLAND HILLS SHOPPING CENTER**  
**NORTHWEST FURNITURE & BRIDGESTONE FIRESTONE RETAIL CENTER**

December 29, 2014

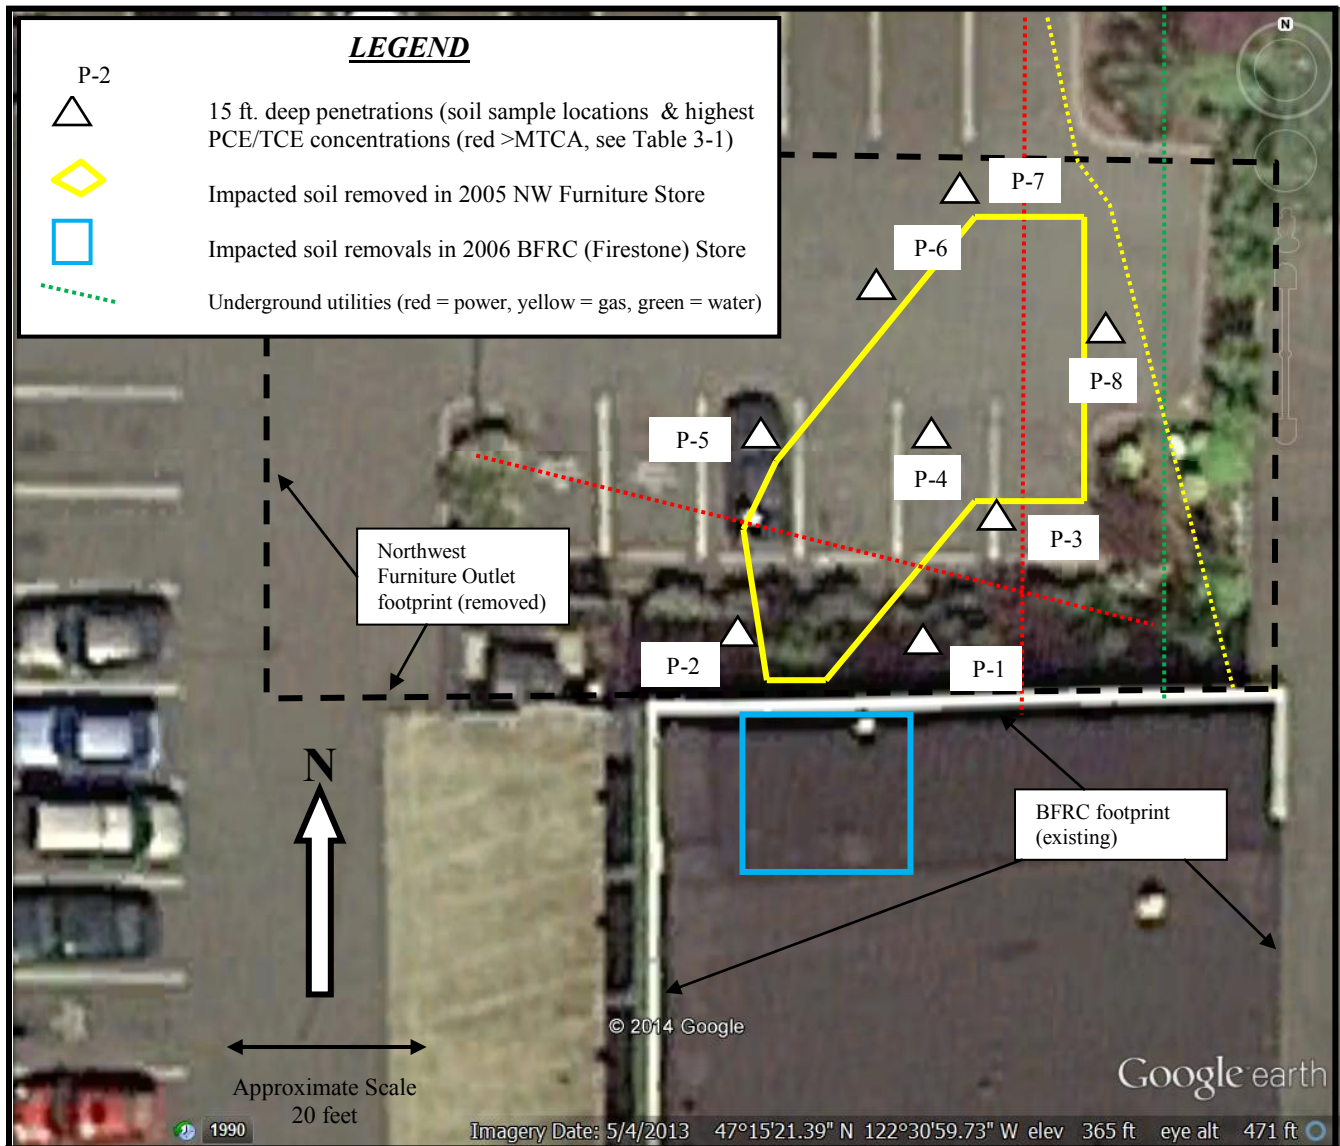
**FIGURE 1-2 – SITE PLAN MAP**

Northwest Furniture & Bridgestone Firestone Retail Center Property Focused SCCI

The single story, 5,000 square foot Northwest Furniture Outlet structure was constructed to house the Daisy Clothing Care business in 1969. The facility had washing machines, clothing dryers and seven dry cleaning units. Daisy Clothing Care was in operation at the site until 1985 and the cleaners ceased its operation at that time. Reportedly, the Northwest Furniture Outlet suite was vacant until circa 1993 when the Northwest Furniture Outlet occupied the structure. The structure was demolished in April 2008 and most of the footprint of the structure was capped with asphalt with a small area adjacent to the remaining BFRC structure planted with vegetation and small shrubs and trees (*See Figure 1-2 — Site Plan Map*).
