**2013 Environmental Subsurface
Investigation**

University of Washington - Tacoma
CPO Project No. 204277
South 17th Street to South 21st Street and
South Tacoma Avenue to Pacific Avenue
Tacoma, Washington

File No. 0183-085-00

December 19, 2014

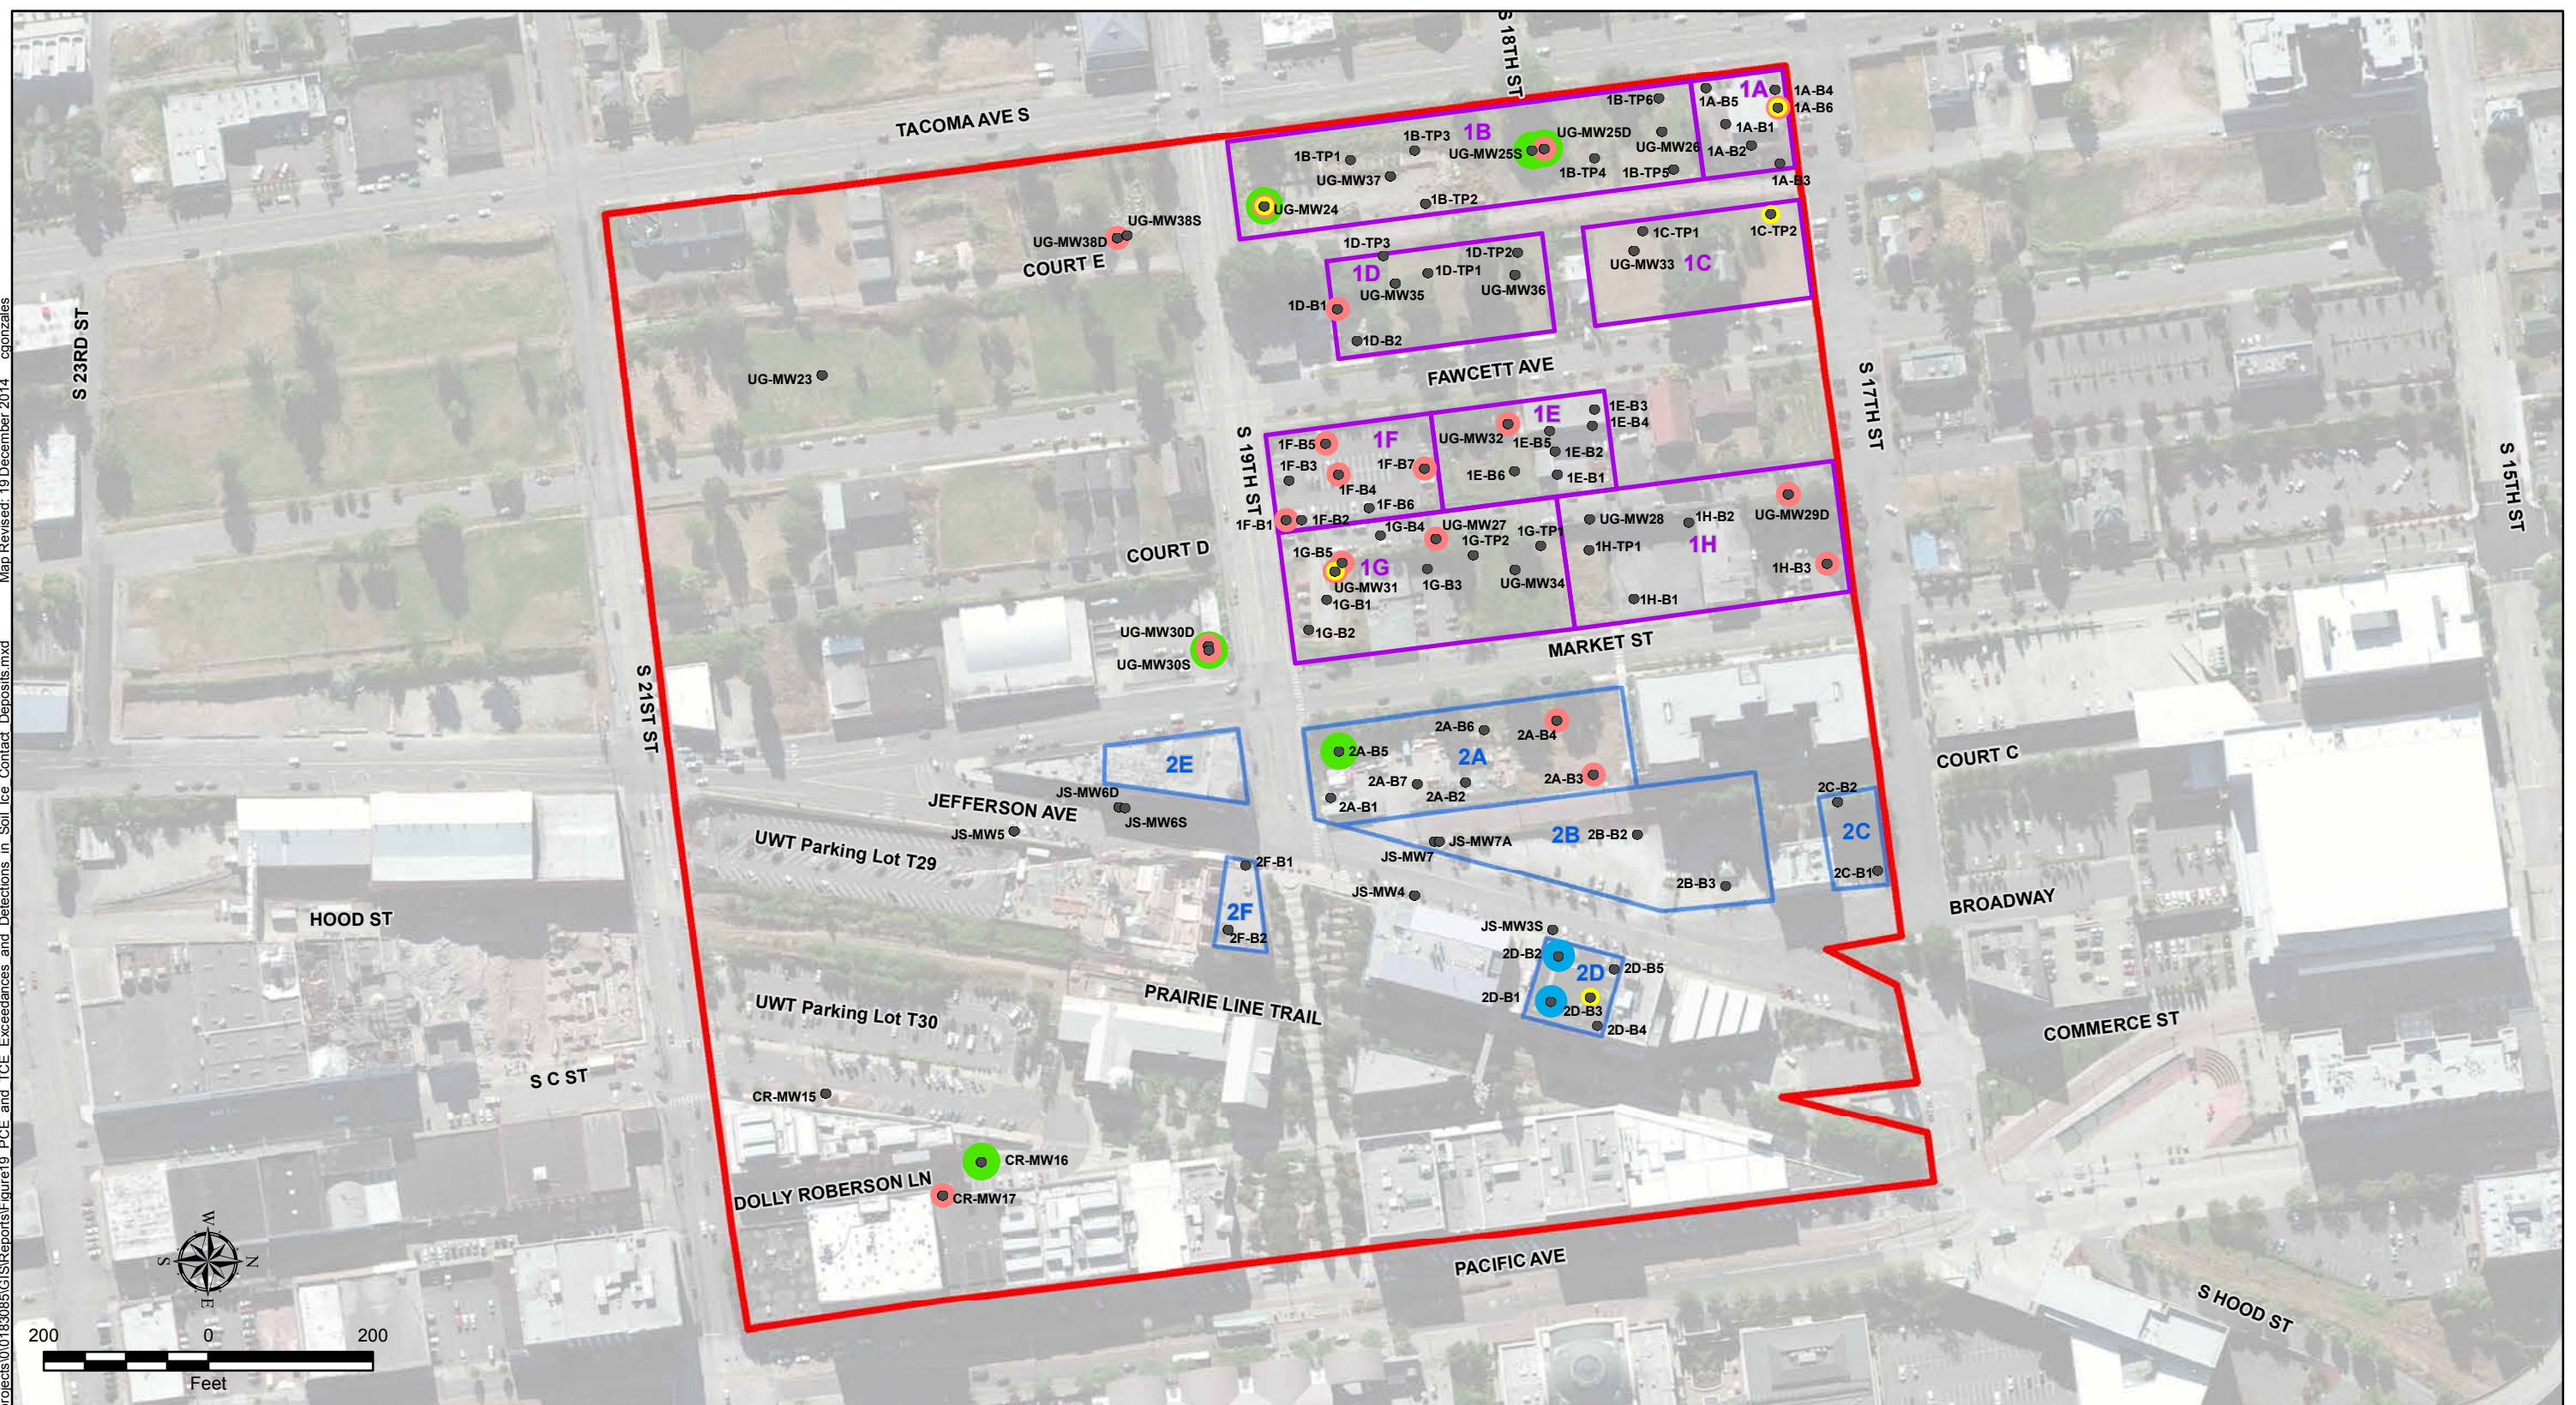
Figure 19

Westerly Plume - Ice-Contact Deposits - VOCs. VOCs were detected within the ice-contact deposits in the Westerly Plume in PDA 1A through 1H, 2A, 2D and within UG-MW28, UG-MW30S, UG-MW30D, UG-MW38S and UG-MW38D. The following sections summarize the chemical analytical results. The chemical analytical detection are summarized in Tables 15 and 16 and shown on Figure 19.

Easterly Plume - Ice-Contact Deposits - VOCS. VOCs were detected within the ice-contact deposits in the Easterly Plume in borings CR-MW16 and CR-MW17. The chemical analytical results are summarized in the following sections. The chemical analytical results (detections only) are summarized in Tables 15 and 16 and shown on Figure 19.

PCE-impacted soil was identified within the ice-contact deposits in four general areas of the Westerly Plume boundary as shown on Figure 19. The four areas include PDA 2D – Tacoma Paper and Stationary (see discussion above), PDA 1G – Laborers/Lot T39 and T40, PDA 1B – Tacoma Vacant and the adjacent areas PDA 1A – Upton and PDA 1C – Fawcett North. The PCE-impacted soil is a possible indication that groundwater in the shallow aquifer may also contain PCE and associated breakdown products.

TCE. TCE-contaminated soil was identified in three general areas in the ice-contact deposits within the Westerly Plume as shown on Figure 19. The three areas include PDA 1B – Tacoma Vacant, PDA 2A – Sound Care, and wells UG-MW30S and UG-MW30D. The source of the TCE is unknown in these three areas.

TCE-impacted soil was identified within the ice-contact deposits in areas throughout a majority of the Westerly Plume boundary as shown on Figure 19. The TCE-impacted soil is a possible indication that groundwater in the shallow aquifer may also contain TCE and associated breakdown products.

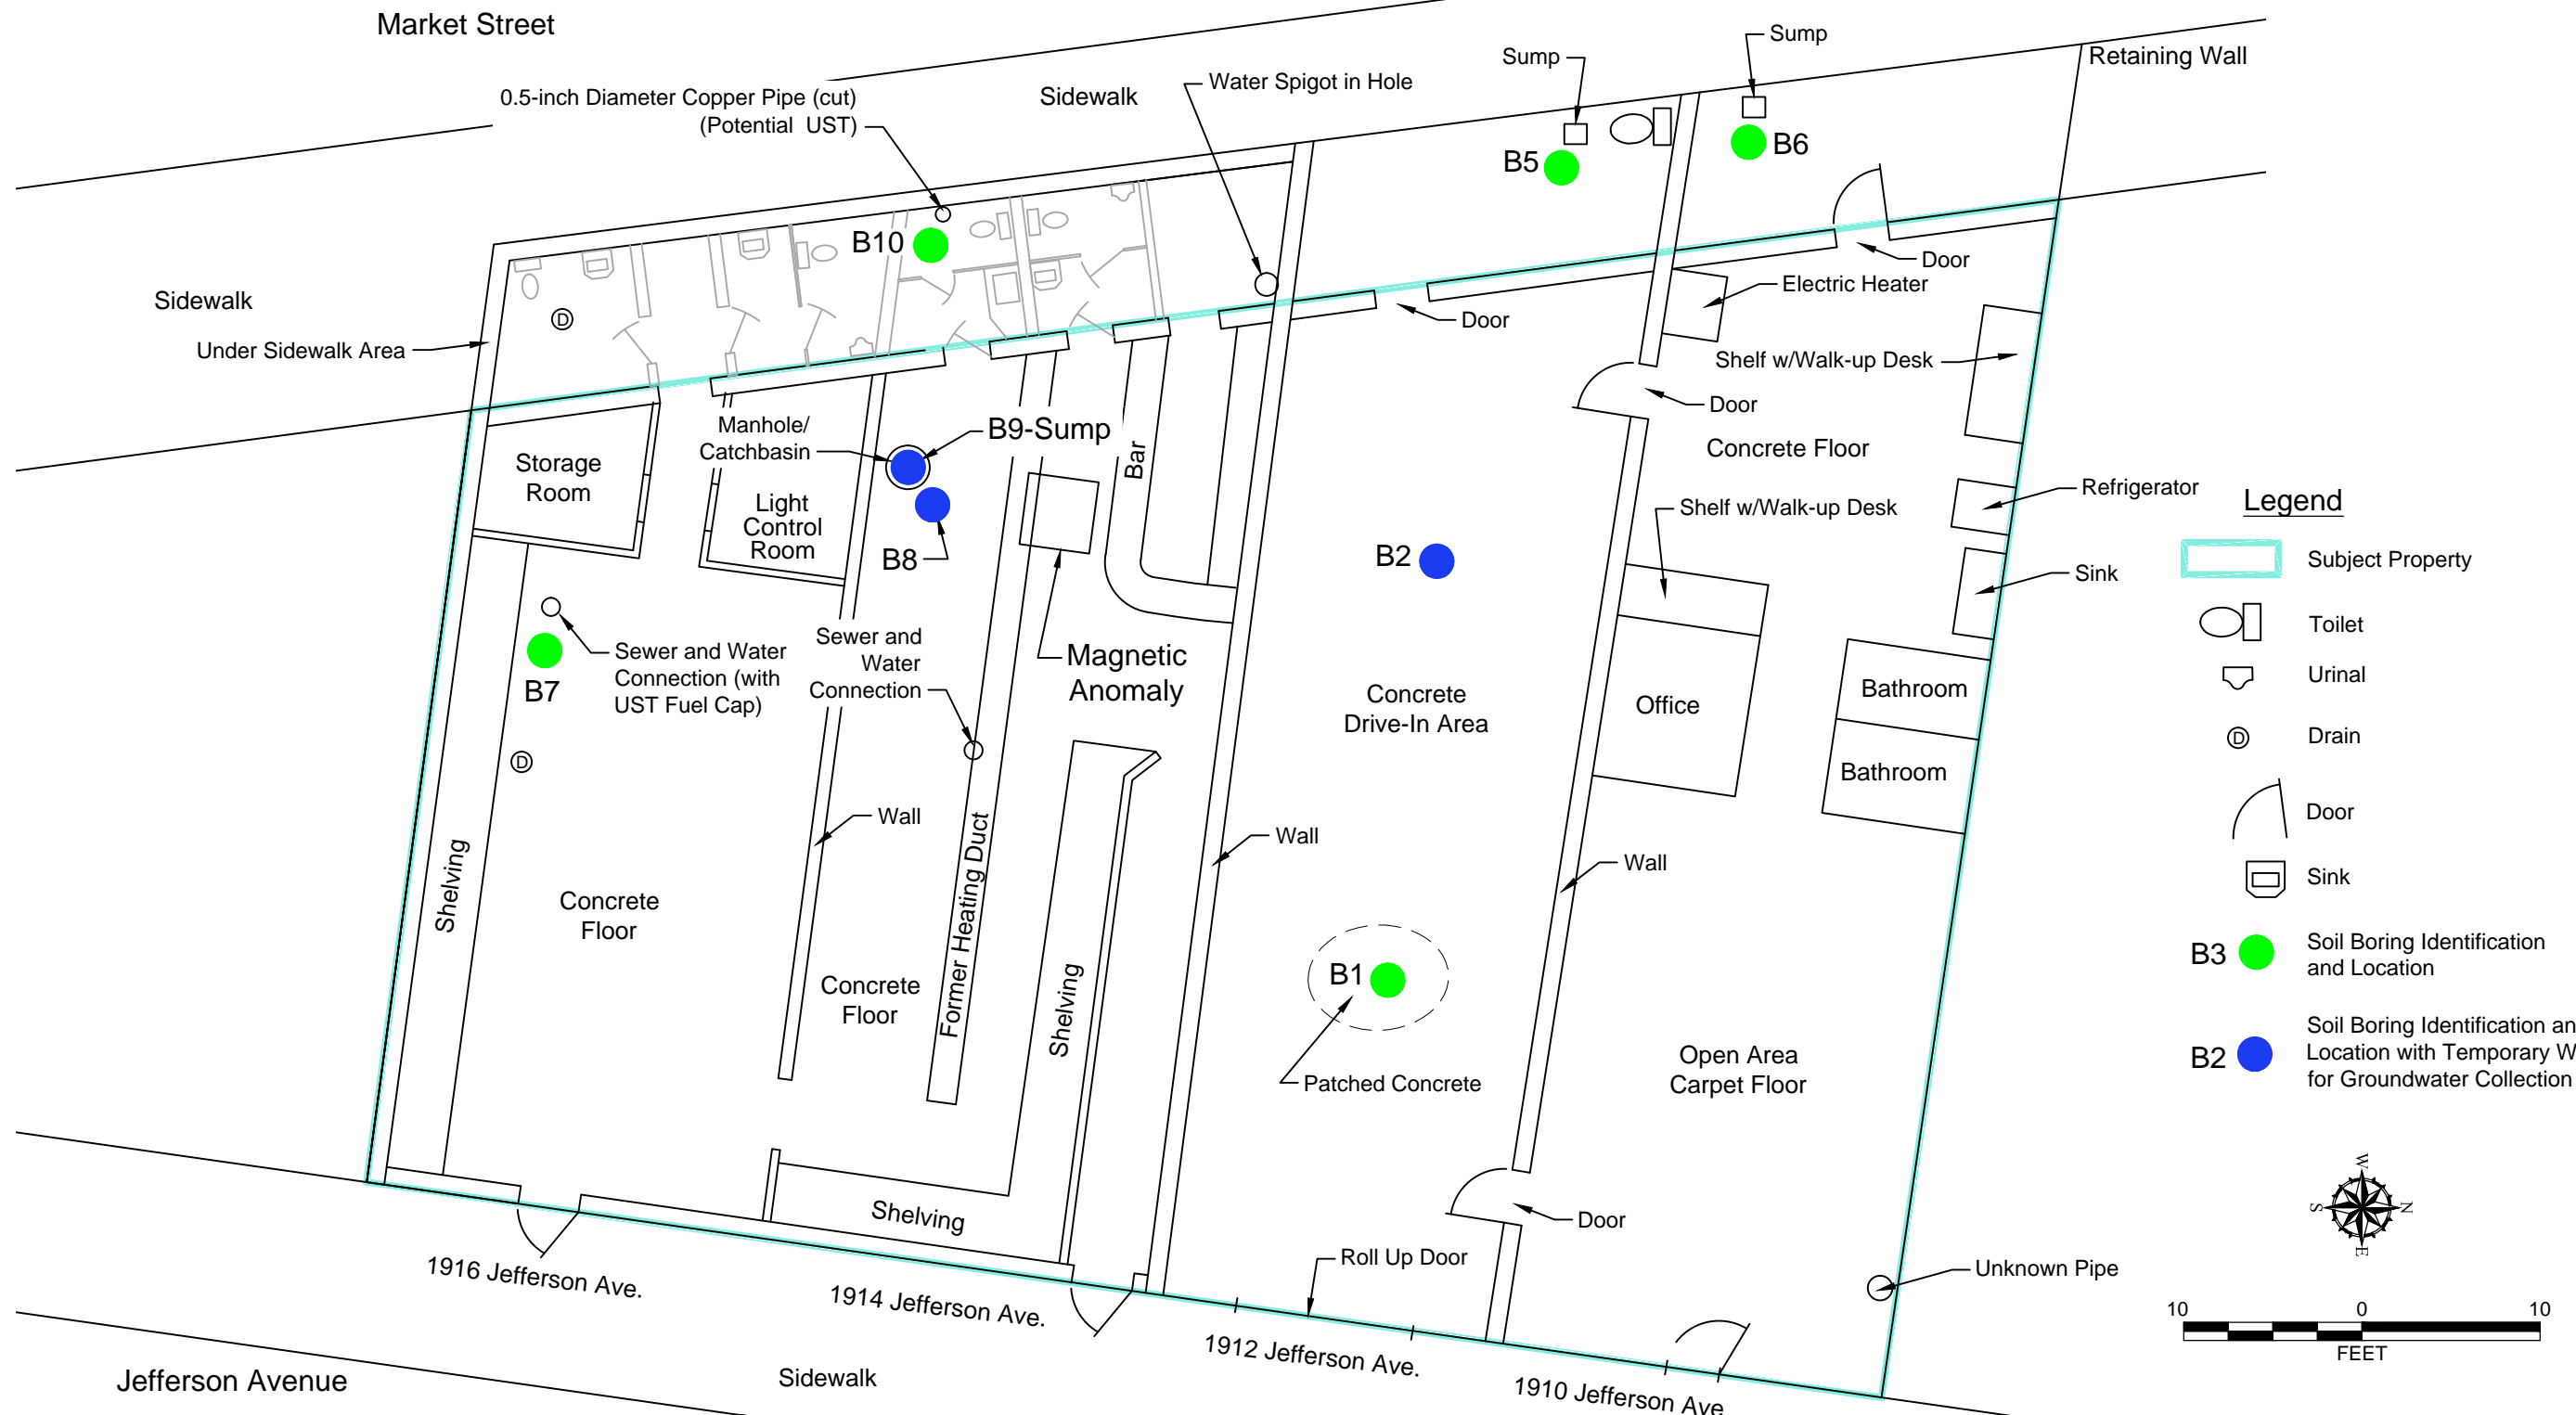
Figure 3

An M/GPR survey was performed in July 2013 to further investigate the presence of potential USTs in and adjacent to the Frederick Wild building during the Phase II ESA. An M/GPR survey was not completed within the Swiss Building. The survey identified three magnetic anomalies as shown on Figure 3. Two magnetic anomalies were located along the Jefferson Avenue sidewalk. One anomaly was observed in the interior of the building at 1914 Jefferson Avenue.

July 2013 Phase II ESA Boring Locations	
UWT Environmental Assessment Priority Development Areas - CPO Project No. 204277 Tacoma, Washington	
GEOENGINEERS
