**Underground Storage Tank Removal,
Site Characterization, and Site Cleanup Report
19804 and 19806 Aurora Avenue North
Shoreline, Washington**

**Environmental Report Tracking System (ERTS)
#660148**

January 18, 2016

City of Shoreline
Shoreline, Washington

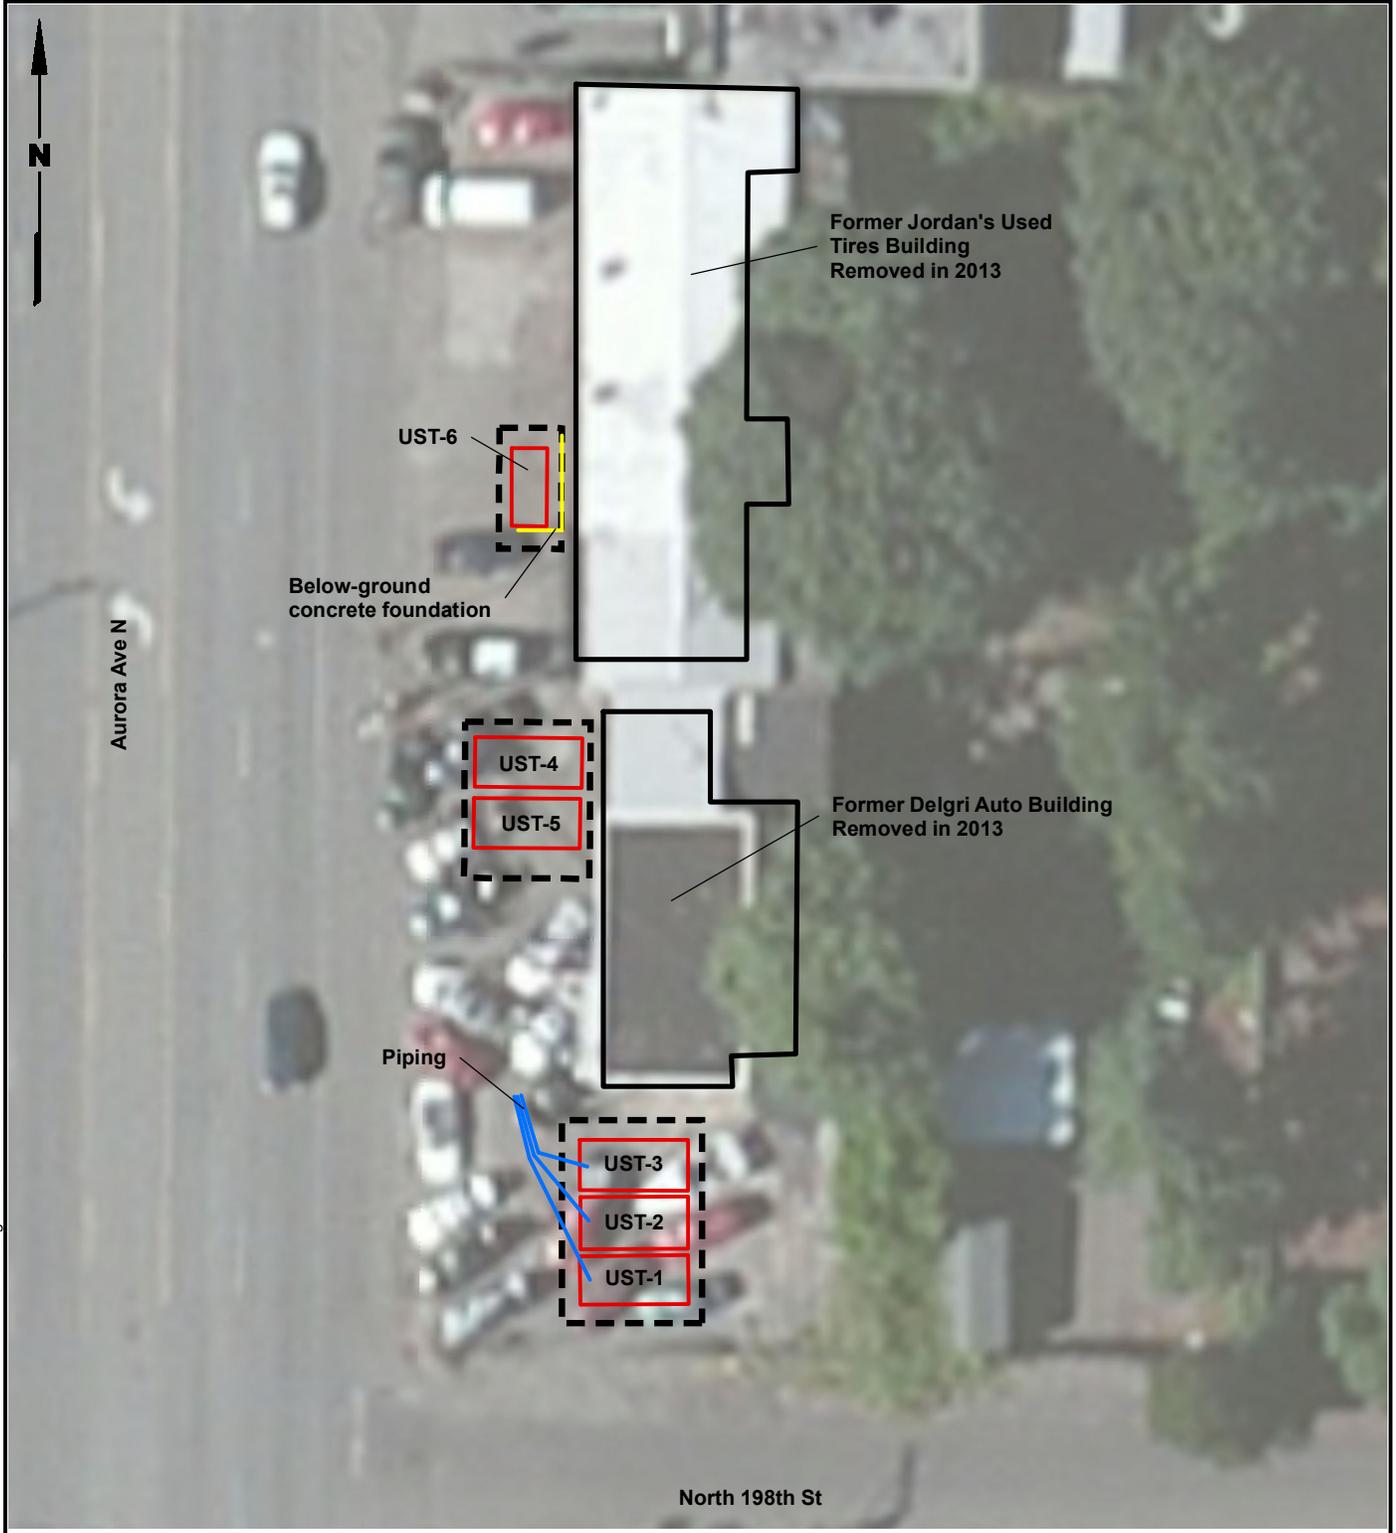
Aurora-Gunderson Property Shoreline, Washington	Site Plan	Figure 2
--	------------------	--------------------

The approximate locations of the six USTs prior to removal are shown on Figures 2 and 3. The USTs were located during the site reconnaissance (see above), and during asphalt removal and grading work at the site associated with the Aurora Avenue North widening project. The capacity and condition of the six USTs at the time of removal were as follows:

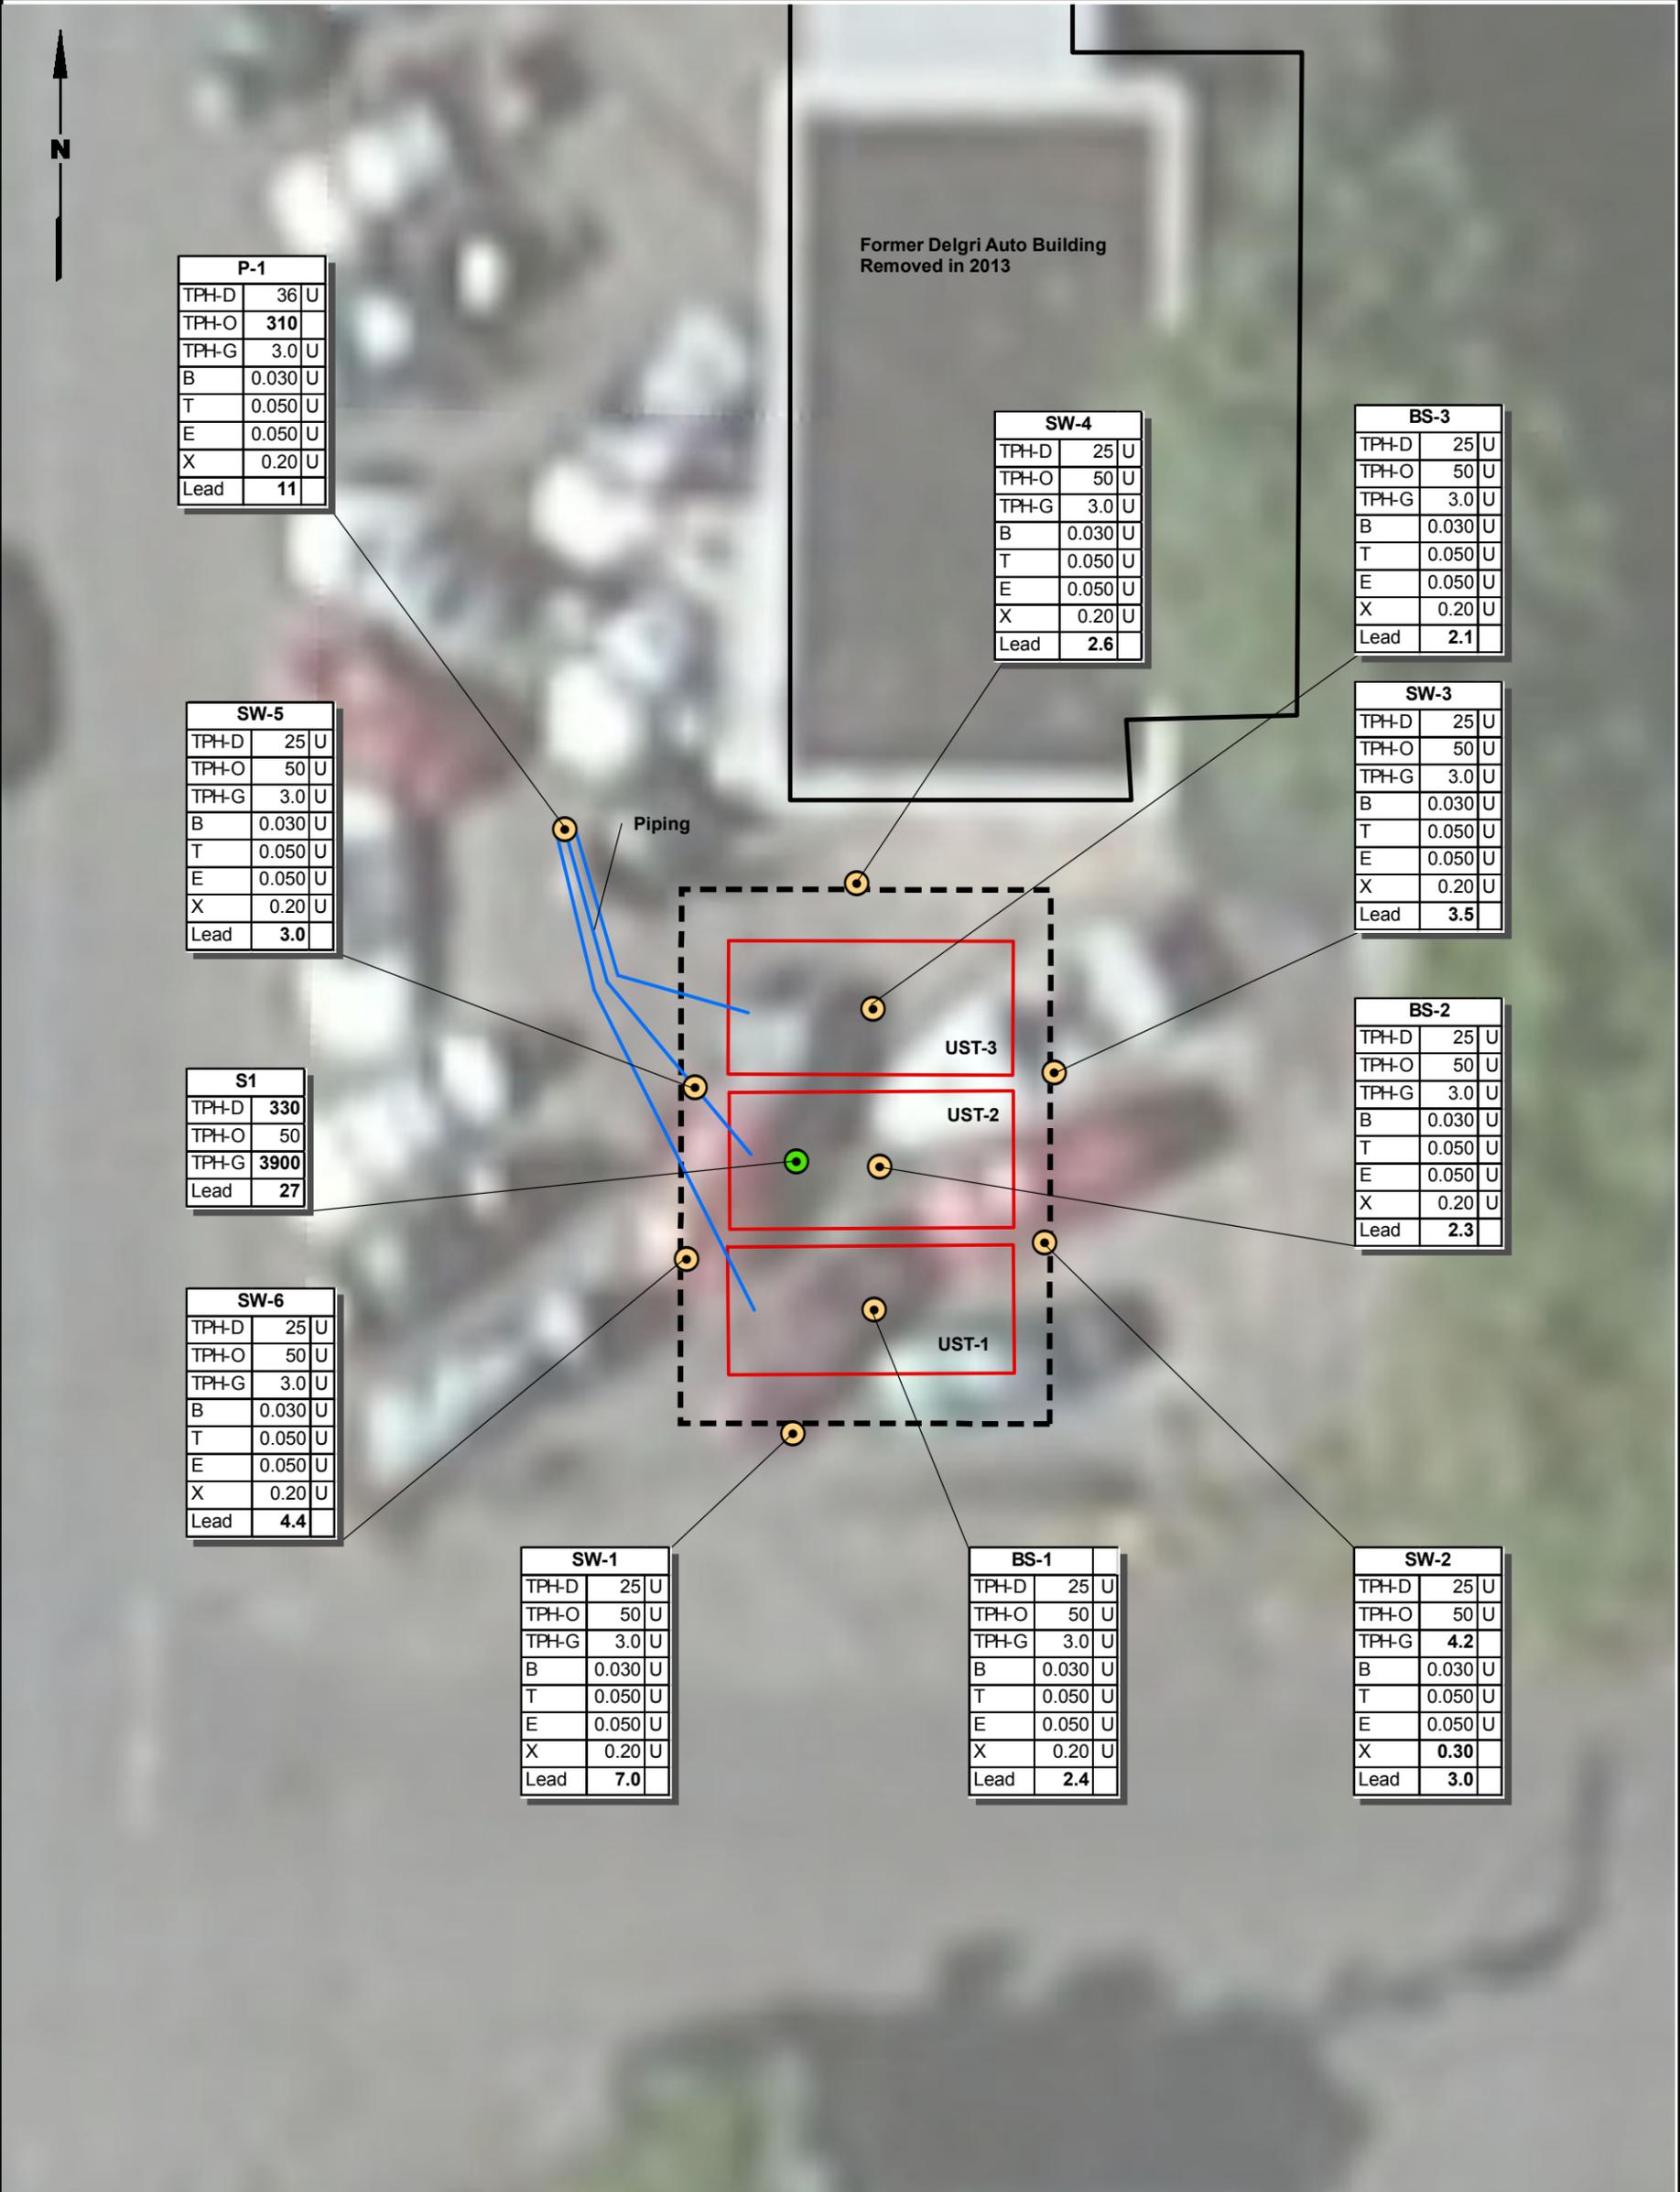
Figure
4

Field screening during excavation found evidence of PCS associated with the USTs in the upper 4 ft of overburden soil above the USTs. A characterization sample (S1) was collected by Landau Associates to verify the field-screening observations. Based on the former contents of the tanks in this area, which included gasoline and diesel, this characterization sample was submitted to ALS Laboratory (ALS) in Everett, Washington and analyzed for TPH-G by Method NWTPH-Gx, and TPH-D and TPH-O by Method NWTPH-Dx. Analytical results for this sample indicated TPH-G concentrations in soil greater than the cleanup levels. Analytical results for characterization sample S1 are summarized in Table 1 and on Figure 4.

The extent of the excavation associated with removal of the diesel and gasoline USTs and the characterization and confirmation sample locations are shown on Figure 4.

Confirmation soil samples were collected by Landau Associates and analyzed by ALS. The samples were selectively analyzed for TPH-D and TPH-O using Method NWTPH-Dx, TPH-G by Method NWTPH-G, BTEX by Method 8021, and total lead by Method SW6020. The confirmation soil analytical results are summarized in Table 1 and on Figure 4. Copies of the laboratory data reports are provided in Appendix D. The approximate locations of where the confirmation samples were collected are shown on Figure 4.

The analytical results for all of the confirmation samples indicated TPH-D, TPH-O, TPH-G, BTEX, and total lead concentrations less than their respective MTCA Method A soil cleanup levels.

Based on the analytical results for the characterization sample, a cleanup of PCS in the UST-1, -2, and -3 excavation area was completed by soil removal. The excavation for the removal of the USTs and the surrounding soil resulted in an excavation approximately 18 ft by 30 ft, and approximately 10 ft deep. Excavated soil from above and around the three USTs was loaded directly onto trucks and removed as PCS for offsite disposal.

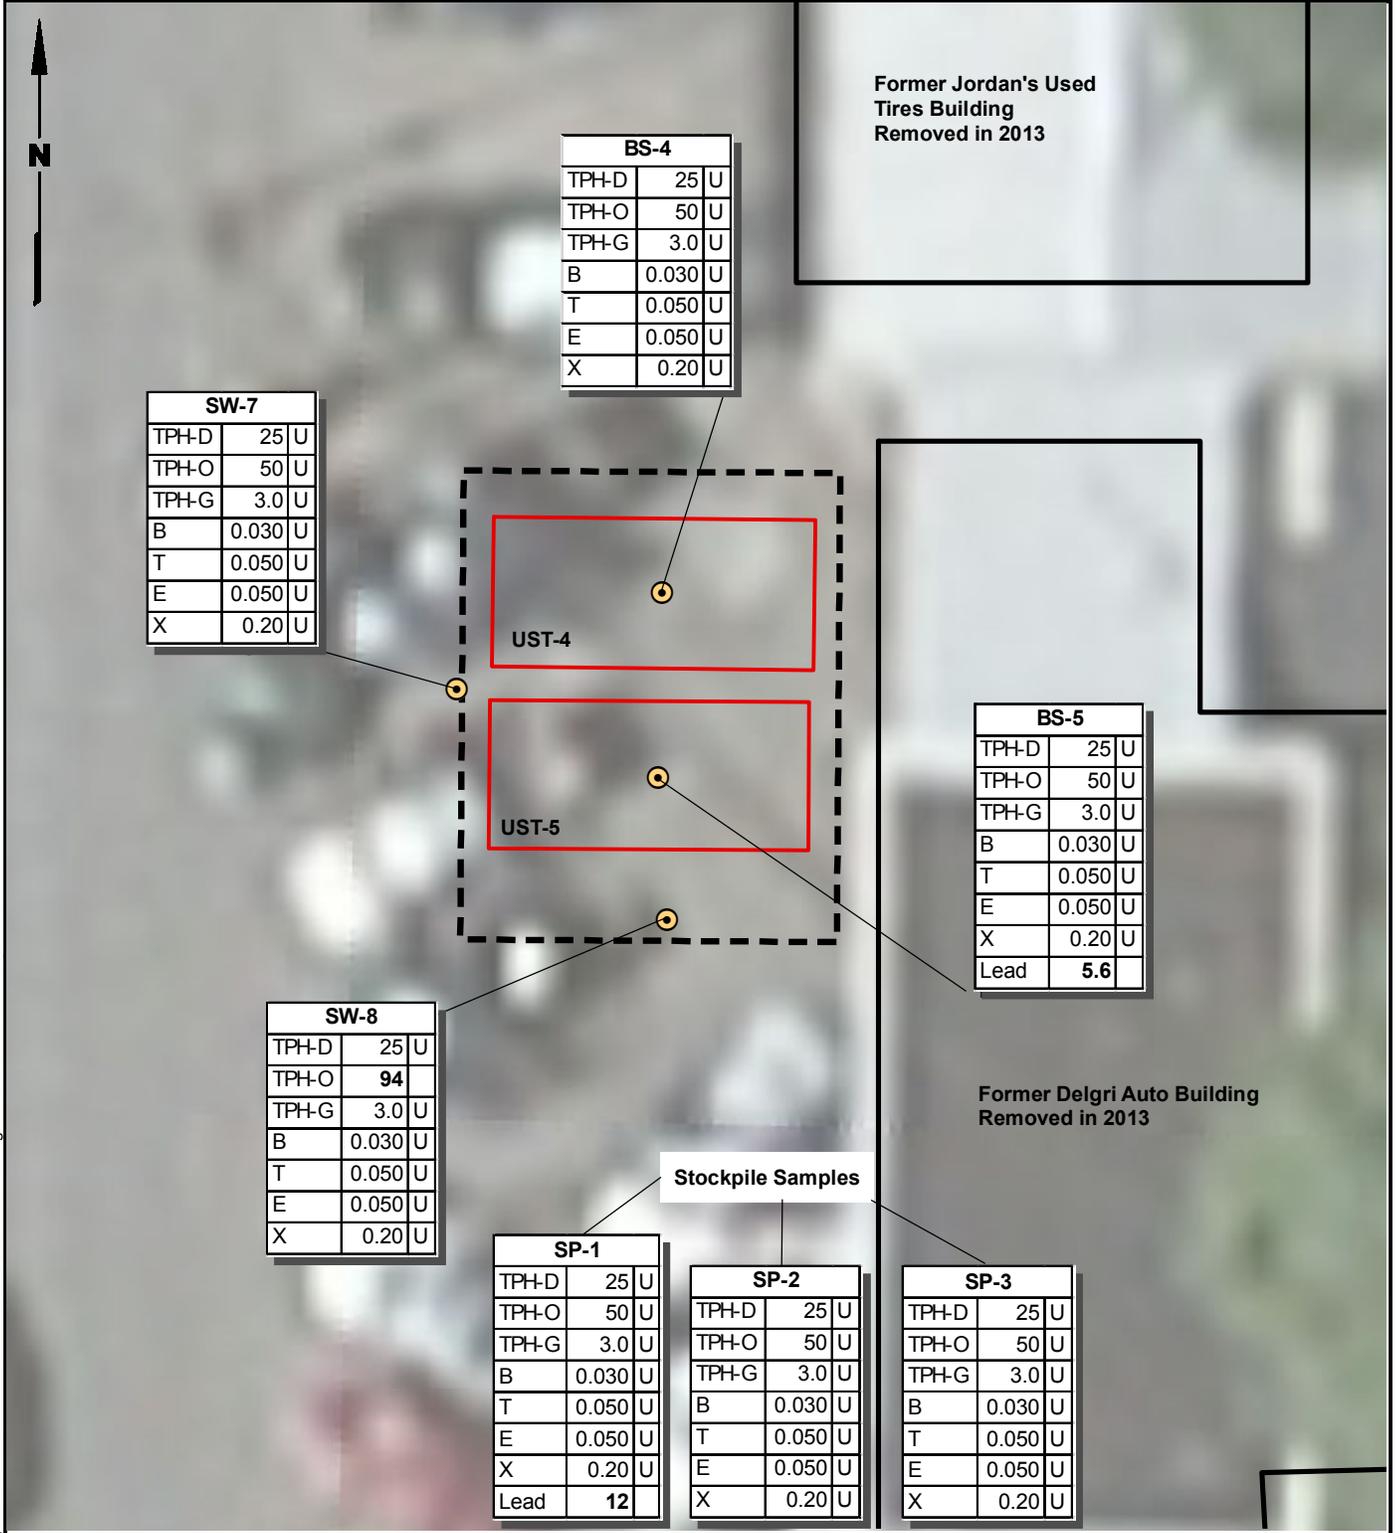
Aurora-Gunderson Property Shoreline, Washington	UST-4 and UST-5 Analytical Data	Figure 5
--	--	--------------------

The extent of the excavation associated with removal of the USTs and confirmation sample locations are shown on Figure 5.

Confirmation soil samples were collected by Landau Associates and analyzed by ALS. The samples were selectively analyzed for TPH-D and TPH-O using Method NWTPH-Dx, TPH-G by Method NWTPH-G, BTEX by Method 8021 and total lead by Method SW6020. The confirmation soil analytical results are summarized in Table 1 and on Figure 5. Copies of the laboratory data reports are provided in Appendix D. The approximate locations of where the confirmation samples were collected are shown on Figure 5.

The analytical results for all of the confirmation samples, including the stockpile samples, indicated TPH-D, TPH-O, TPH-G, BTEX, and total lead concentrations less than their respective MTCA Method A soil cleanup levels. After the receipt of the analytical data, stockpiled soil was used to backfill the UST-4 and UST-5 excavation.

BS-4		
TPH-D	25	U
TPH-O	50	U
TPH-G	3.0	U
B	0.030	U
T	0.050	U
E	0.050	U
X	0.20	U

SW-7		
TPH-D	25	U
TPH-O	50	U
TPH-G	3.0	U
B	0.030	U
T	0.050	U
E	0.050	U
X	0.20	U

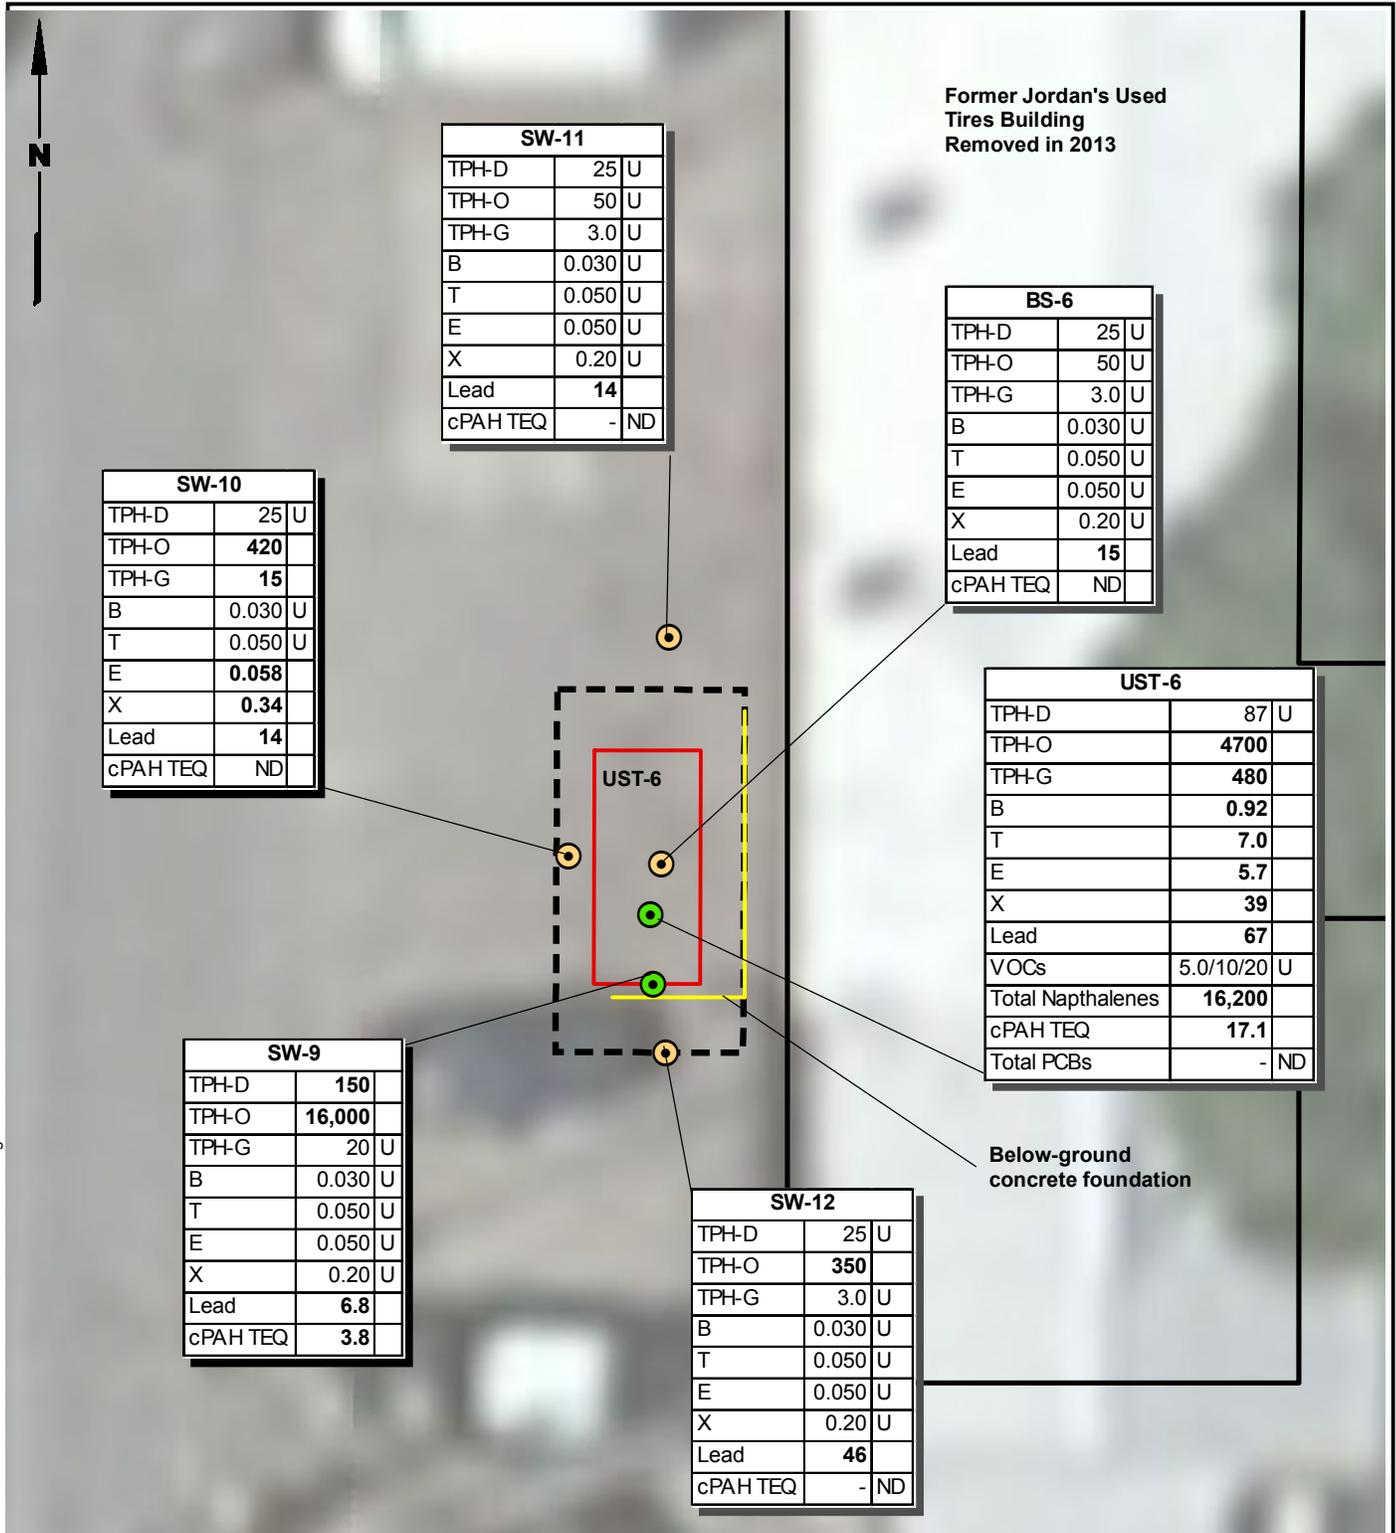
Field screening during initial excavation found evidence of PCS associated with UST-6 including dark staining of soil and a heavy oil-like odor in the soil. These indications of PCS were observed below and to the south of the UST; no staining or other evidence of contamination was observed in soils to the west or north, or on the concrete wall to the east. A characterization sample (UST-6) was collected by Landau Associates to verify the field-screening observations. This characterization sample was submitted to ALS for analysis for TPH-G by Method NWTPH-Gx, TPH-D and TPH-O by Method NWTPH-Dx, BTEX by EPA Method 8021, and total lead by Method SW6020. Based on the former use of this tank for storage of waste oil, the sample was also analyzed for VOCs by EPA Methods 8260 and 8260-SIM, carcinogenic and non-carcinogenic polycyclic aromatic hydrocarbons (cPAHs and PAHs) by EPA Method 8270-SIM, and polychlorinated biphenyls (PCBs) by EPA Method 8082. Analytical results for this sample indicated concentrations of TPH-O, TPH-G, benzene, total xylenes, and total naphthalenes greater than the soil cleanup levels. VOCs and PCBs were not detected at concentrations greater than the laboratory reporting limits. Analytical results for characterization sample UST-6 are summarized in Table 1 and on Figure 6.

Three sidewall (SW-9, SW-10, and SW-11) and one base (BS-6) confirmation soil samples were collected from the excavation following tank and soil removal. Soil from the south sidewall sample (SW-9) was collected from the south concrete wall. Field screening of soil at the SW-9 sample location indicated potential contamination but at a lesser degree than previously observed in excavated soils. No PCS was observed or identified based on field screening beneath or at the east, north, or west sidewalls of the removed UST. Based on the analytical results (discussed below), additional excavation in the area of SW-9 was completed to the south before collecting an additional sidewall confirmation sample (SW-12).

SW-11		
TPH-D	25	U
TPH-O	50	U
TPH-G	3.0	U
B	0.030	U
T	0.050	U
E	0.050	U
X	0.20	U
Lead	14	
cPAH TEQ	-	ND

Based on the results of the characterization sample, a cleanup of PCS in the UST-6 excavation area was completed by soil removal. The excavation resulting from the removal of UST-6 and the surrounding PCS was approximately 8 ft by 15 ft, and approximately 9 ft deep. The east sidewall of the excavation was an existing concrete wall that extended from approximately 2 ft below ground surface to the bottom of the excavation. As discussed above, field screening during the excavation found evidence of PCS associated with the UST along the south side of the removed UST-6. Therefore, the cleanup excavation to the south extended to another east-west section of concrete wall. Excavated soil from above and around the UST was loaded directly onto trucks and removed as PCS for offsite disposal.

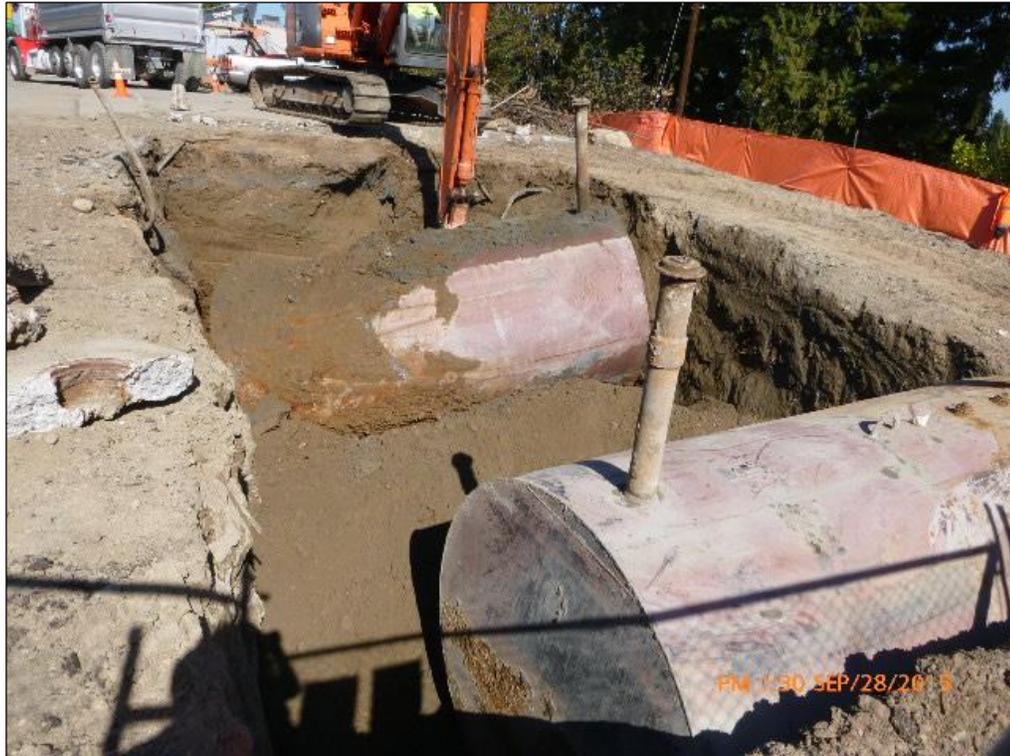
1. UST-1, UST-2, and UST-3 excavation and removal, looking north.

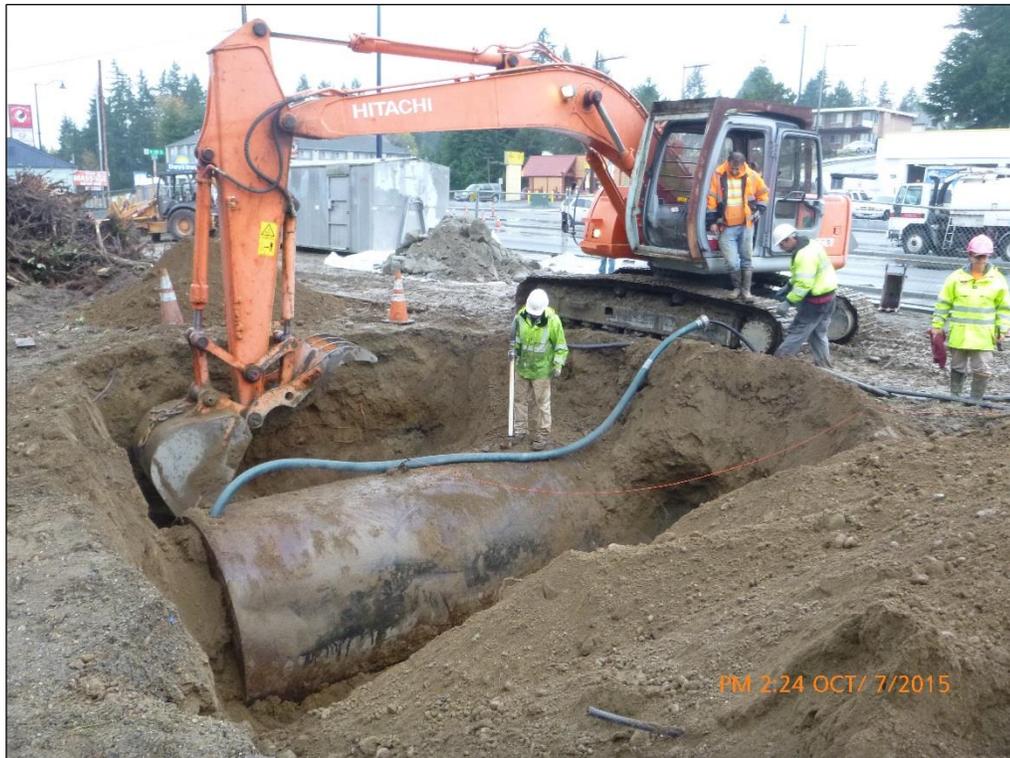
2. UST-5 decommissioning, looking southwest.

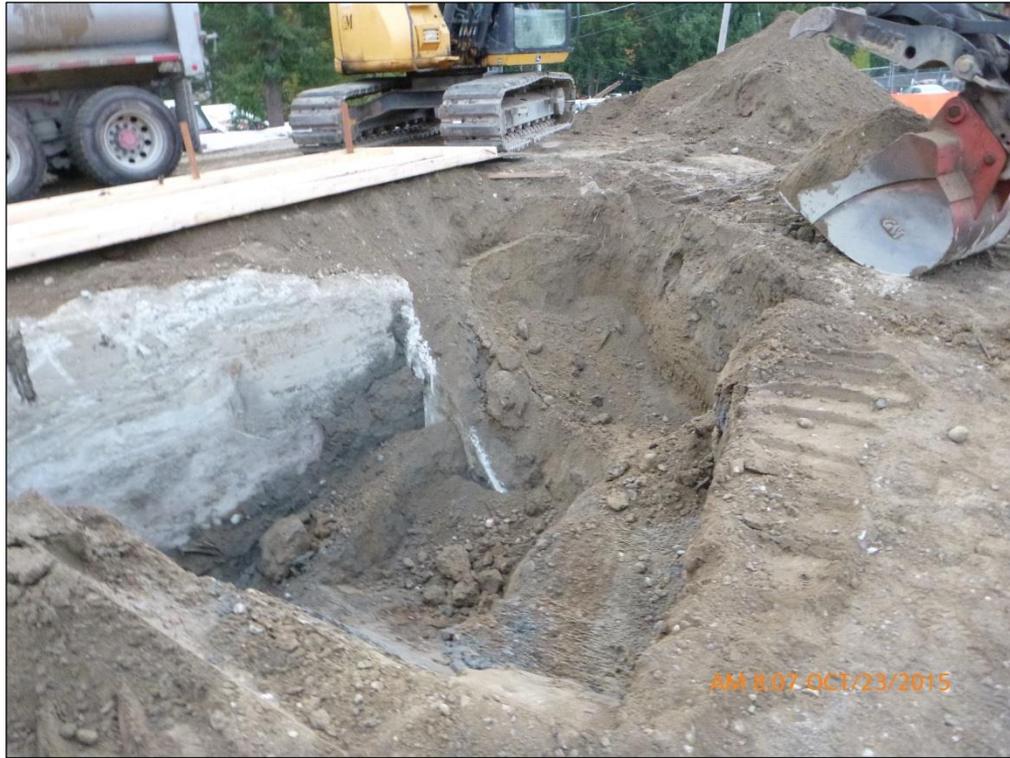
UST-6	300	Waste Oil	Approximately 2 inches of product in tank; corrosion observed at seams on the ends of tank, some dark staining of soil beneath the tank.

3. UST-6 excavation, looking southeast.
