February 17, 2016  
HWA Project No. 98165-670

**Subject: Gas Sampling Annual Report, 2015  
Everett Landfill/Tire Fire Site  
Everett, Washington**

This letter presents the annual report for gas monitoring at the Everett Landfill (herein referred to as the Landfill) for calendar year 2015, per the Compliance Monitoring and Contingency Plan.

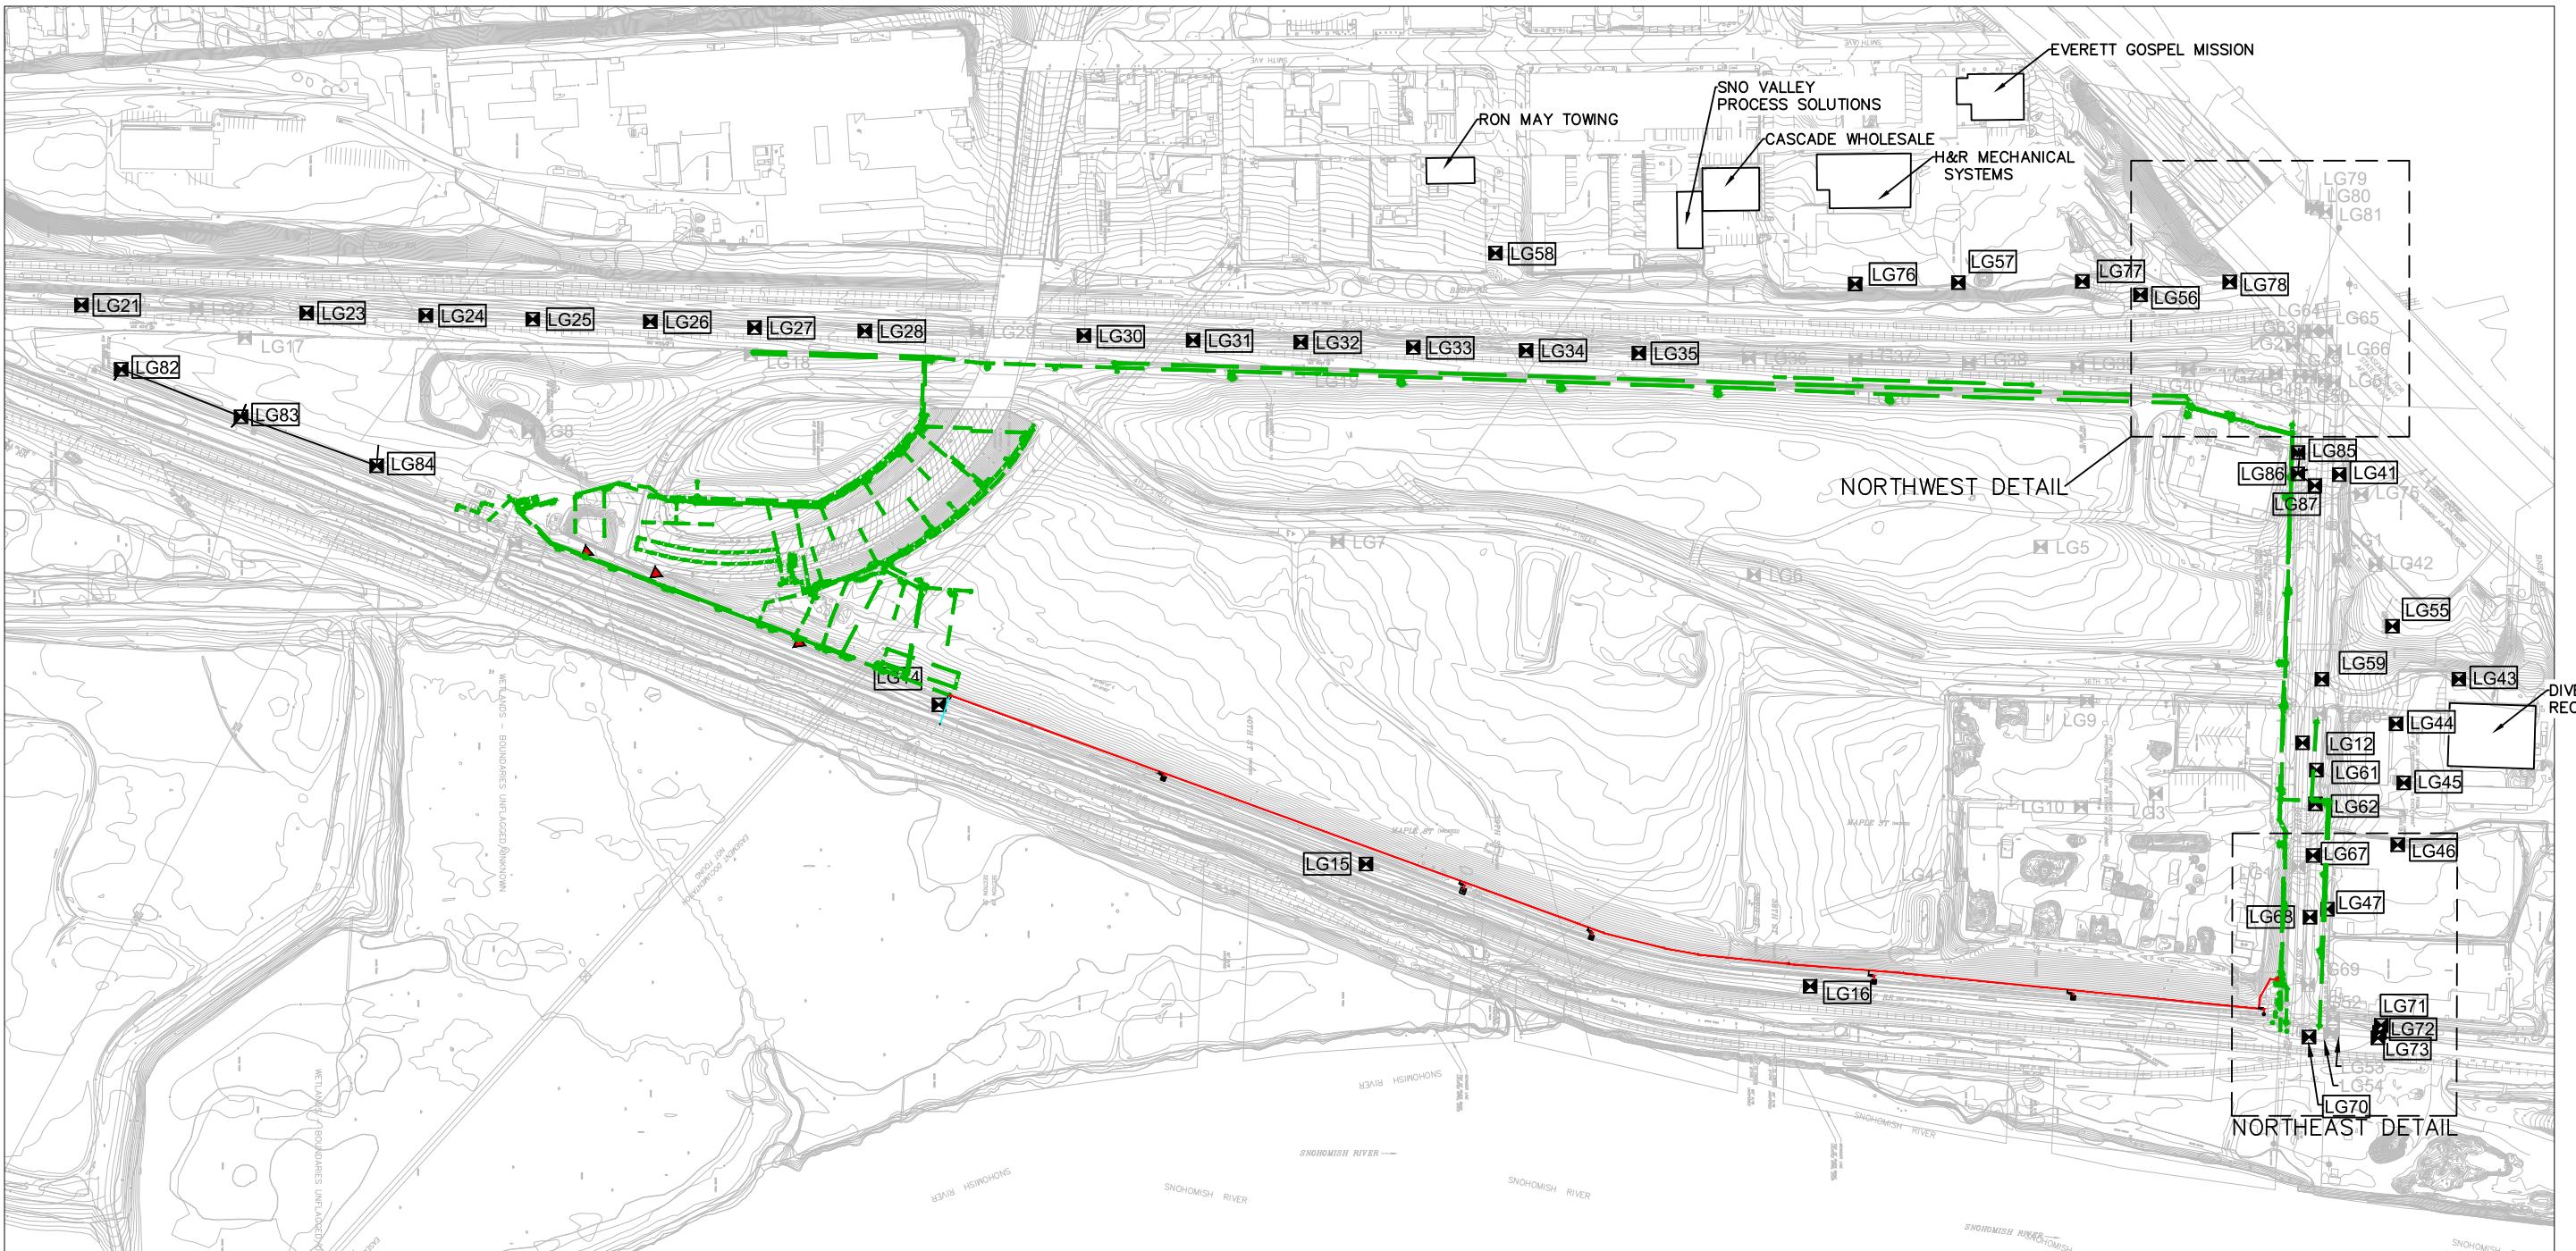
LANDFILL GAS PROBE  
LOCATION MAP

Figures 1 and 2 show the gas monitoring probe and building locations. Gas monitoring data at selected Landfill gas probes is summarized in Table 1. A Landfill gas extraction trench (also known as a gas interception or collection trench) was constructed along the northern portion of the west Landfill boundary and commenced operation in April 2004. This trench was designed to prevent offsite migration by intercepting the Landfill gas at the site boundary. A northern extension of the perimeter gas interception trench was added in November 2005. The 41<sup>st</sup> Street overcrossing gas extraction system was started in July 2006.

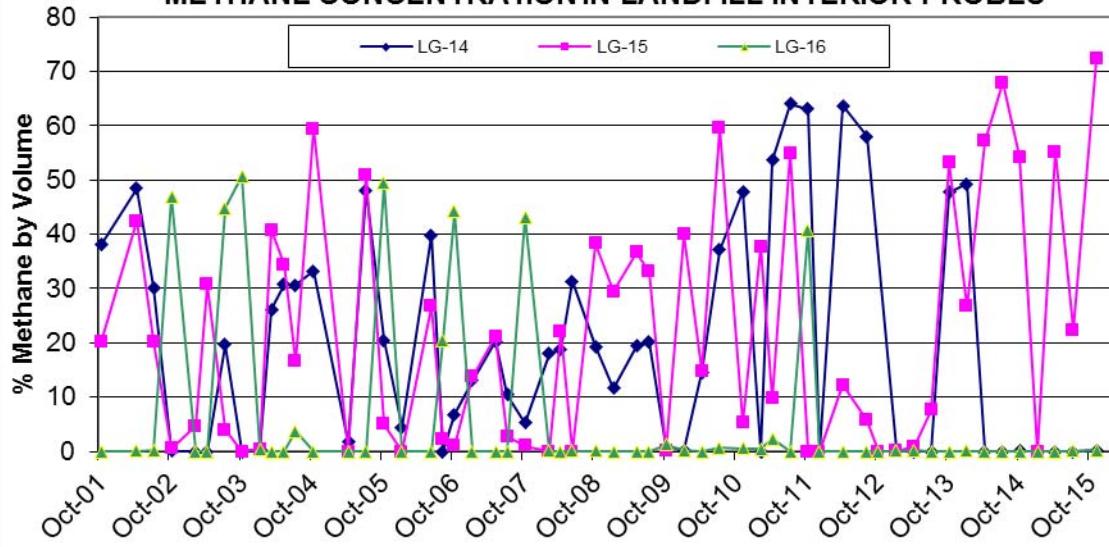
**FIGURE 3**  
**METHANE CONCENTRATION IN LANDFILL INTERIOR PROBES**

Landfill interior – Methane exceeding 5% by volume (which equals 100% of the lower explosive limit, or LEL) had been historically detected in most of the Landfill interior gas probes (which were completed in or near waste), as expected. By 2008, all but gas probes LG-14, LG-15, and LG-16 within the Landfill footprint were decommissioned in accordance with Chapter 173-160 WAC in preparation for site development activities. Of these three remaining probes, LG-15 generally had the highest methane concentrations in 2015, with concentrations up to 72%. Probe LG-14 has not had any methane exceeding 5% since January 2014, and LG-16 has not had any exceedances over 5% since October 2011. Interior probes have not exhibited any apparent trends over time since January 2008 (Figure 3). The wellheads of the three probes were adjusted during trail construction along the east side of the Landfill in 2013.

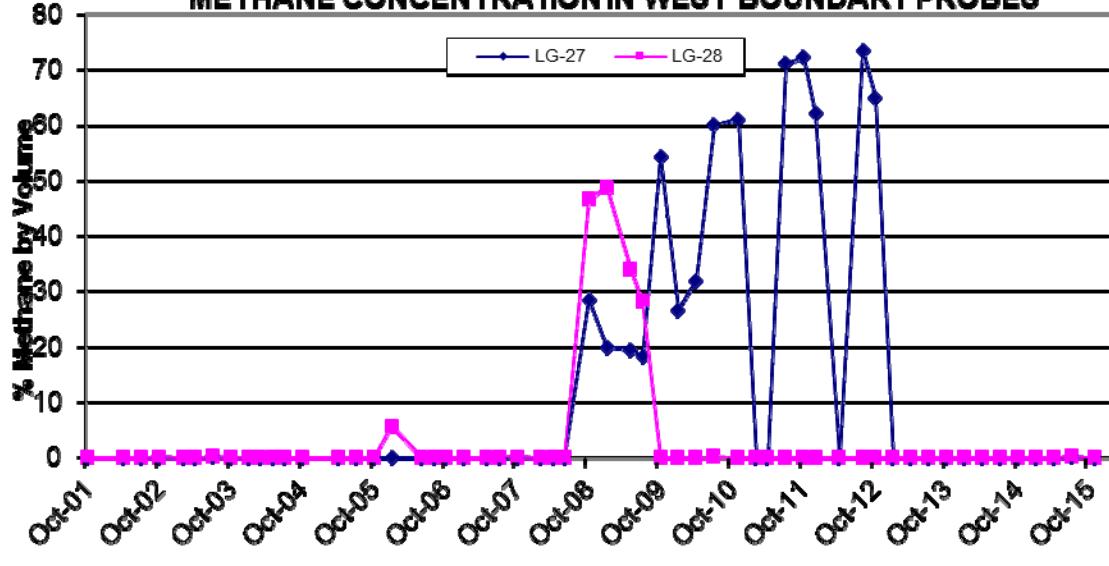
**FIGURE 4**  
**METHANE CONCENTRATION IN WEST BOUNDARY PROBES**

West end of Landfill – The number of probes with detected methane and the magnitude of methane concentrations along the western end of the Landfill decreased since startup of the Landfill gas extraction system in April 2004. Starting in October 2008, two probes along the western boundary, LG-27 and LG-28, started displaying elevated methane concentrations with a maximum concentration of 49% observed in LG-28 in January 2009, and a maximum of 74% observed in LG-27 in August 2012 (Figure 4). Methane has not been detected in either probe since January 2013. The elevated methane concentrations at LG-27 likely was due to preloading of adjacent areas within the Landfill for future site development.

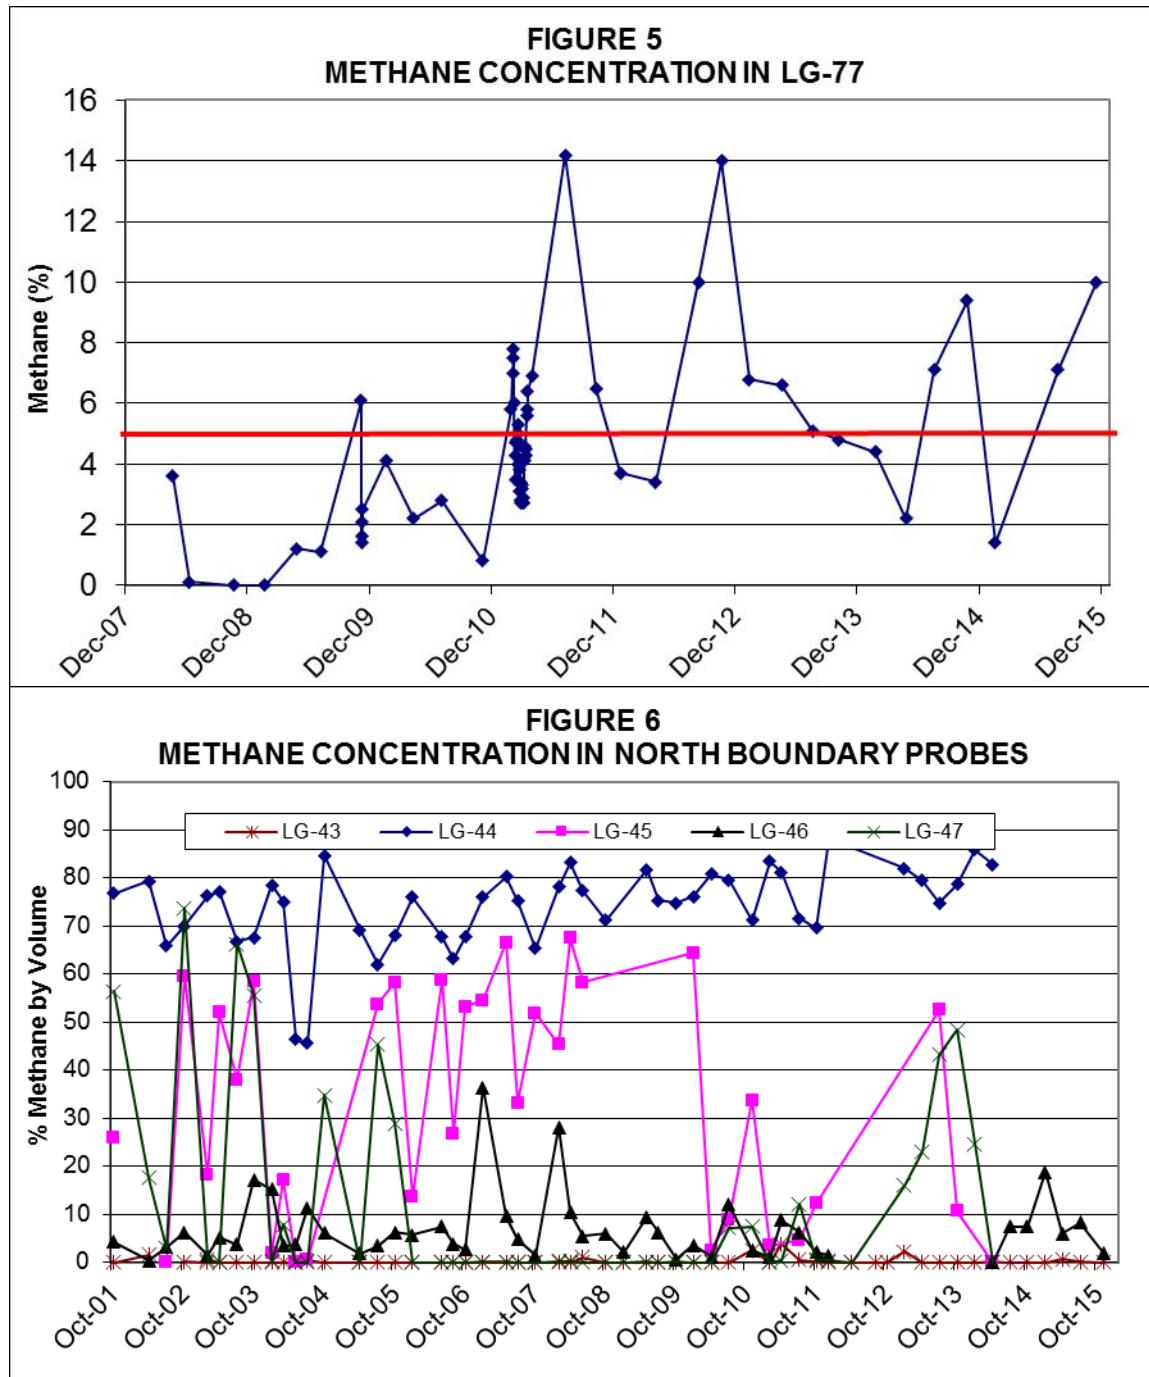
readings collected from these probes since 2009. Figure 5 shows the LG-77 methane concentrations over time.
