Third Quarter 2015 Remedial Systems Operations and Maintenance (O&M) Report

TOC Holdings Co. Facility No. 01-176
24205, 24225, 24309 56th Avenue West
Mountlake Terrace, WA

HydroCon Project No: 01-176

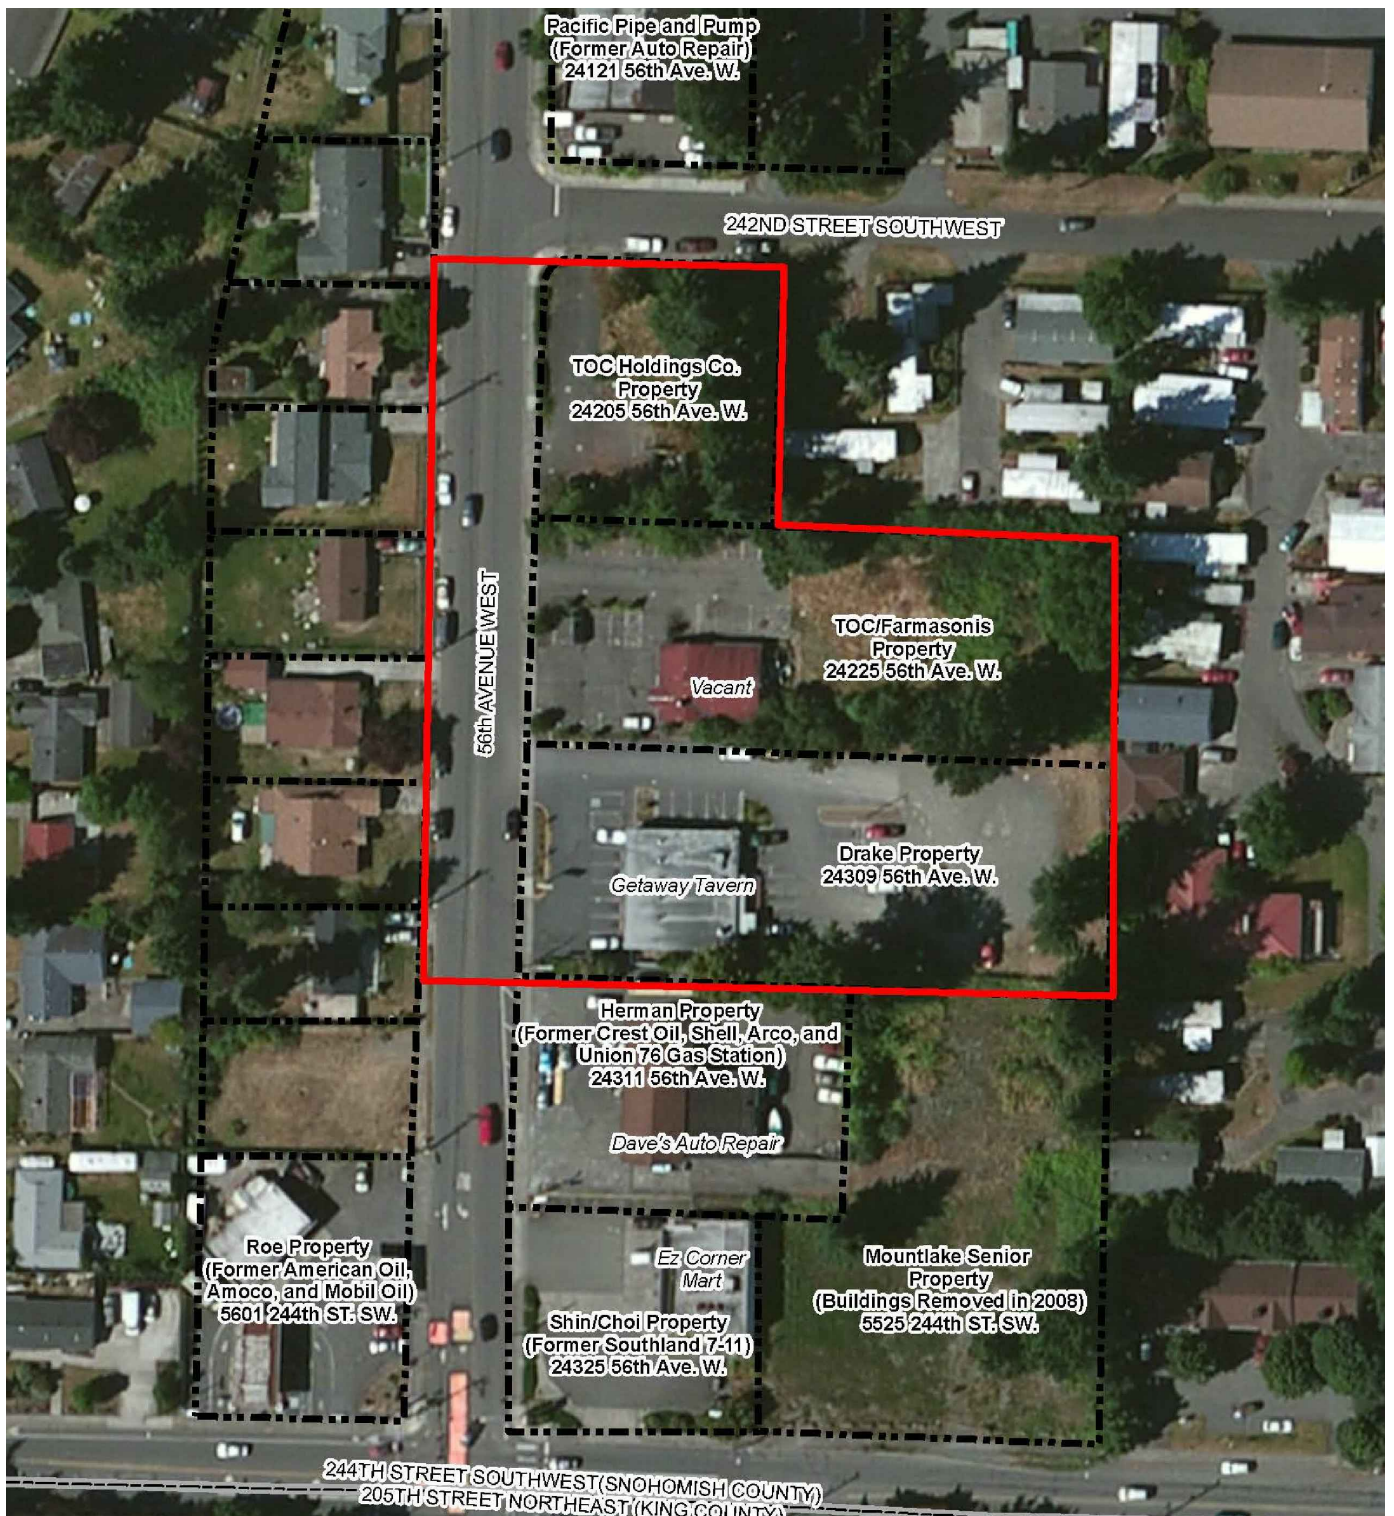
FIGURE 2
 SITE MAP

As described in the IRAWP, the TOC Facility No. 01-176 is termed the "Interim Remedial Project Area" (IRPA) and consists of the following four properties located in Mountlake Terrace, Washington (Figure 2):

- TOC Property: 24205 56th Avenue West
- TOC/Farmasonis Property: 24225 56th Avenue West
- Drake Property: 24309 56th Avenue West
- Portions of the 56th Avenue West Right-of-Way (ROW): adjacent to the TOC, TOC/Farmasonis and Drake properties
