Reconnaissance Survey of Inner Shelton Harbor Sediments

Chemical Screening of Nearshore Sites and Evaluation of Wood Waste Distribution

May 2000

Publication No. 00-03-014

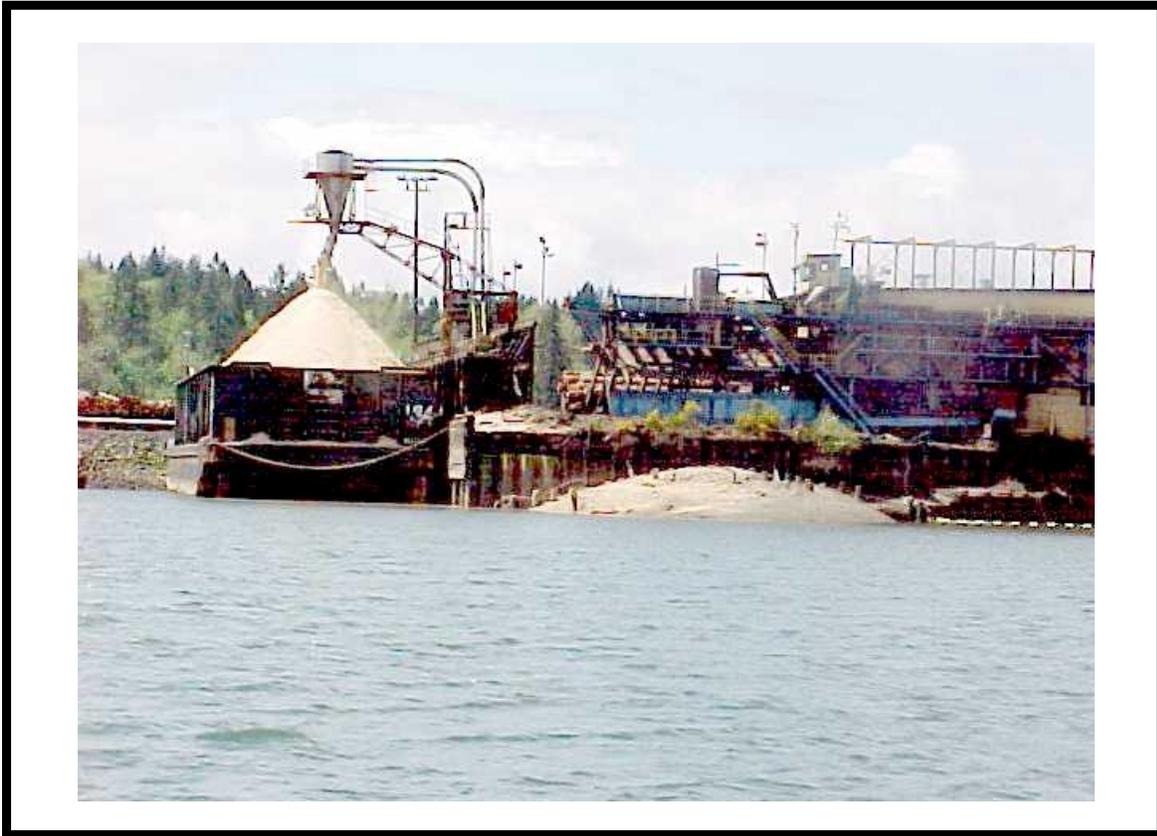
On a larger scale, a significant accumulation of wood chips was observed on the north side of the chip barge loading area at low tide. This accumulation is shown below in Figure 8.

The accumulation of wood chips appears to be the result of wind drift during barge loading operations. Implementation of best management practices during loading operations would greatly reduce this loss of chips into the marine environment.

Figure 8. Chip Barge Loading Area at Simpson Mill, Shelton.
