**REPORT  
ENVIRONMENTAL SITE ASSESSMENT  
PHASE I**

**ALOHA MOTEL  
301 AND 315 NORTH SAMISH WAY  
WHATCOM COUNTY PARCELS 380331425243 & 380331421256  
BELLINGHAM, WASHINGTON 98225**

October 23, 2014

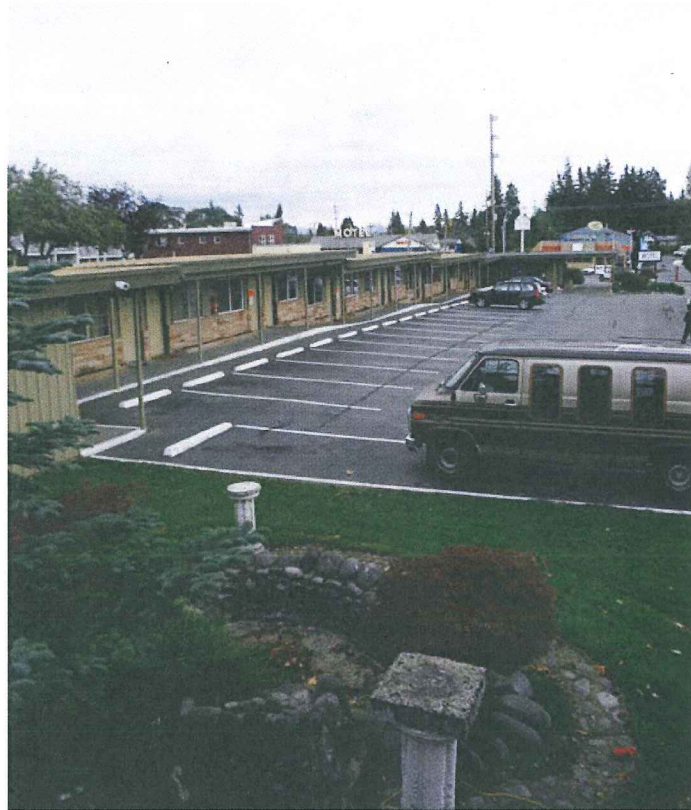
**Figure 3.** View of Building A and parking lot. Photo is taken looking northeast from southern portion of property.

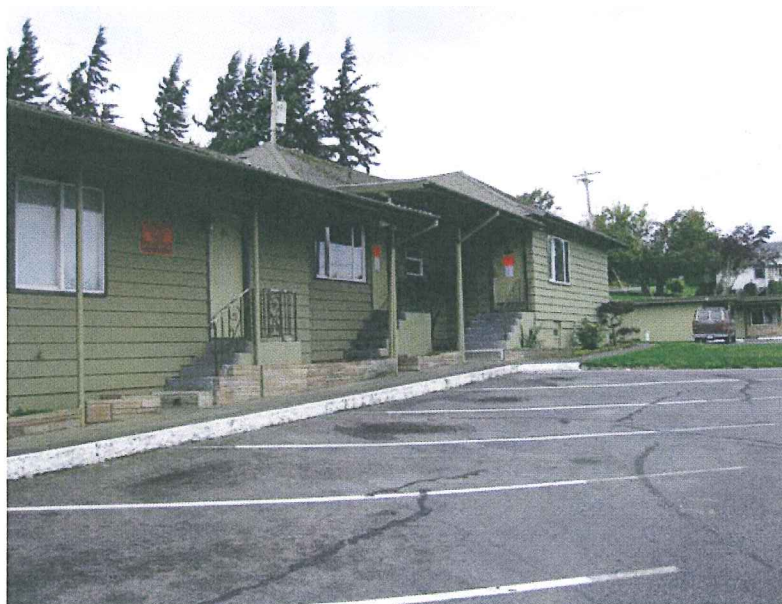
**Figure 4.** Building B on southern portion of property.

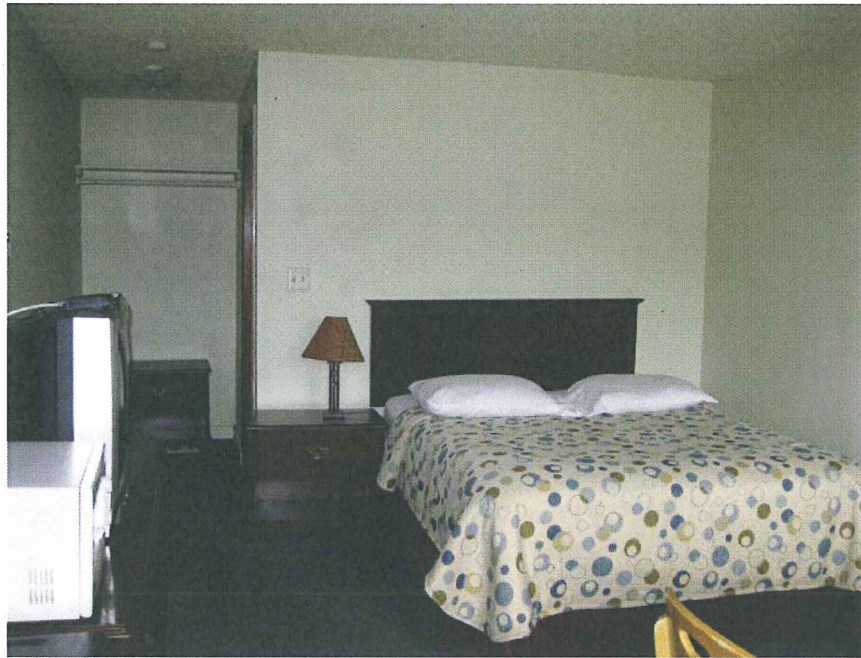
**Figure 5.** Interior of an actively rented motel room in Building A.

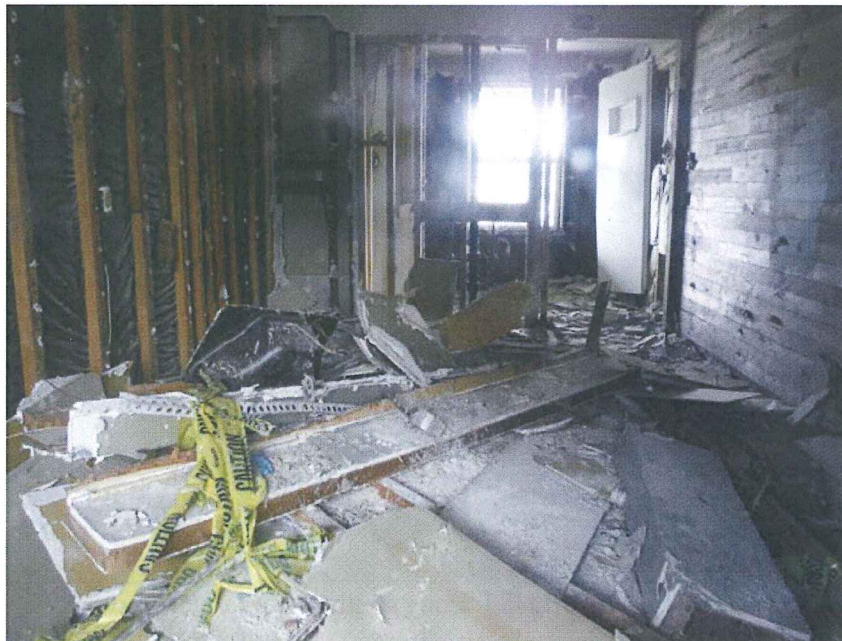
Ten of the 28 motel rooms on the site were condemned by the city of Bellingham for methamphetamine contamination at the time of our site visit. Contaminated rooms were posted with orange signs on the doors. Decontamination had begun in many of them, including piles of sheetrock on the room floors. We did not enter the contaminated rooms.

**Figure 6.** Interior of a contaminated room in process of decontamination in Building B.

We recommend that additional methamphetamine sampling take place within the buildings to define the extent of contamination or assume that all the motel rooms have been impacted by methamphetamine smoke. The methamphetamine contamination is present in the building materials, but no evidence of release to the soil and/or groundwater was identified during our site evaluation. Health department and solid waste regulations should be followed for decontamination and/or demolition processes.

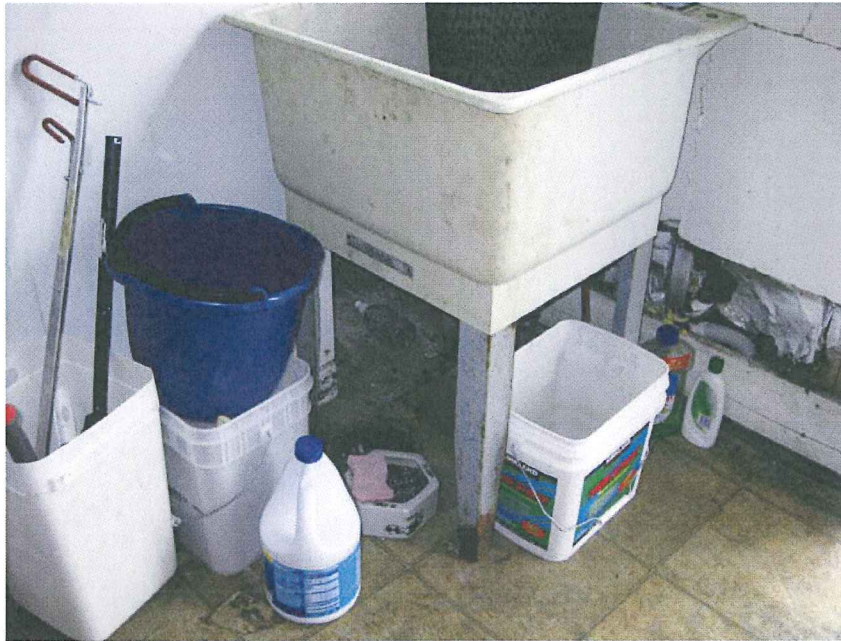
The motel office is located at the northeast end of the northern building (Building A). A laundry room is adjacent to the office. One floor drain is located under the utility sink in the laundry room.

According to a motel maintenance worker, the drain is connected to the sewer lines. Two industrial-sized dryers (natural gas powered) and one washing machine are located in the laundry room. A few household cleaning supplies are stored on shelves.

**Figure 7.** Floor drain beneath utility sink in laundry room, Building A.

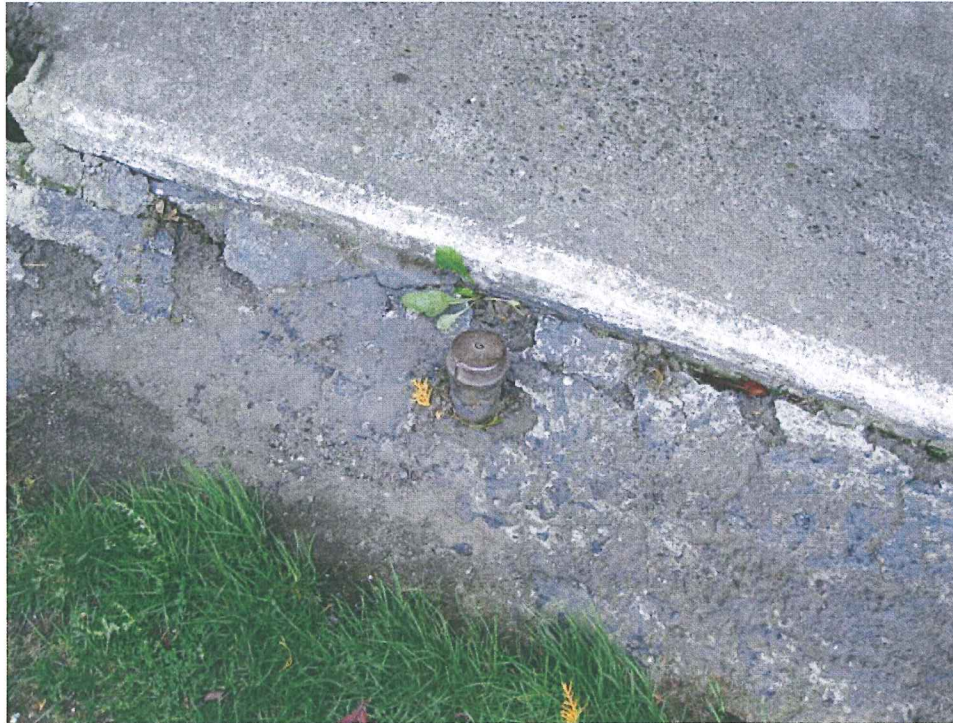
**Figure 9.** Close-up of fill pipe associated with Building B.

The heating oil UST poses a potential risk of petroleum contamination to the soil and/or groundwater at the site. The size, age, and/or contents of the tank are currently unknown. Based upon the tank being no longer in use, we recommend that the tank be removed and soil sampling take place around the tank. If more certainty is desired to define the potential risk of contamination posed by the heating oil tank, sampling can be conducted prior to the property purchase or tank removal.

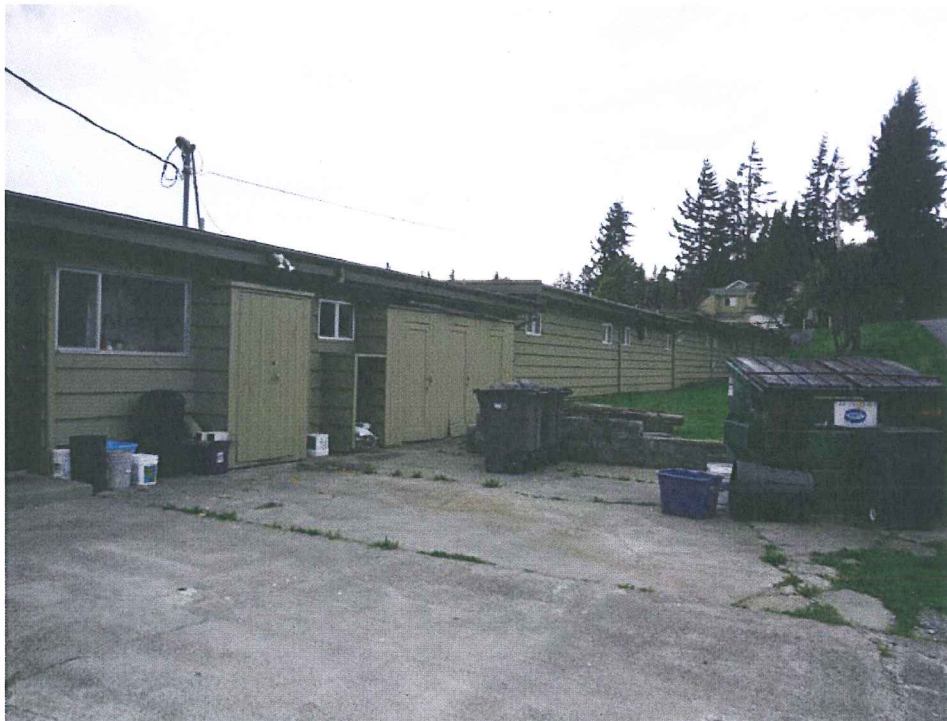
Trash receptacles are located on an open concrete pad on the northwest side of Building A. An underground drain runs southwest to northeast behind Building A. We observed no signs of chemical disposal or dumping in these locations or elsewhere on the property.

**Figure 10.** Trash and recycling area behind Building A.
