Cleanup Action Report

Ninth and Lenora Redevelopment
2101 9th Avenue
Seattle, Washington
Facility/Site #91413494
Cleanup Site ID: 1802
VCP Project No. NW2980

Cleanup Action Report
Ninth and Lenora Redevelopment
2101 9th Avenue
Seattle, Washington

GeoEngineers File No. 21138-001-03

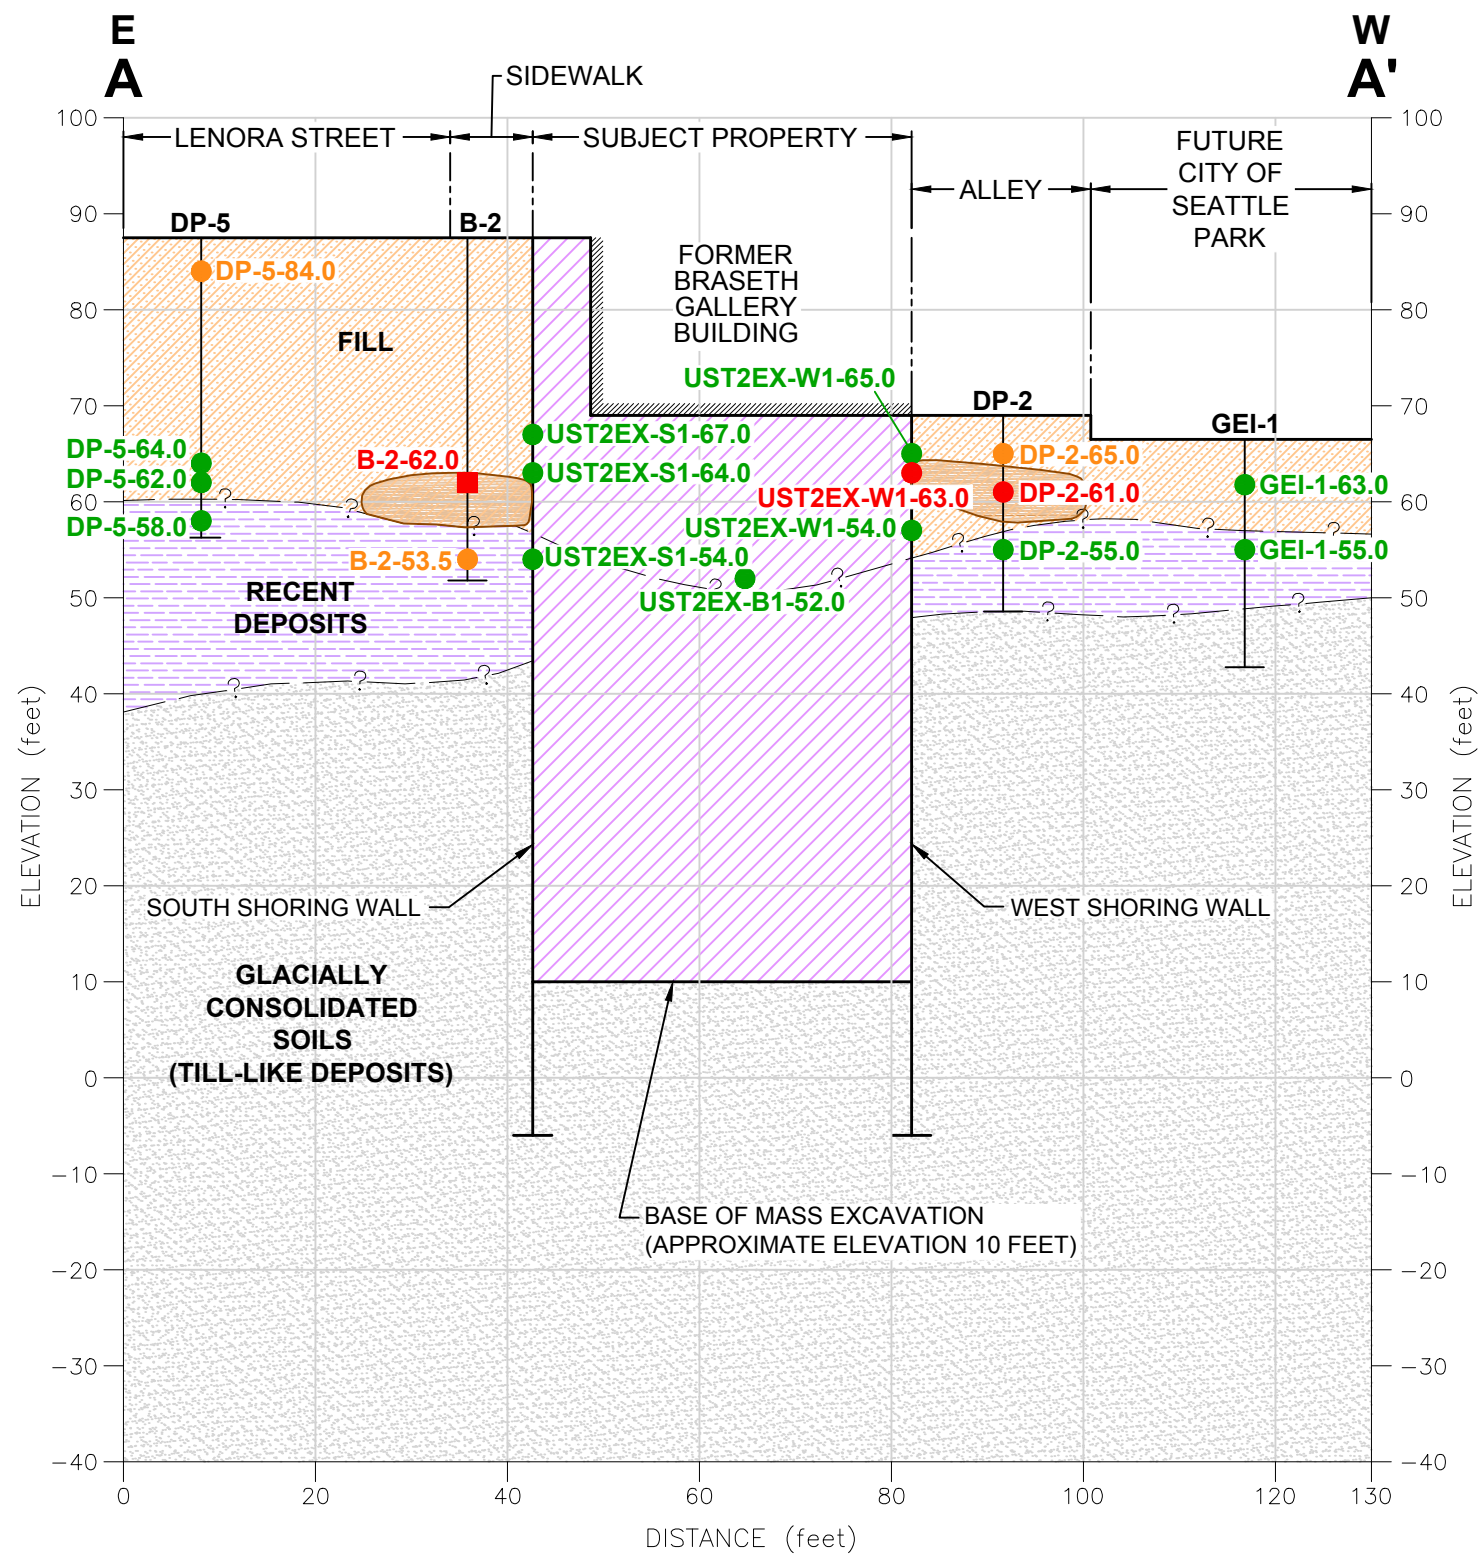
P:\21\2138001\03\CAD\REVISED CAR\2113800103_T500_REV_CAR_F6_CROSS SECTION A-A'.DWG\TAB\F6 MODIFIED BY SY1 ON MAR 11, 2016 - 21:56

- Notes:**
1. The subsurface conditions shown are based on interpolation between widely spaced explorations and should be considered approximate; actual subsurface conditions may vary from those shown.
 2. Refer to Figure 7 for location of Cross Section.
 3. This figure is for informational purposes only. It is intended to assist in the identification of features discussed in a related document. Data were compiled from sources as listed in this figure. The data sources do not guarantee these data are accurate or complete. There may have been updates to the data since the publication of this figure. This figure is a copy of a master document. The master hard copy is stored by GeoEngineers, Inc. and will serve as the official document of record.

The field screening and chemical analytical results of the characterization and remedial excavation confirmation samples are summarized in Table 3. The approximate final limits of the UST2 remedial excavation along with confirmation samples are shown in Figure 3. The approximate extent of residual MTCA exceeding soil in Lenora Street and alley is generally shown in Figure 5. A geologic and chemical analytical profile of the subsurface conditions in the south portion of the Site is graphically shown in attached Cross Section A-A', Figure 6. A copy of the laboratory reports is presented in Appendix C.
