Periodic Review

Gilbert Elementary School
Facility/Site ID # 5154076
Cleanup Site ID # 2254
4400 Douglas Drive
Yakima, Washington 98908

Prepared by:
Washington State Department of Ecology
Central Regional Office
Toxics Cleanup Program

November 2015

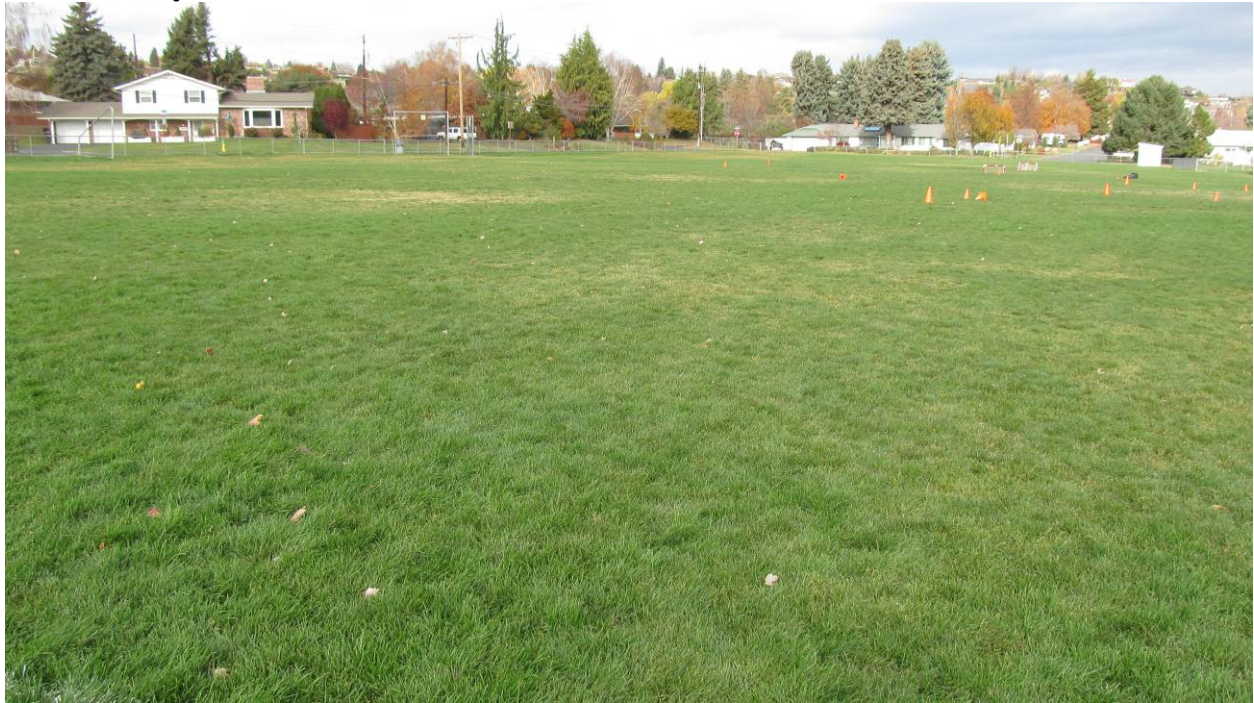
Photo 3: Play Field Turf - from the south

Based upon the Site visit conducted on November 17, 2015, and interviews with School maintenance personnel, no repair, maintenance or contingency actions have been required. Sample data indicates that the clean soil cap on the Site continues to reduce the human exposure pathway to contaminated soils to acceptable levels. A photo log is available as Appendix 6.5.
