PRELIMINARY REMEDIAL INVESTIGATION AND FEASIBILITY STUDY

NORTH CASCADE FORD PROPERTY SEDRO-WOOLLEY, WASHINGTON

> Prepared for VSF PROPERTIES, LLC December 9, 2015 Project No. 0747.01.05

Prepared by Maul Foster & Alongi, Inc. 1329 N State Street, Suite 301, Bellingham WA 98225

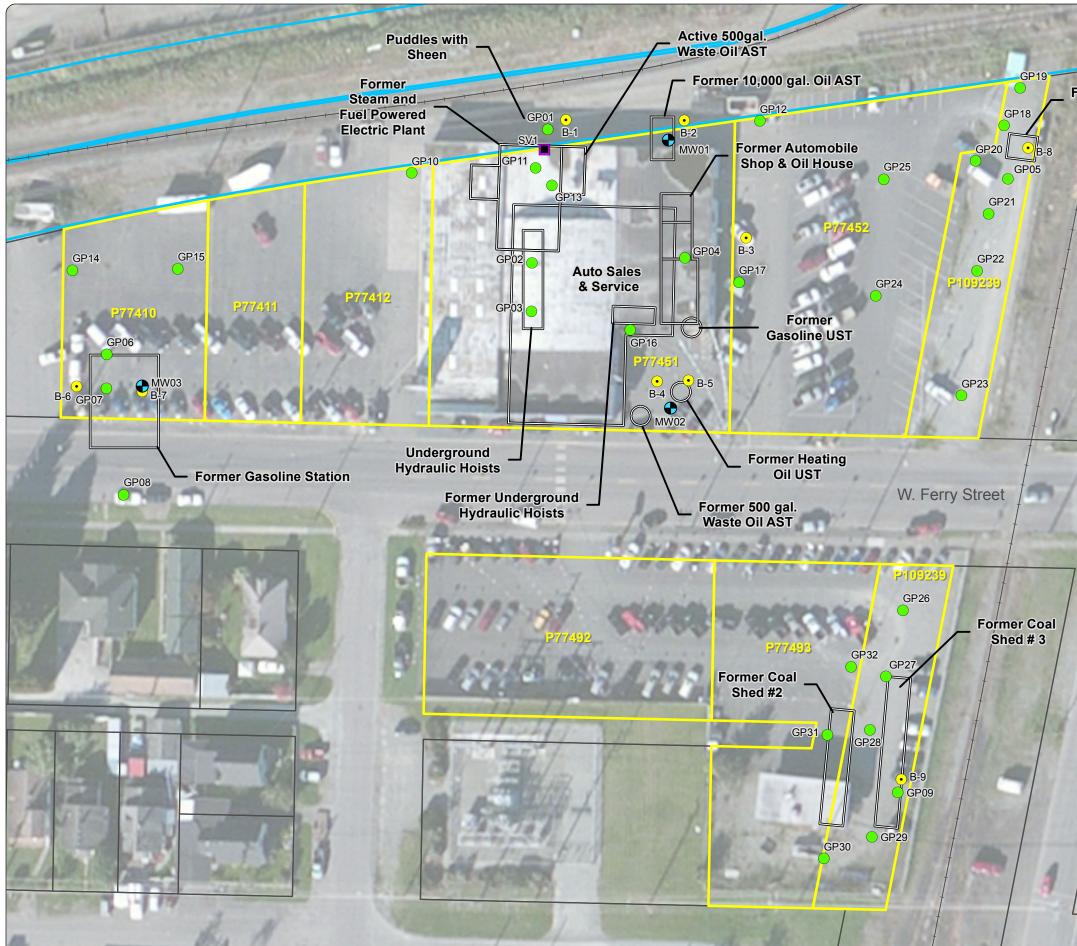
Figure 1-2 Site Features and Sample Locations

The Phase I ESAs (see Appendix A) identified a number of recognized environmental conditions (RECs) at the Property. Additional features identified in the reports were not categorized as RECs, but MFA considered them potential sources of environmental impacts (MFA, 2012a). Collectively, these "features of environmental concern" were investigated as part of this preliminary RI and are shown in Figure 1-2.

Underlying the surficial cover and fill is a geologic unit consisting of generally brown to gray sand, with varying amounts of silt, extending to approximately 10 feet below ground surface (bgs). At approximately 10 feet bgs, a layer of well-sorted sand with trace woody debris, gravel, and orange mottling or staining, extending down to 25 feet bgs, was encountered. At 25 feet bgs, a poorly sorted gray sand, extending to 32.9 feet bgs, the maximum depth observed in any boring, was encountered. An approximately 2-foot-thick lens of clay and silt was encountered in some locations at approximately 15 feet bgs. A 1-foot-thick layer of woody debris was encountered at 8 feet bgs at boring location GP11 (see Figure 1-2).

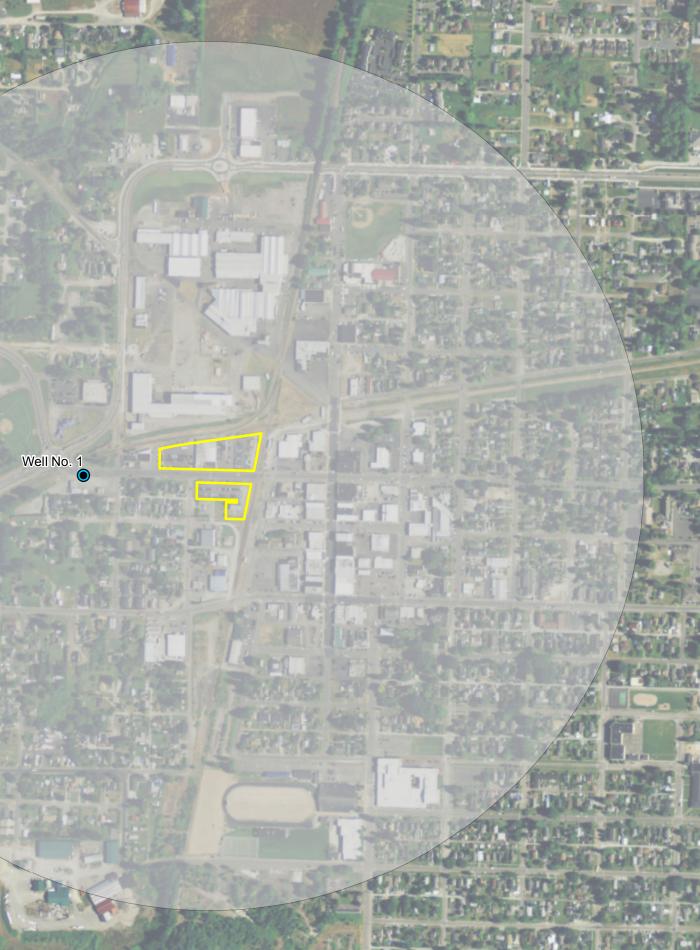
Figure 6-1 Water Well Locations

There is no known use of groundwater at the Property. The Property and surrounding area are supplied with water from the City of Sedro-Woolley (the City). The current groundwater use is likely to continue in the future. Three water wells were identified in the study area (see Figure 6-1). As discussed below, the current beneficial use listed for one of the three water wells found in the study area is irrigation. No water use information was provided for the other two water wells.

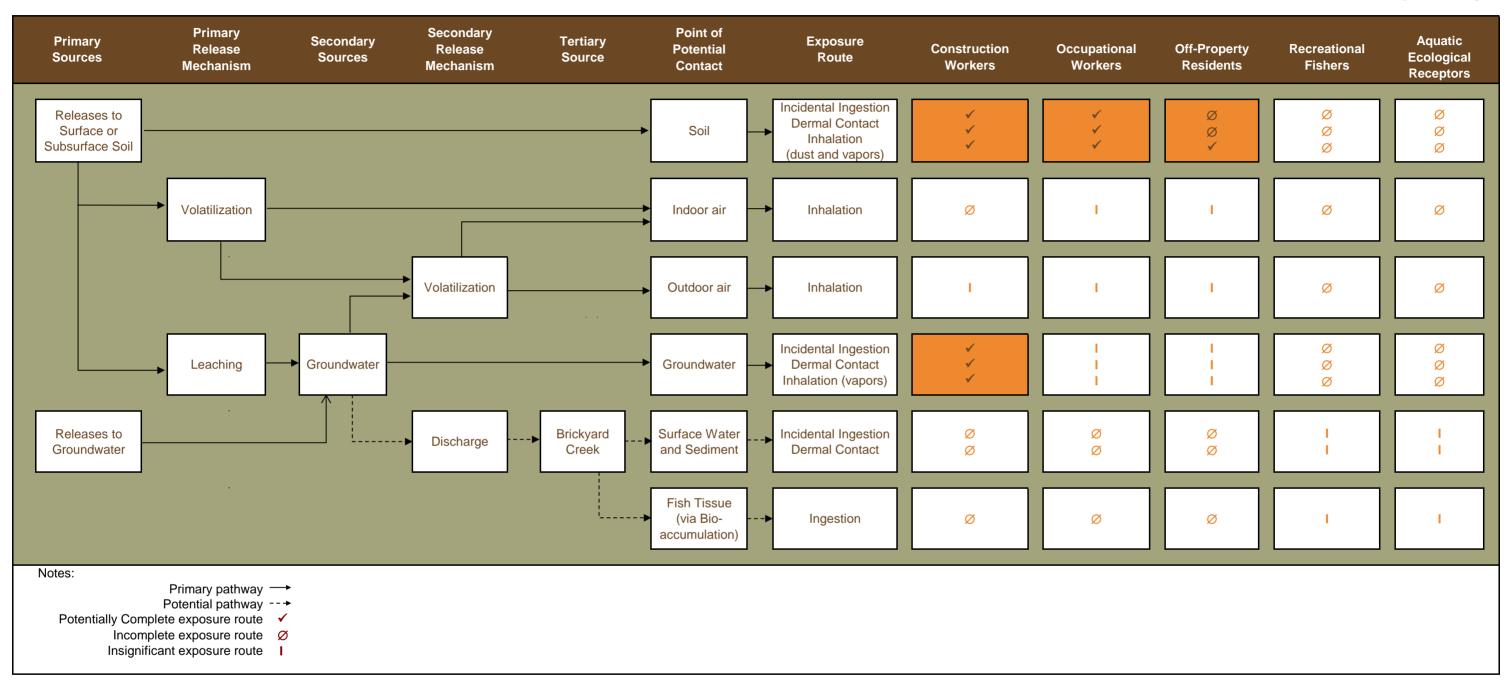
Figure 6-2 Preliminary Conceptual Site Model North Cascade Ford Property Sedro-Woolley, Washington

The primary mechanisms likely to influence the fate and transport of chemicals at the Property include natural biodegradation of organic chemicals, sorption to soil, advection and dispersion in groundwater, volatilization of volatile chemicals from soil or groundwater to air, and leaching of chemicals from soil to groundwater. The relative importance of these processes varies, depending on the chemical and physical properties of the released contaminant. The properties of soil and the dynamics of groundwater flow also affect contaminant fate and transport.

The Property is unvegetated and mostly paved; an unpaved, gravel driveway runs along the eastern perimeter of the Property. The soil-to-groundwater migration pathway is potentially complete because of the potential for infiltration of precipitation through unpaved areas and through cracks in the pavement or in stormwater piping at the Property into the vadose-zone soil. Leaching of nearsurface soil impacts during precipitation events could result in impacts to shallow groundwater at the Property.
