January 4, 2008
000111-01 BG01 T04

Re: Duwamish Shipyard – Stormwater System Cleanout Completion

Attachment E: Stormwater System Cleanout Photograph Documentation

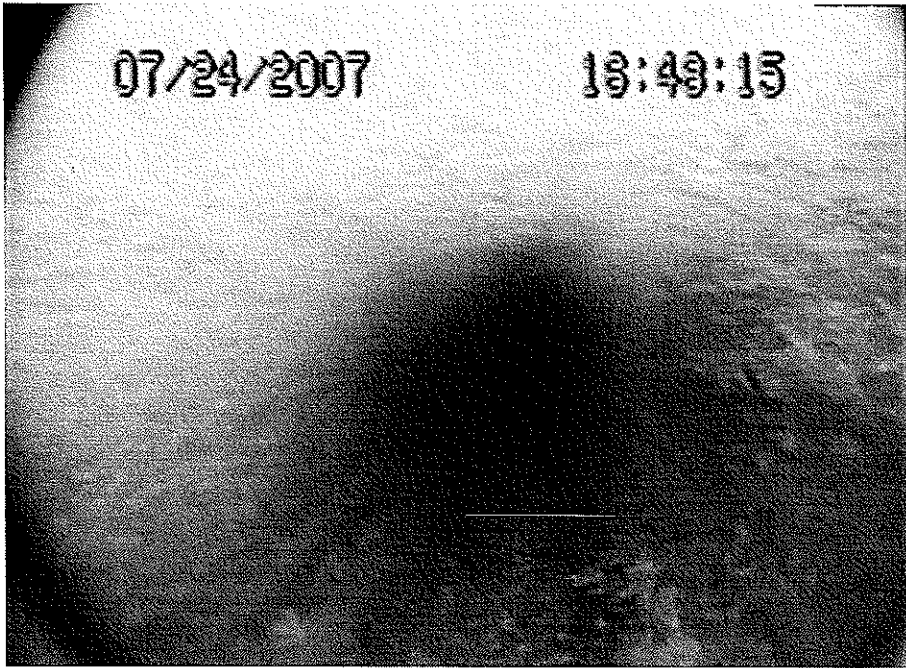
Photograph E-03: Lateral line section from DSI-14 to DSI-13. This lateral line is approximately 3-inch diameter concrete pipe.

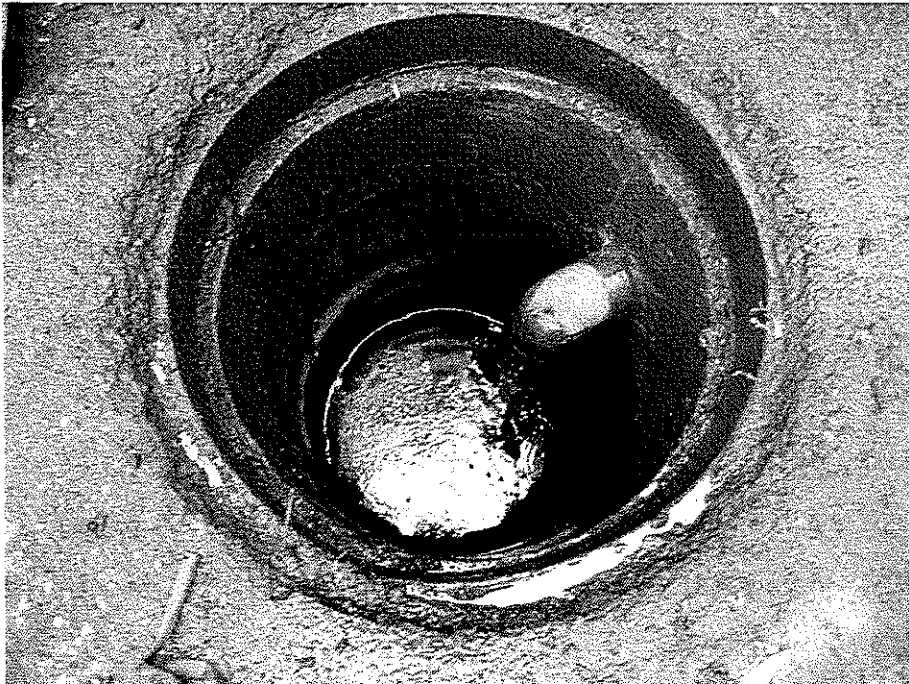
Photograph E-06: Catch basin DSI-15. The lateral piping between DSI-15 and the main-line was not accessible to clean due to the presence of the piping elbow (below) and the piping connection directly to the main-line (rather than piping to a catch basin).

CCS performed the stormwater system cleanout by using a 120-barrel vacuum truck with a jet rodder and suction hose to collect generated water. Prior to the stormwater system cleanout, measures were performed to eliminate potential discharges to the Duwamish River. An inflatable plug was placed in the catch basin nearest the shoreline outfall and the outfall valve was closed. The outfall discharge pipe was routinely monitored to confirm that generated water from the cleanout was not discharging to the Duwamish River. The mainline stormwater system piping was accessible and cleaned without incident. All but two lateral stormwater system lines were accessible. The lines from catch basin DSI-15 to the mainline and DSI-18 to DSI-19 were not accessible due to piping construction or apparent blockage.
