RE: Report of Monitoring Well Installation
Poulsbo Village Fuel
19560 7th Ave NE
Poulsbo, Washington 98370

VILLAGE FUEL 76 – MONITORING WELL INSTALLATION
 19560 7th AVE NE, POULSBO, WA

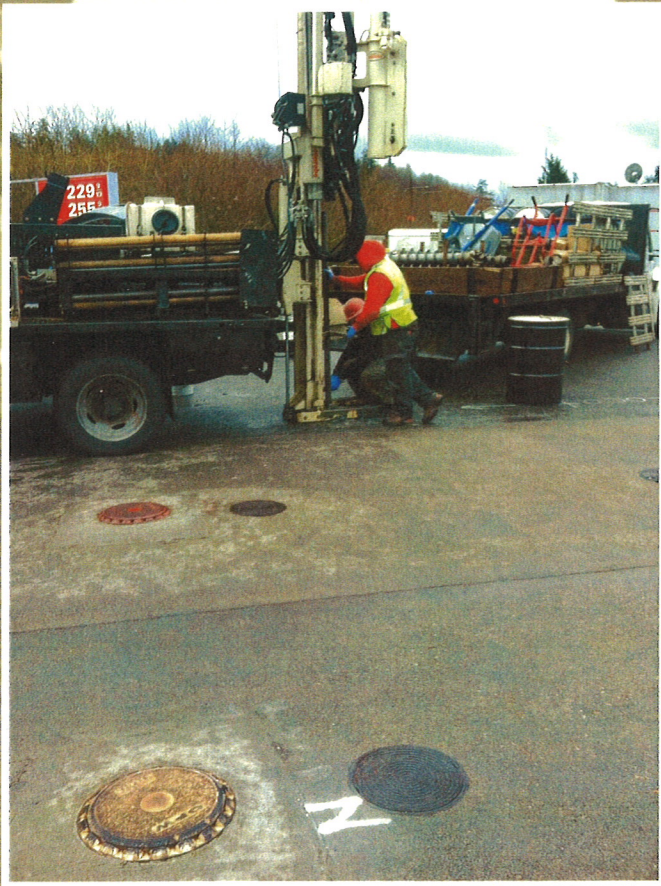
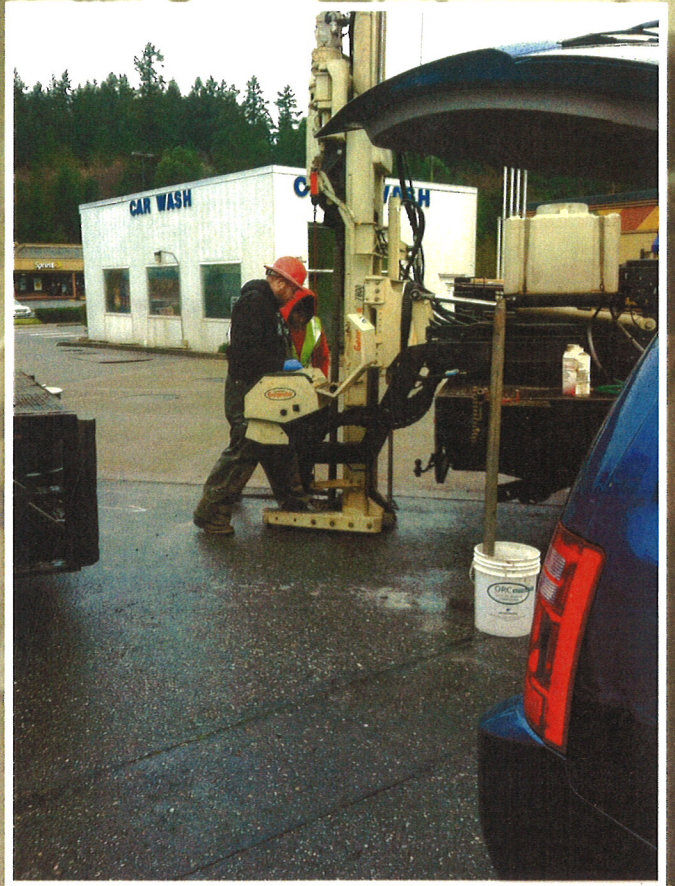
Drilling and Well Installation. On January 11, 2016 Geoprobe and monitoring well installation activities were completed by ESN Northwest located in Olympia, Washington. ESN is a state-licensed well drilling company. ESN drilled and installed one 2-inch diameter groundwater monitoring well to a depth of 25 feet below ground level. (MW-1 see figure 1). A Geoprobe was used first to obtain soil samples at depths of 15 – 25 feet bgl. Then using a hollow-stem auger the well consisted of 2-inch diameter, schedule 40, flush-threaded PVC, 15-foot long, 10-slot screen and 2/12 silica sand pack, with hydrated bentonite seal above the sand pack, and a flush-mounted, traffic rated steel monument at ground surface. The well conforms to the requirements described in Chapter 173-160, “Minimum Standards for the Construction of Maintenance of Wells’.
