INITIAL INVESTIGATION FIELD REPORT

ERTS Number: 641341
Parcel #: 27101900102400
County: Snohomish
FS ID: 23508
CSID: 13039

Site Name (e.g., Co. name over door): Index Sportsmen Club	Site Address (including City and Zip+4): 49601 Old Goldbar Index Rd Index, WA 98256	Site Phone: N/A
Site Contact and Title: N/A	Site Contact Address (including City and Zip+4): N/A	Site Contact Phone: N/A
Site Owner: Mt Baker-Snoqualmie National Forest Joseph Neal, Ranger U.S.	Site Owner Address (including City and Zip+4): Skykomish Ranger District, 74920 NE Stevens Pass Hwy Skykomish, WA 98288	Site Owner Phone: 801-733-2685
Site Owner Contact: Joseph Gibbens On-Scene Coordinator USDA Forest Service	Site Owner Contact Address (including City and Zip+4): Pacific Northwest Region PO Box 3623 Portland, OR 97208-3623	Owner Contact Phone: 360-956-2352 503-808-2468 jfgibbens@fs.fed.us
Alternate Site Name(s): Index Shooting Range	Comments:

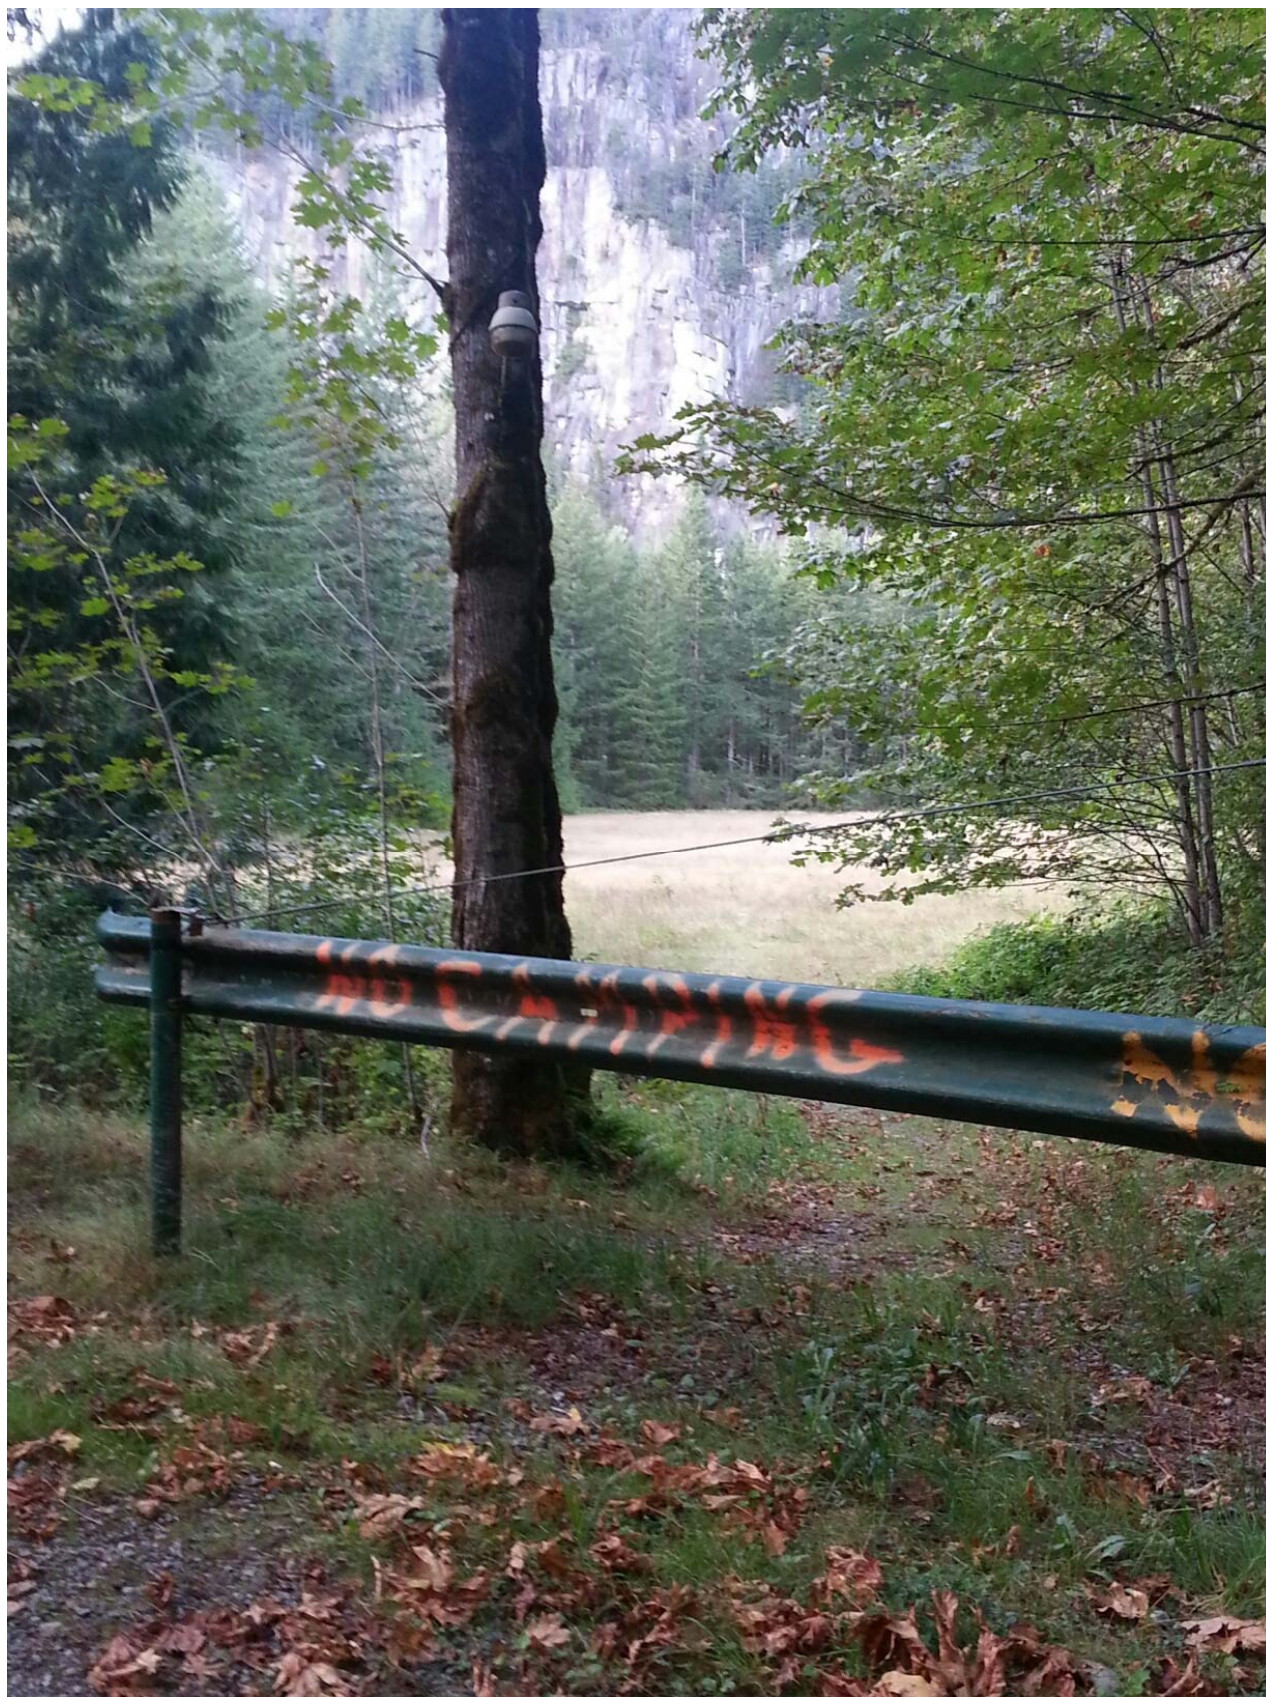
The adjoining property to the west is Washington State Park Land. The adjoining property to the north is BNSF railroad. The city limits are defined by the east property line. The adjoining property to the south is a public trail owned by the town of Index. The site is not fenced, but has a gate at the entrance. The gate is marked "No camping", but there are no other restrictions for anyone to walking on the site. See photo attached.

Photograph of gate for access to the site, taken from adjacent public trail south of the site owned by the town of Index;
by Mike Young 8/27/2013

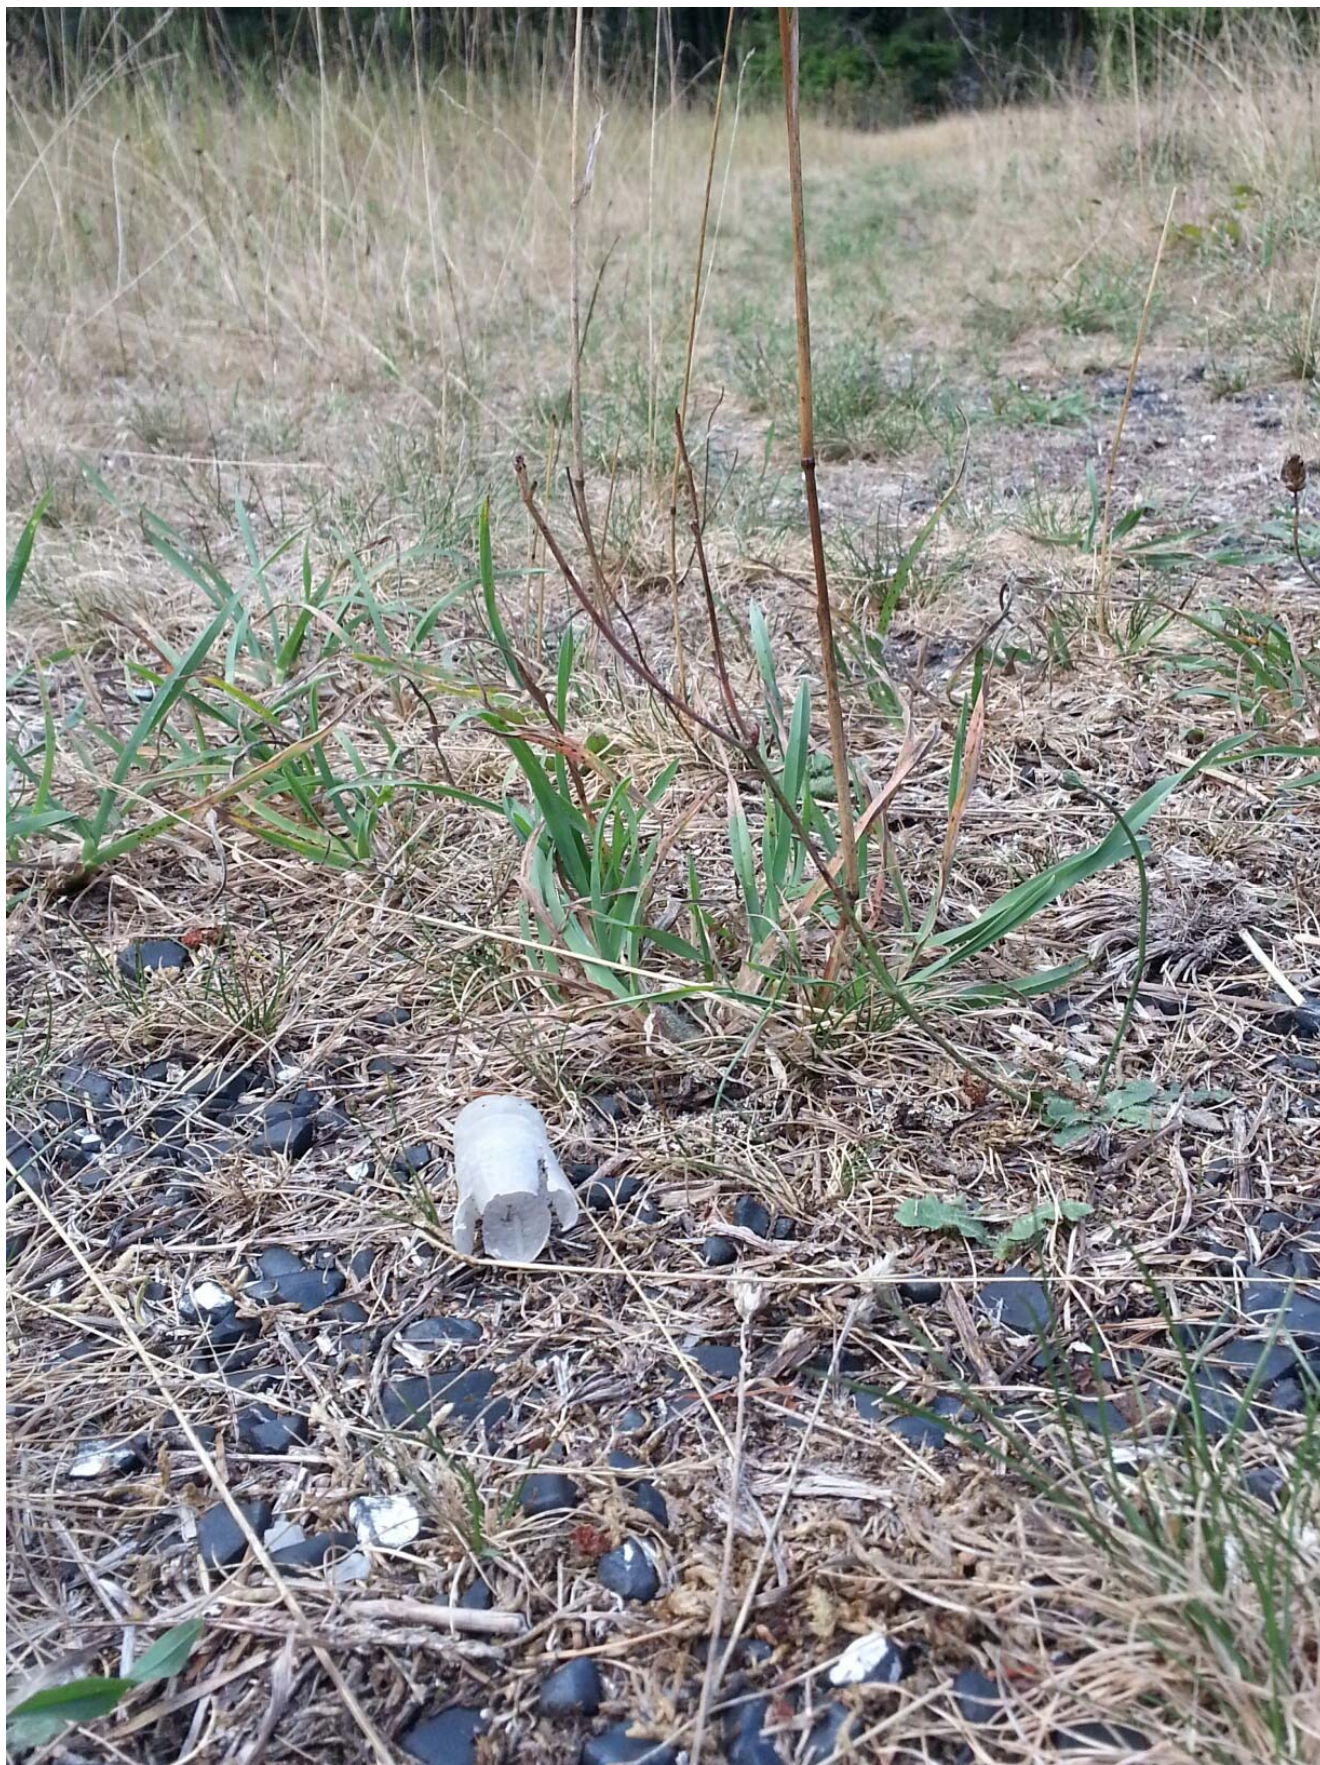
This USFS property is 37 acres, with a 3.9 acre grass area surrounded by trees located in the NE ¼ of Sec 19, T27N, R10E. When the USFS required the gun club vacate the property, they had the gun club remove all buildings and other material from the site. The only objects remaining on the site are three monitoring wells. The location of the baseball diamond and shooting range can still be seen because of the soil disturbance and clay pigeons fragments that litter the ground. See photo attached.

Photograph of clay pigeons fragments that litter the ground by Mike Young 8/27/2013
