19 April 2004
13890.20

**SUBJECT: Index Sportsmen's Club – Final Field Investigation Report
Mt. Baker-Snoqualmie National Forest**

Figure 1
 Site Location Map
 Index Sportsmen's Club
 Index, Washington

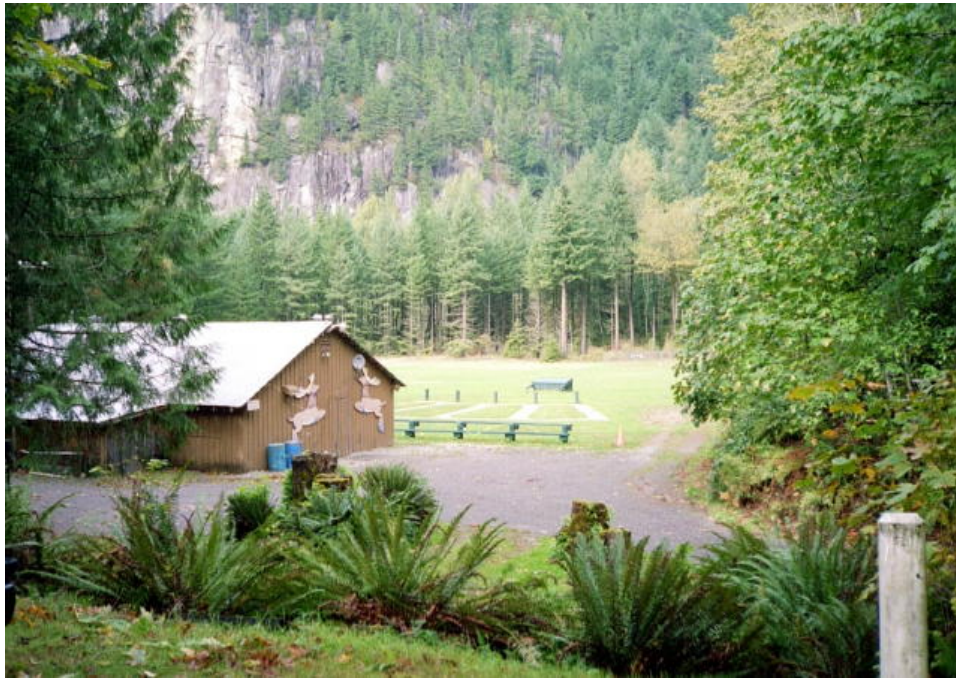
Photo 1 Date: 10/13/03 Looking north from south end of the site, across the parking lot and club building.
Time: 1250

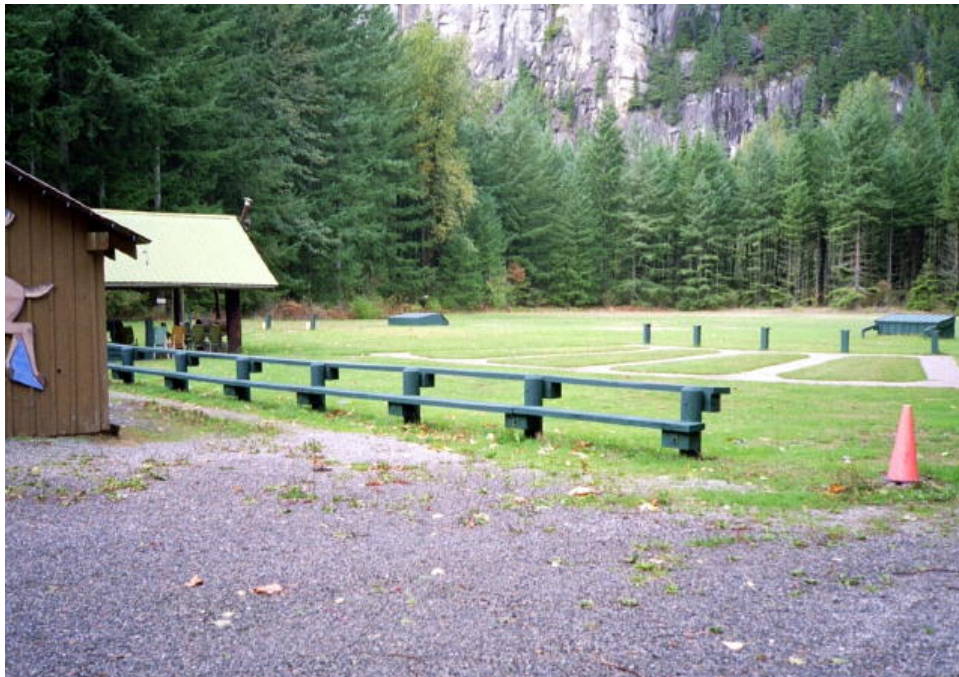
Photo 2 Date: 10/13/03 Looking northwest across the cleared range area from the club house area.
Time: 1301

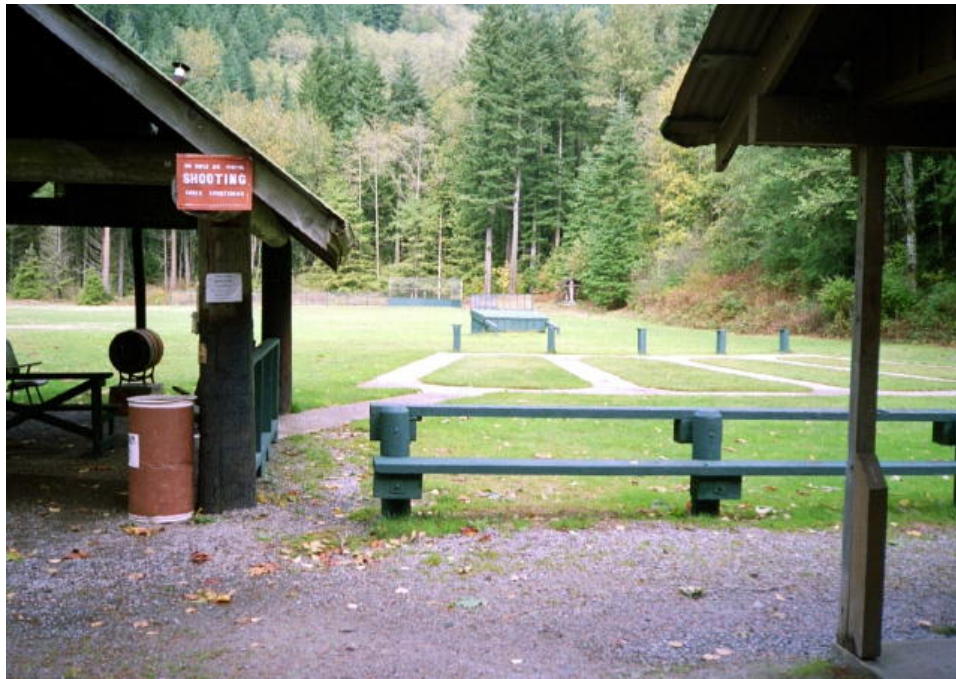
Photo 3 Date: 10/13/03 Looking generally northwest across the site from the club house and covered shelter area.
Time: 1255

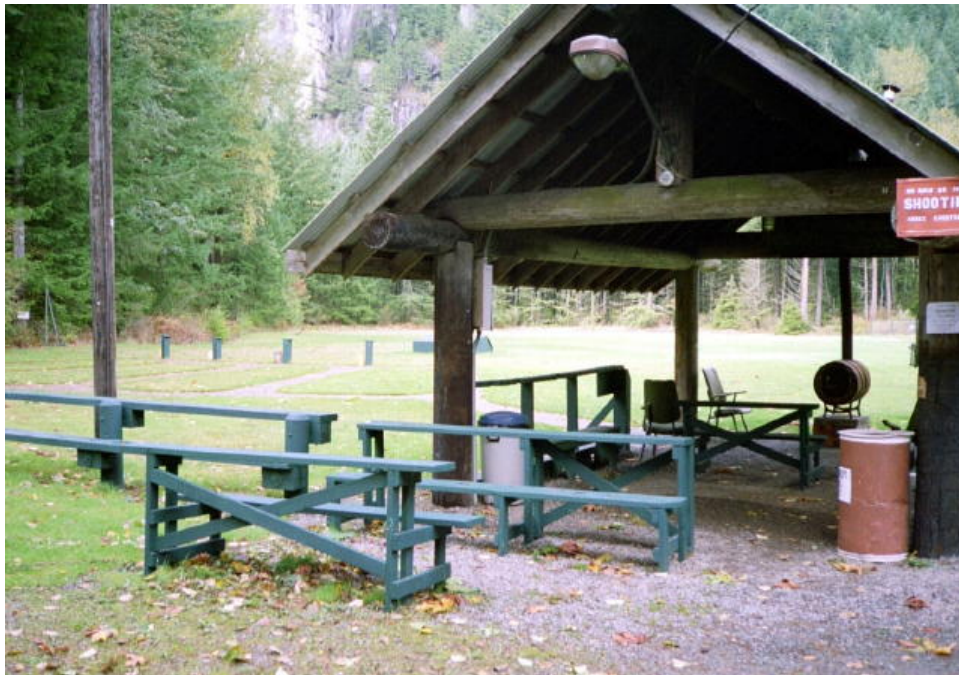
Photo 4 Date: 10/13/03 Looking north across the site and through the covered shelter, from the club house area.
Time: 1300

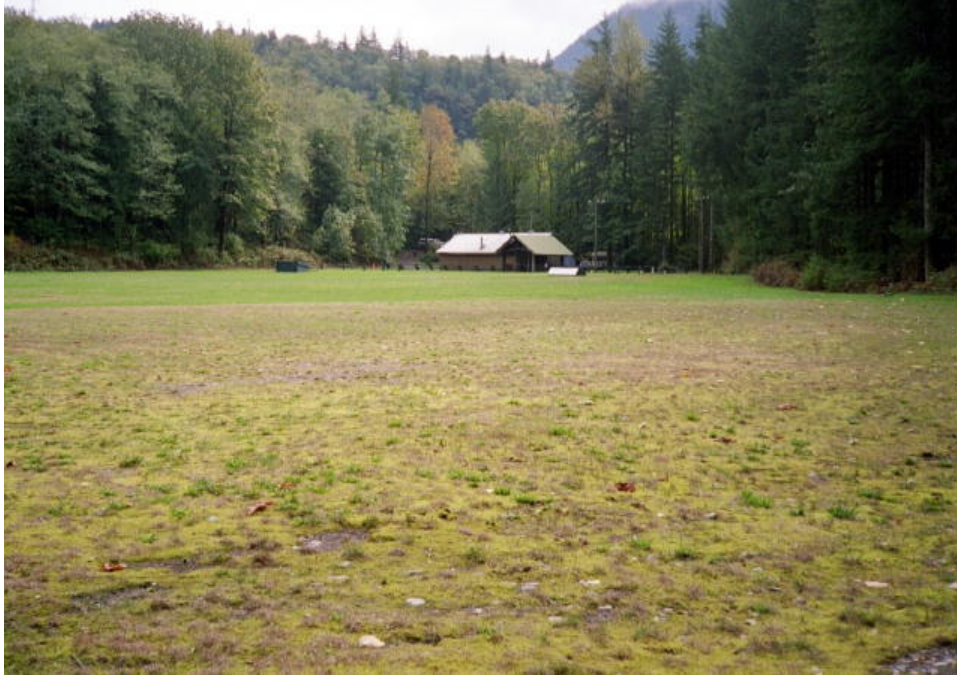
Photo 5 Date: 10/13/03 Looking south-southwest from the northeast corner of the site.
Time: 1310

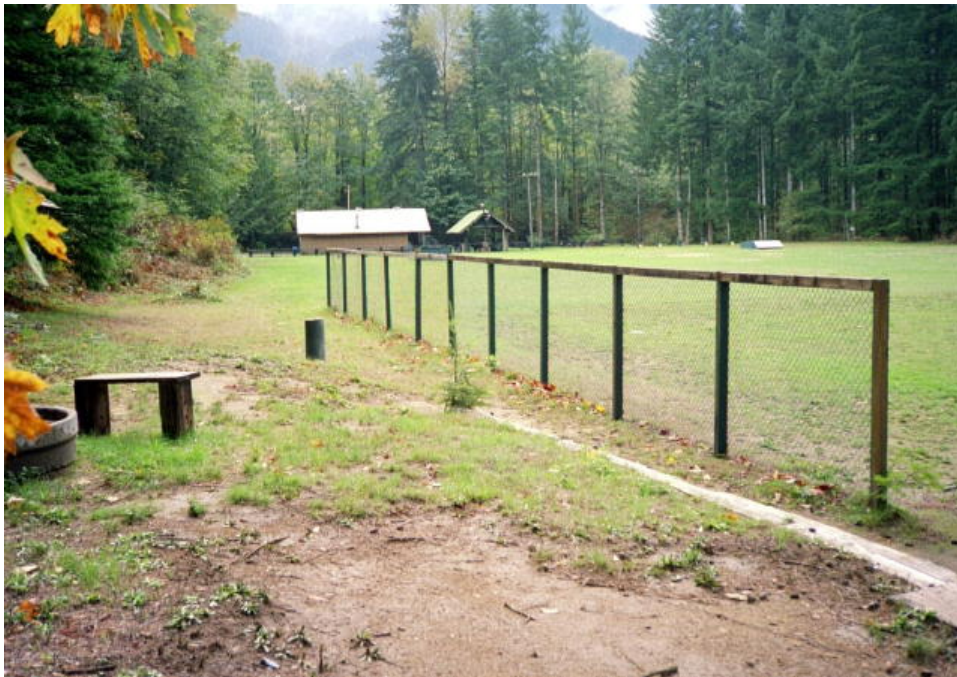
Photo 6 Date: 10/13/03 Looking generally southeast across the site from the northwest corner.
Time: 1330 Baseball field is to the right, fire ring and water tap on the left.

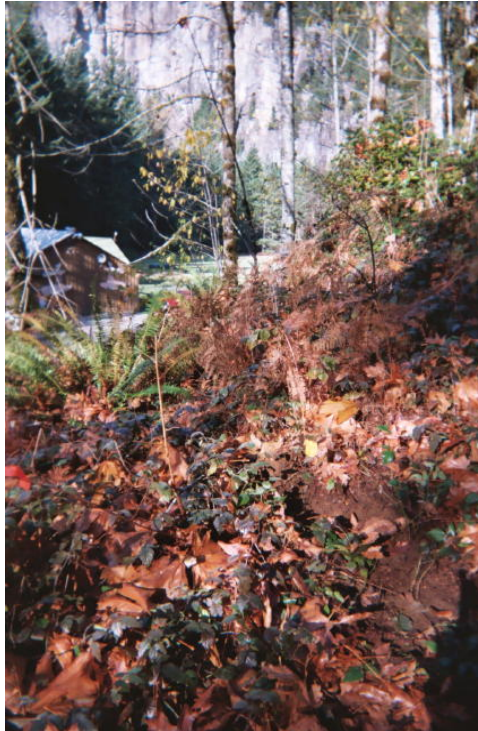
Photo 7 Date: 11/12/03 Background sampling location BK-01, looking generally north-northwest
Time: 1043 toward the site. Sample hole is just right of center below the ferns.

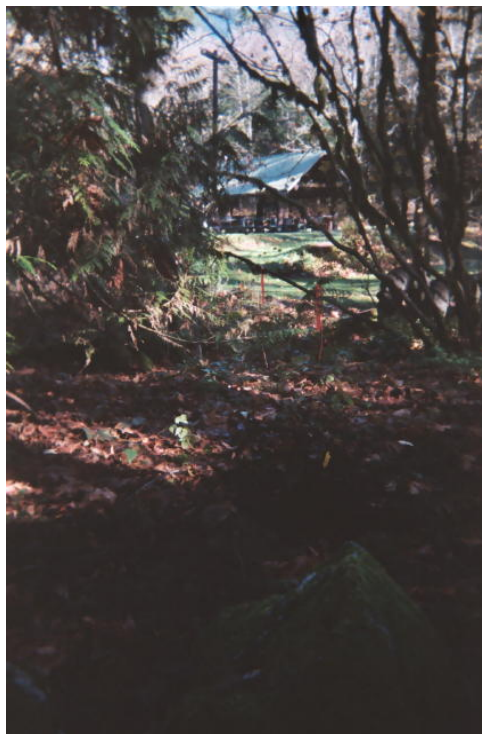
Photo 8 Date: 11/12/03 Background sampling location BK-02, looking generally northeast towards
Time: 1108 the site. Hole is at the yellow flag just below and right of center.

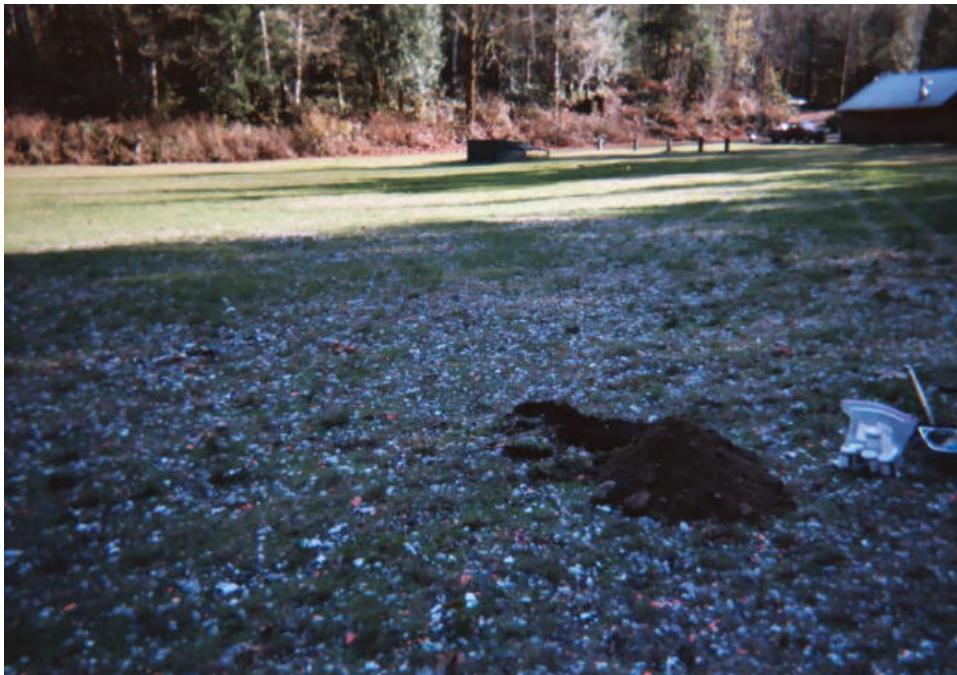
Photo 10

Looking generally southeast across sampling location TA-04. Note dense debris cover.

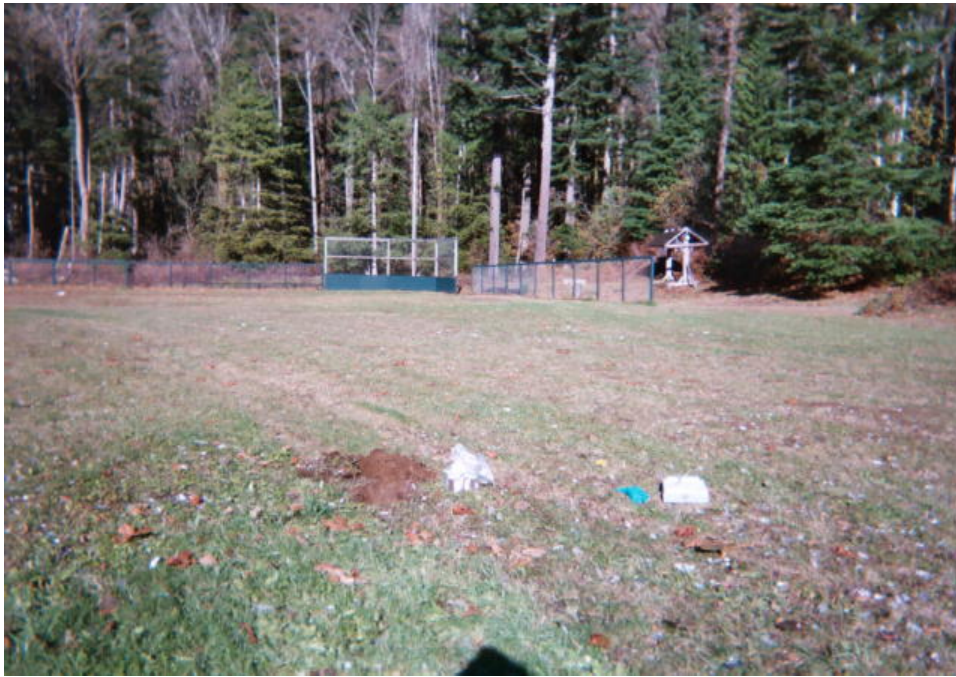
Photo 11 Date: 11/12/03 Looking generally northeast across sampling location TA-05 (dirt pile).
Time: 1245

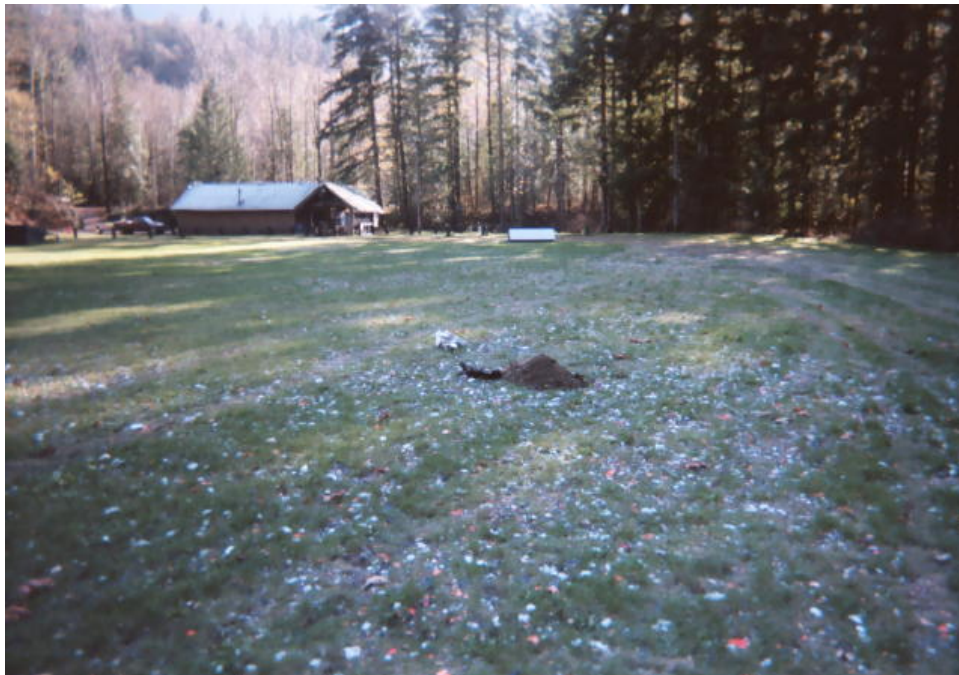
Photo 12 Date: 11/12/03 Looking south across the site and sampling location TA-06 (dirt pile). Note
Time: 1315 surface debris.

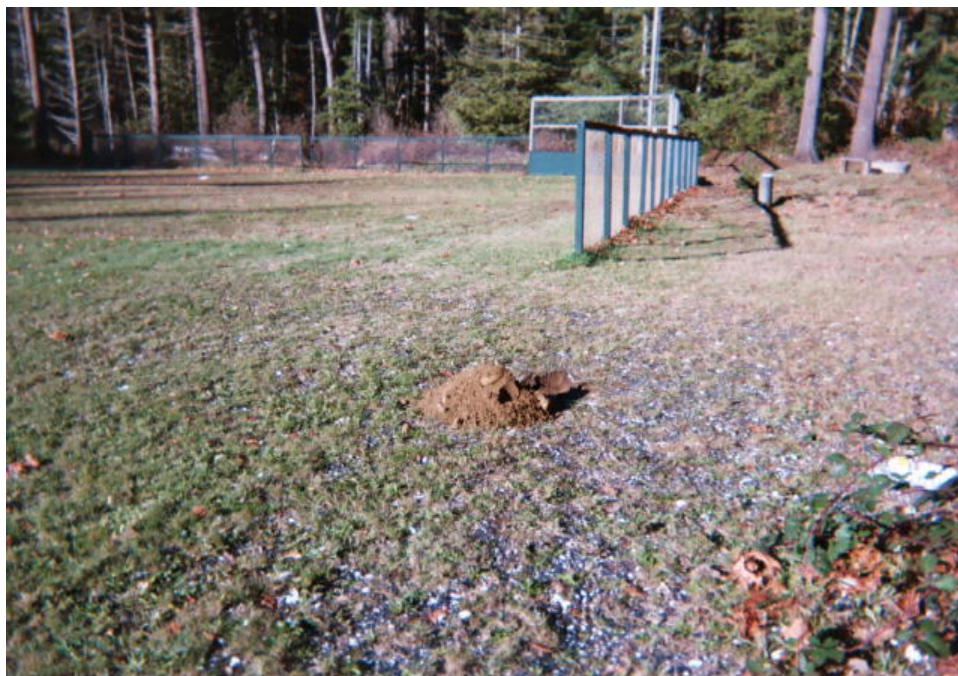
Photo 13 Date: 11/12/03 Looking north across sampling location TA-07 (dirt pile). Note debris on
Time: 1345 land surface.

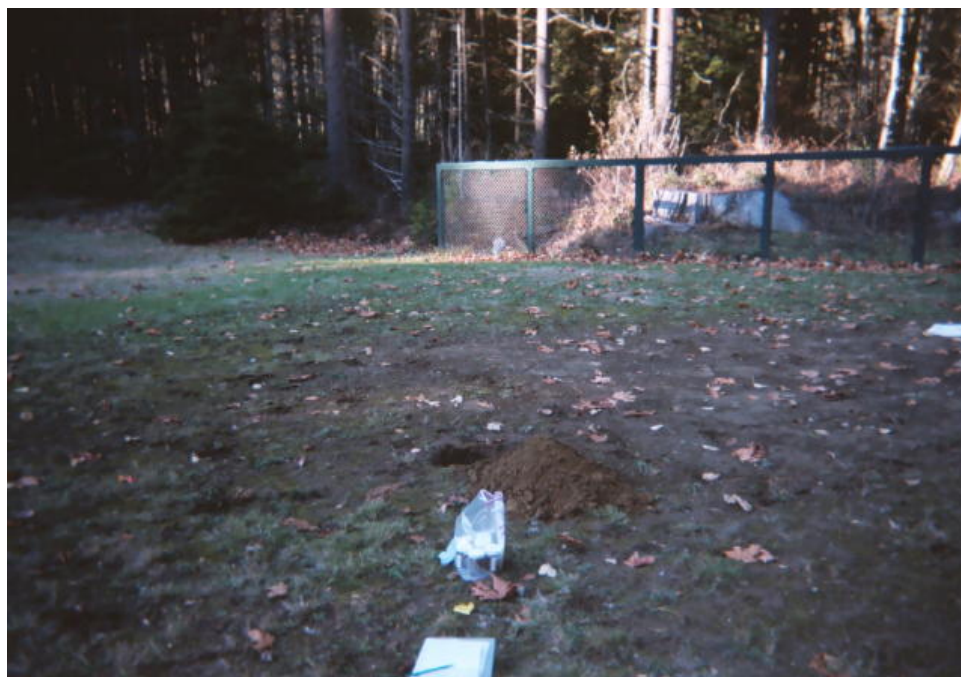
Photo 14 Date: 11/12/03 Looking north across sampling location TA-08, in the ballfield area. This is a
Time: 1416 low spot where site runoff collects.

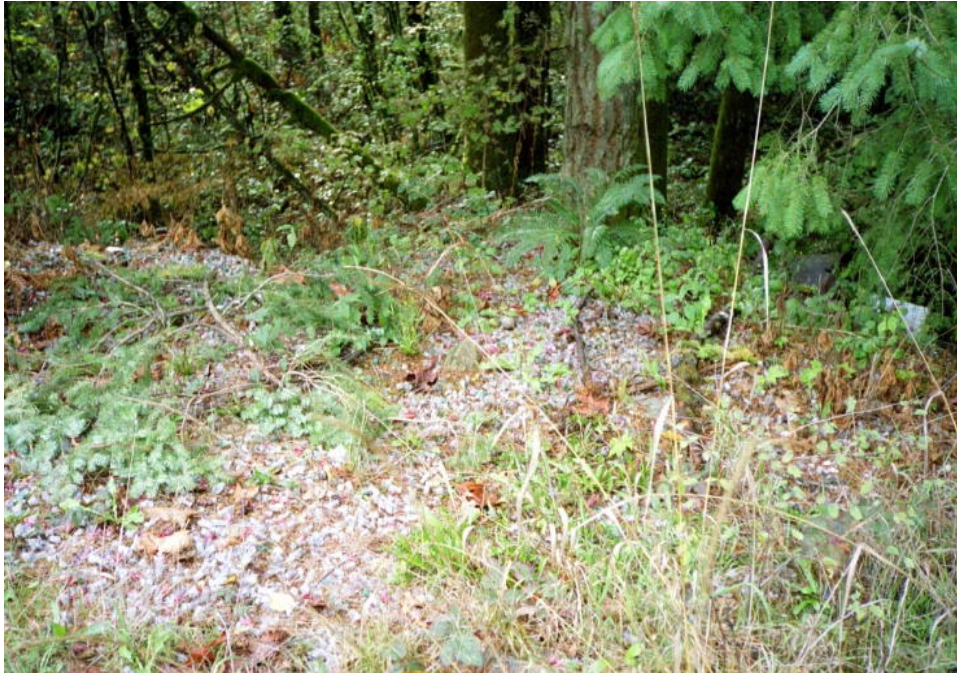
- Surface debris (pieces of clay targets and shells) appears to be heaviest on the west side of the site, within the cleared range area.
- Clay targets and shells have been vacuumed or scraped from the surface of the shooting range periodically and left as waste piles on the west side of the site. Several 55-gallon drums (one labeled motor oil), tires, and an old refrigerator were also observed in this area.

Photo 15 Date: 10/13/03 Debris scrapings piled on the west side of site, at the edge of the cleared
Time: 1340 range area.

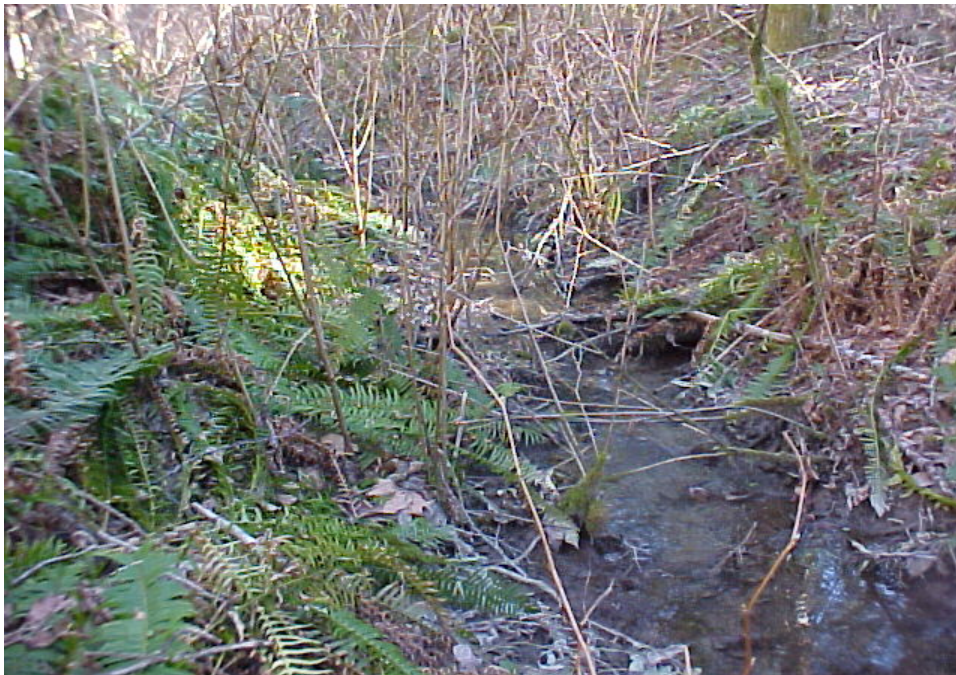
- The wooded area to the north includes several depressions and low spots that tend to pond water. A discontinuous drainage runs along the toe of the railroad berm, flowing generally east to west and ending in ponded areas with no apparent outlet.

Photo 16 Date: 02/12/04 Looking east at drainage north of site along the railroad berm.
Time: 1149

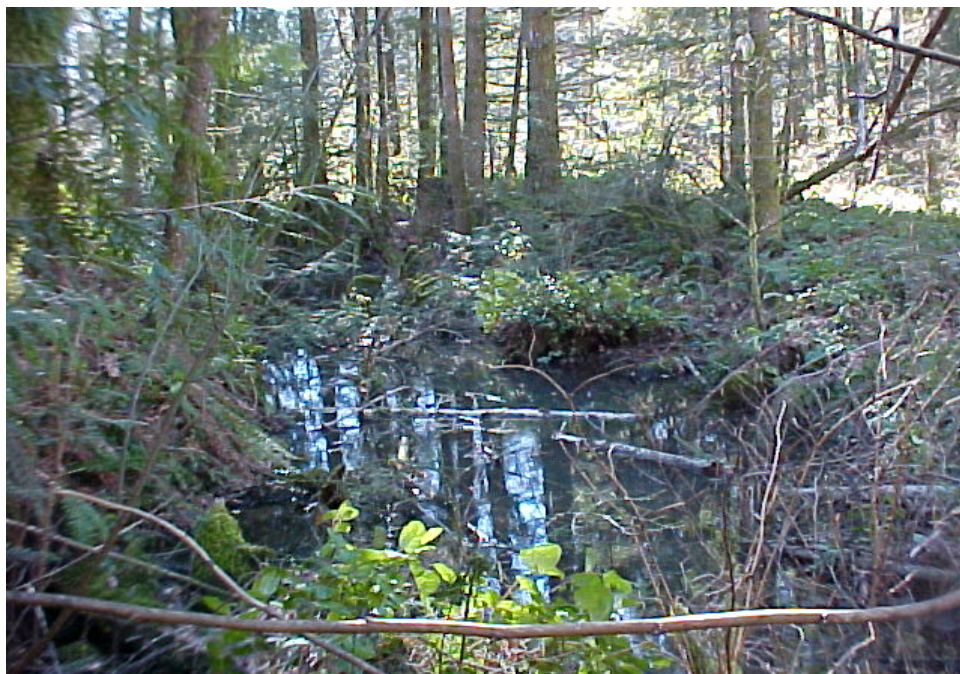
Photo 17

Surface water tends to pond in the wooded area north of the cleared range area. This is also the area where the vast majority of the shot accumulates. The high organic content of the soils in this area tends to cause a low soil pH. This, in turn, tends to cause accelerated degradation of the shot, with dissolved lead released to the environment. In addition, lead shot and dissolved lead can be moved by surface water runoff, causing it to concentrate in low, ponded areas. Although surface water was observed to flow from east to west in a discontinuous drainage along the railroad berm, the water ponded in several areas with no apparent outlet.

Date: 02/12/04 Ponded water in depression north of the site.
Time: 1217

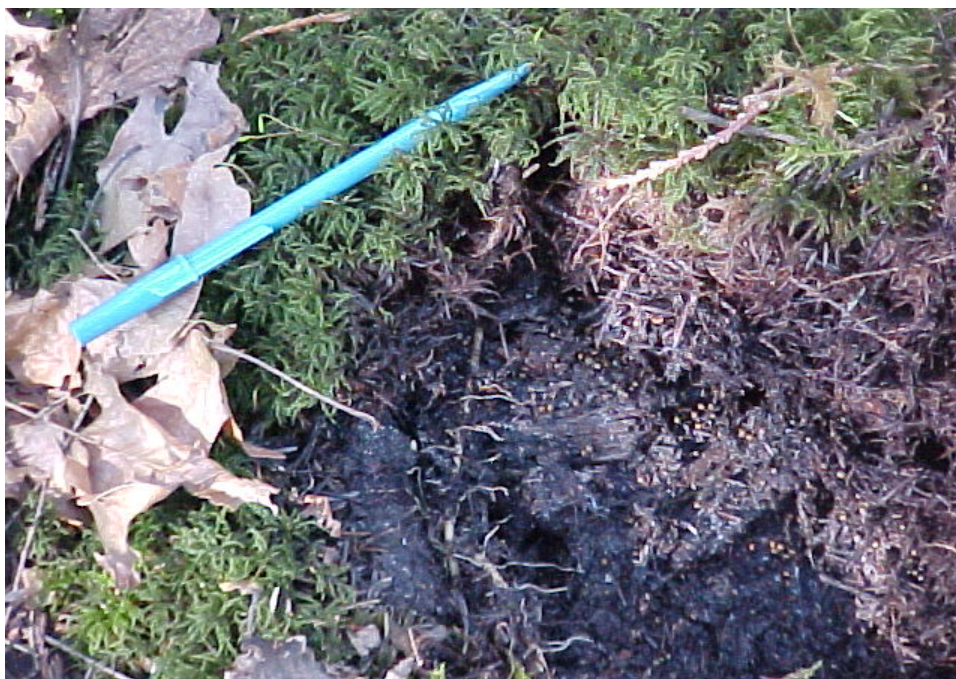
Photo 18

Surface soil samples from the wooded area, north of the cleared range area, were collected from locations with large amounts of visible shot. The shot was sieved out of the samples. Surface soil samples collected from this area contained elevated concentrations of lead (exceeding all of the comparison criteria). A couple of these samples also contained elevated concentrations of arsenic. The highest concentrations of lead and arsenic were detected in a surface soil sample collected from a depression which collects stormwater runoff from the site area (location TA-14; see Figure 2 and Photo 18). A large amount of shot was observed in soil throughout much of this depression. Shot observed on and near the

land surface in this location was noticeably weathered. An attempt was made to collect a deeper sample at this location; however, groundwater was encountered only a few inches below the ground surface. An SPLP sample was not collected from this location due to difficulty in sieving the organic-rich, wet soil and in obtaining sufficient sample volume.

Date: 02/12/04 Abundant shot in soil just beneath the moss cover (cover is peeled back).
Time: 1220 Located in the depression north of about mid-site, near sampling location TA-14.

- Add lime to soil periodically to maintain a pH of approximately 7. Lime spreading is particularly important in heavily wooded areas where soil removal is difficult and where surface detritus tends to increase soil acidity.

- Add phosphate to soil to tie up lead. Phosphate addition is especially important in locations where there is a high potential for migration of lead to groundwater (i.e., low soil pH and shallow groundwater).

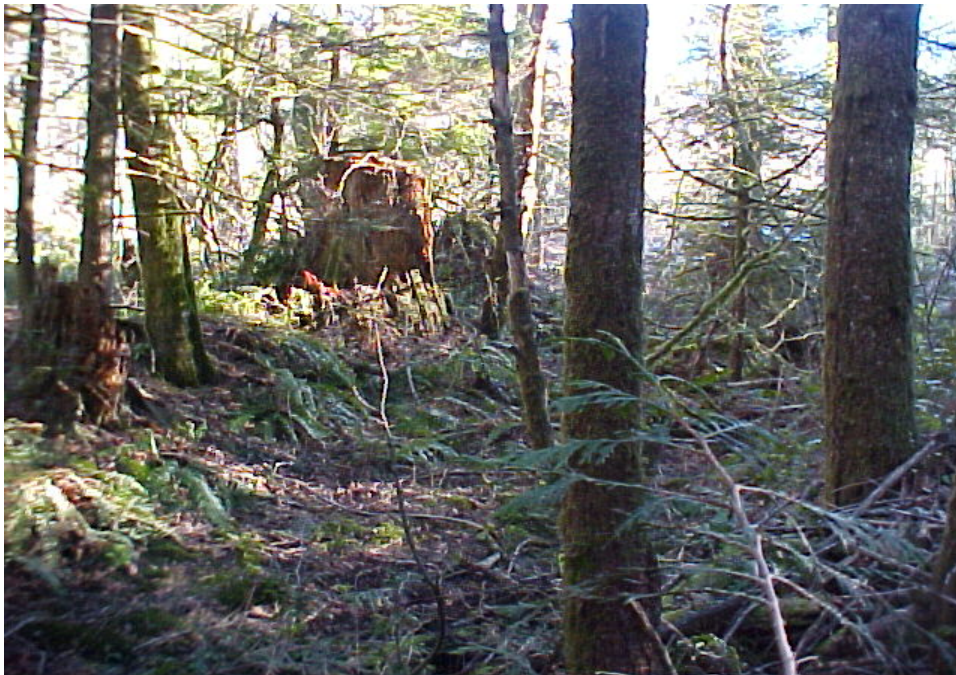
Photo 20 Date: 02/12/04 Looking across sampling location TA-14, toward the range (south). Note
Time: 1509 very dense vegetation.

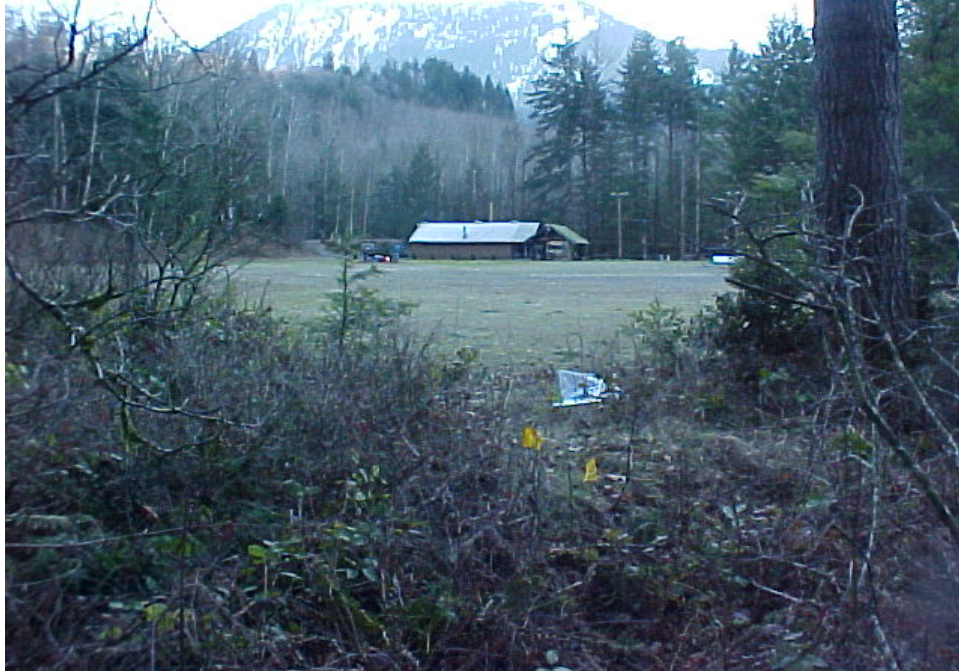
Photo 21 Date: 02/12/04 Sampling location TA-16, looking south towards the clubhouse.
Time: 1535

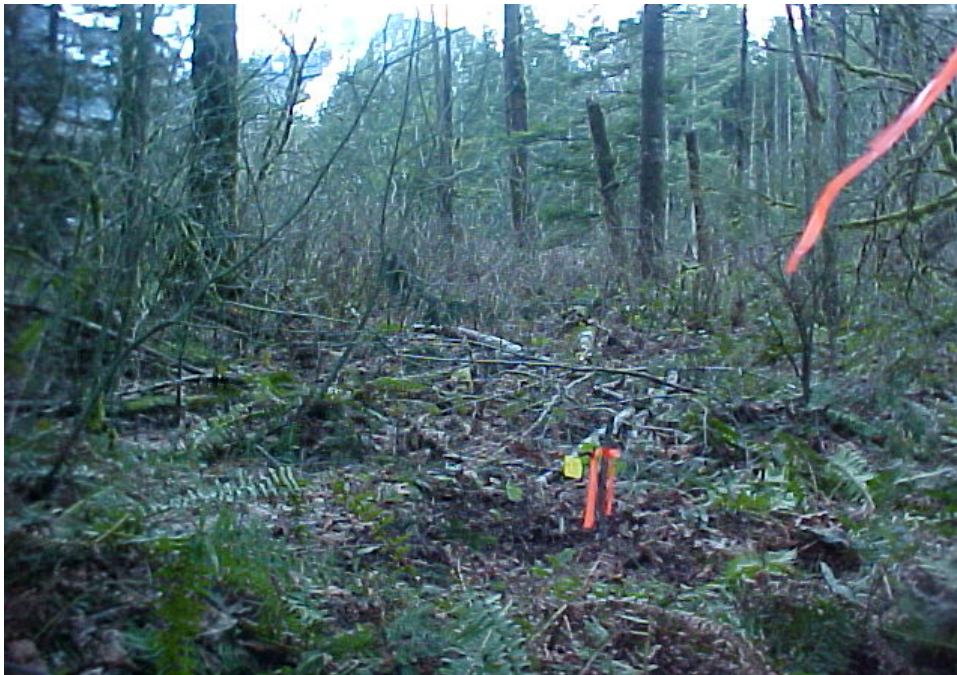
Photo 22 Date: 02/12/04 Sampling location TA-15, looking southward. Note very dense vegetation.
Time: 1626
