Remedial Investigation Report

**Duvall Market
15820 (15802) Main Street Northeast
Duvall, Washington 98019
Facility/Site No.: 7646431
VCP No.: NW0995**

April 11, 2015

Project Number: 67802

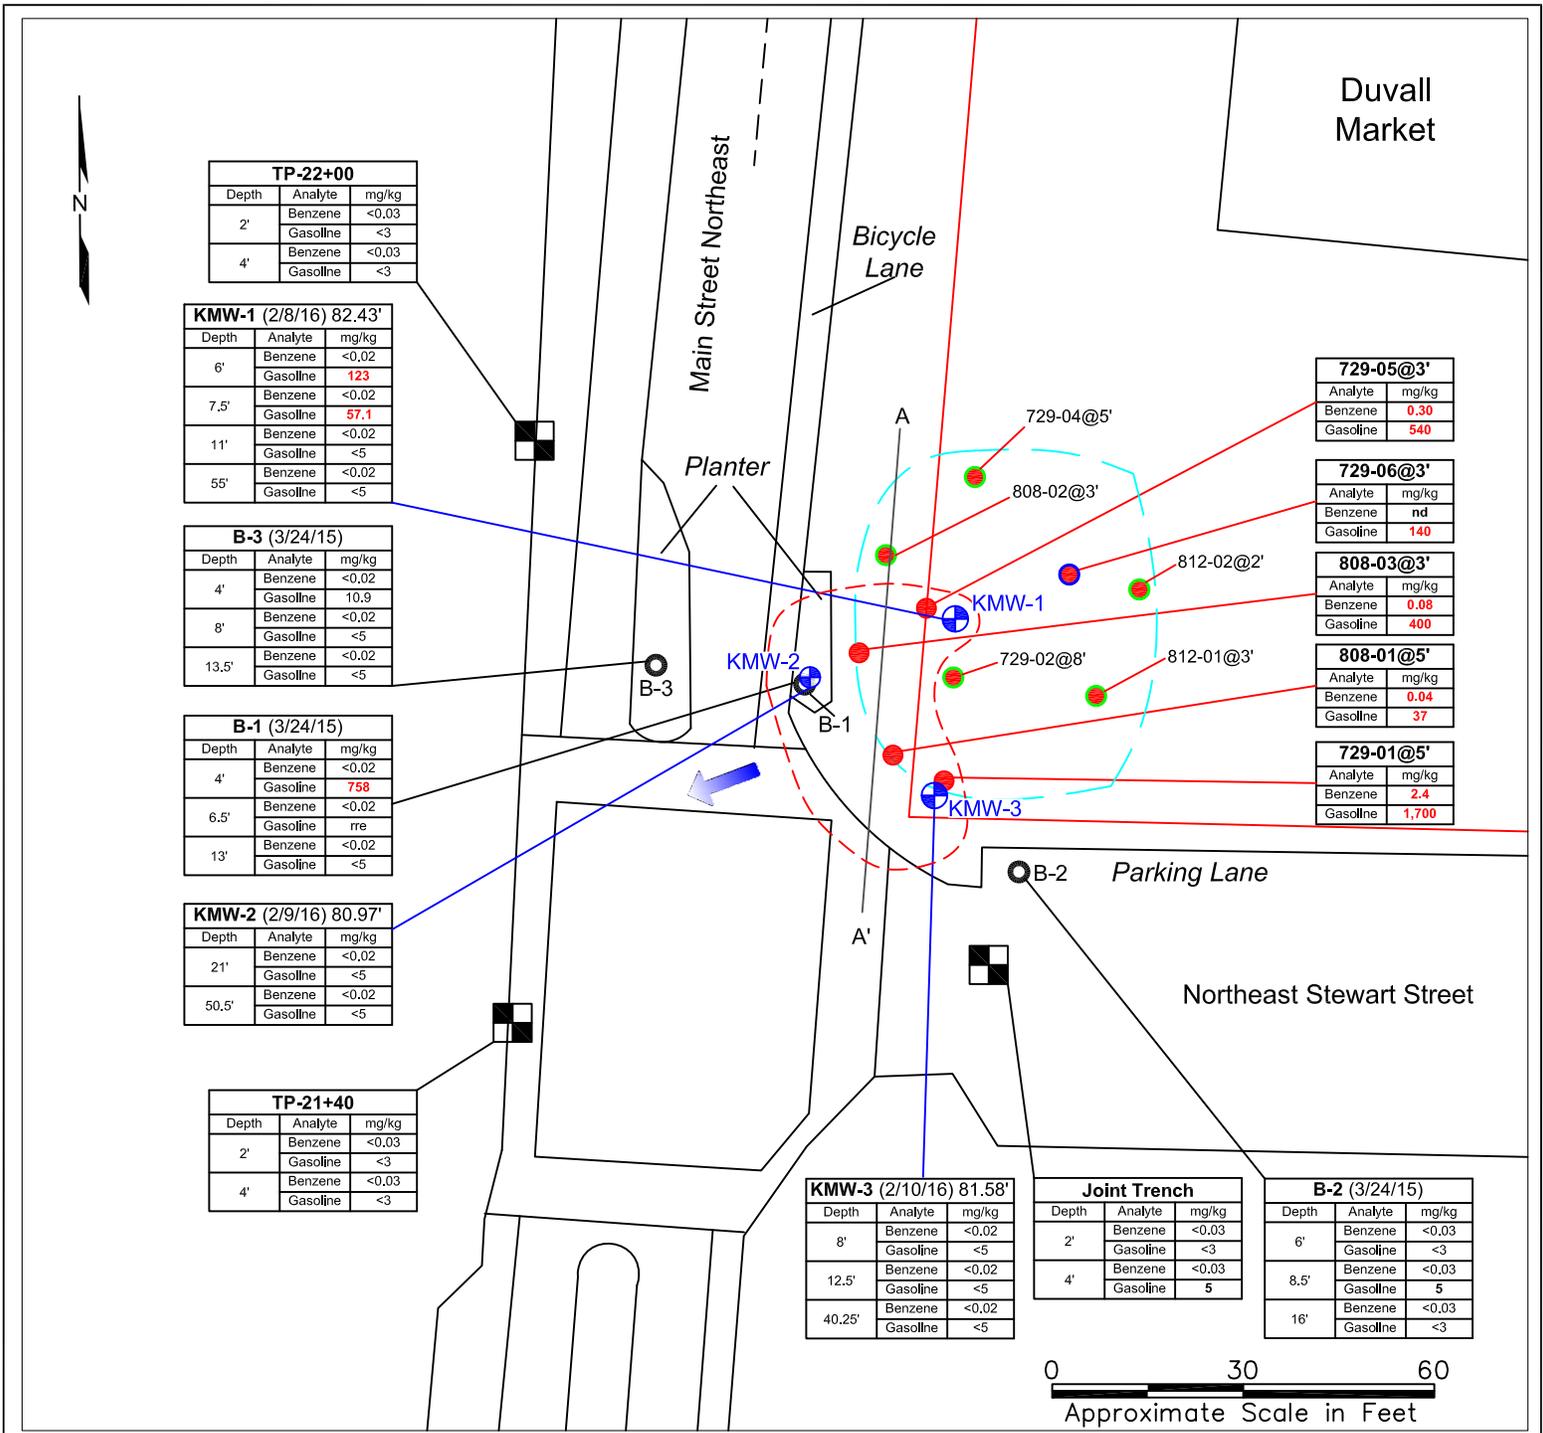
- Approximate Location of Property Line
- Approximate Locations of 2015 Hollow Stem Auger Borings
- ⊕ Approximate Locations of 2016 Groundwater Monitoring Well Installations
- Approximate Locations of 2002 WT Services Sample Collection with Soil with MTCA Method A Exceedances Left In Place
- Green Indicates no MTCA Exceedances ● Blue Indicates Subsequent Over-excavation of Contaminated Soil
- ⊠ Approximate Locations of 2008 HWA Soil Sample Collection
- - - - - Approximate Boundary of 2002 WT Services Excavation
- - - - - Approximate Boundary of Zone of Contaminated Soil
- ← Direction of Calculated Groundwater Gradient (2/29/16)

A—A' Path of Cross Section Displayed in Figure 4
 Soil Data Appearing in Red Exceed the MTCA Method A Soil Cleanup Level for Unrestricted Land Uses

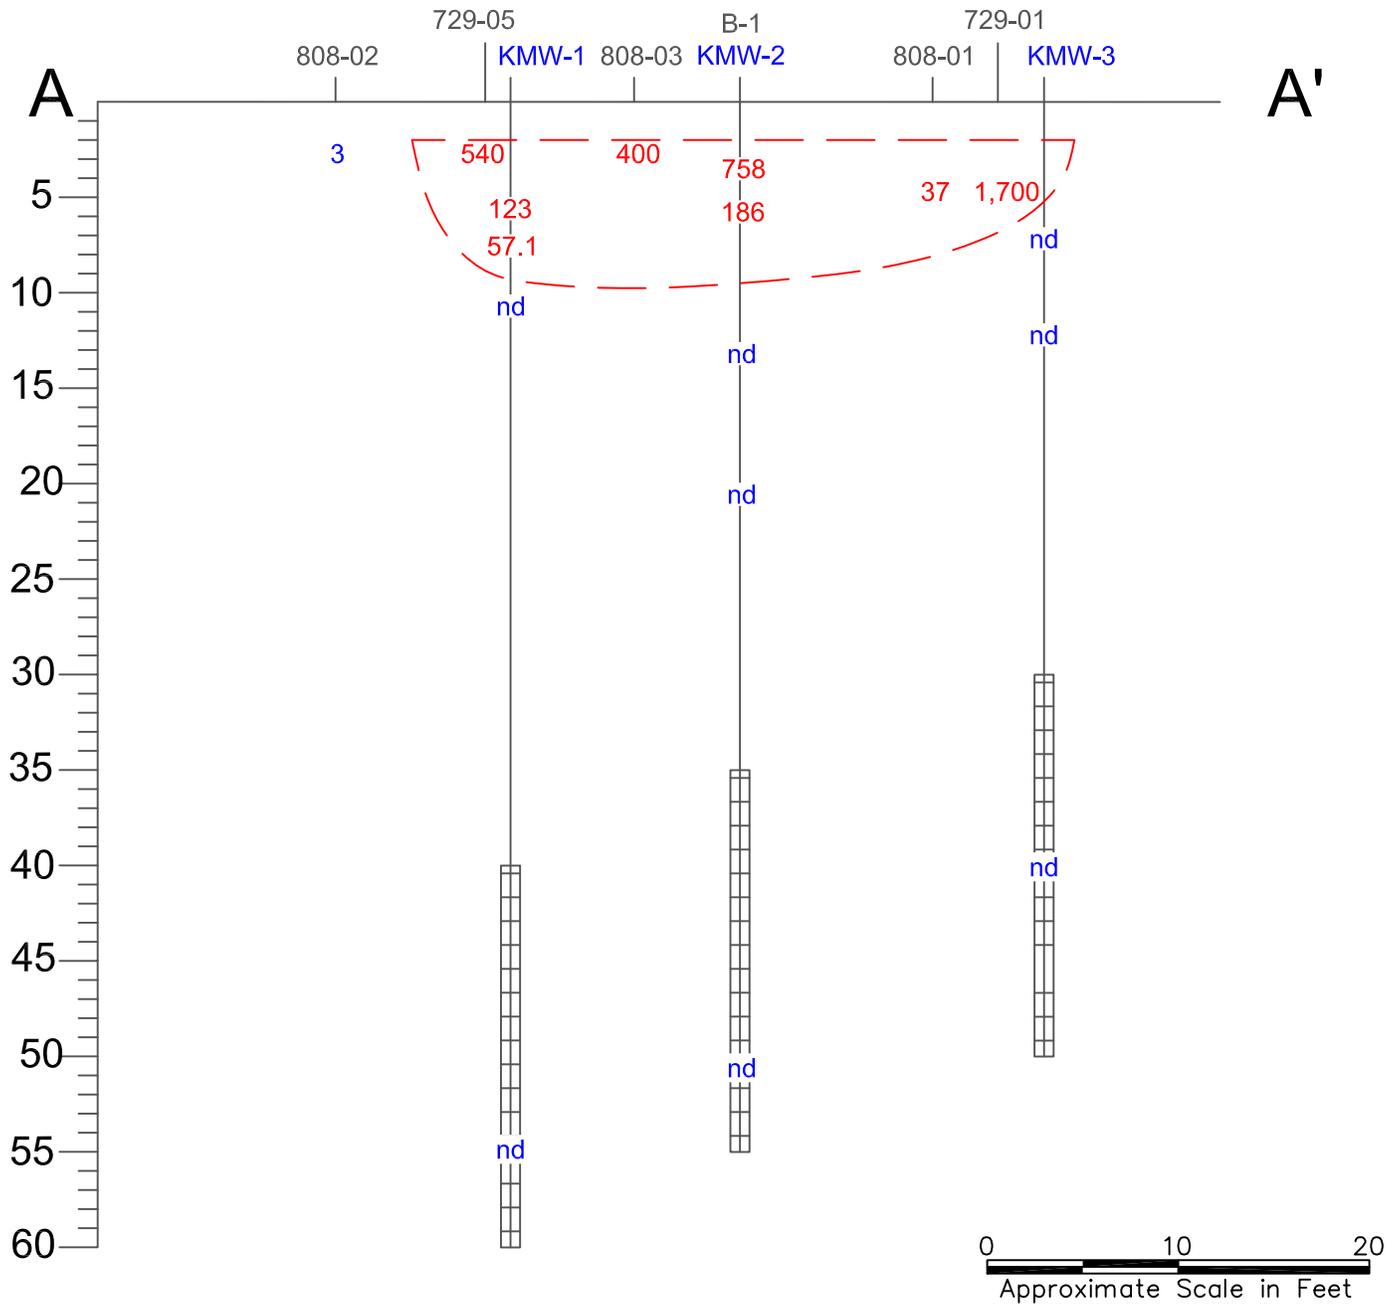
- KMW-1 ← Monitoring Well Identification
- ← Ground Surface
- ← Boring Path (Screen Interval Shown)
- nd, 400, 24 ← Analyte Concentration (Red Indicates Value Exceeding MTCA Method A Cleanup Level for Unrestricted Land Uses for Gasoline of 30 mg/kg)
- - - ← Approximate Boundary of Gasoline Contaminated Soil

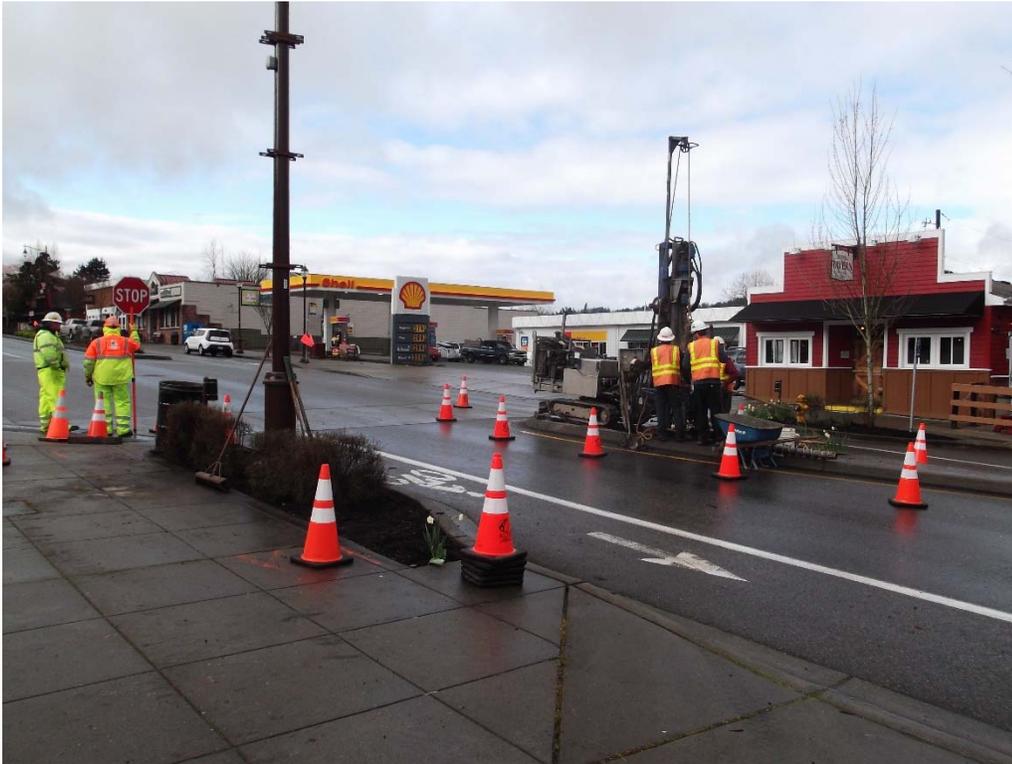
Photograph 5 – View southwest showing boring B-3 being advanced in the Main St NE median planter.

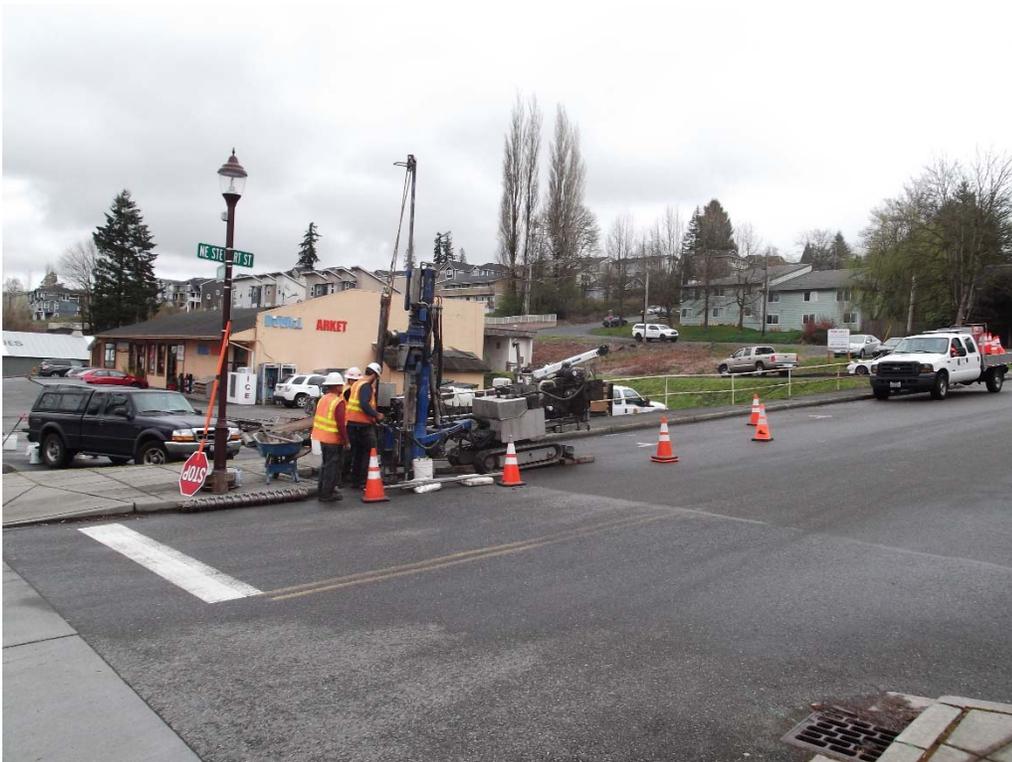
Photograph 6 – View northeast showing boring B-2 being advanced in the NE Stewart St parking lane.

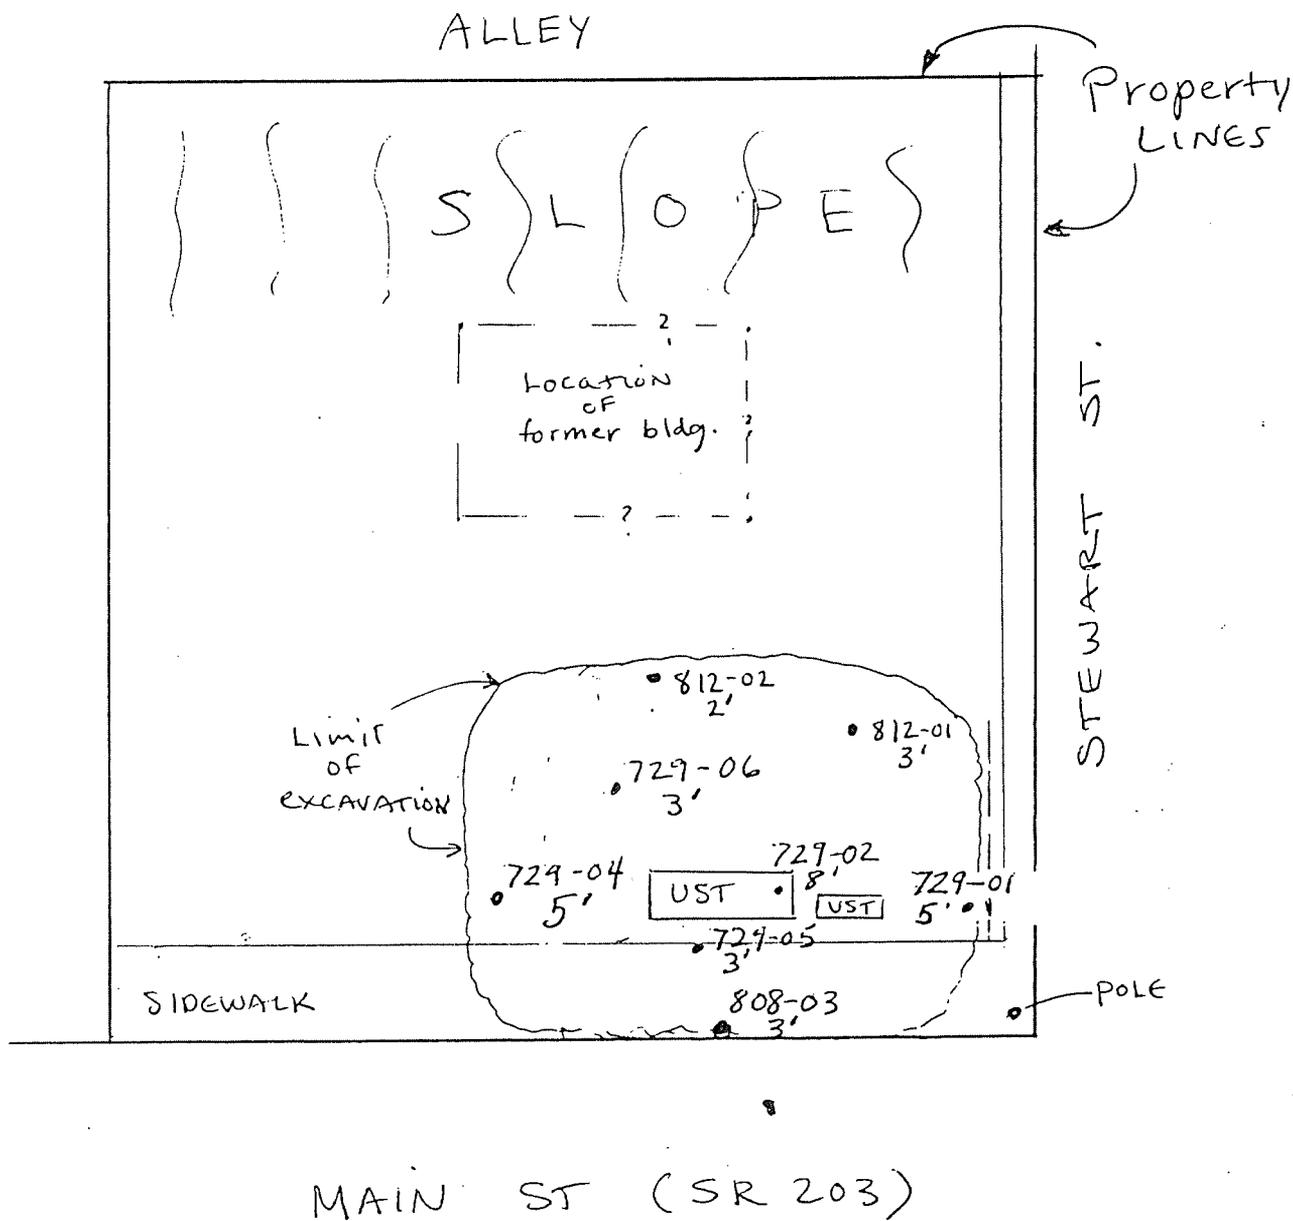
Site PLAN

Each tank contained a small amount of water with a trace of gasoline product. The tanks appeared to be in an intact condition, with no apparent holes or significant rust. The location of the tanks is shown on the site plan, page 5.

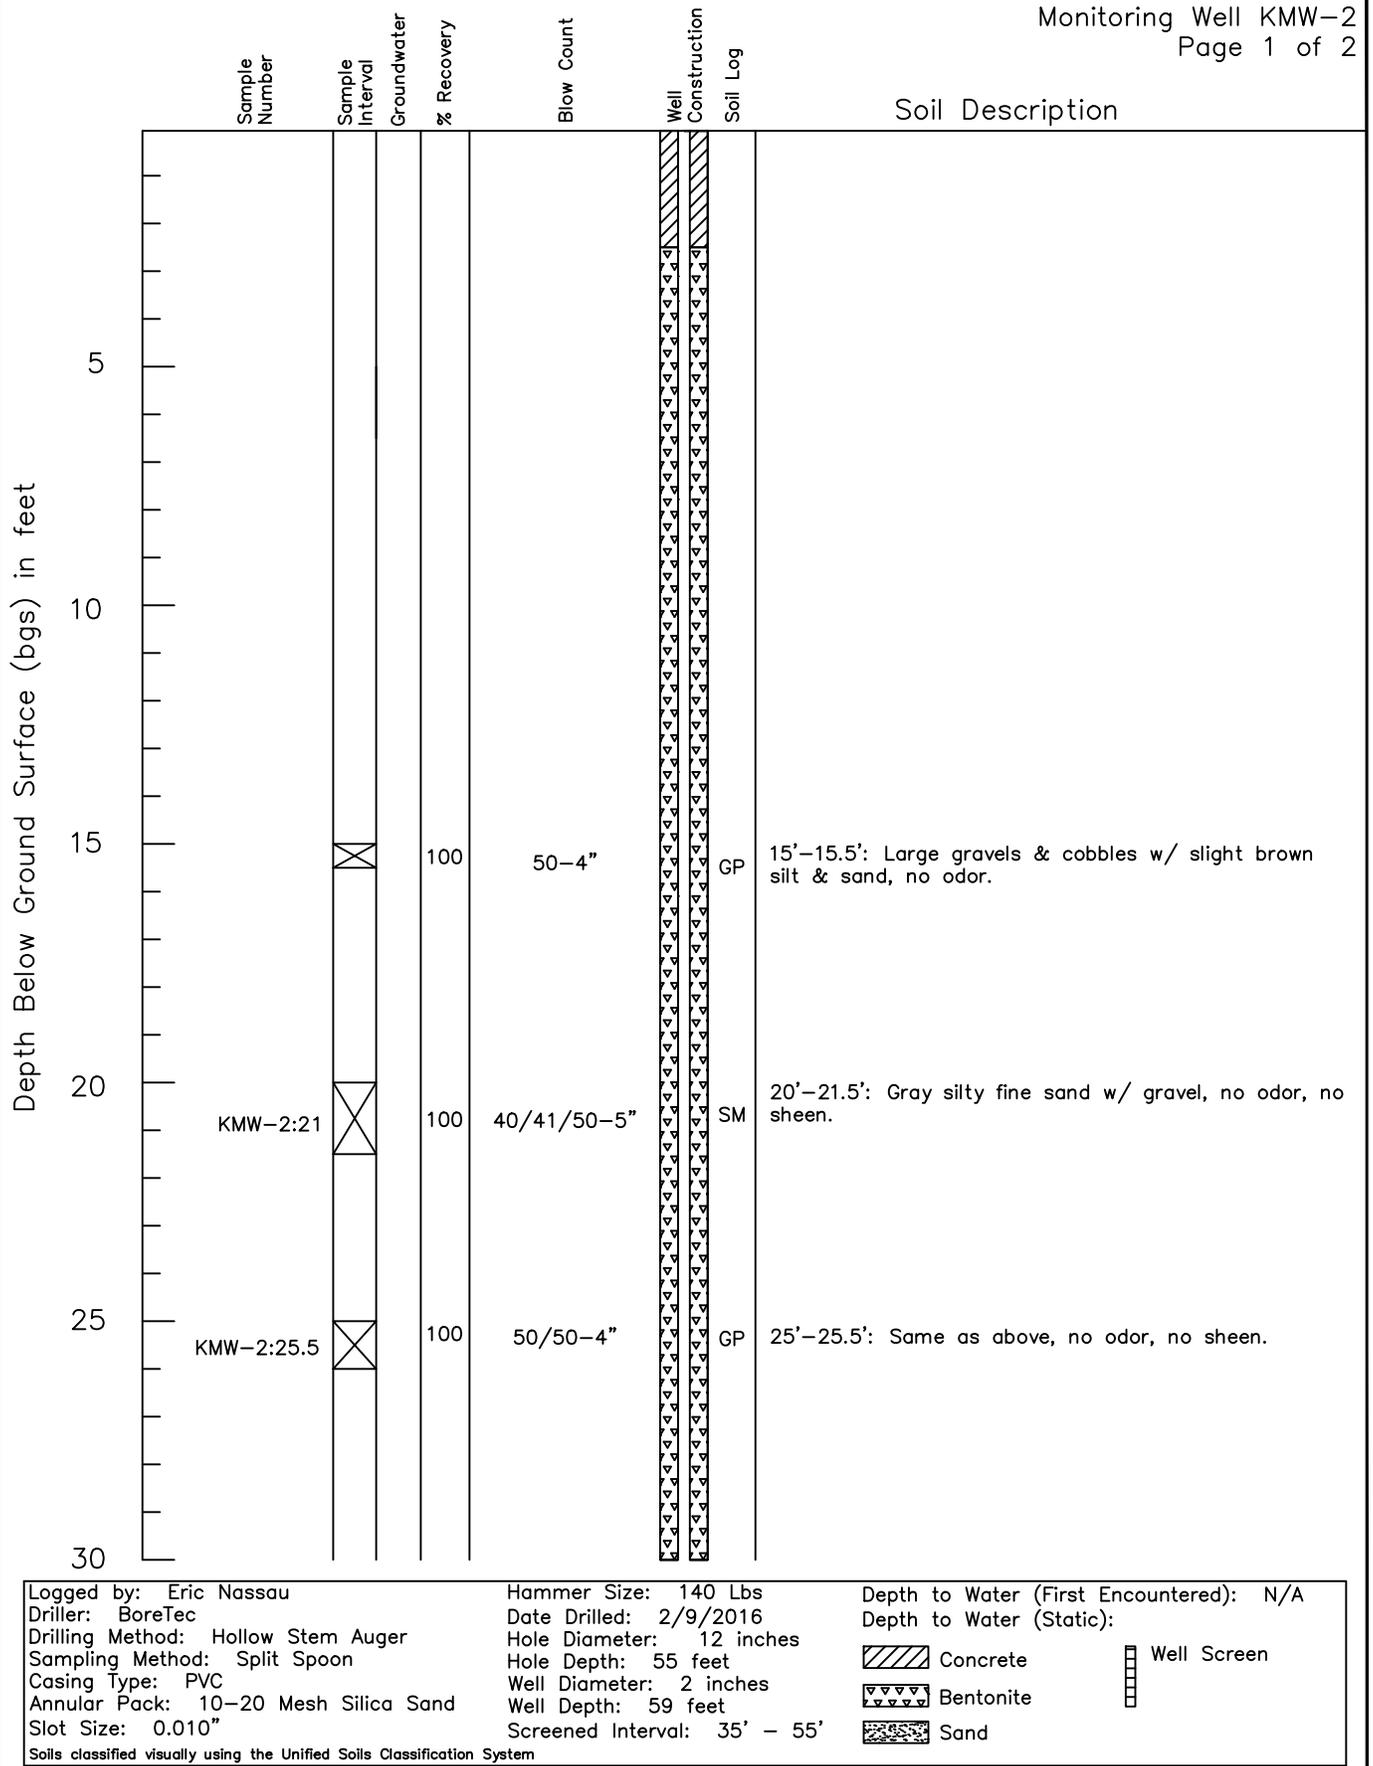
Well Construction Log

Logged by: Eric Nassau
 Driller: BoreTec
 Drilling Method: Hollow Stem Auger
 Sampling Method: Split Spoon
 Casing Type: PVC
 Annular Pack: 10-20 Mesh Silica Sand
 Slot Size: 0.010"

Hammer Size: 140 Lbs
 Date Drilled: 2/9/2016
 Hole Diameter: 12 inches
 Hole Depth: 55 feet
 Well Diameter: 2 inches
 Well Depth: 55 feet
 Screened Interval: 35' - 55'

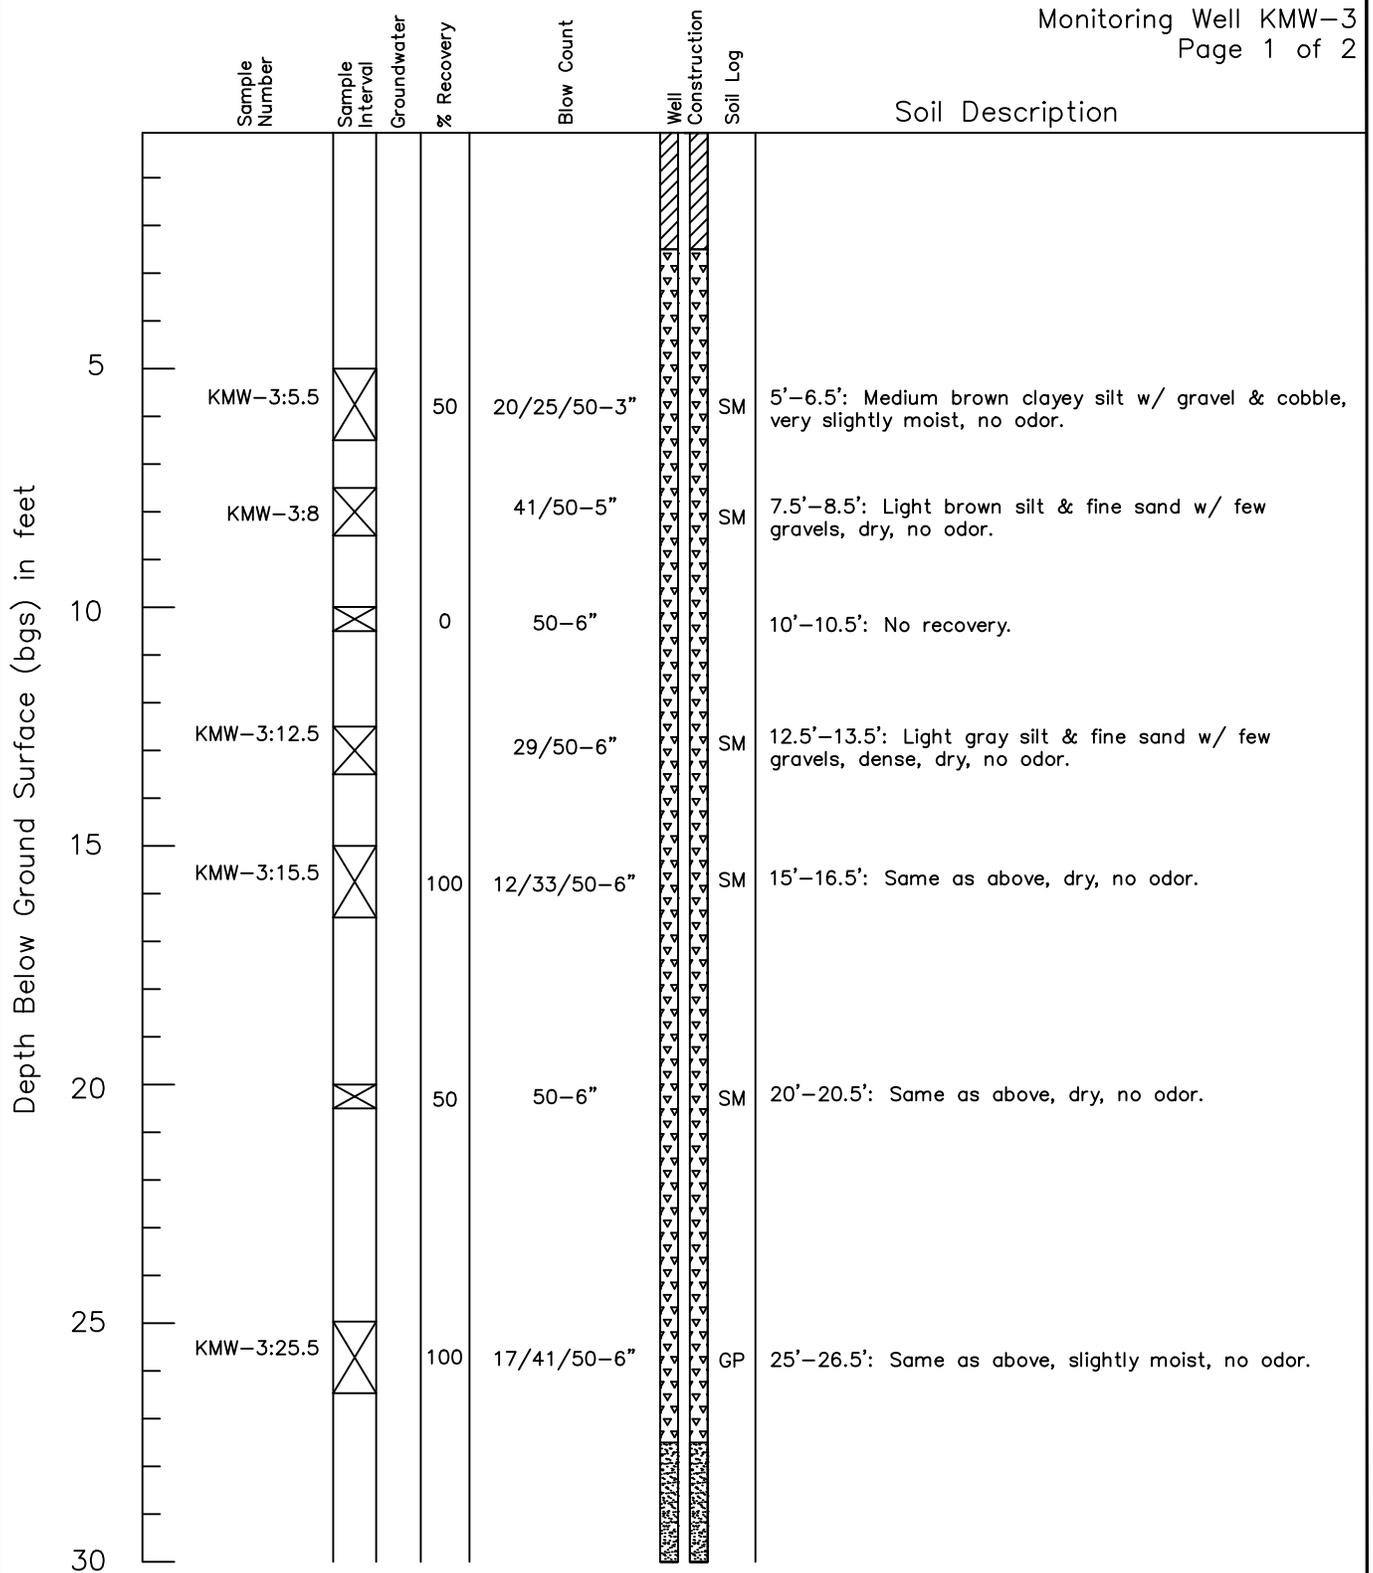
Well Construction Log

Logged by: Justin Vetter
 Driller: BoreTec
 Drilling Method: Hollow Stem Auger
 Sampling Method: Split Spoon
 Casing Type: PVC
 Annular Pack: 10-20 Mesh Silica Sand
 Slot Size: 0.010"

Hammer Size: 140 Lbs
 Date Drilled: 2/10/2016
 Hole Diameter: 12 inches
 Hole Depth: 50.5 feet
 Well Diameter: 2 inches
 Well Depth: 50 feet
 Screened Interval: 30' - 50'

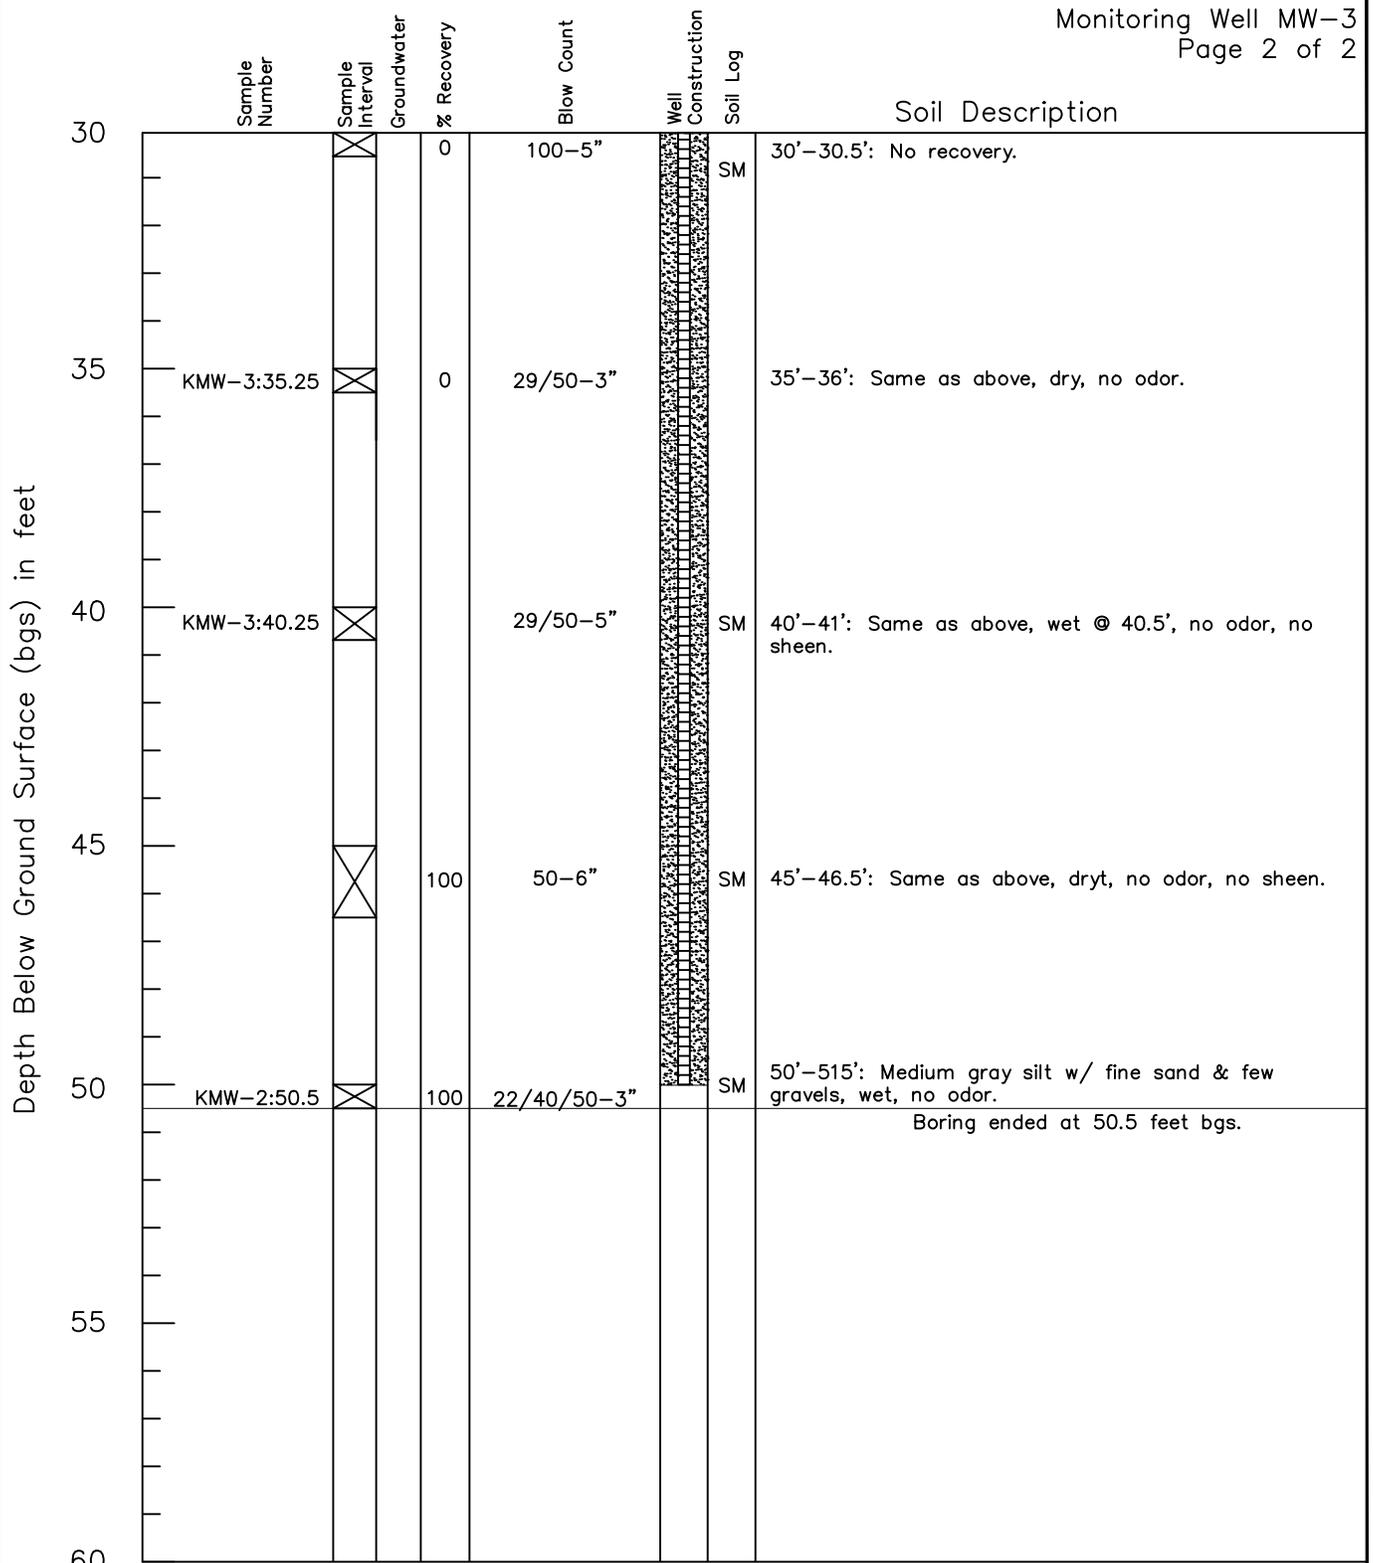
Well Construction Log

Logged by: Justin Vetter
 Driller: BoreTec
 Drilling Method: Hollow Stem Auger
 Sampling Method: Split Spoon
 Casing Type: PVC
 Annular Pack: 10-20 Mesh Silica Sand
 Slot Size: 0.010"

Hammer Size: 140 Lbs
 Date Drilled: 2/10/2016
 Hole Diameter: 12 inches
 Hole Depth: 50.5 feet
 Well Diameter: 2 inches
 Well Depth: 50 feet
 Screened Interval: 30' - 50'
