STATE OF WASHINGTON DEPARTMENT OF ECOLOGY

Re: Further Action at the following Site:

• Site Name: Plaid Pantry 23

• Site Address: 5210 East Fourth Plain Boulevard, Vancouver, Washington

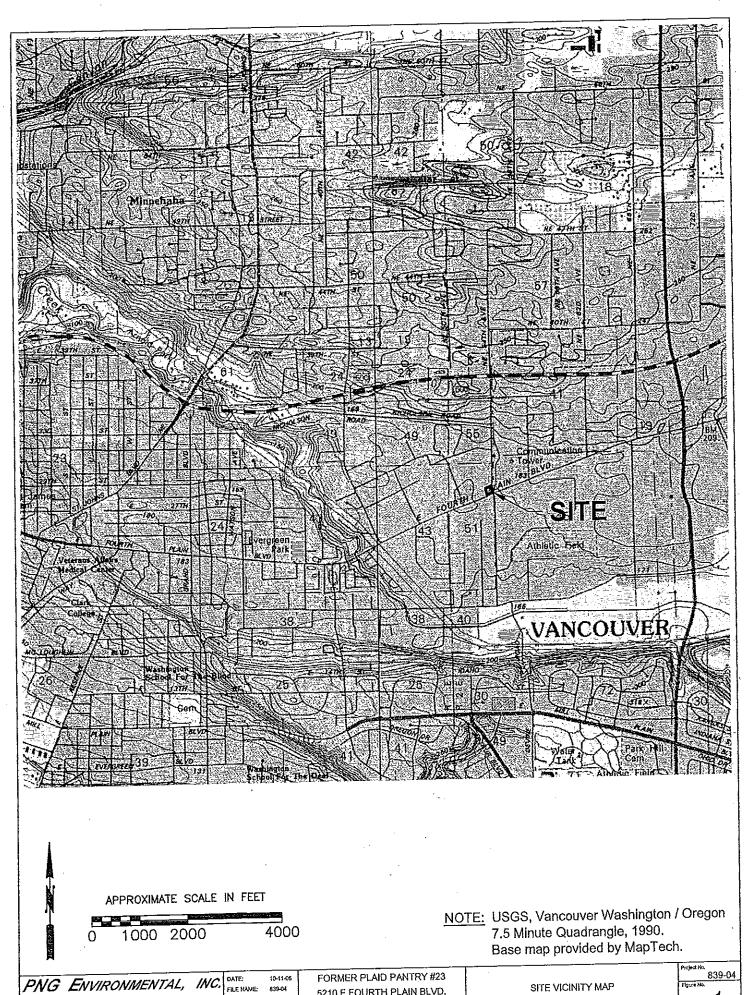
SITE VICINITY MAP

The Plaid Pantry 23 (Site) is located at 5210 East Fourth Plain Boulevard in Vancouver, Clark County, Washington (see Figure 1). The Site has been zoned for general commercial (CG) purposes. The CG zoning district is designed to allow for a full range of retail, office, and civic uses with a citywide to regional trade area. The parcel on which the facility is located encompasses approximately 0.42 acres and contains one building that is currently vacant retail space. Previous commercial enterprises that have operated on the Site include service station operations, convenience store/refueling operations, and other commercial/retail outlet venues. The Site is bordered on the north by commercial/retail parcels, on the east by Stapleton Road, on the south by East Fourth Plain Avenue, and on the west by commercial/retail parcels. The Clark County Assessor's office notes the Site as being comprised of one parcel having an assigned tax parcel number of 30243030.
