MEMORANDUM

Project: 9003.01.39

RE: Off-Property Portion Phase 2 Remedial Investigation Approach

**DRAFT SITE-SPECIFIC SAMPLING AND ANALYSIS PLAN
OFF-PROPERTY PORTION, FORMER PACIFIC WOOD TREATING CO. SITE
FACILITY ID 1019, CLEANUP SITE ID 3020
RIDGEFIELD, WASHINGTON**

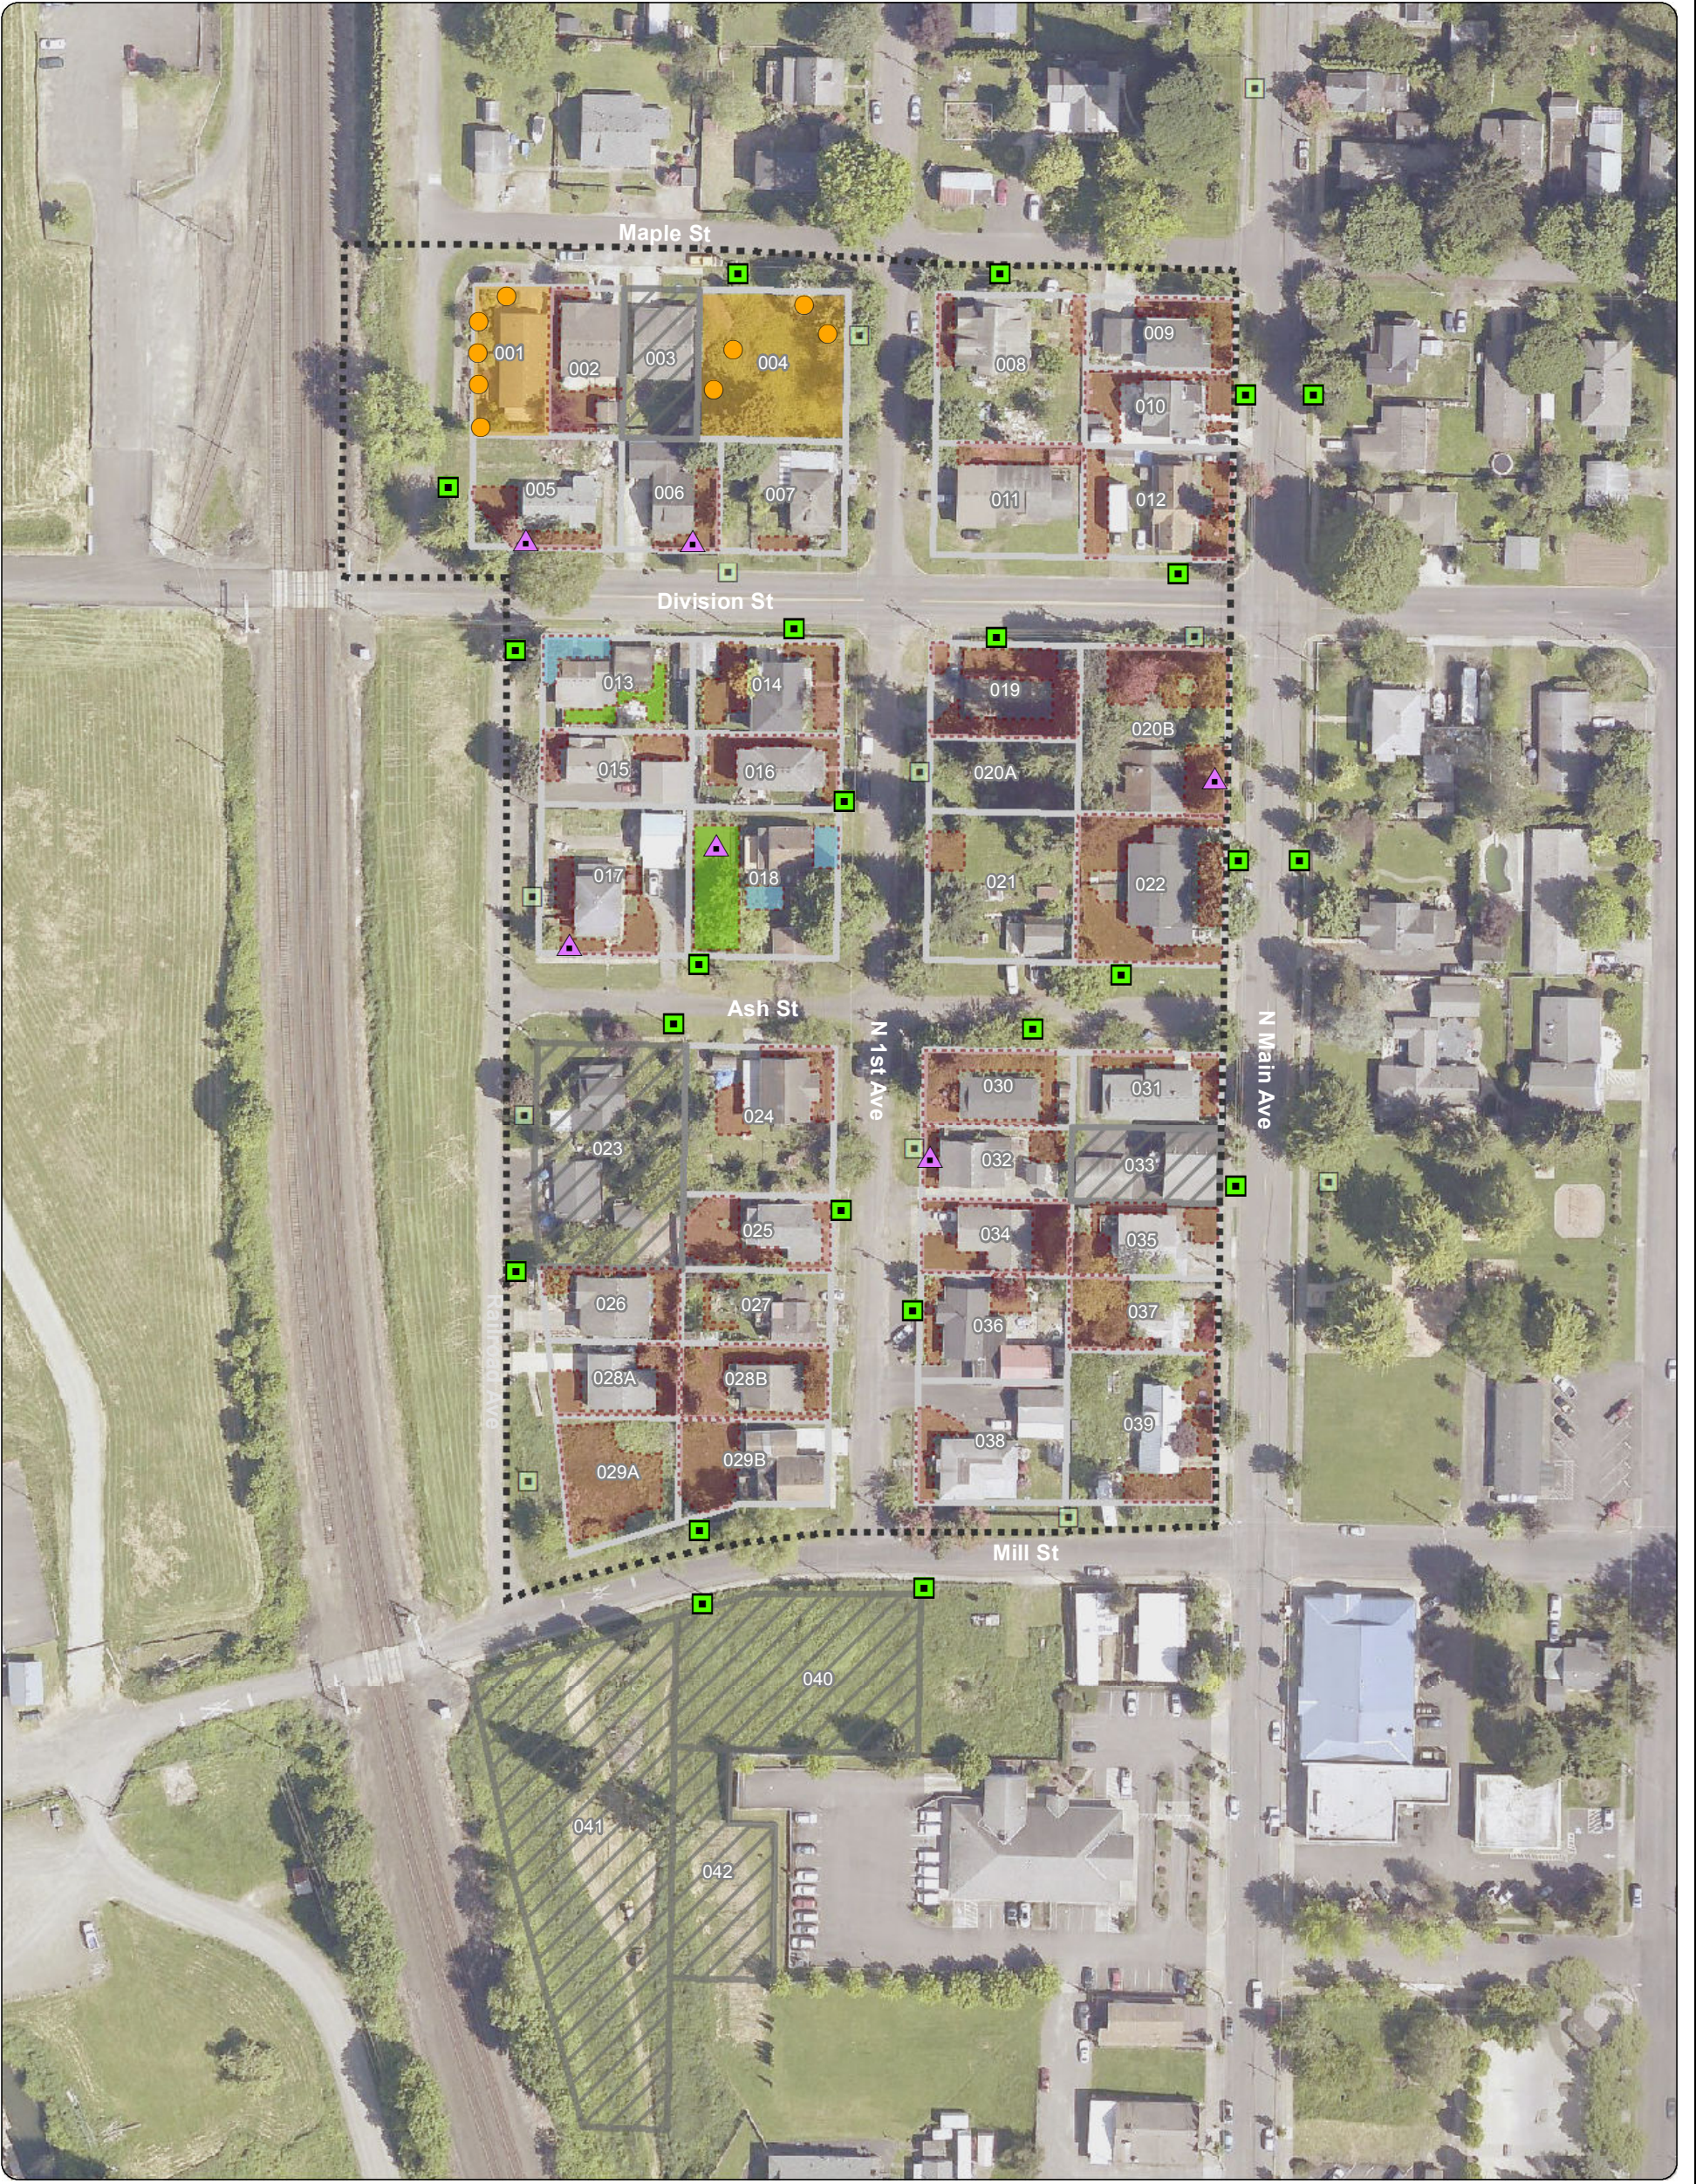
Figure 1
Off-Property Portion
Sample Locations

One ISM sampling area was identified for each property, with the exception of 013 and 018. For these properties, a front yard (F) and backyard (B) sampling area was identified.

Previous sampling completed is shown in gray in the Table below and includes 1) incremental sampling methodology (ISM) surface samples collected from zero to 0.5 foot below ground surface (bgs); 2) discrete subsurface (DSBS) samples collected from 0.5 to 1 foot bgs; 3) discrete ROW surface (zero to 0.5 foot bgs) and subsurface samples collected from the same location; and 4) composite soil samples (see property 001 and 004 described below). Subsurface ROW samples are archived and analyzed only if dioxin concentrations exceeding the MTCA Method B CUL (CUL) in the corresponding shallower sample are determined. The SAP identified several types of quality assurance samples for collection: two ISM triplicates (three sets of ten increment samples from differing locations), one duplicate DSBS sample, and rinsate blanks; in addition a field ISM duplicate (two sets of ten samples from the same locations) was collected. Locations sampled to date are shown in Figure 1.

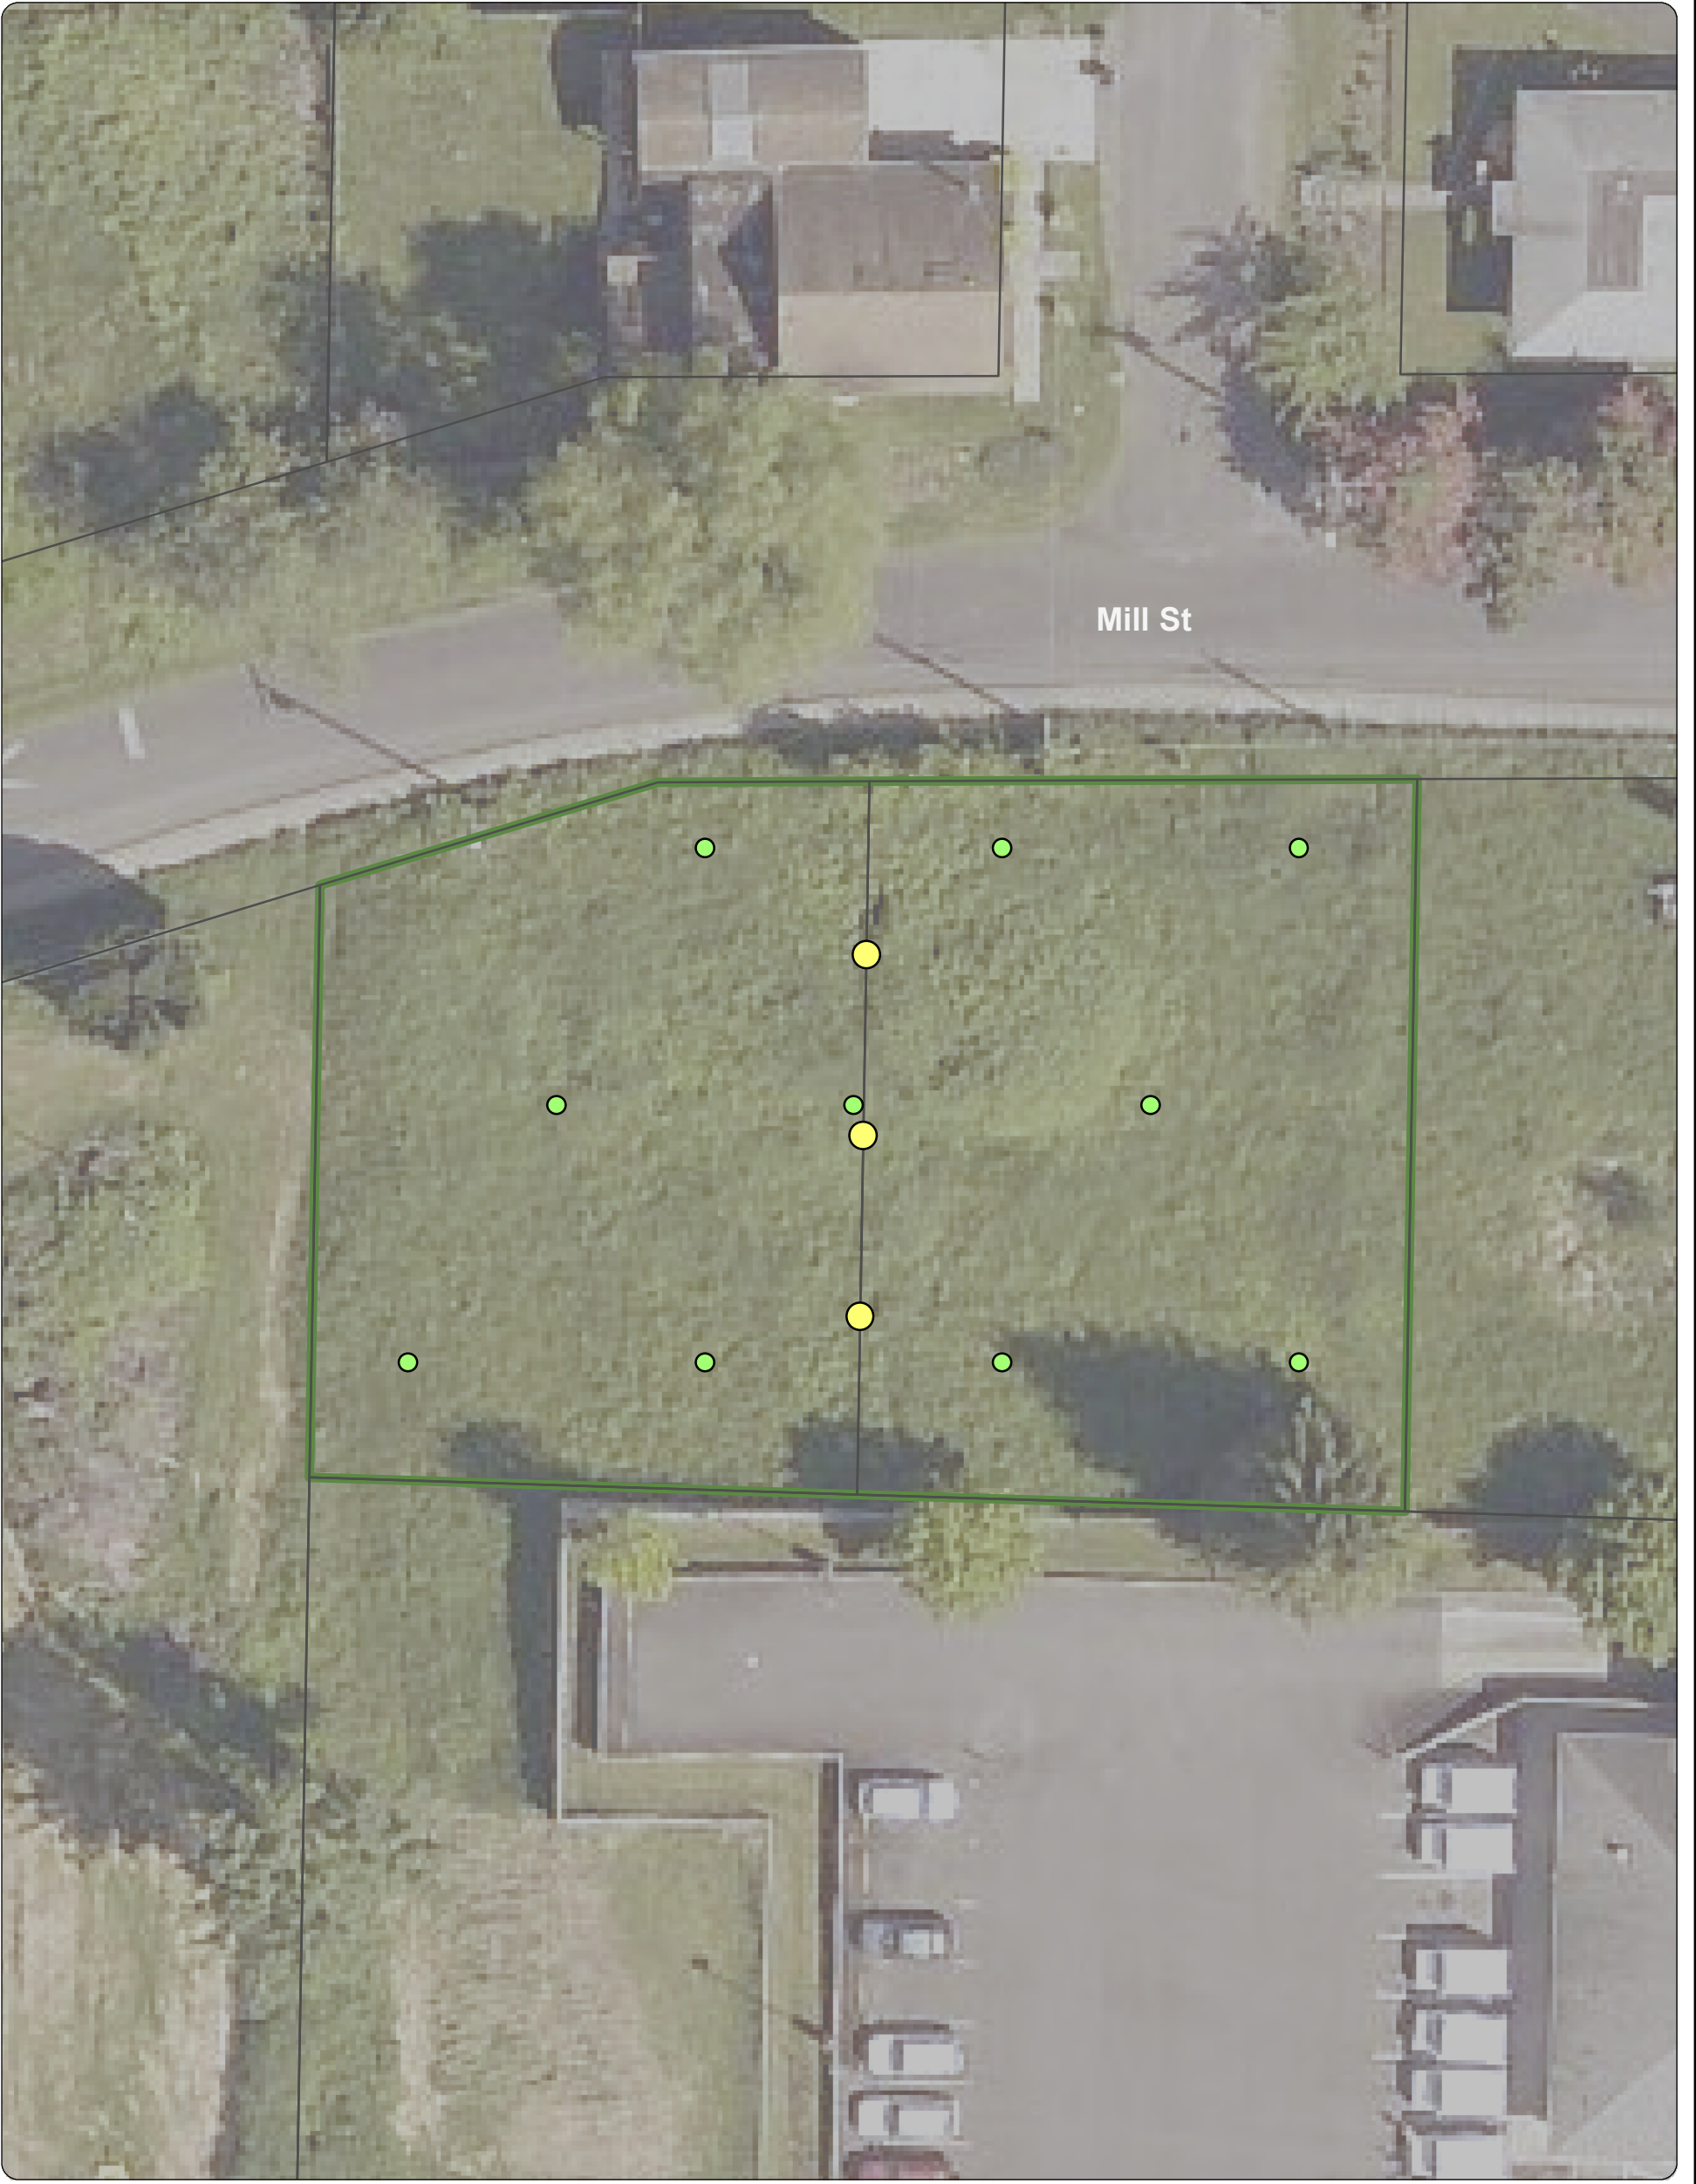
**Figure
Sampling Plan
AOI-040**
Former PWT Site
Ridgefield, Washington

- Legend**
- ISM Sample Location
 - Discrete Sample Location
 - AOI-040 Sampling Boundary
 - Tax Lot

Location	Address	Sample Type(s) and Number	Analysis		Sampling Schedule	Comments
AOI-040	South of Mill Street and North 1 st Avenue	ISM (1) DSS (3, Archive) ROW (2)	Dioxins by USEPA 1613B	Total organic carbon by PSEP/SM 5310B	Following receipt of Access Agreement	This is an undeveloped lot that includes taxlots 67992000 and 67992005. An ISM sample will be collected and analyzed. Three discrete surface samples will be collected along a north-south transect and archived; the discrete samples may be released for analysis to further delineate impacts, in the event the ISM sample shows concentrations above the CUL. ROW samples (ROW-029B South and ROW-038 South, see below) were previously collected adjacent to the property. See Figure 1 for ROW sample locations.
AOI-041	South of Mill Street and Railroad Avenue	ISM (2) DSS (5, Archive) ROW (0)	Dioxins by USEPA 1613B	Total organic carbon by PSEP/SM 5310B	Following receipt of Access Agreement	This is an undeveloped lot (taxlot 68002000). Two ISM samples will be collected and analyzed, one each for the northern and southern portions of the 0.8 acre lot. Five discrete surface samples will be collected along a north-south transect and archived; the discrete samples may be released for analysis to further delineate impacts, in the event an ISM sample shows concentrations above the CUL.
