## Remedial Action Report

**H & H Property**

407 Porter Way

AEG Project #: 15-112

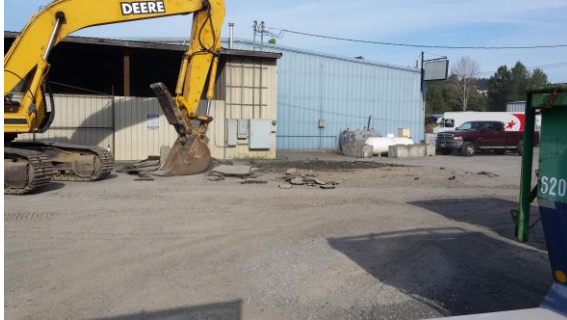
Photo #1: *Removing asphalt (uncovering AEG MW-3)*

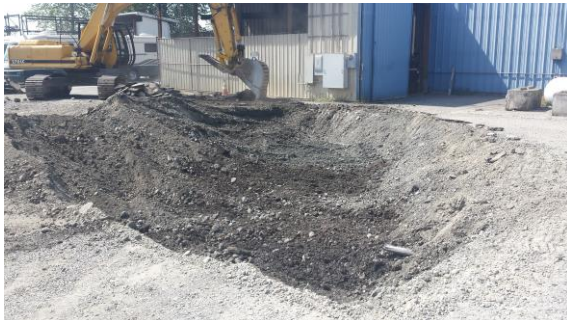
Photo #3: *TP-1 to west excavation*

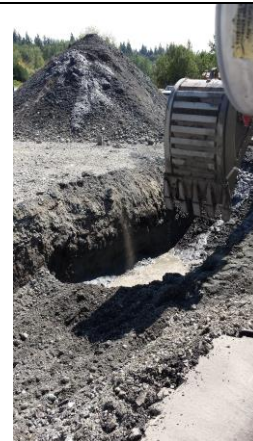
Photo #4: *Trenching on the east side of utility trench*

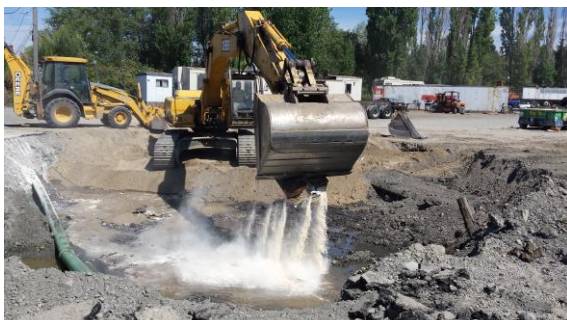
Photo #5: *Mixing in ORC-Advanced to soil/groundwater*

Twelve 30-pound bags of Regeneration Oxygen Reduction Compound-Advanced® (ORC-A®) was mixed in the exposed groundwater and sloughed soils at the base of the excavation. A total of 991 pounds of ORC-A® pellets, 390 pounds of RegenOx Part A, and 120 pounds of RegenOx Part B were mixed in three sections from south to north prior to installing the PMF. AEG placed the PMF to the east of the stormwater pipe to create a barrier where hydrocarbons can adhere to the geotextile fabric and the mulch mix introduced into the silt free fill. The purpose of the PMF is to limit the remaining contamination under the lean-to structure from migrating to the newly placed, uncontaminated fill.

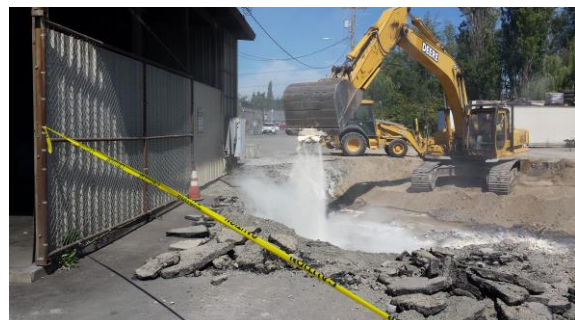
Photo #6: *Mixing In ORC-Advanced to north*

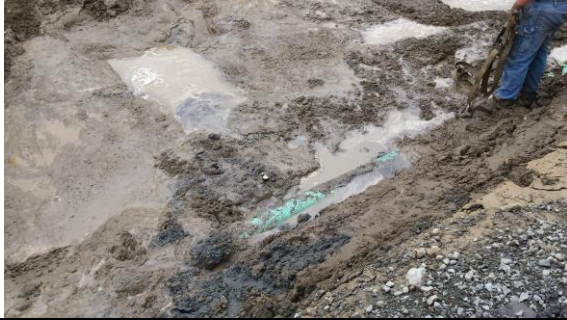
Photo #7: After ORC-Adv. Mixed in east of stormwater pipe (green) note oil residue seeping from west of pipe creating sheen near pipe.

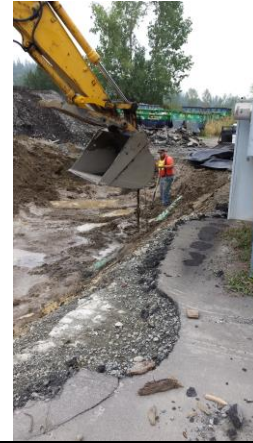
Photo #8: Resetting stormwater pipe grade

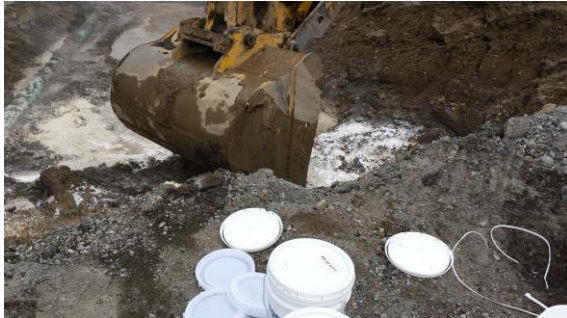
Photo #9: Mixing in ORC-Adv Pellets and RegenOx Part A and Part B.

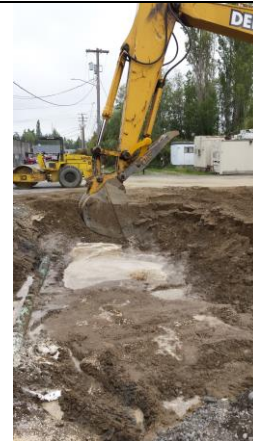
Photo #10: Frothing of groundwater creating a brown color, many bubbles forming.

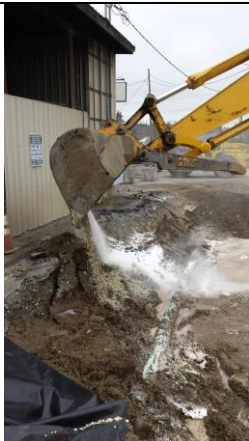
Photo #11: Sidewall distribution of ORC-Advanced and RegenOx products

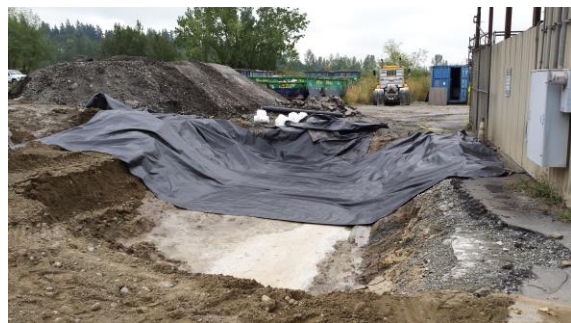
Photo #12: Laying base of Permeable Membrane Filter PMF

The PMF was created using TenCate Mirafi X-Series Woven Polypropylene Geotextile fabric. Sheets 12 feet by 25 feet were cut and laid out in an east-west orientation with approximately 3 feet of overlap progressing to the north. These sheets were laid in the base of the excavation at approximately 7 to 8 feet bgs and pulled taught. Clean fill was placed on top of the fabric to about

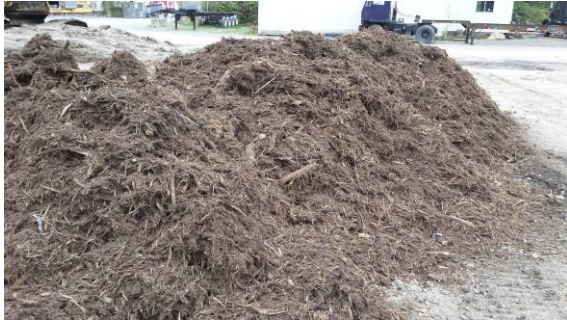
Photo #13: *Mulch mix- Blended 40% by volume into bank run import fill material. Placed inside membrane.*

2 feet bgs. A total of 40% mulch by volume was mixed in with the imported sand with trace silt fill. When the combination fill reached 2 feet bgs, the ends of each sheet were folded over the mulch-fill. The final dimensions of the PMF were approximately 55 feet north-south, 15 feet east-west, and 7 to 8 feet in vertical profile. Three sheets were placed directly on top of the PMF north to south with approximately 3 feet of overlap to provide a bridging effect due to the potential of settling material that was used in the PMF.

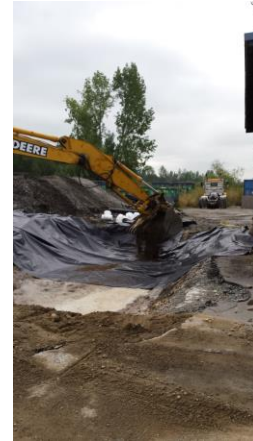
Photo #14: *First placement of Soil/Mulch Mix extended to approx. 7-8 in excavation next to pipe. Below water table in picture.*

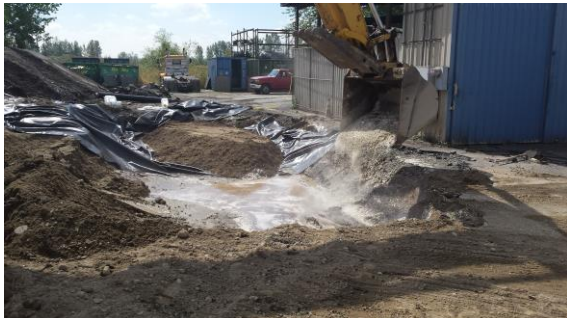
Photo #15: *Mixing Regenesis chemicals in northern portion of excavation. 60% of total chemicals placed here due to previous analyticals being well above MTCA lean up levels.*

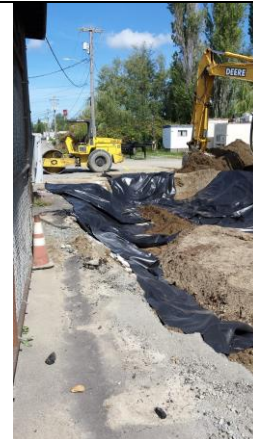
Photo #16: *Placing Soil/Mulch mix in north end of the excavation.*

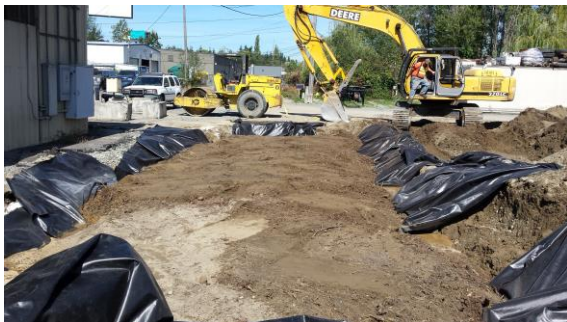
Photo #17: *Filled to 2 feet below finish grade for structural fill placement.*

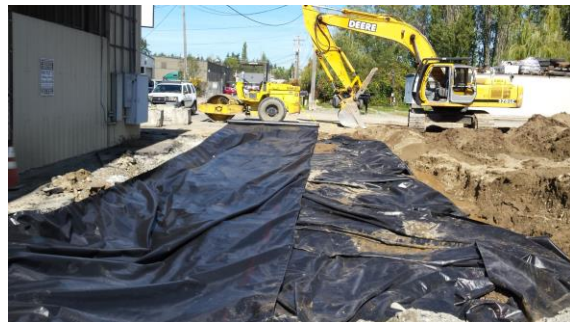
Photo #18: *Fully wrapped soil/mulch mix with geotextile fabric running north south for bridging affect, stability.*

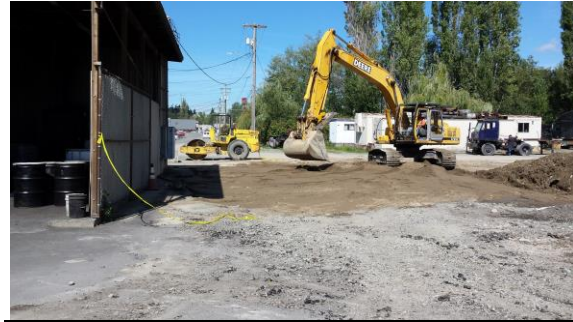
| Photo<br>#20: | <i>Final subgrade elevation</i> |
