AS-BUILT CONSTRUCTION COMPLETE REPORT

FORMER TRUCK CITY SITE
3216 OLD HIGHWAY 99 SOUTH
MOUNT VERNON, WASHINGTON

Prepared for
SKAGIT COUNTY
MOUNT VERNON, WASHINGTON
March 30, 2016
Project No. 0714.03.01

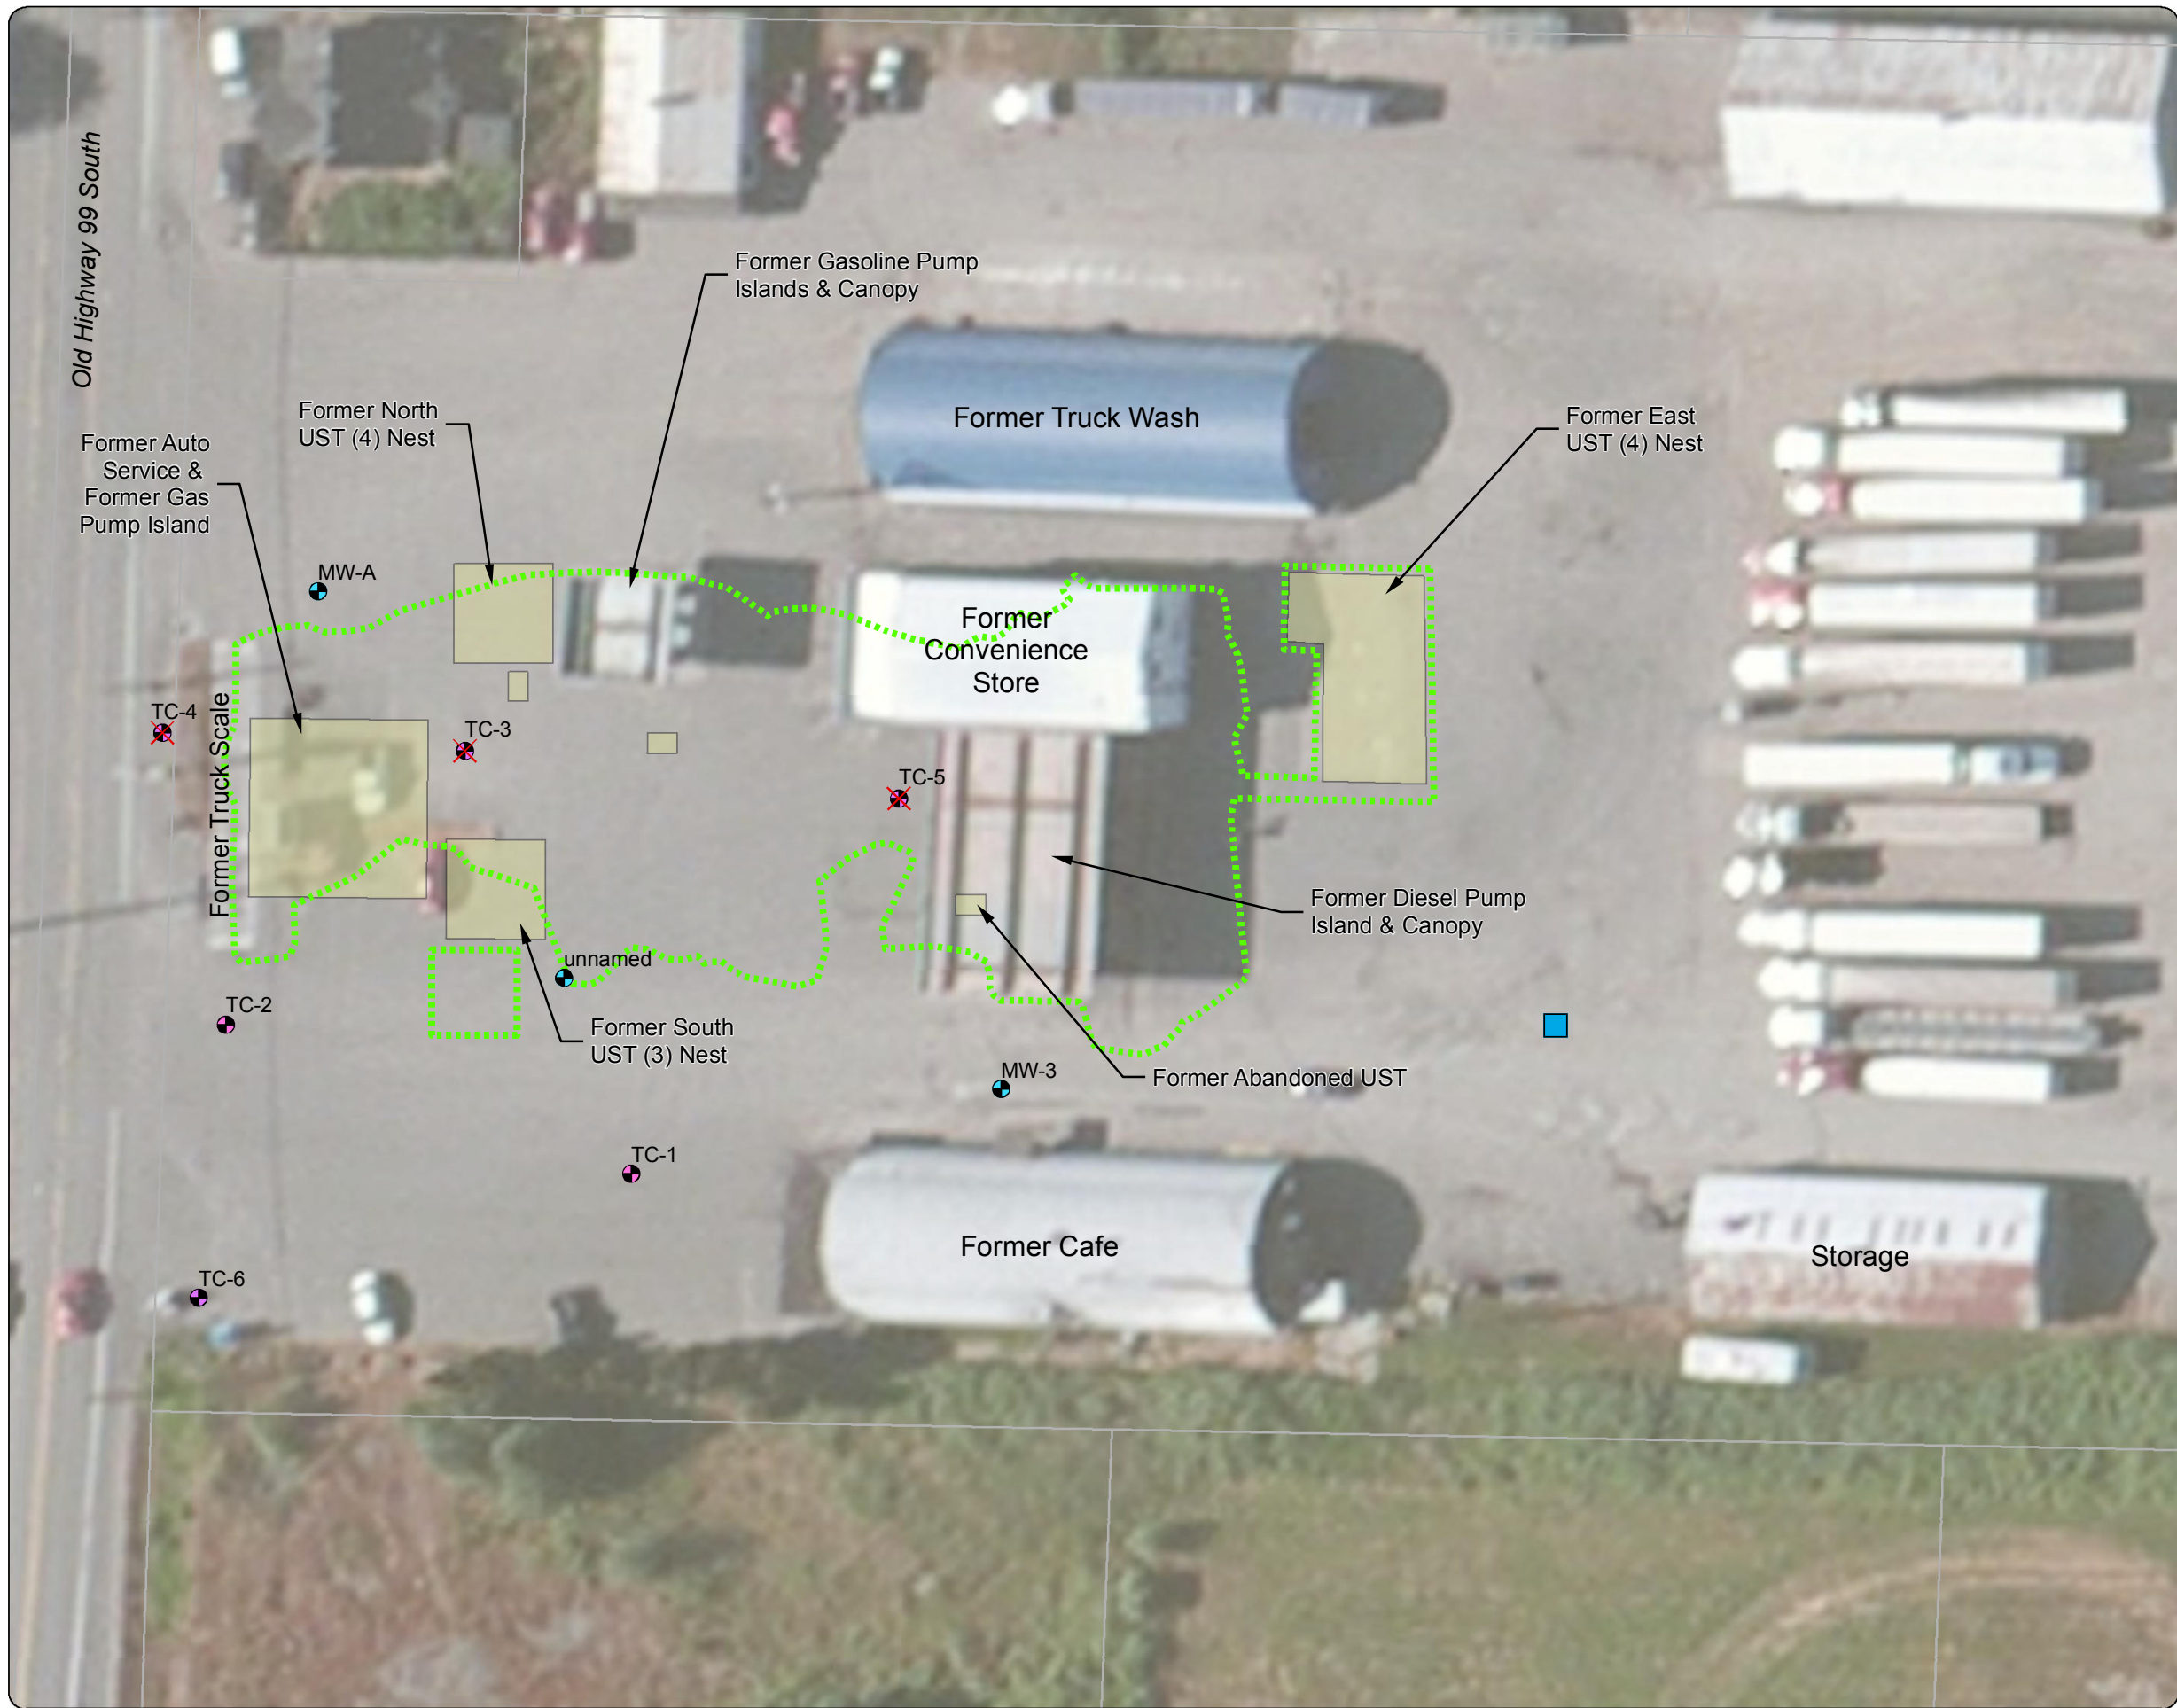
**Figure 5-1
Site Overview -
Remedial Action**
Former Truck City Site
Mount Vernon, Washington

During the remedial excavation (RE) activities, a closed-in-place, 650-gallon UST was found in the southern pump island dispenser area to the west of the former pump islands. The location of this abandoned UST is shown on Figure 5-1. This UST is also discussed in Section 7.2 below.

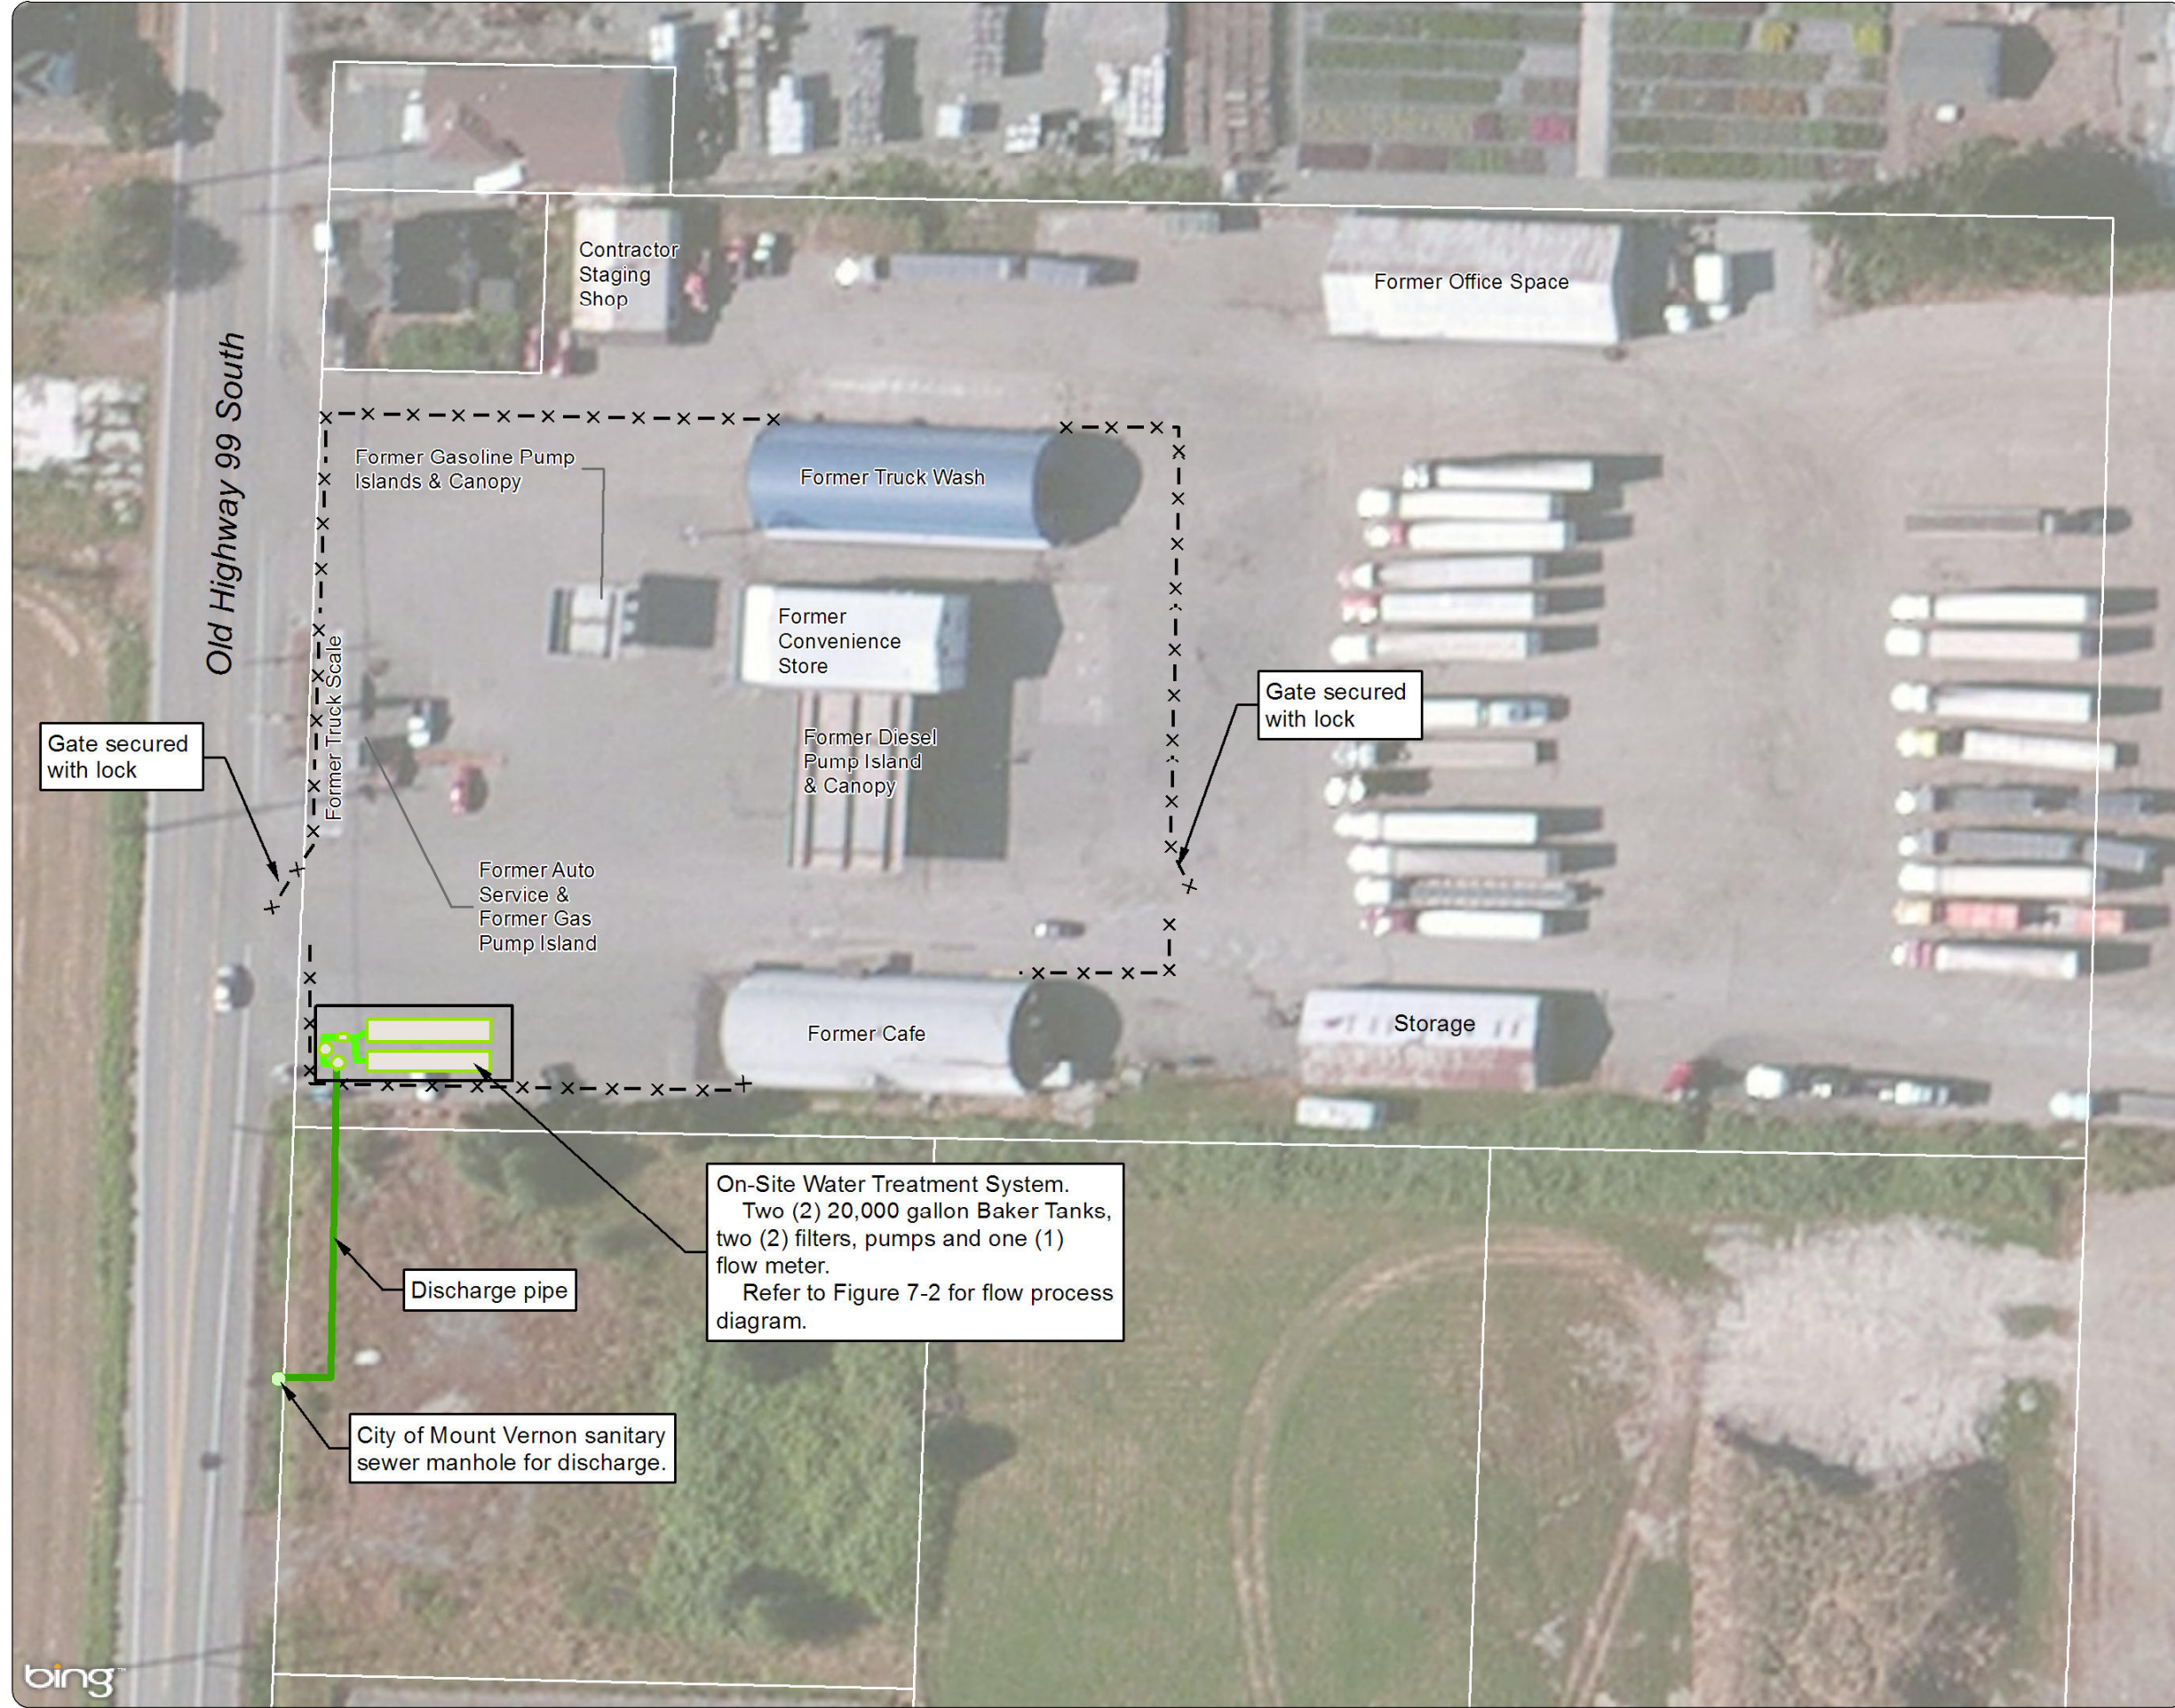
Figure 7-1
Overview of On-Site
Water Treatment and
Discharge System
 Former Truck City Site
 Mount Vernon, Washington

Water-containing tanks: The tanks were equipped with over weirs and under weirs for removal of settleable solids and separated-phase hydrocarbons (i.e., free product), as well as a sorbent boom at the inlet to remove any floating free product. The tanks were also fitted with a containment berm system in order to provide secondary containment in the event of a fittings leak or other leakage issues.

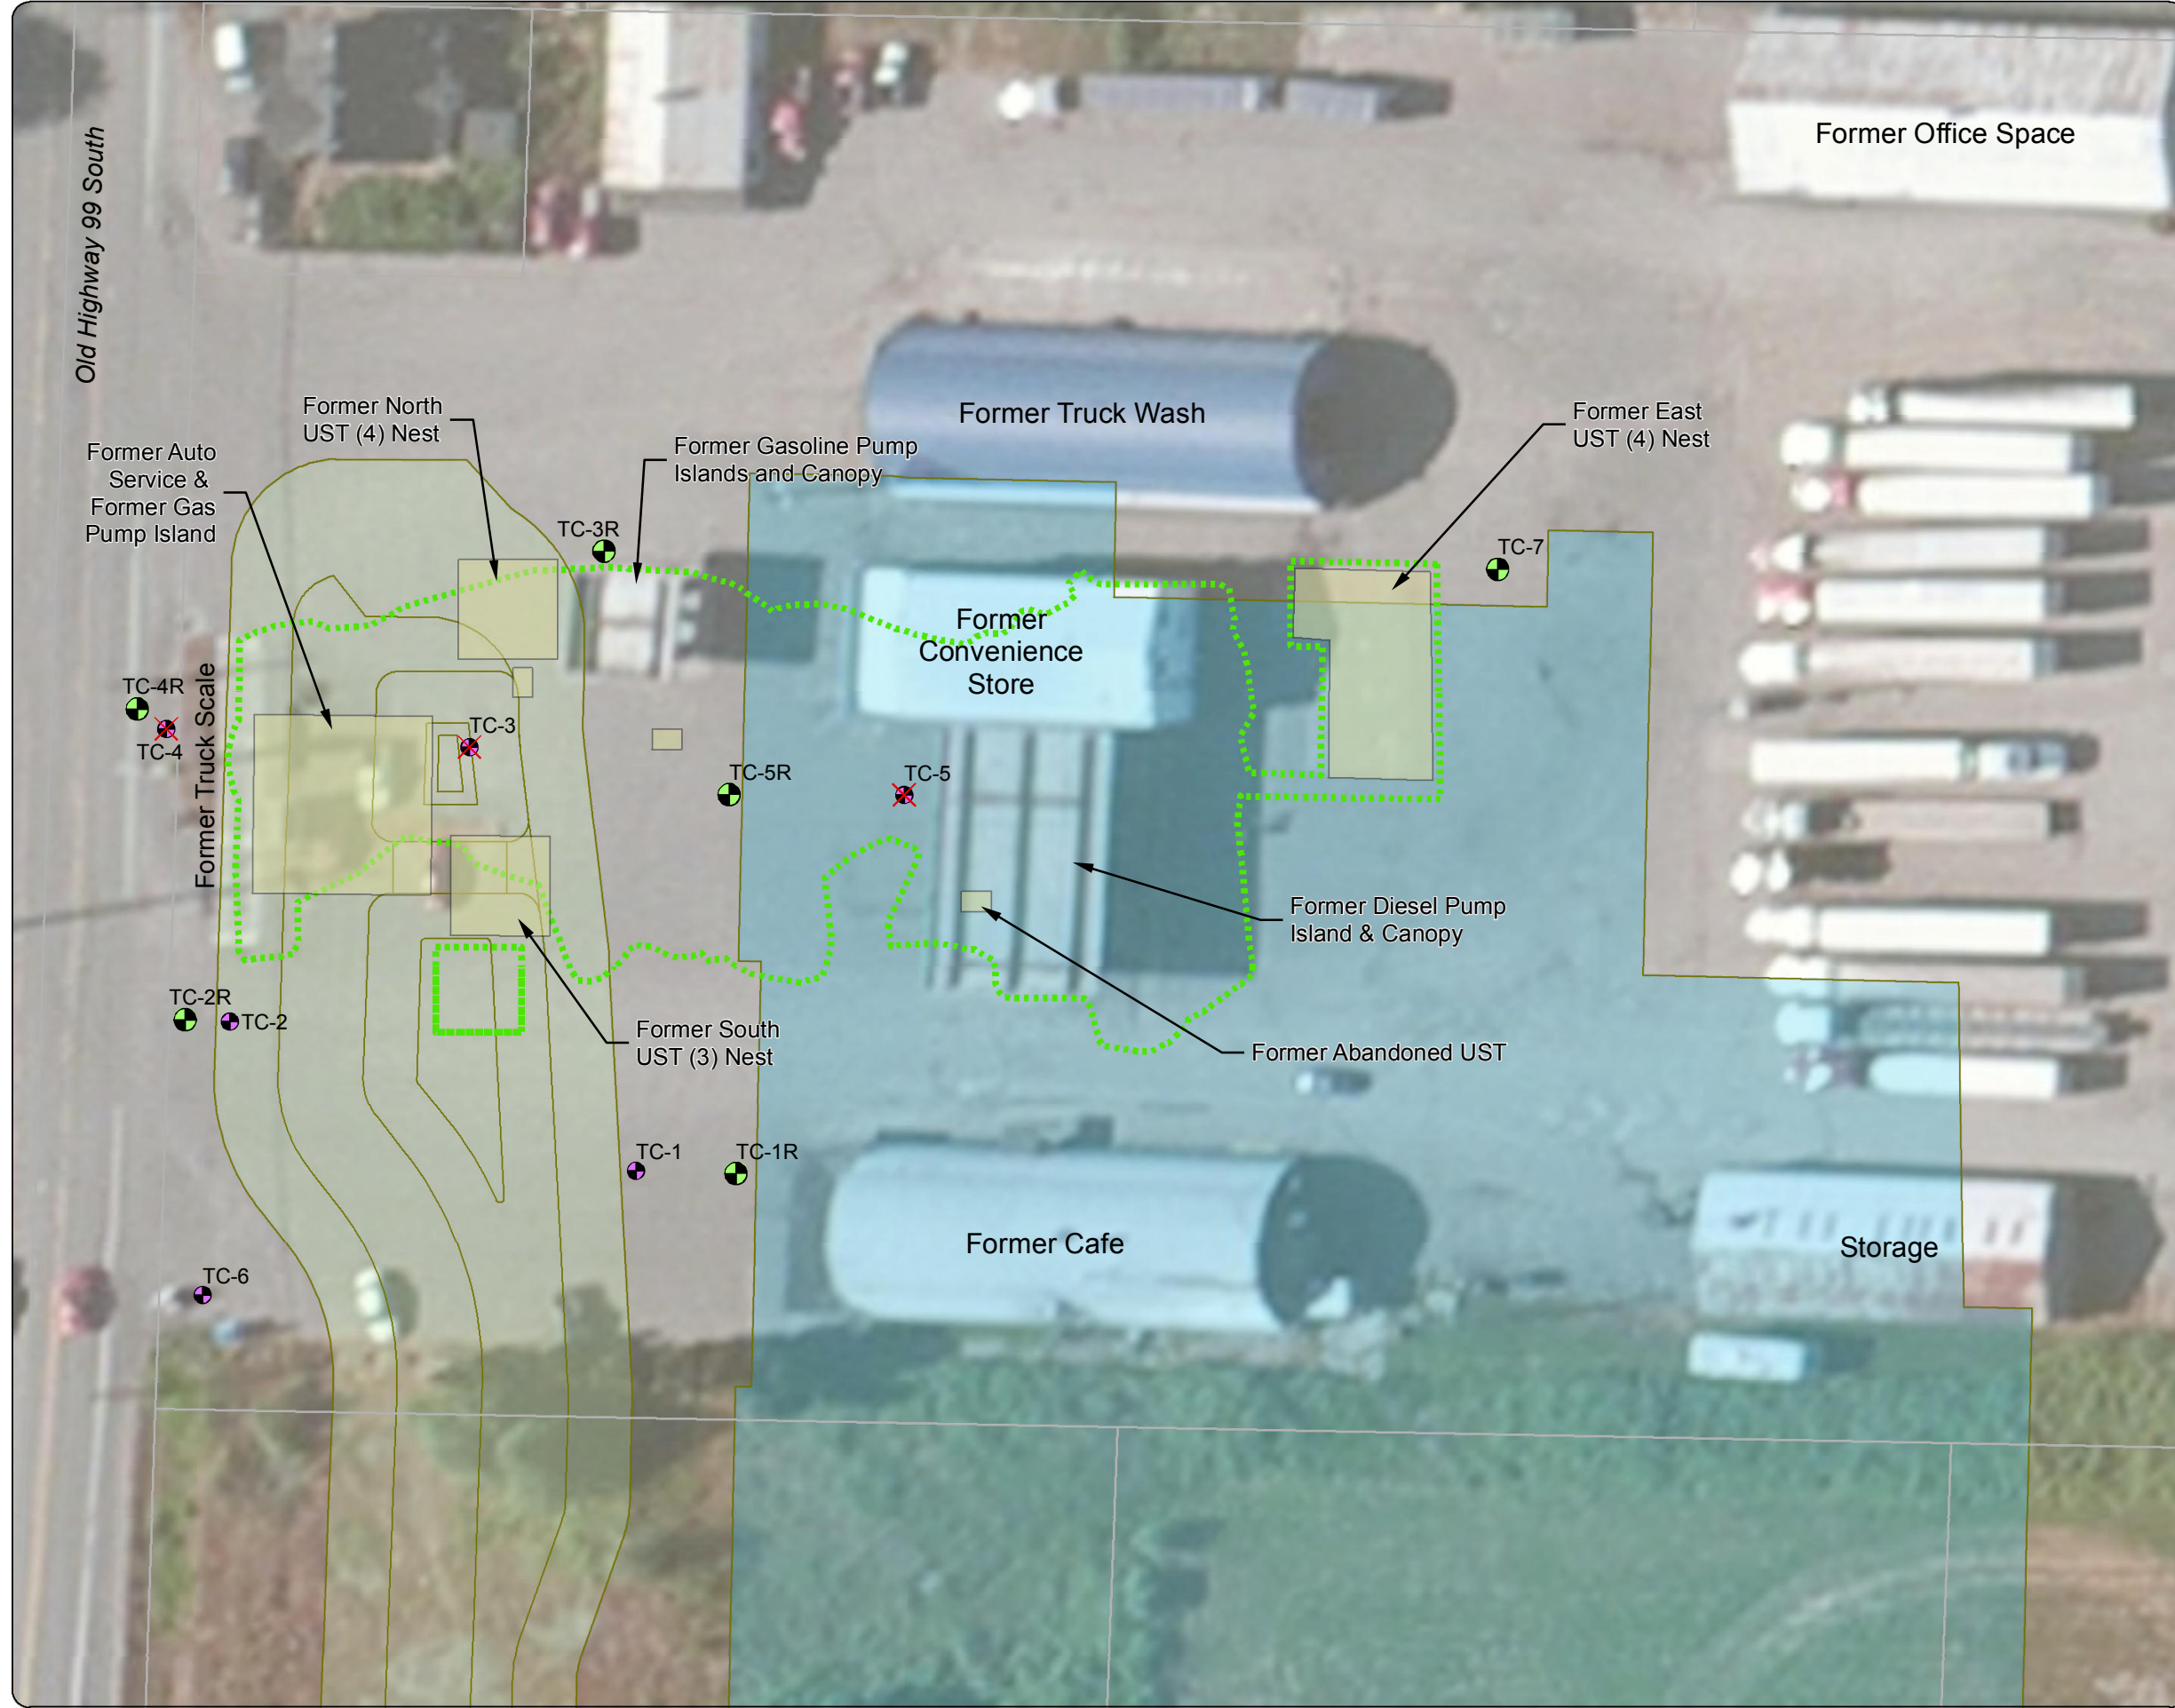
**Figure 11-1
Proposed Replacement
Monitoring Wells Locations**

Six replacement groundwater monitoring wells (TC-1R, TC-2R, TC-3R, TC-4R, TC-5R, and TC-7) are proposed for installation within and adjacent to the remedial action excavation footprint, at inferred downgradient and upgradient locations, to evaluate the effectiveness of the remedial action and monitor the groundwater quality of this area.

The Ecology site manager authorized the locations of the proposed replacement monitoring wells on December 22, 2015 (Ecology, 2015b). Figure 11-1 presents the locations of proposed wells with respect to the site features of the proposed Skagit County Jail. Replacement of the original wells is necessary, as some of them would interfere with the proposed retention pond and/or are projected to be in the pathway of a maintenance road to be constructed in the area.

Each replacement well will be installed, using a direct-push drilling rig, to a depth of 15 feet bgs and will be constructed according to the Washington well construction standards (WAC 173-160) and procedures outlined in MFA's Focused Site Assessment Work Plan's Sampling and Analysis Plan (MFA, 2014a), with pre-packed well screen installed from 5 to 15 feet bgs.

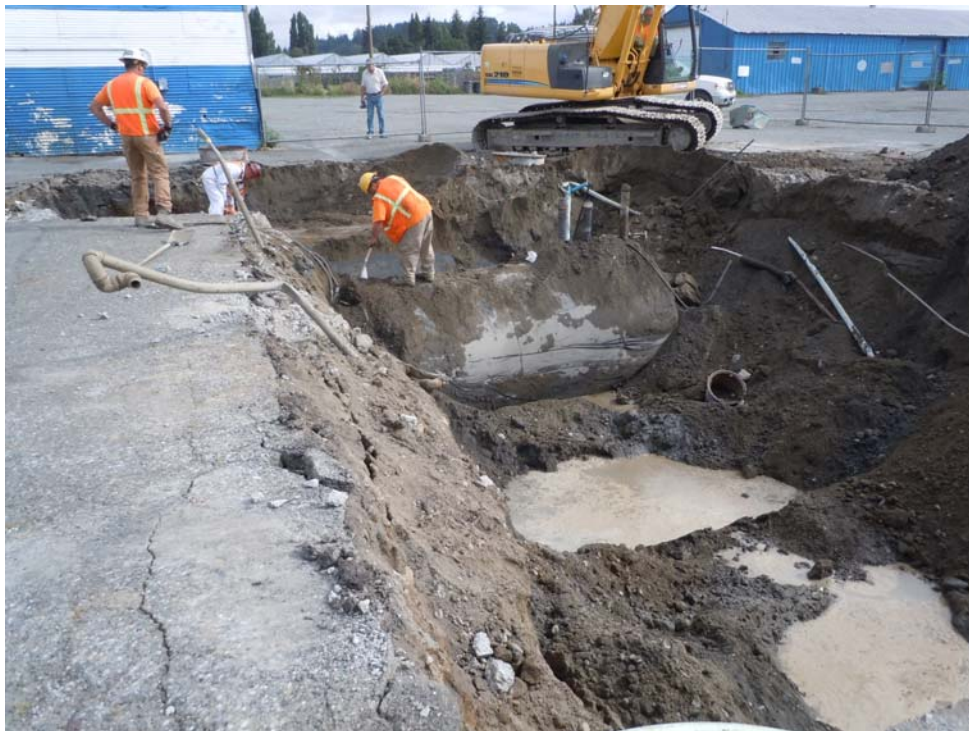
Decommissioning and removal of one 500-gallon underground storage tank (UST) and one 15,000-gallon UST, looking north. Photo taken on 8/6/2015.

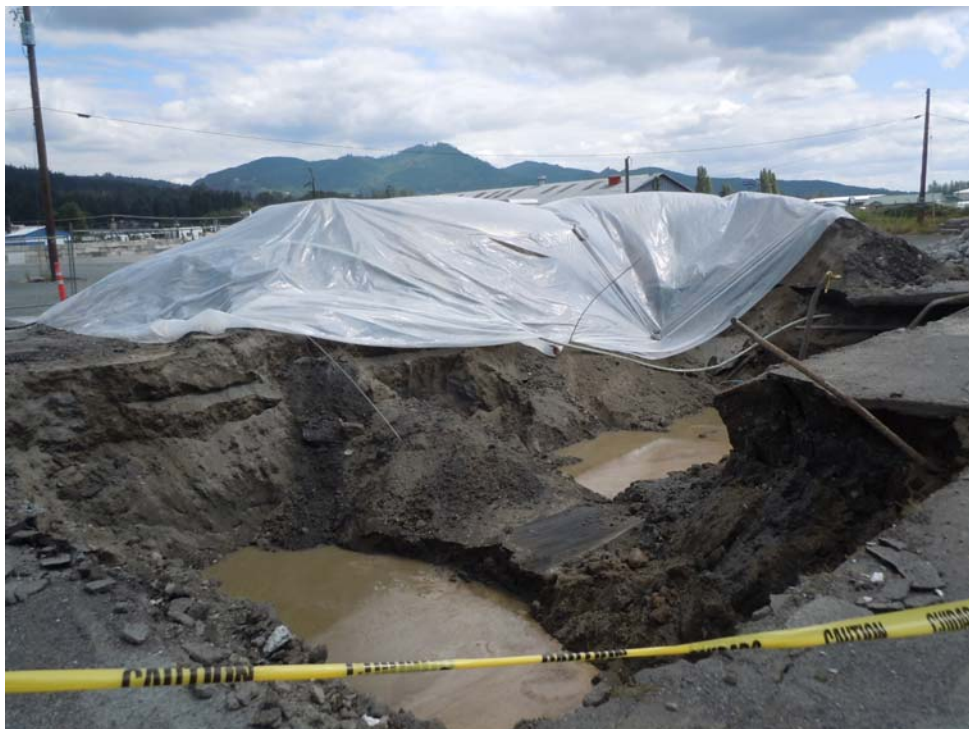
UST excavation pit, looking east. Photo taken on 8/6/2015.

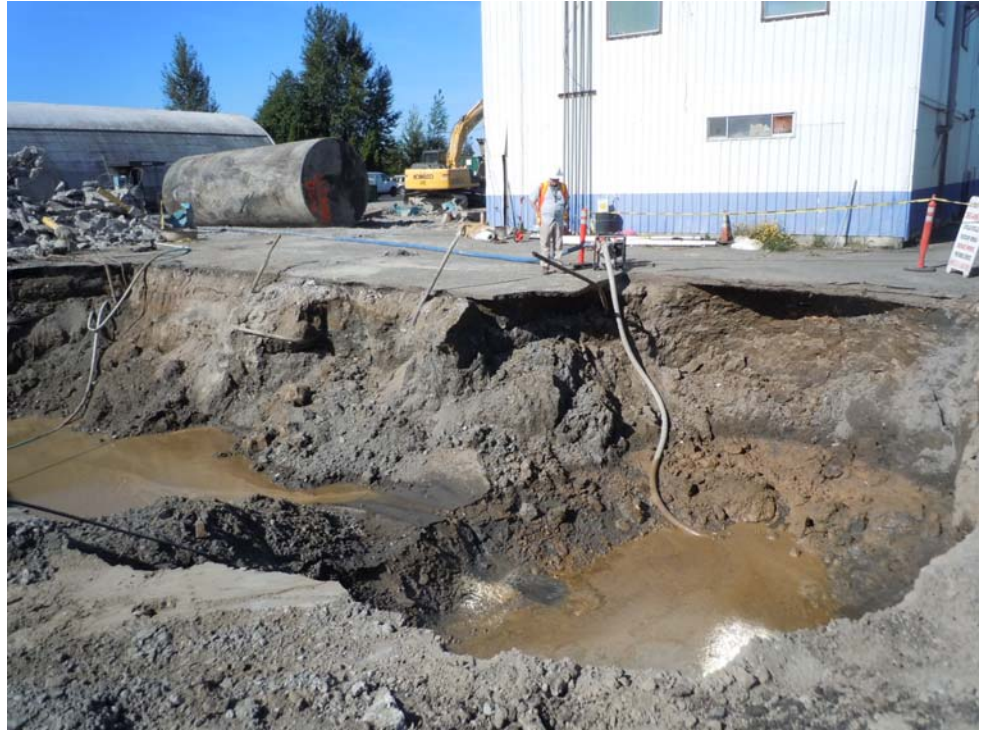
UST excavation and dewatering, looking west.
Photo taken on 8/7/2015.

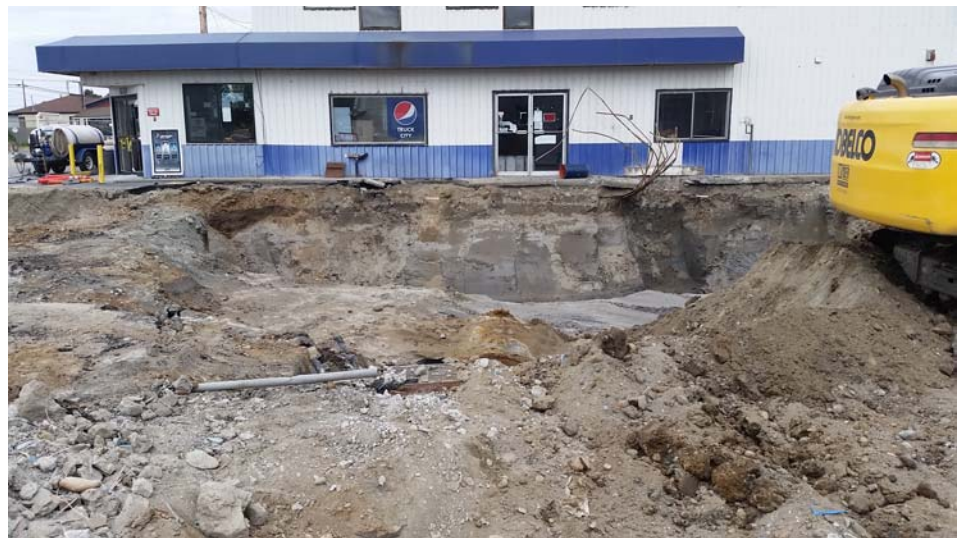
South dispenser island excavation showing location of abandoned UST, looking north. Photo taken on 8/20/2015.

As mentioned above in Section 5.2, on August 20, 2015, during the extended PCS excavation east of RE3, Wyser uncovered an abandoned UST that had not been previously identified. It appeared to have a capacity of approximately 475 gallons and contained an unknown oil. MFA sampled the contents of the UST; laboratory results indicated that it was a motor oil (Table 5-3). On August 25, 2015, following the City of Mount Vernon fire marshal's inspection of the tank (which was found to be in good condition), the tank contents were pumped out (by Marvac) and the tank removed (by Wyser). See selected photographs provided in Appendix C.

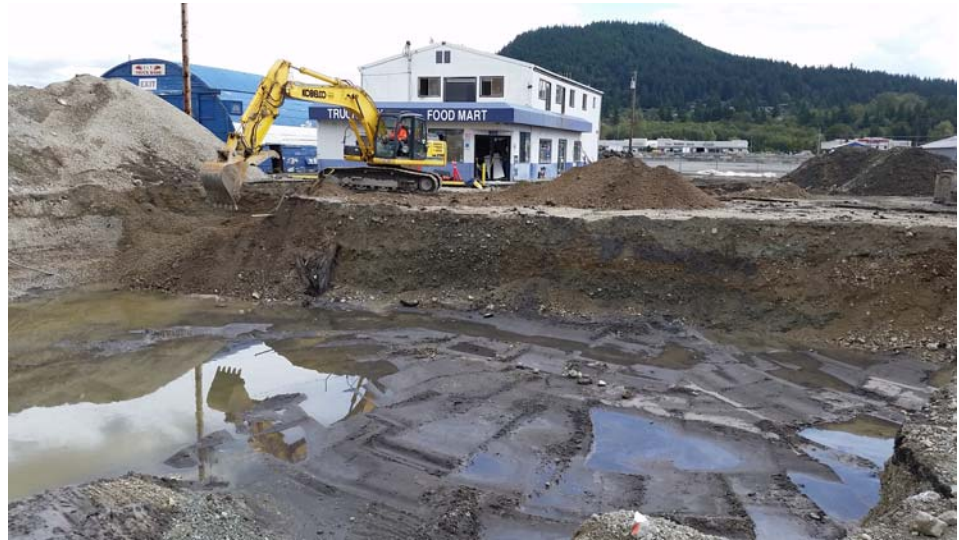
Staining observed along eastern wall of western excavation, looking east. Photo taken on 9/3/2015.

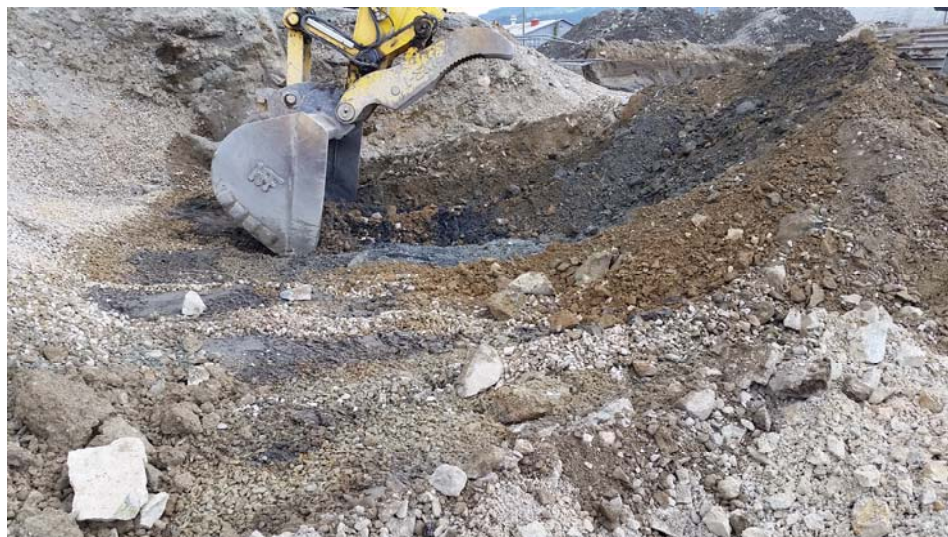
Stained soil south of the former convenience store, looking east. Photo taken on 9/4/2015.

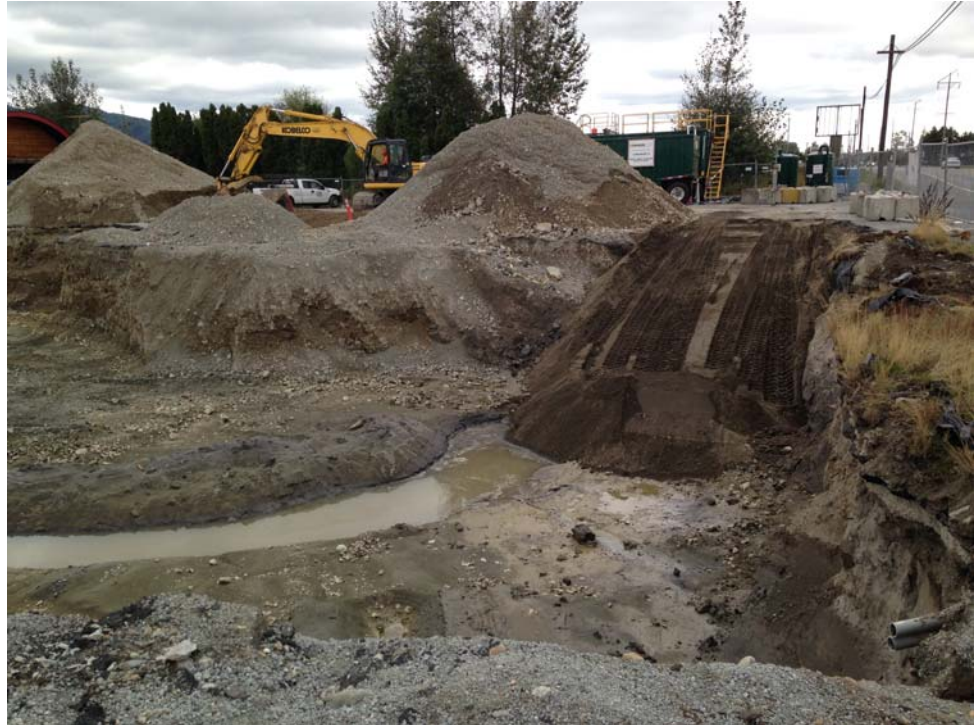
Dewatered excavation and initial backfilling of imported clean fill material in excavation area near former truck scale. Photo taken on 9/8/2015.

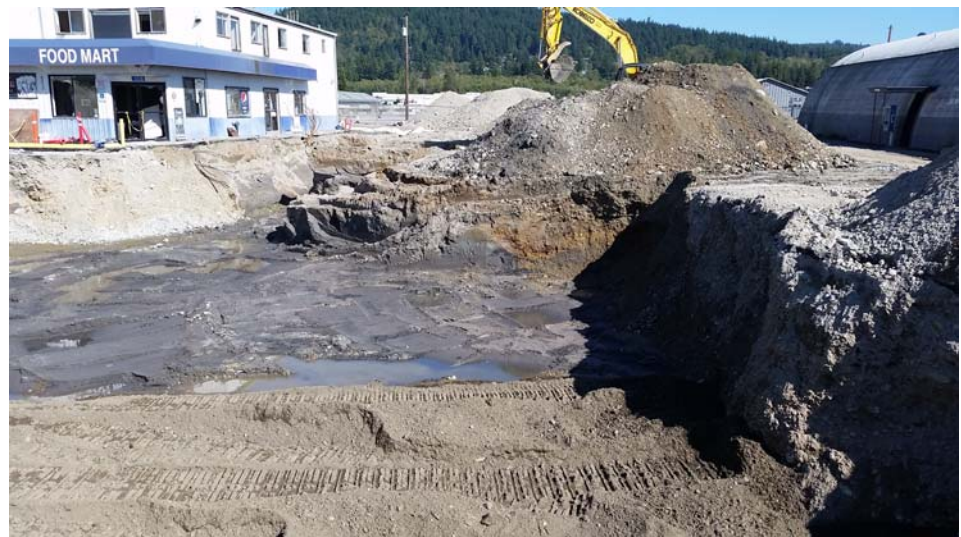
Stained soil south of the former convenience store, looking east. Photo taken on 9/10/2015.

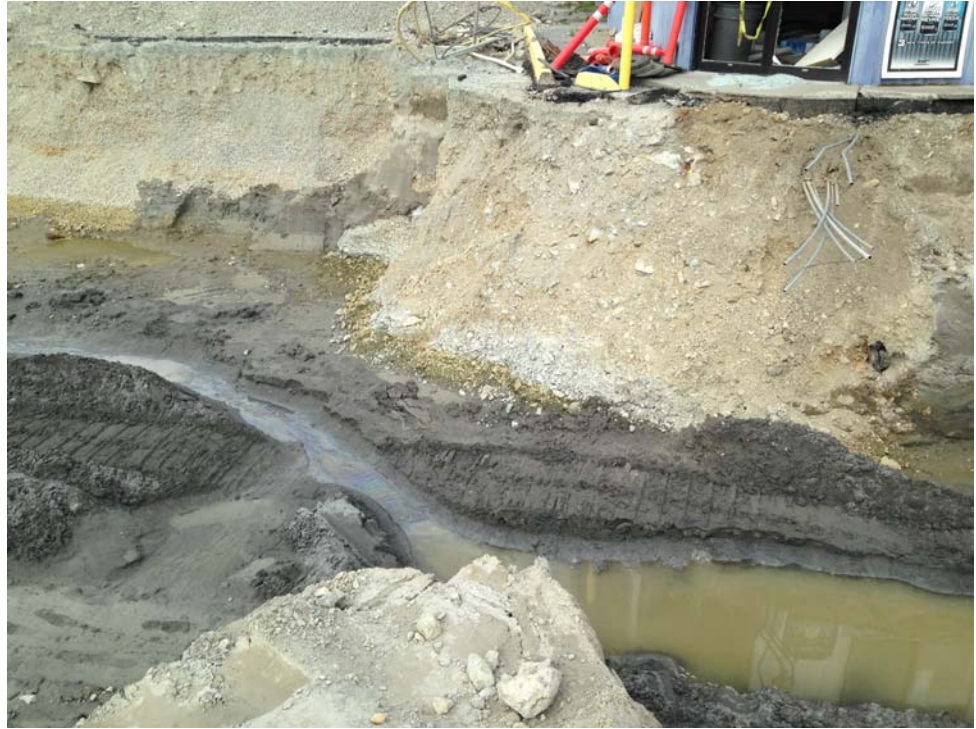
Shewn in water to the south of the former convenience store, looking north. Photo taken on 9/14/2015.

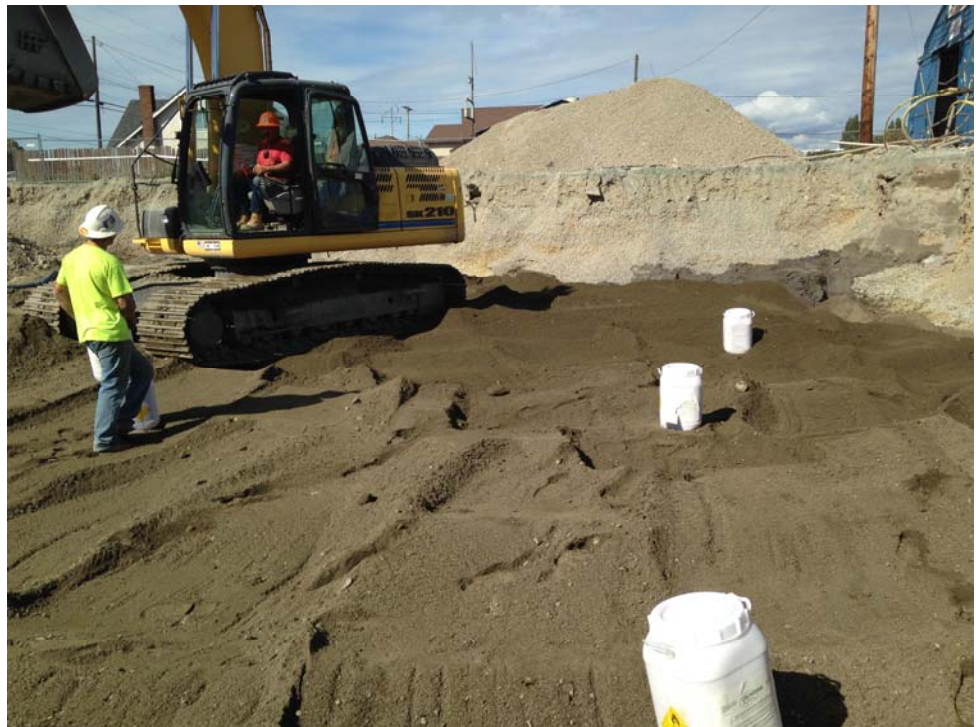
Preparation of ORCa application to imported clean backfill, looking north. Photo taken on 9/16/2015.

ISBR included the use of enhanced aerobic biodegradation to expedite the biodegradation of TPH and VOCs in soil and groundwater by adding ORCa to accelerate the microbial degradation of remaining petroleum-hydrocarbon-impacted vadose zone and groundwater. The addition of a controlled-release supplemental source of oxygen enables the indigenous microorganisms (bacteria) to expedite the biodegradation process. The ORCa product will, when hydrated (with groundwater), produce a controlled release of oxygen for up to 12 months on a single application, which will assist in accelerating the naturally occurring aerobic contaminant biodegradation in groundwater and saturated soils.

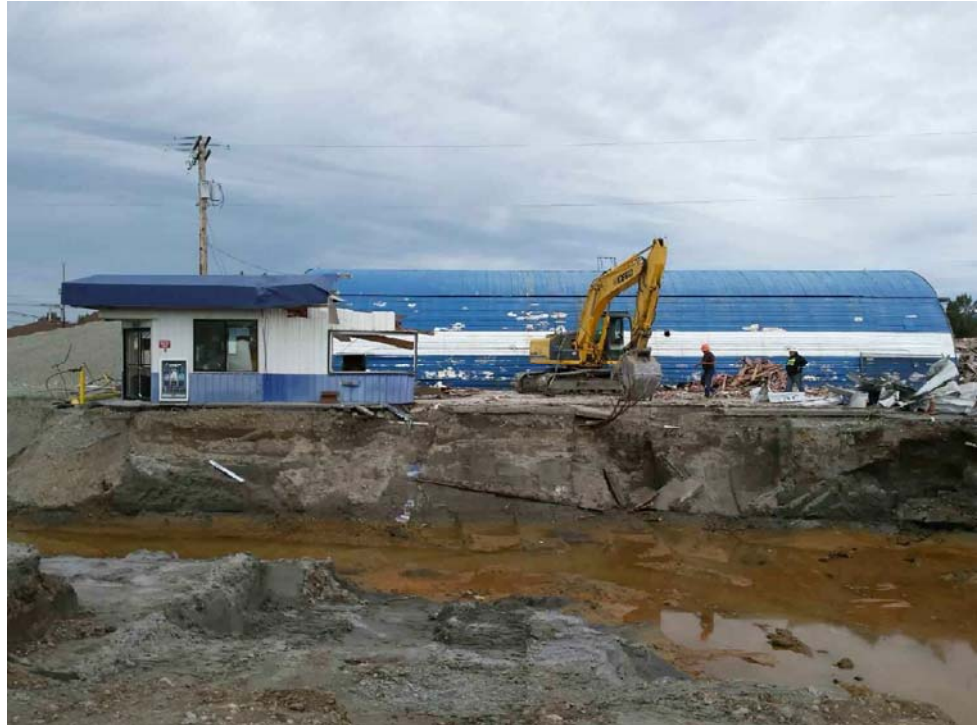
Demolition of former convenience store, looking north. Photo taken on 9/24/2015.

Demolition of the former convenience store began on September 22, 2015. Following demolition and removal of debris, Wyser extended the PCS excavation beneath the former building footprint. In general, the excavation extended to approximately 10 feet bgs beneath the former product line area and to 5 feet bgs or less beneath the building footprint and south of the product line. This surface excavation is also shown on Figure 5-2. The RE3 excavation also extended east. Not only was impacted soil found in the vicinity of the product line, but it also appeared to follow a section of the concrete storm sewer line and associated catch basins. The impacted soil extended east, slightly beyond the eastern edge of the former convenience store.

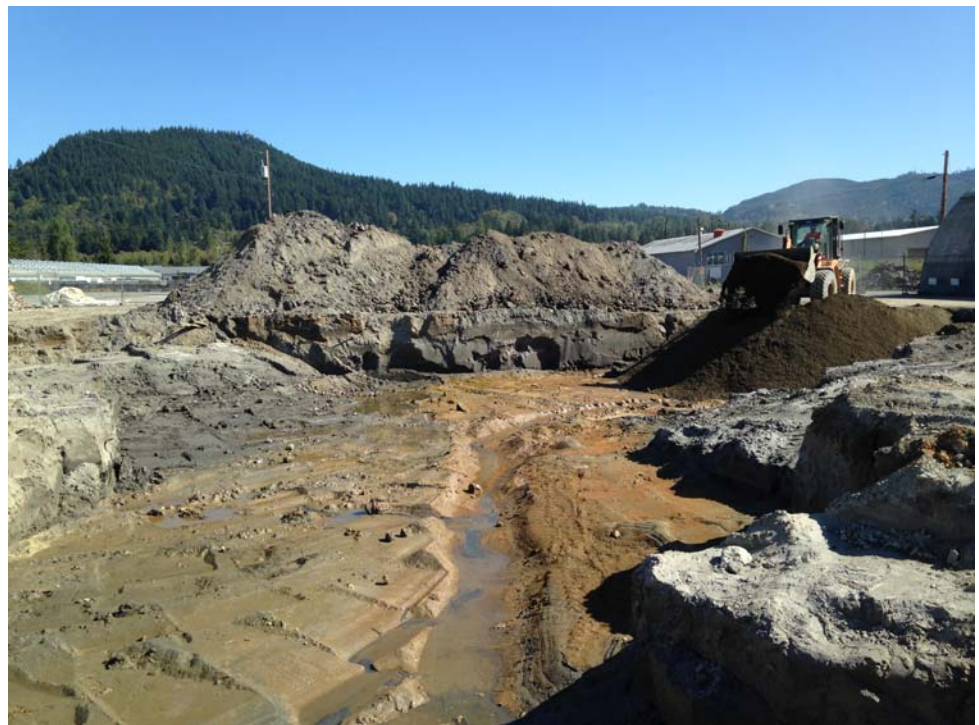
Excavation extent of eastern excavation, looking east. Photo taken on 9/29/2015.

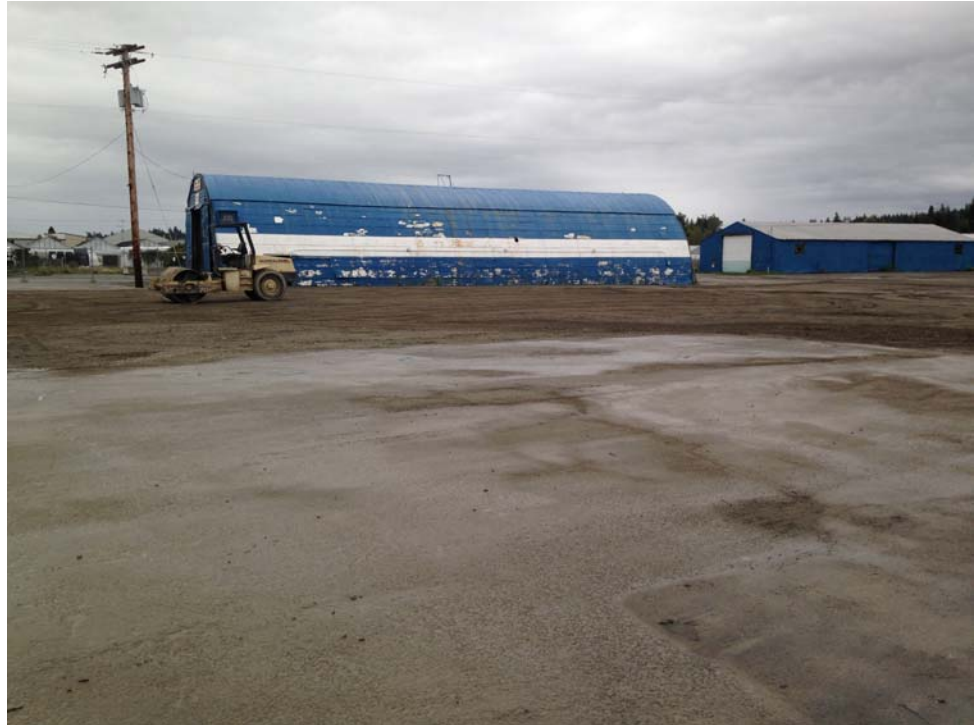
Remedial excavation
backfilled to grade,
looking north toward the
former Truck Wash.
Photo taken on
10/12/2015.

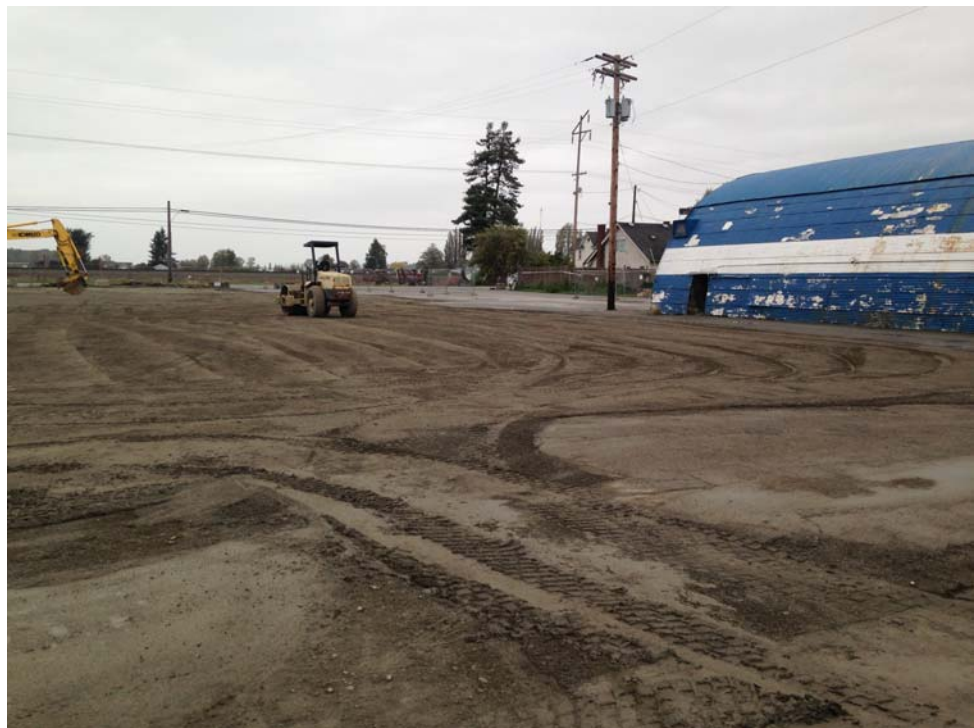
Remedial excavation
backfilled to grade,
looking west. Photo
taken on 10/12/2015.

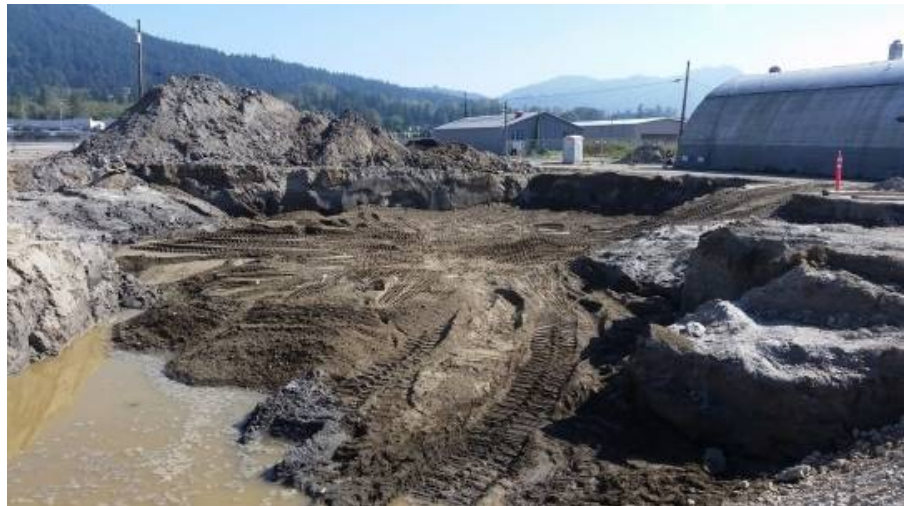
A photo of the west area of excavation, with on-site crushed being used as Structural Fill, during wheel rolling.
