Sunnyridge Building #2 Rt. 2 Box 2555 Hermiston, OR 97838 (541) 564-0991 Fax (541) 564-0928 GN Northern Job No. 199-349 GN Northern Document No. 199-349.RPT 3/29/99

UNDERGROUND STORAGE TANK SITE ASSESSMENT FORMER L & L EXXON SERVICE STATION 1315 LEE BOULEVARD RICHLAND, WASHINGTON

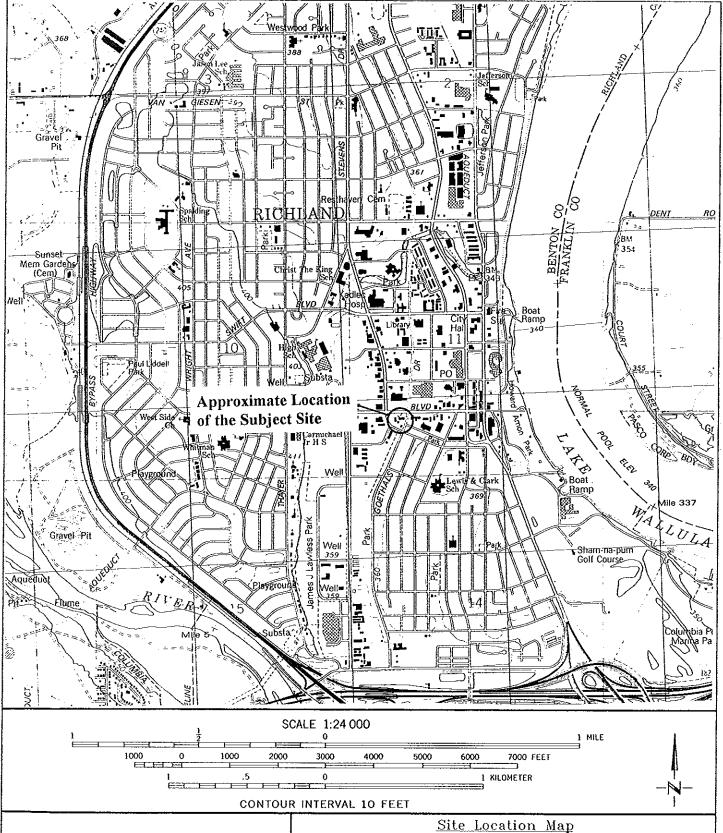
FIGURE NO.

USGS 7.5 Minute Series (Richland Quadrangle)
Underground Storage Tank Site Assessment
L & L Exxon Service Station
1315 Lee Boulevard
Richland, Washington

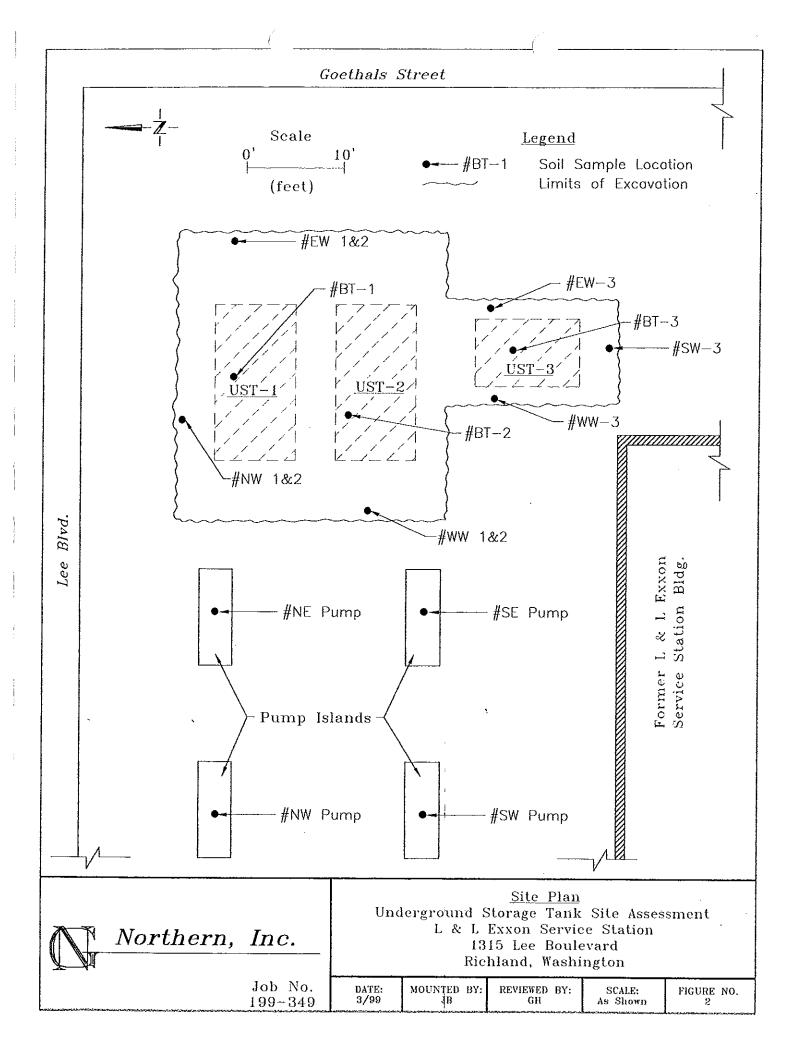
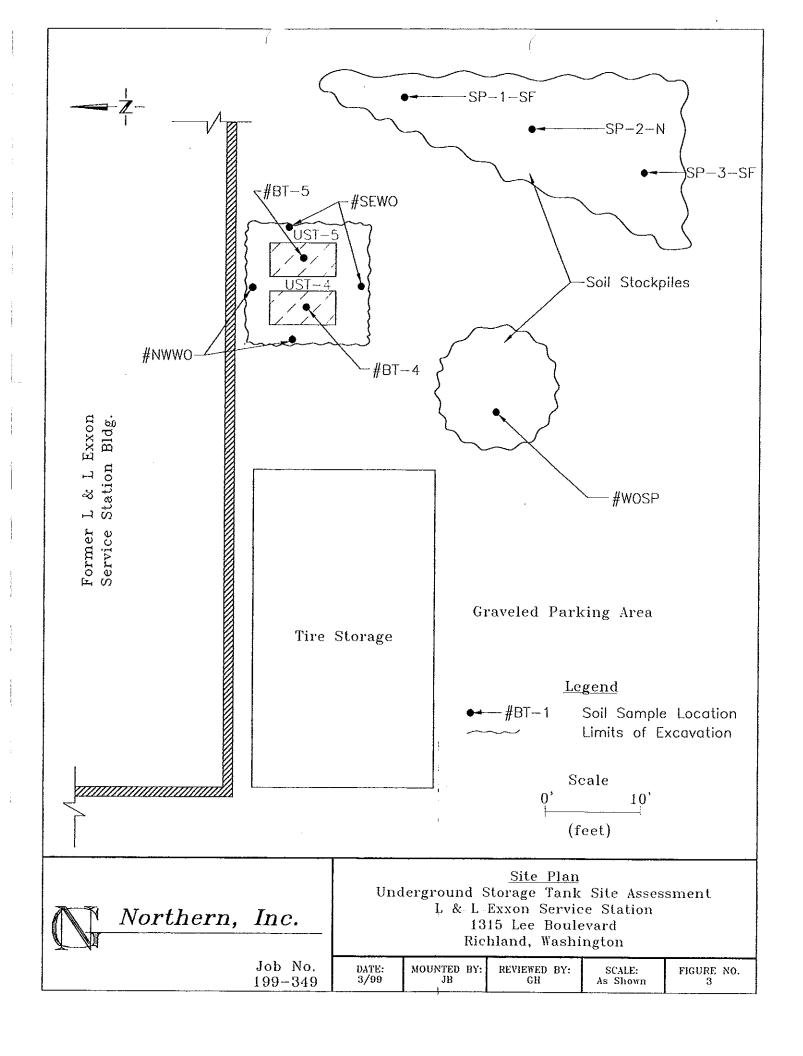
observations, soil samples were collected from the tank basin areas and the stockpiled overburden material. The sample locations are shown on Figures 2 and 3, Appendix 1.
