First Quarter 2016 Remedial Systems Operations and Maintenance (O&M) Report

TOC Holdings Co. Facility No. 01-176
24205, 24225, 24309 56th Avenue West
Mountlake Terrace, WA

HydroCon Project No: 01-176

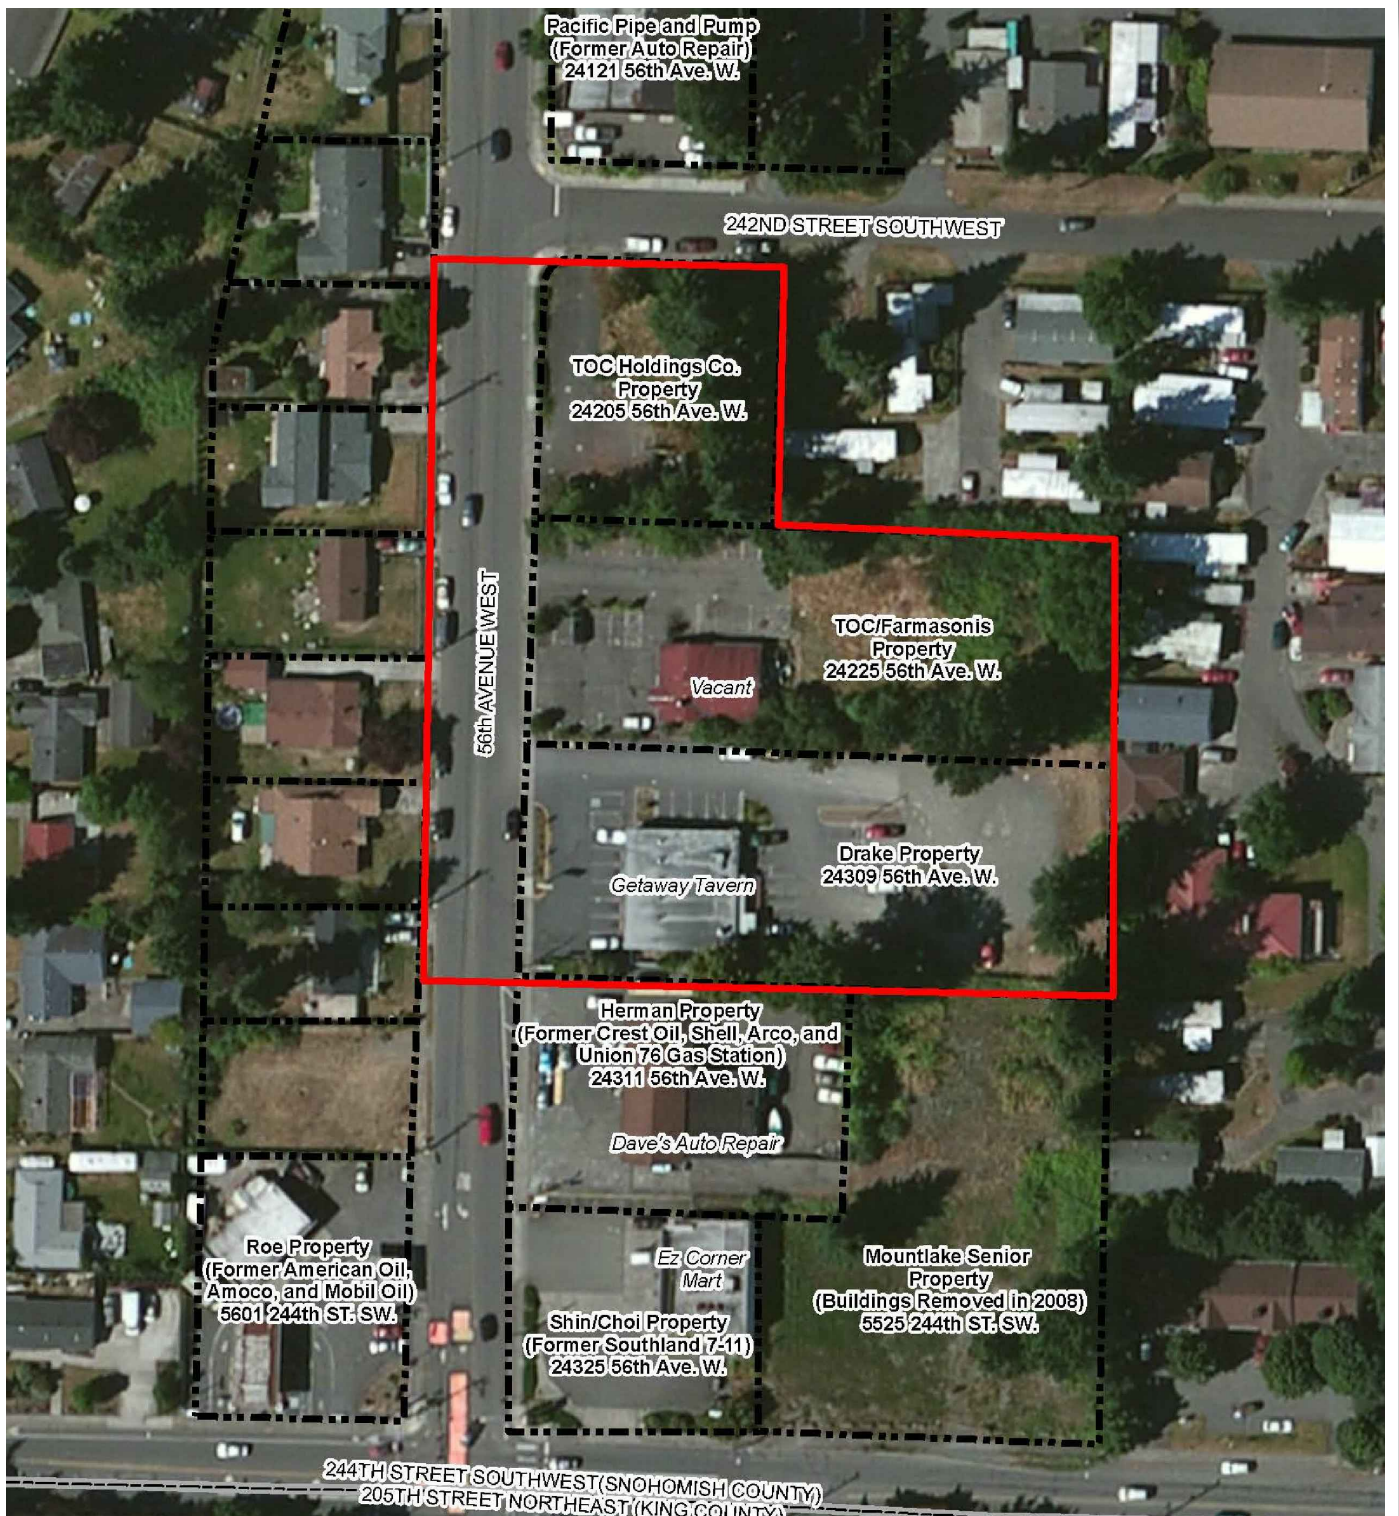
FIGURE 2
 SITE MAP

As described in the IRAWP, the TOC Facility No. 01-176 is termed the "Interim Remedial Project Area" (IRPA) and consists of the following four properties located in Mountlake Terrace, Washington (Figure 2):

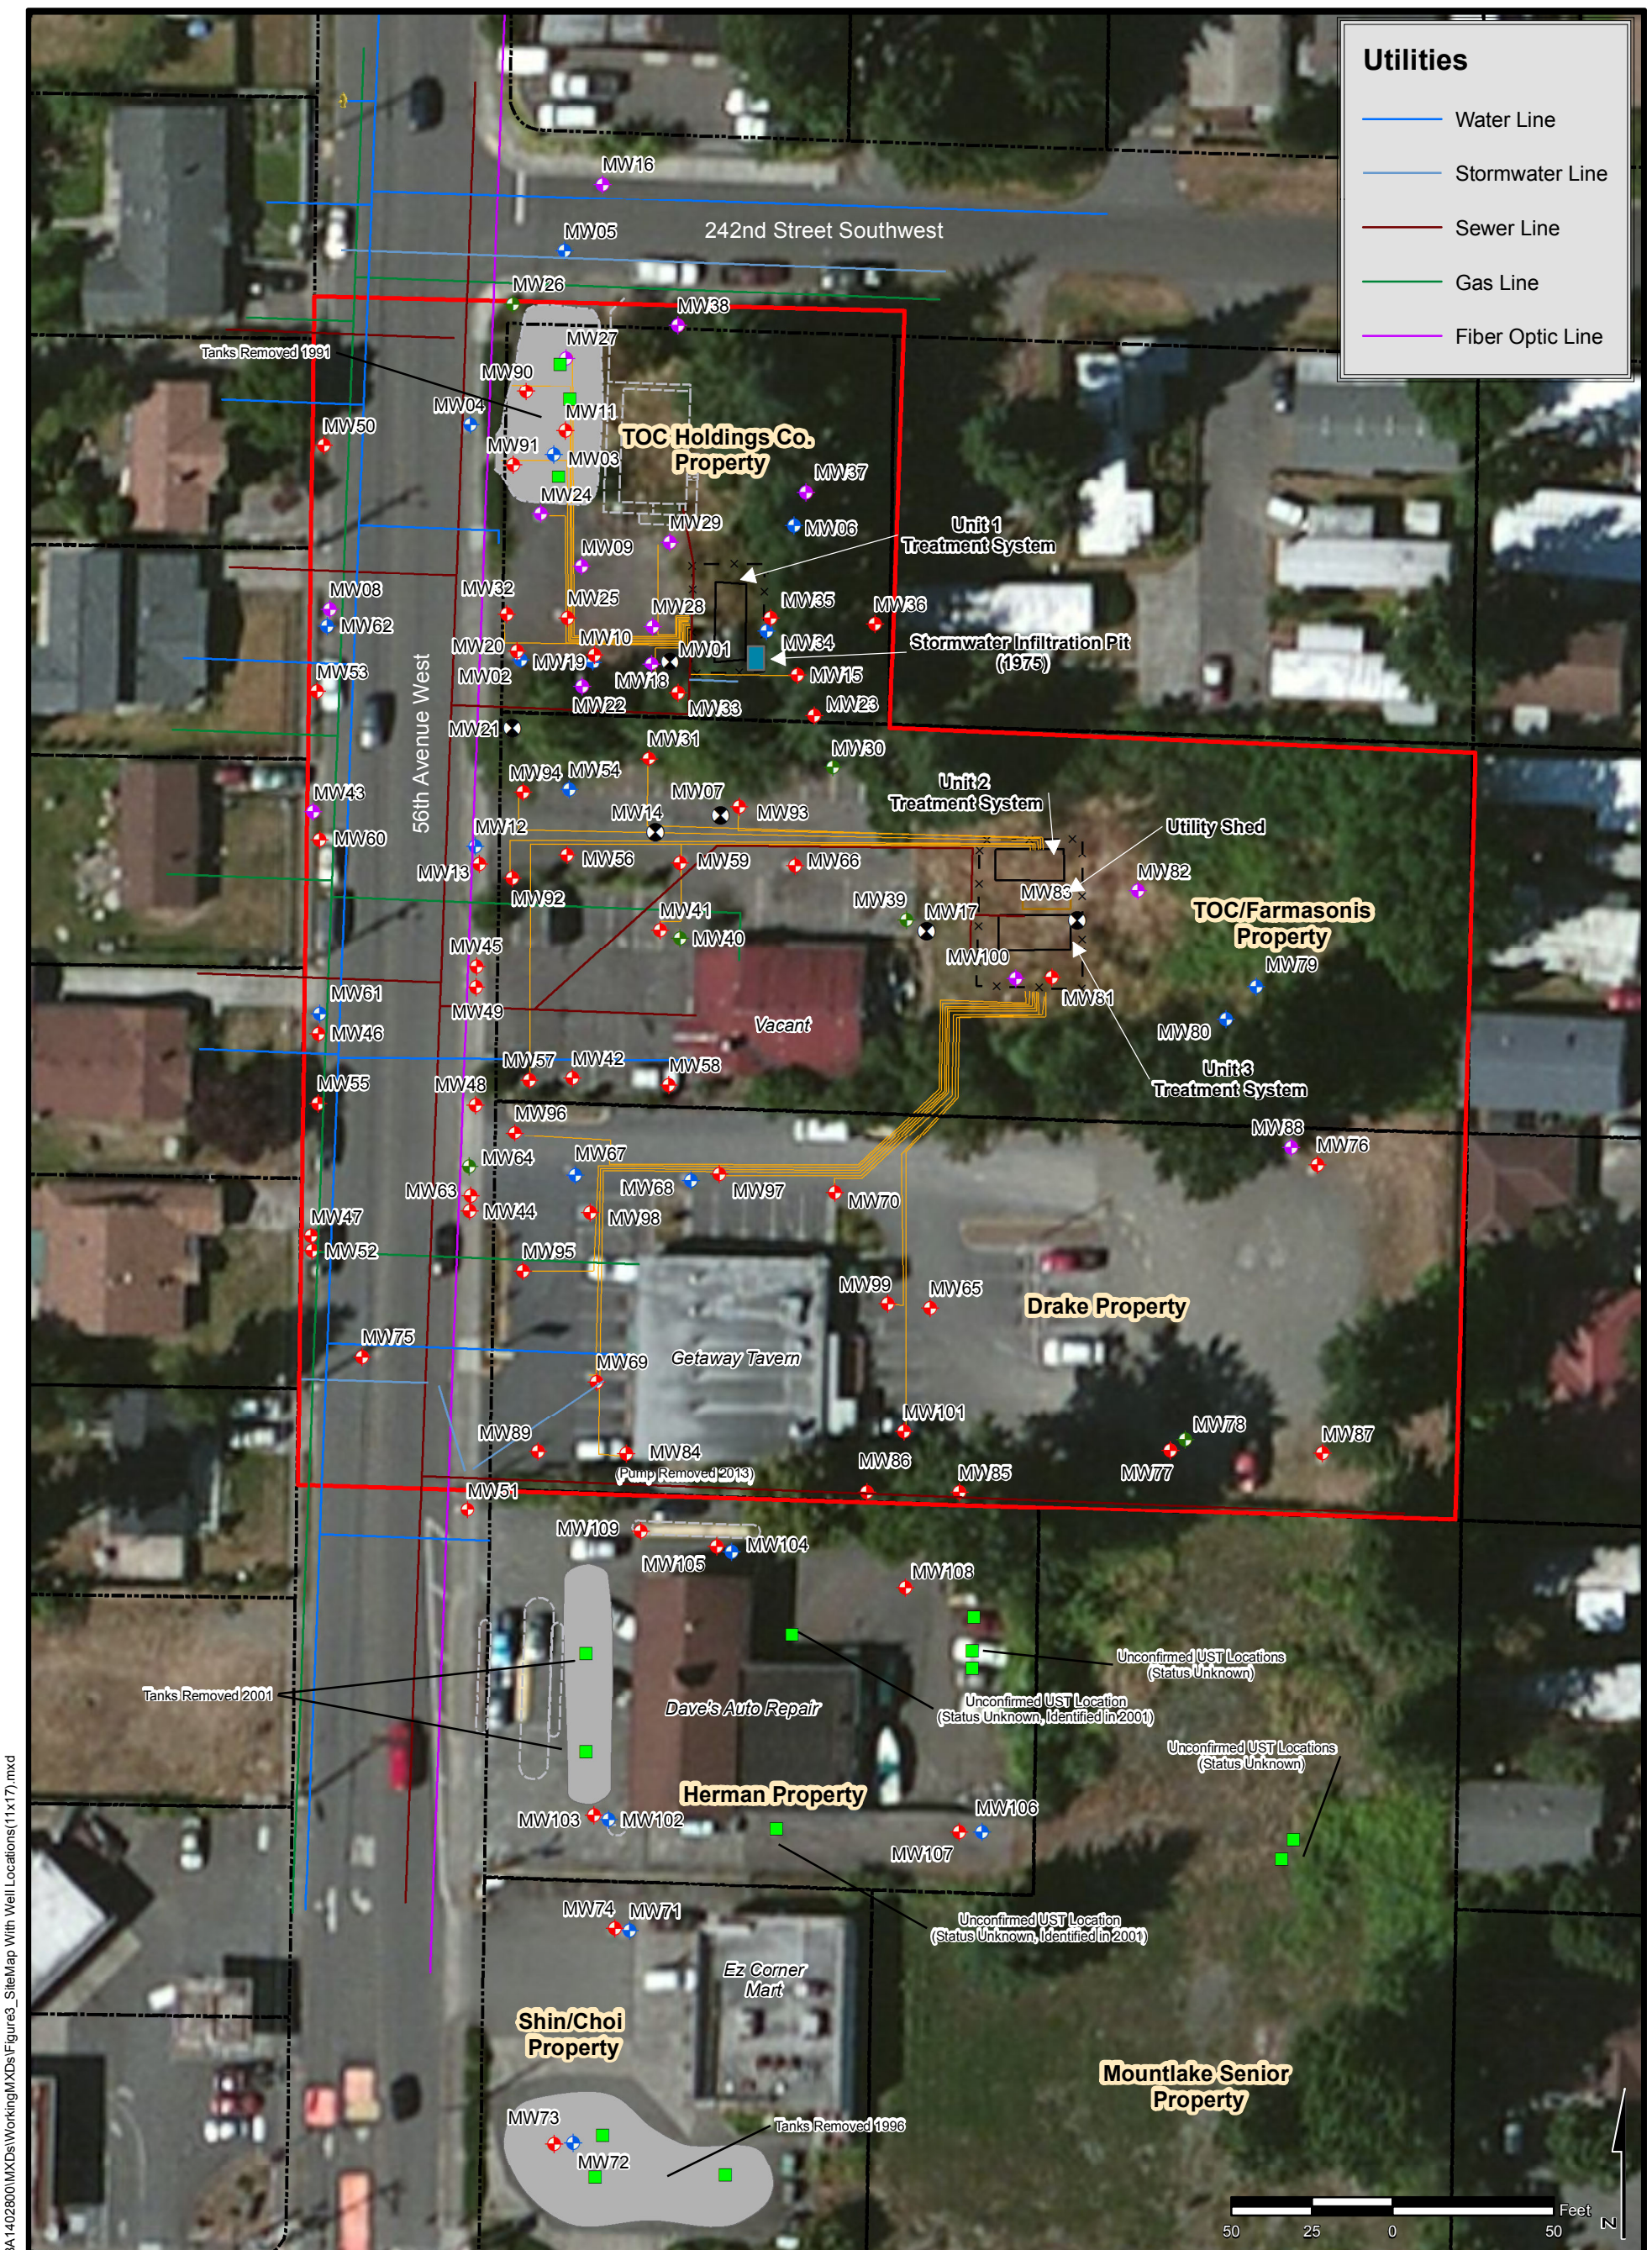
FIGURE A-1: LOCATIONS OF WELLS AND REMEDIATION SYSTEMS

O&M activities are conducted to monitor the performance of three multi-phase extraction (MPE) remediation systems currently operating at the IRPA. The MPE remediation systems were installed to remediate petroleum hydrocarbon-contaminated groundwater, soil vapor, and free product. Unit 1 is located on the TOC Property; Units 2 and 3 are located on the TOC/Farmasonis Property. Unit 1 is associated with the operation of remediation wells installed on the TOC Property; Units 2 and 3 are associated with the operation of wells installed on the TOC/Farmasonis and Drake Properties, respectively.

Details on remediation well identification and locations are provided in the description of remedial systems in Appendix A.
