SUBJECT: UNDERGROUND STORAGE TANK SITE ASSESSMENT AND REMEDIAL EXCAVATION REPORT
Bothell Mercantile Property
10201 Main Street
Bothell, Washington
Project Number: 0432-057-05

FIGURE 3
UST AND SOIL SAMPLE LOCATIONS

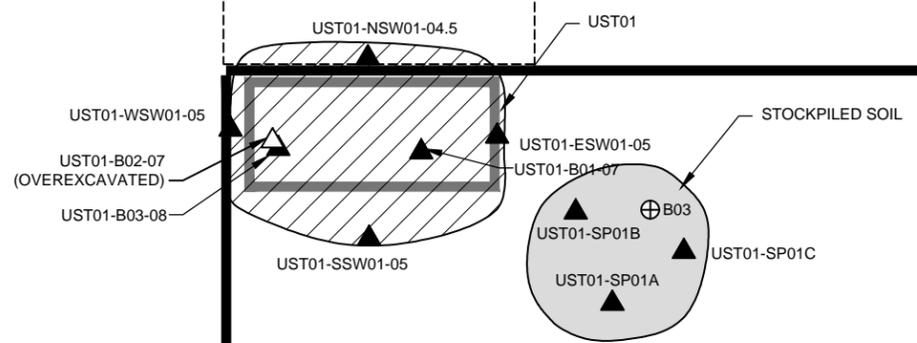
Soil samples were analyzed for GRPH, BTEX, DRPH and ORPH. None of the soil samples contained detectible concentrations of petroleum except for sample UST01-B02-07, which was collected from below the western end of the tank. Sample UST01-B02-07 contained an ethylbenzene concentration of 0.23 milligrams per kilogram (mg/kg), a GRPH concentration of 510 mg/kg, and a DRPH concentration of 1,800 mg/kg. The GRPH concentration exceeded the Washington State Model Toxics Control Act (MTCA) Method A Cleanup Level for Unrestricted Land Uses (the CUL), whereas the ethylbenzene and DRPH concentrations were less than their respective MTCA CULs. Sample UST01-B02-07 was subsequently

A summary of the soil analytical results are presented in Table 1 and illustrated on Figure 3. Copies of the UST site assessment laboratory analytical reports are included in Attachment D.

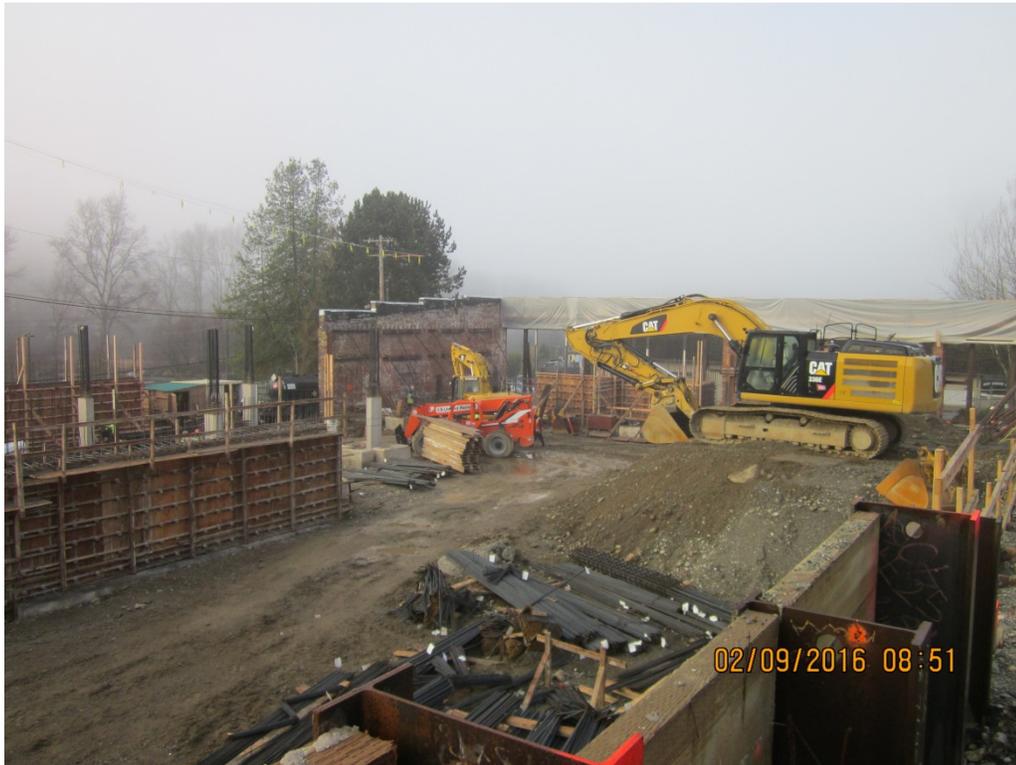
Photograph 1. Overview of the Property during redevelopment activities, looking southwest.

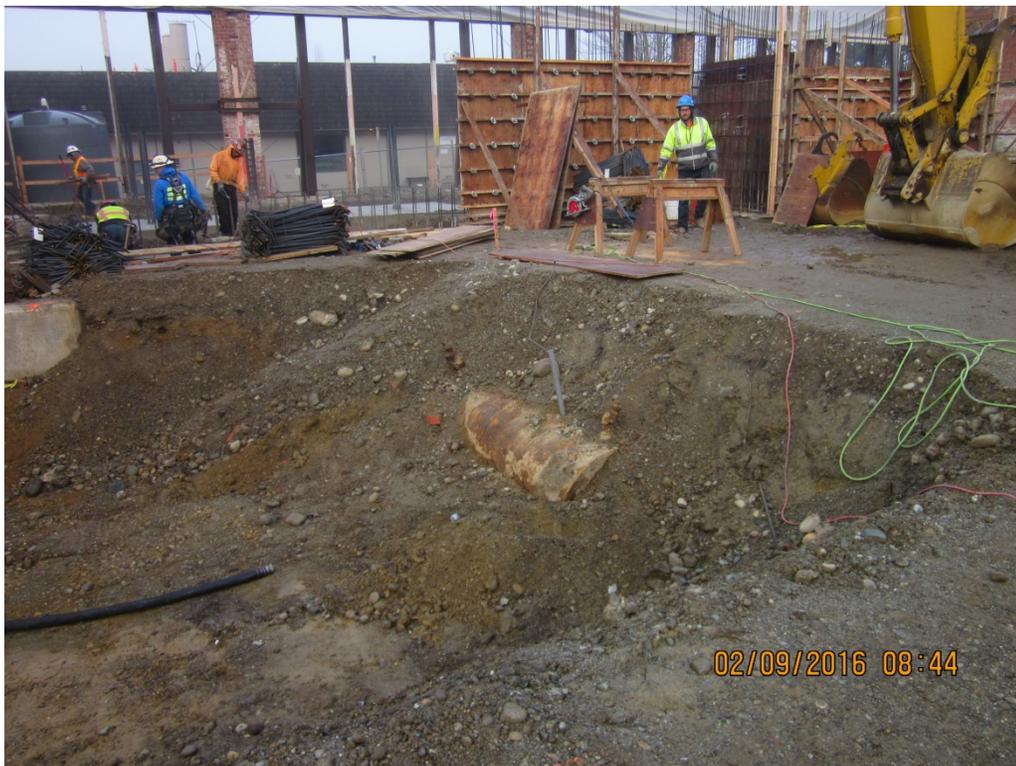
On February 1, 2016, Venture General Contracting, LLC discovered a UST in the southwest portion of the Property during redevelopment activities (Figure 2 and Photograph 2). The UST was located adjacent to the former historic gasoline engine that was identified as a REC. A SoundEarth UST Site Assessor (Attachment A) arrived at the Property on February 2, 2016 to document conditions and to collect a sample of the tank contents for chemical analysis. The single-steel walled UST was partially exposed, the top of which was situated approximately 2.5 feet below the existing grade, aligned in an east-west direction, and measured approximately 8 feet in length by approximately 42 inches in diameter. Based on the tank measurements SoundEarth estimated the tank to have a 550 gallon capacity.

No apparent product or vent lines were observed attached to or in the vicinity of the UST, nor were there any apparent petroleum stains adjacent to or surrounding the tank.

Photograph 2. Looking northwest at the UST prior to removal.

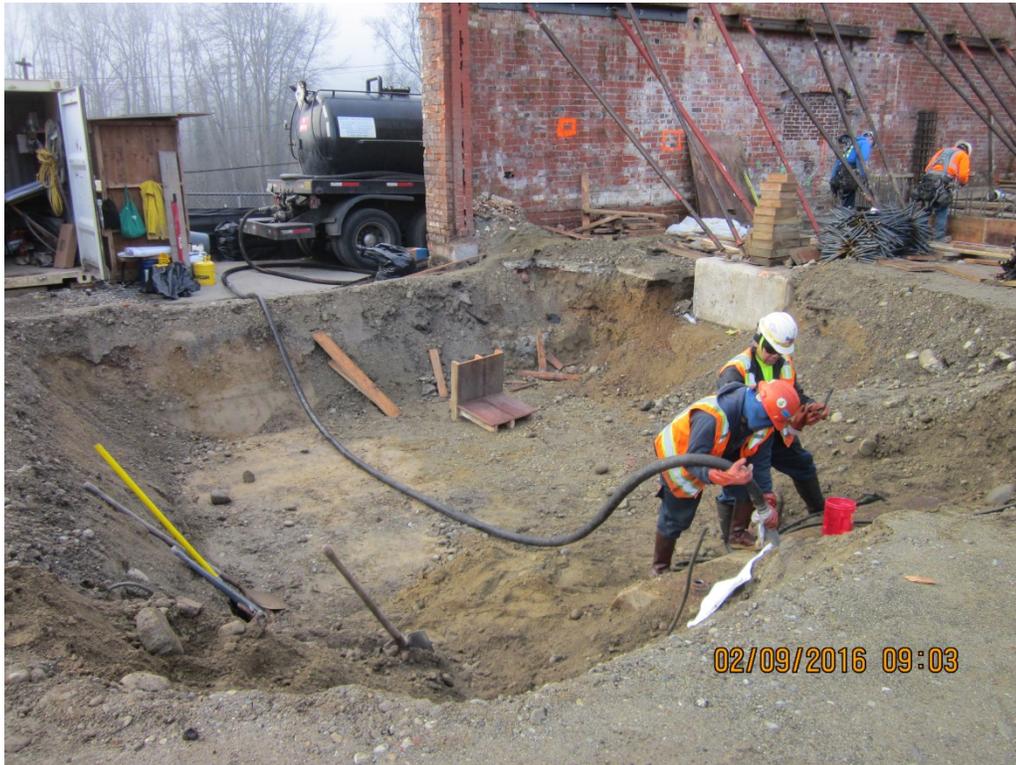
Photograph 3. MarVac triple rinsing the tank after removing the contents during decommissioning activities.

UST decommissioning field activities were performed on February 9, 2016. The UST contents were removed by Marine Vacuum Services, Inc. (MarVac) of Seattle, Washington after which MarVac triple-rinsed the tank. S3 proceeded to inert the tank with compressed carbon dioxide after the triple-rinse (Photographs 3 and 4). After receiving approval from the City of Bothell Fire and EMS inspector to remove the tank, the UST was removed by Elk Heights Excavation, LLC (Elk Heights). The UST was inspected by SoundEarth after removal and was found to contain one ½-inch diameter hole on the bottom of the tank (Photograph 5) and approximately 4 smaller sized holes on the bottom of the west end of the tank (Photograph 6). Except for the east end of the tank that was ruptured during removal, the endcaps and top of the tank were in good condition and were absent of visible holes or failed seams (Photograph 7). Upon completing the inspection the UST was loaded onto a flatbed trailer for off-Property disposal. Copies of the UST decommission documents and permit are provided in Attachment C.

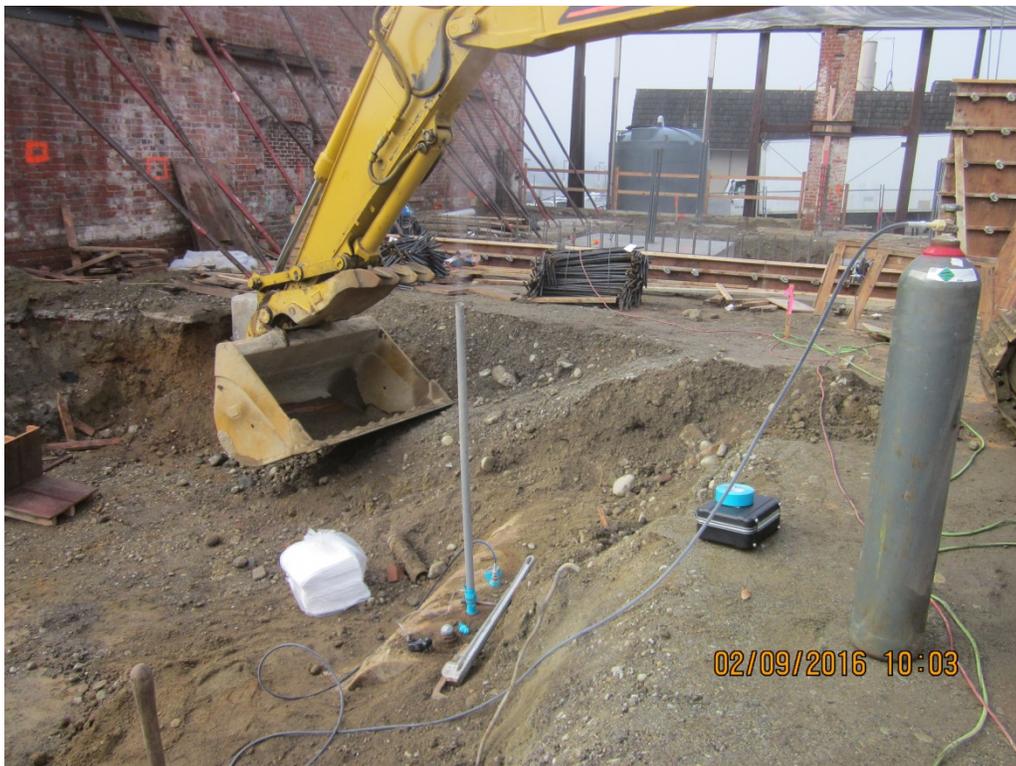
Photograph 4. S3 inerting the UST with carbon dioxide prior to removal.

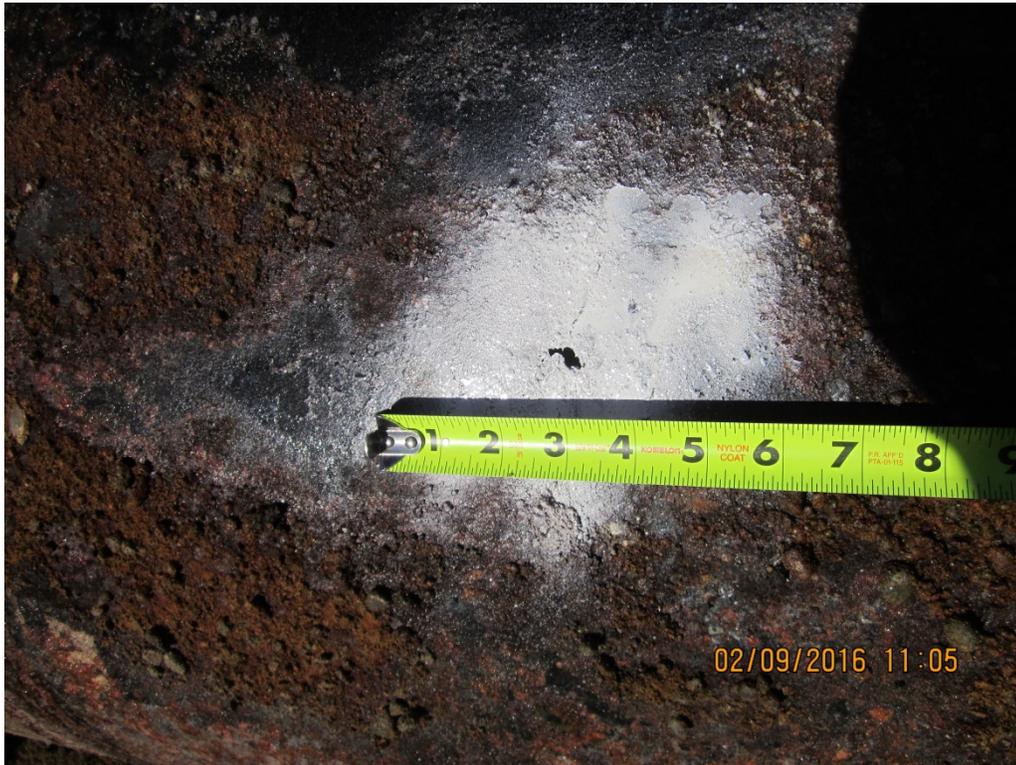
Photograph 5. Close-up view of the 1/2-inch diameter hole observed on the bottom midsection of the UST.

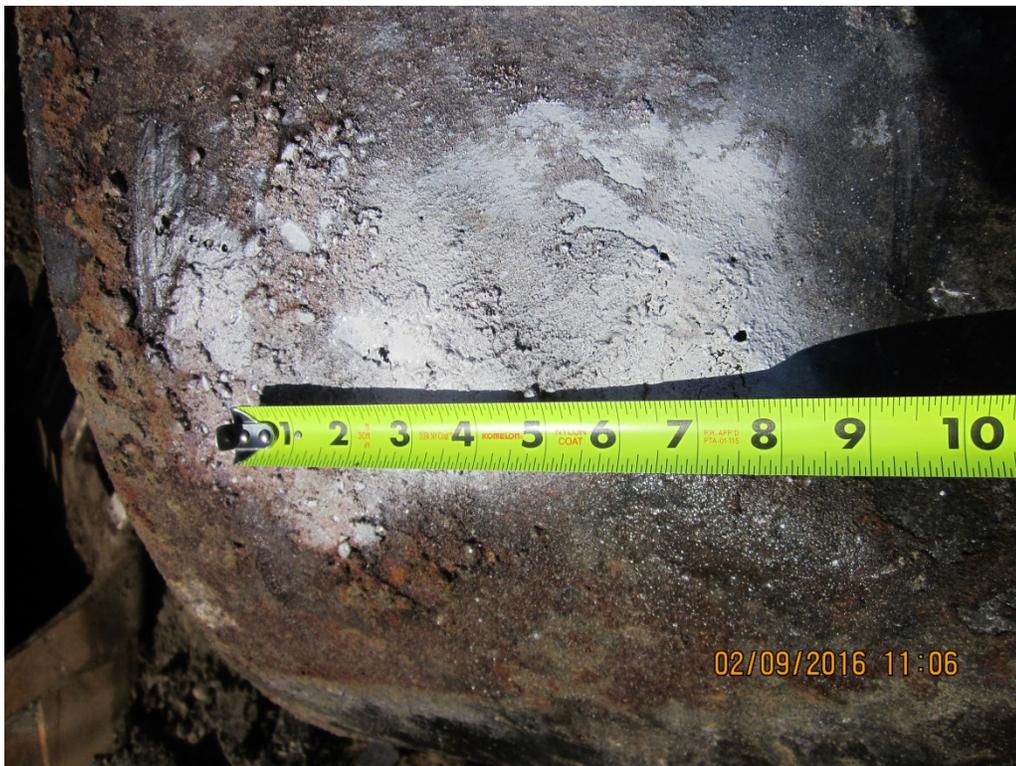
Photograph 6. View of several small holes highlighted with white paint located on the west end of the UST.

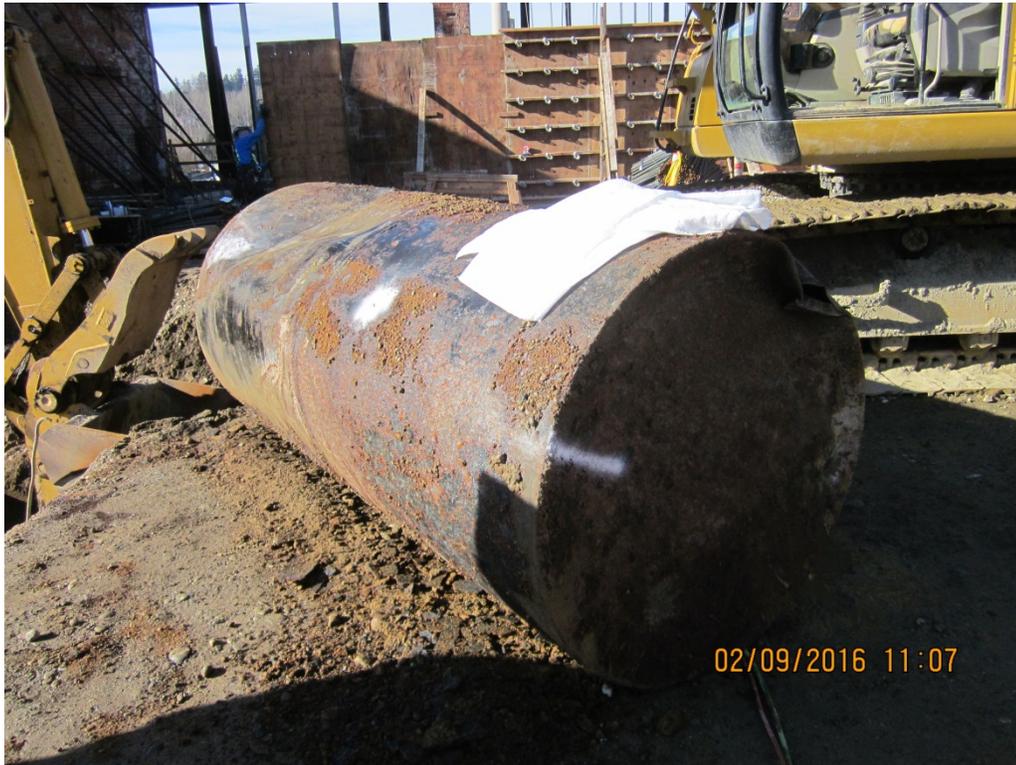
Photograph 7. Looking west at the UST during inspection immediately after its removal.

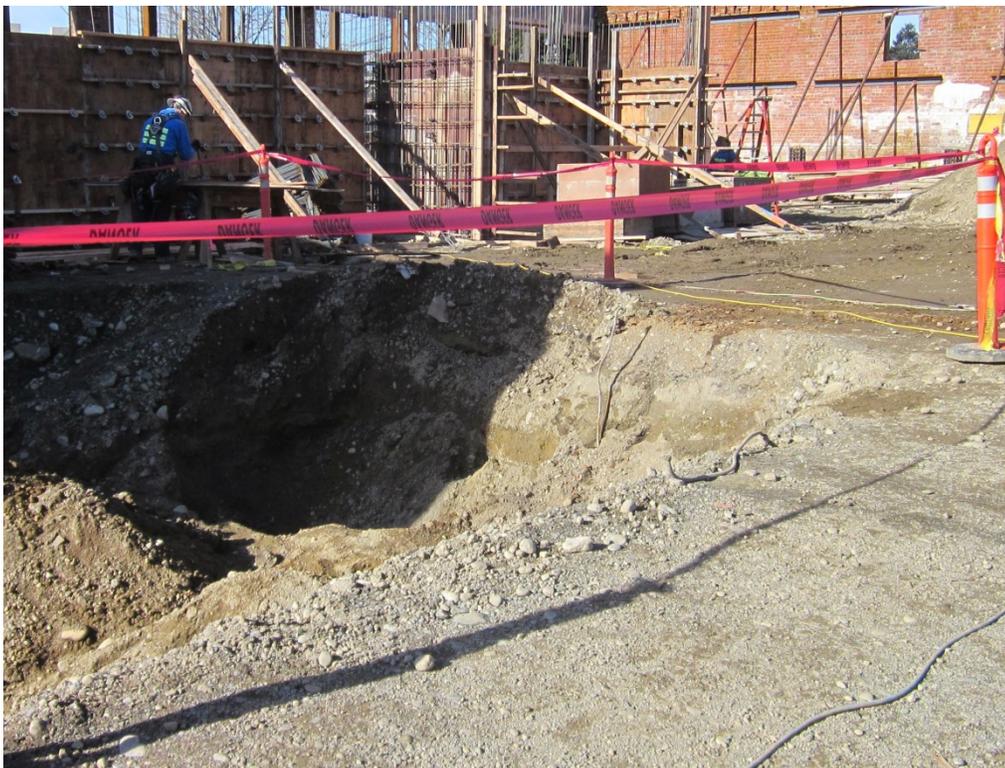
Soil conditions were assessed for petroleum contamination and discrete soil samples were collected from the excavation sidewalls, below the former tank location, and from the stockpiled soil. The UST excavation measured approximately 7 feet north to south, 9 feet east to west, by approximately 7 feet bgs (Photograph 8). Groundwater was not encountered during excavation activities.

Photograph 8. View of the UST cavity after the conclusion of site assessment activities, looking northwest.

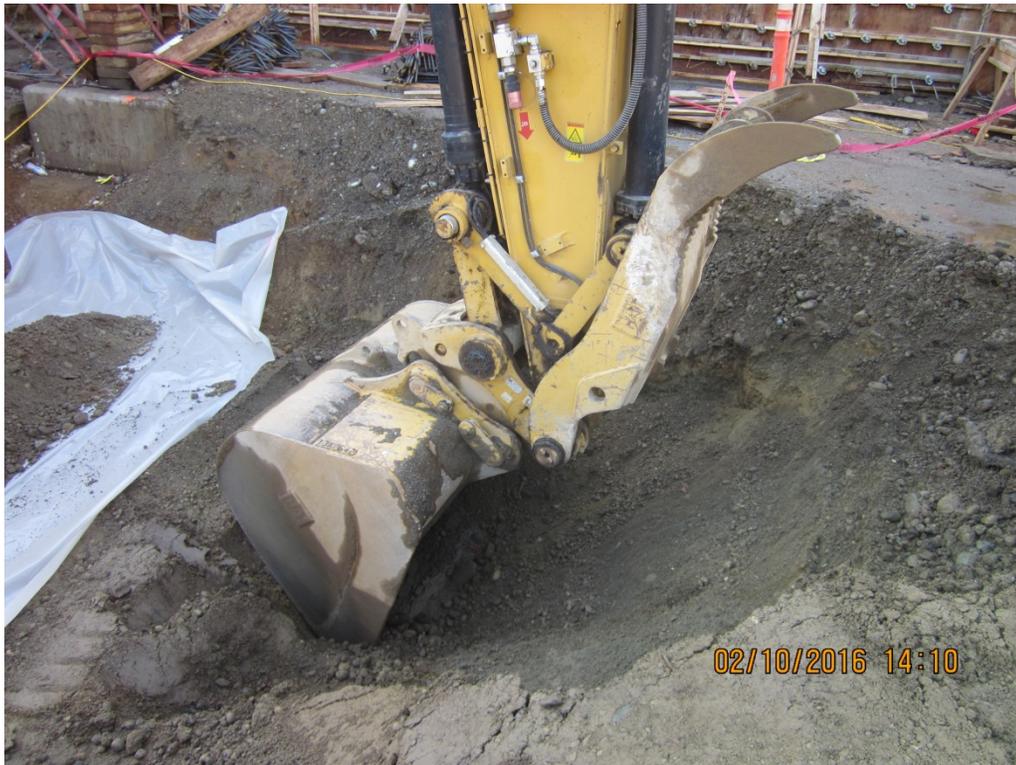
Photograph 9. Removing contaminated soil from below the former UST location, looking west.

SoundEarth returned to the Property on February 10, 2016 to observe the excavation of petroleum contaminated soil (PCS) that was identified below the former UST. Clean overburden soil immediately surrounding the excavation cavity was removed to safely gain access to the PCS. Approximately one foot of PCS in the vicinity of sample UST01-B02-07 was over excavated down to approximately 8 feet bgs (Photograph 9)... PCS was not observed at 8 feet bgs. To verify that the soil conditions at the extent of the excavation comply with the MTCA CULs, confirmation soil sample UST01-B03-08 was collected below sample UST01-B02-07. Soil sample UST01-B03-08 was analyzed for GRPH, BTEX, DRPH, ORPH and cadmium. The sample did not contain detections of chemicals above the laboratory reporting limits. A copy of the analytical report is included in Attachment D.

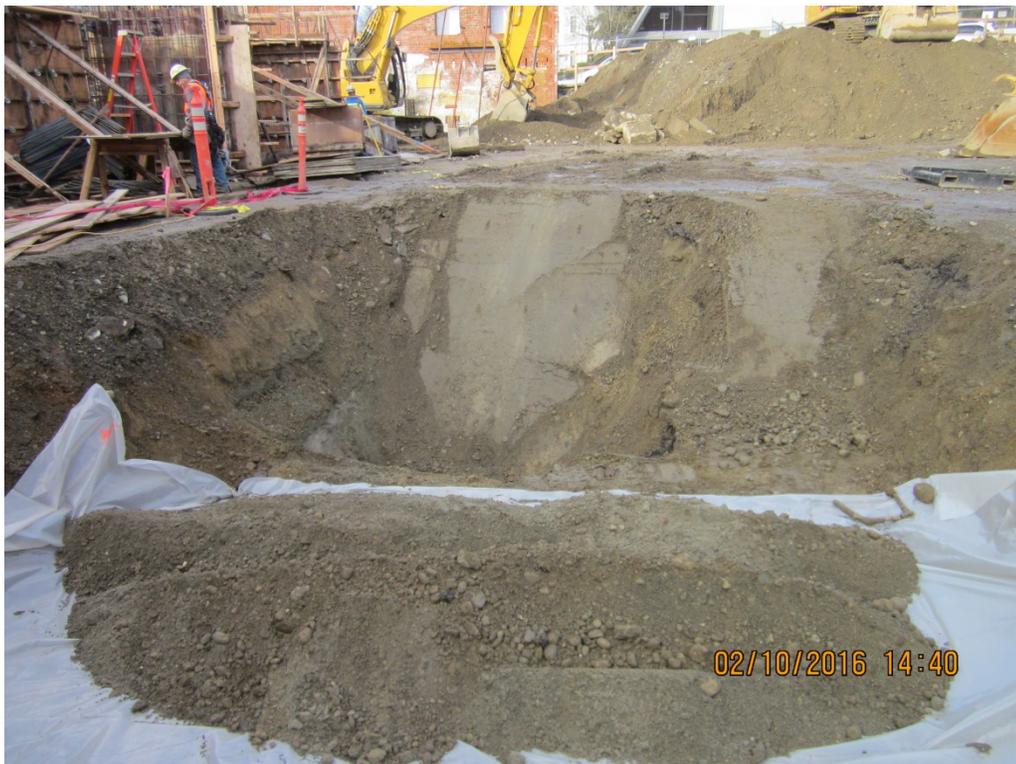
The remedial excavation measured approximately 5 feet north to south by approximately 8 feet east to west. The total depth of the excavation relative to the former grade prior to redevelopment activities measured approximately 8 feet bgs. Excavated PCS was temporarily staged on plastic immediately south of the remedial excavation pending off-Property transport and disposal (Photograph 10). No groundwater was encountered during excavation activities.

Photograph 10. Looking north at the excavation at the conclusion of removal activities with the stockpiled PCS in the foreground.
