TACOMA HOUSING AUTHORITY
BAY TERRACE II DEVELOPMENT
25TH & COURT G
TACOMA, WASHINGTON
INDEPENDENT REMEDIAL ACTION REPORT
APRIL 5, 2016

Tacoma Housing Authority
Bay Terrace Phase II Development
25th & Court G, Tacoma, WA
Independent Remedial Action Report
April 5, 2016

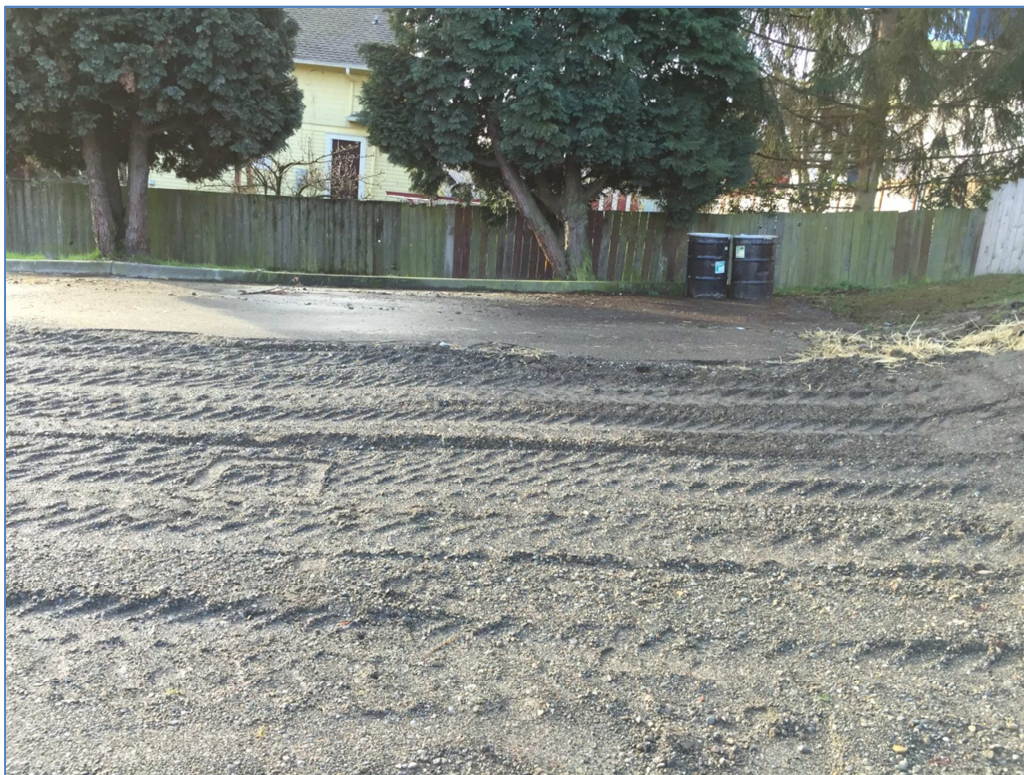
The area of the excavation backfilled prior to the start of drilling

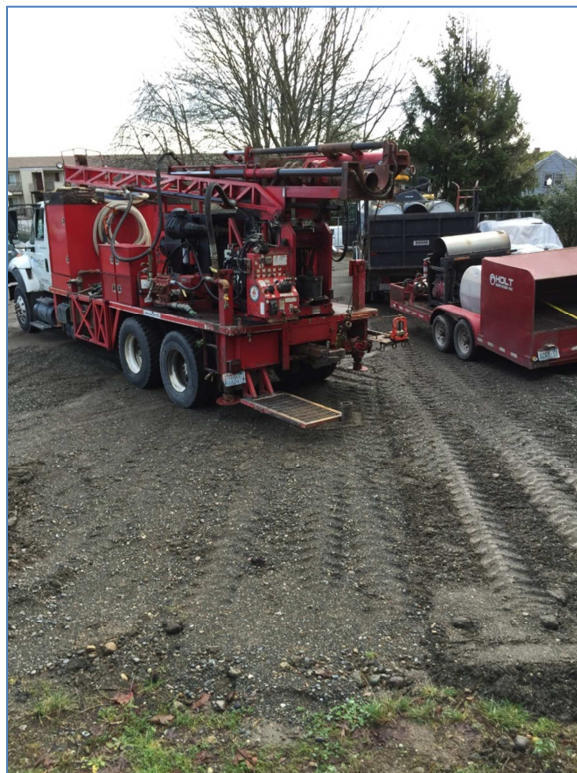
The drilling rig towering up into position over the well site

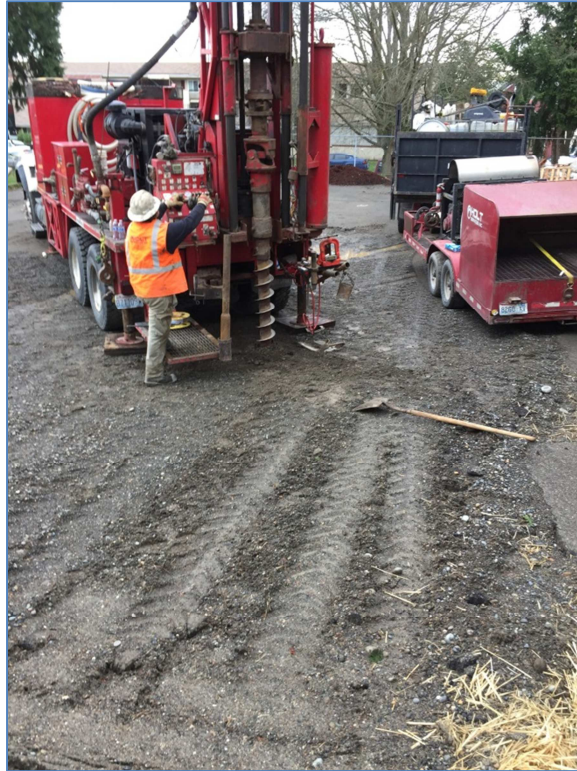
Drilling of the well

The monitoring well, BT2, was drilled to a total depth of 35 feet below ground surface using hollow-stem auger methods. Drilling encountered 17 feet of fill followed by 13 feet of silty sand with gravel and 5 feet of silty sand. Groundwater was encountered at a depth of approximately 22 feet below ground surface. The well was constructed with 15 feet of 2-inch diameter PVC well screen and approximately 20 feet of 2-inch diameter blank PVC riser. Colorado silica sand pack was placed around the screened interval. Figure 4, attached in Appendix A, shows the geology and construction details of the well.

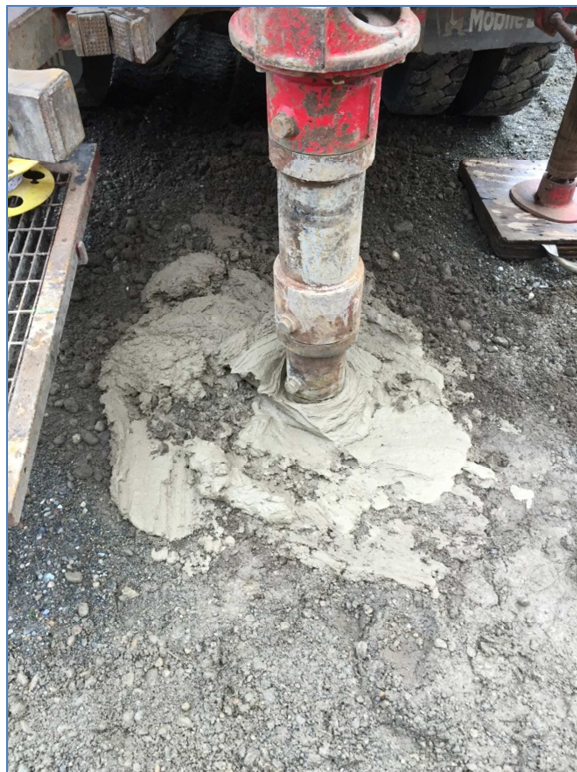
The final depth of 35 feet achieved.

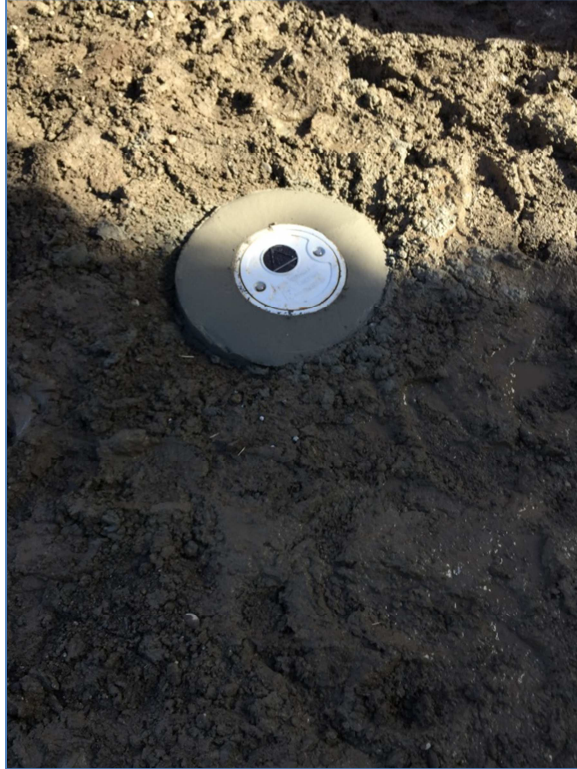
The completed wellhead of BT-2

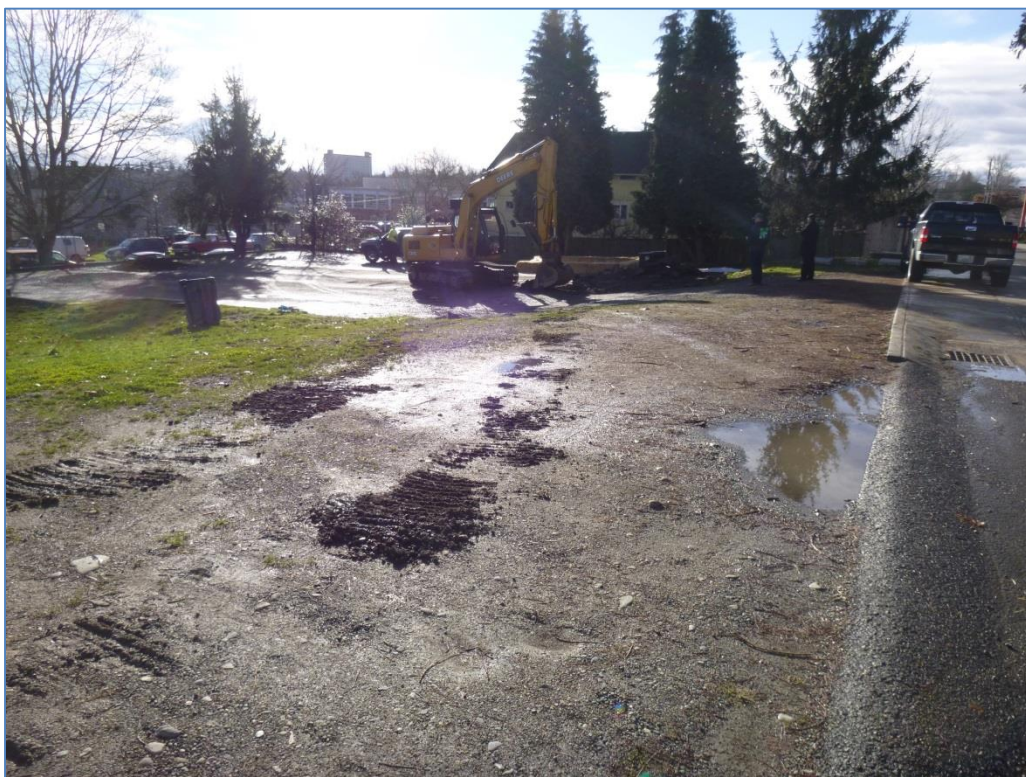
View of the site prior to the start of excavation

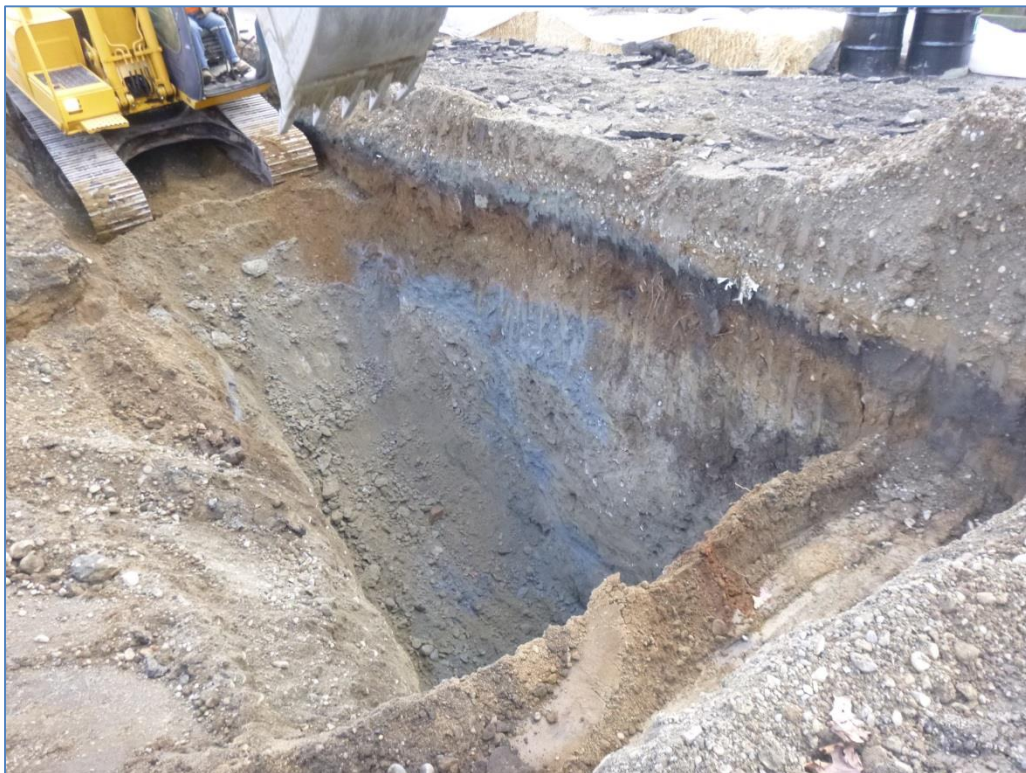
Soil vapor and petroleum staining were encountered from approximately 6 feet below ground down to 16 feet below ground immediately below the location of B6. Further south, vapors and staining were encountered at shallower depths from approximately 4 feet below ground down to 11 feet below ground. Contaminated soils were stockpiled on site in a contained area using hay bales and Visqueen plastic sheeting. Overnight, the contaminated stockpile was covered with Visqueen to prevent wetting. Samples were collected as the excavated soil was placed in the contained area. We collected six contaminated stockpile samples (SP1, SP2, SP3, SP4, SP5, and SP6). Table 1, below, summarizes the analytical results from the stockpile samples.

Gray-stained petroleum contamination encountered below the site

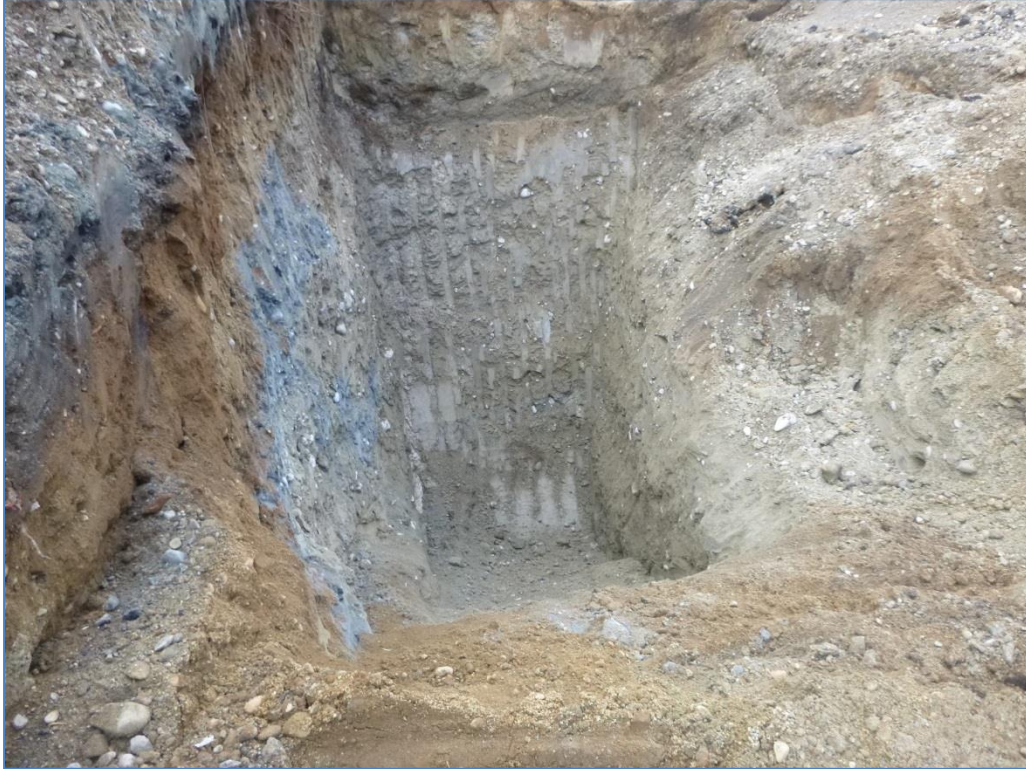
Pit bottom at 17 feet below ground

Following excavation of the visually-impacted and vapor-impacted soils, we collected confirmation samples from the pit bottom and sidewalls of the excavation to ensure all impacted soil had been removed. Three samples were collected from the pit bottom (PB-17', PB2-9', and PB3-11'), and one sample each was collected from the four sidewalls (WW-9', EW-9', NW-10', and SW-10'). Table 2, displays the results of the confirmation samples. Figure 2, attached, shows the location of the samples collected.

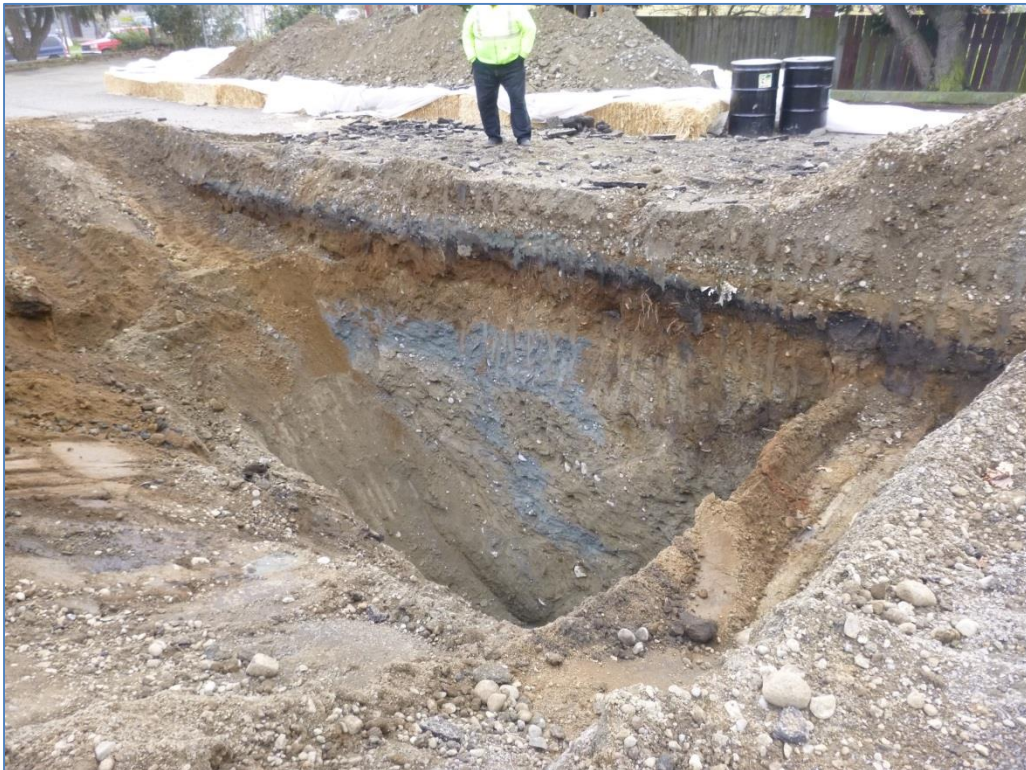
Gray-stained soils on the south wall

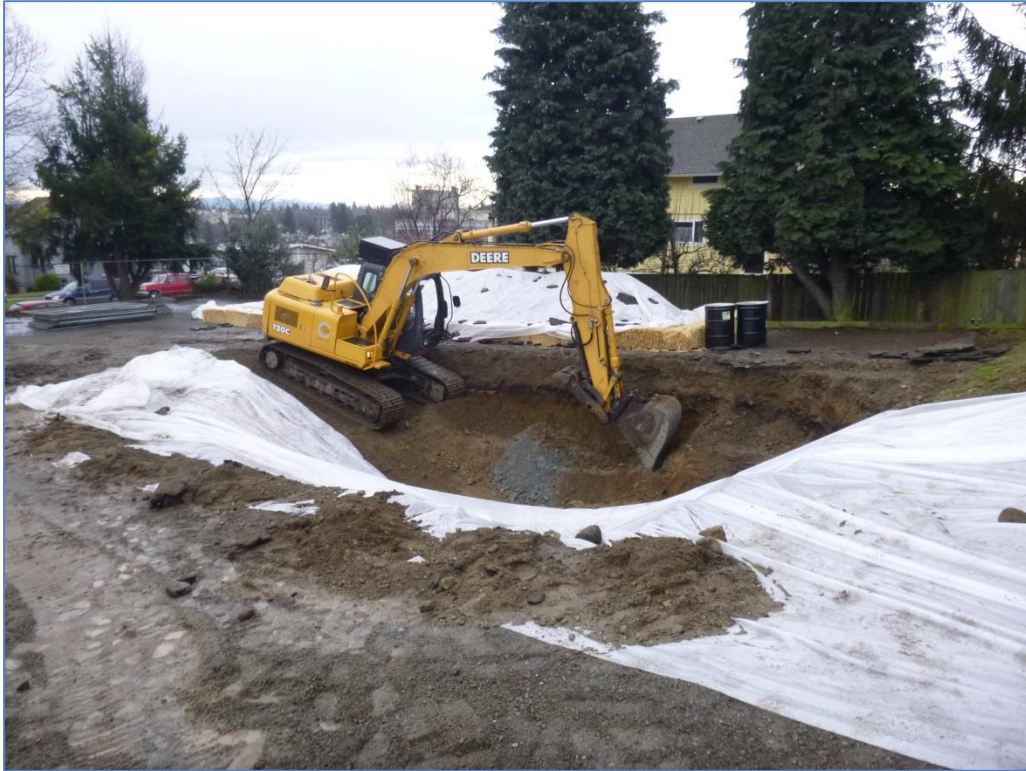
Excavation of the south wall

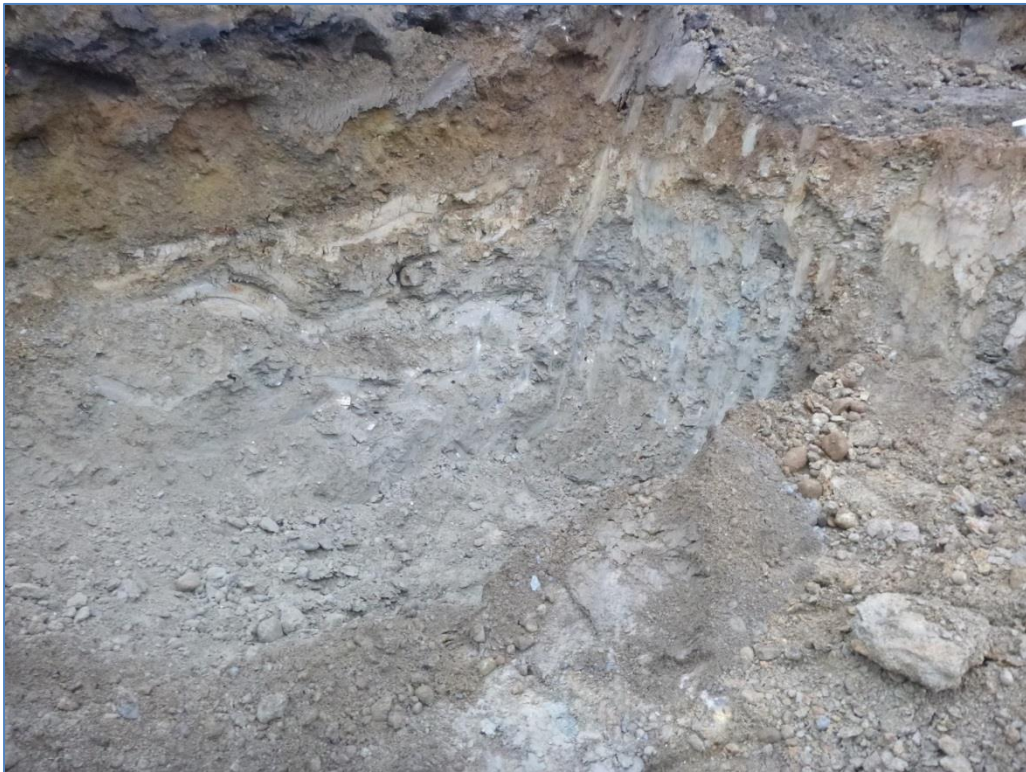
Clean south wall of the excavation

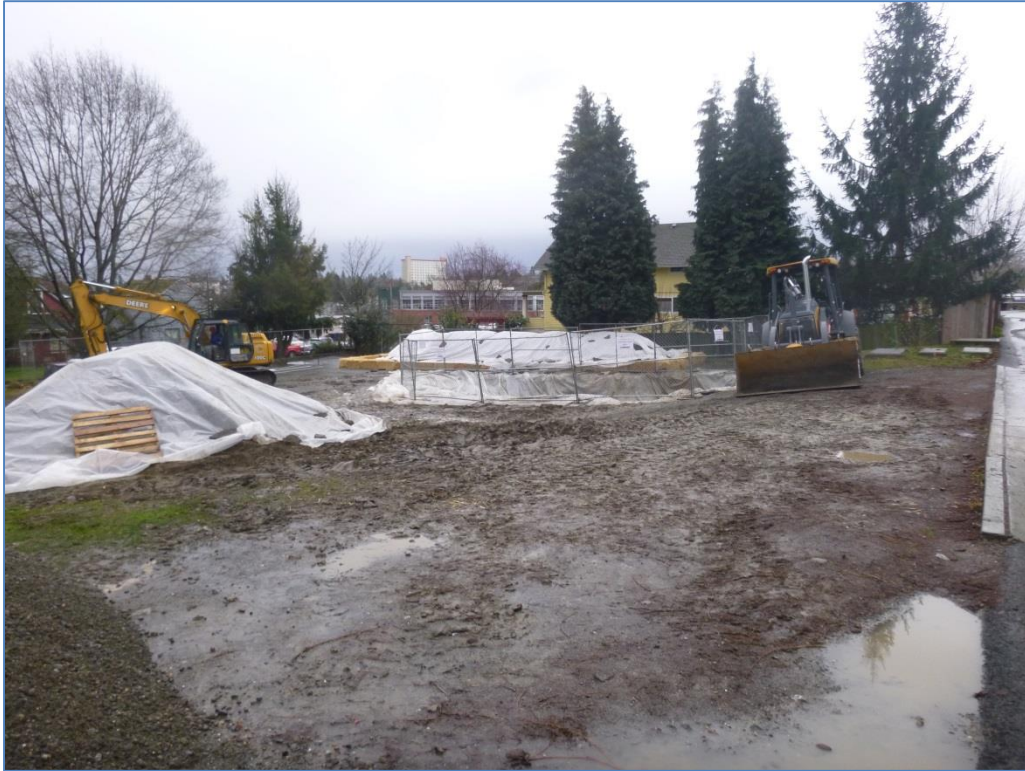
The pit fenced off overnight

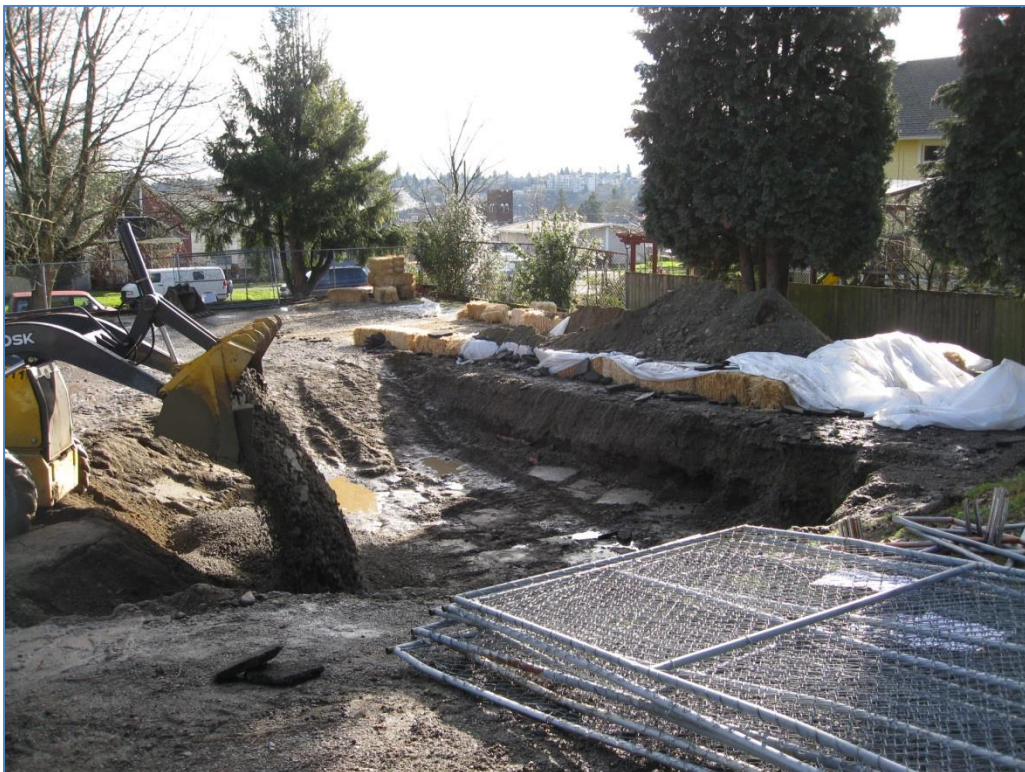
Backfilling and compaction of the pit

Following confirmation of the clean sidewalls and pit bottom, the hole was backfilled with the clean overburden stockpile alternated with pit-run sand and gravel from the Miles Sand & Gravel Fennel Pit. The backfilling was completed in shallow lifts, and the soils were compacted with vibratory plate compactor. Robinson Noble personnel were on site to confirm compaction testing of the materials. The backfill and compaction activities are summarized in the geotechnical field report (Attached in Appendix C).
