**Cleanup Action and Site Restoration
Completion Report**

Irondale Iron and Steel Plant
Irondale, Washington

for
Washington State Department of Ecology

November 4, 2015

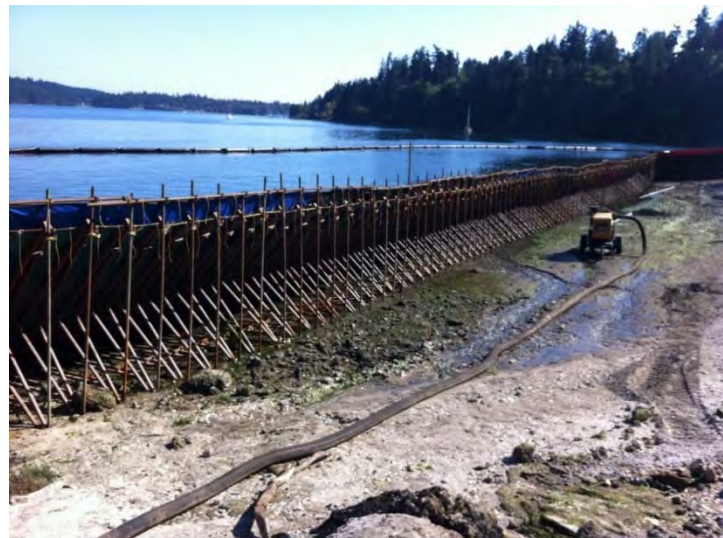
Portadam installed to complete nearshore sediment excavation

The remediation contractor's (AEC) original shoring design, as outlined in their July 20, 2012 Excavation and Disposal Plan, for the removal of near-shore sediments called for the installation of sheet pile walls. AEC attempted to install 36 lineal feet of sheet piles on August 29 and August 30, 2012. These attempts were met with refusal; an impenetrable object was apparently encountered at depths of 8 to 10 feet below the mudline. Ecology approved the use of a Portadam shoring system on September 4, 2012. This alternate shoring design is outlined in AEC's September 5, 2012 Excavation and Disposal Plan (AEC 2012a). The Corps approved the use of a Portadam on September 5, 2012. WDFW had previously approved the use of a Portadam on August 15, 2012.

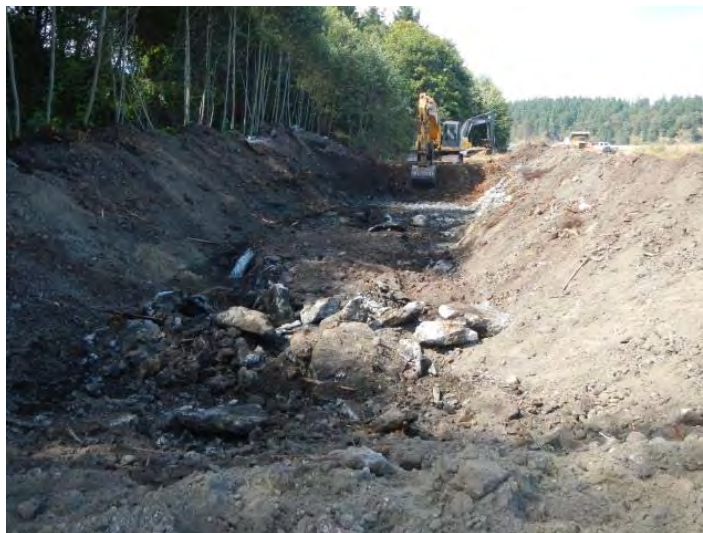
Infiltration ditch

AEC excavated a temporary infiltration ditch on the west side of the gravel access road that runs parallel to the shoreline, between the access road and the bluff. The ditch was completed to dispose of water collected during dewatering activities. This ditch was completed on August 28 and 29, 2012 and was consistent with AEC's August 22, 2012 Dewatering Plan and Stormwater Pollution Prevention Plan (SWPPP; AEC 2012b and c). Chemical analytical results for water samples obtained from the dewatering system are presented in Table 2.

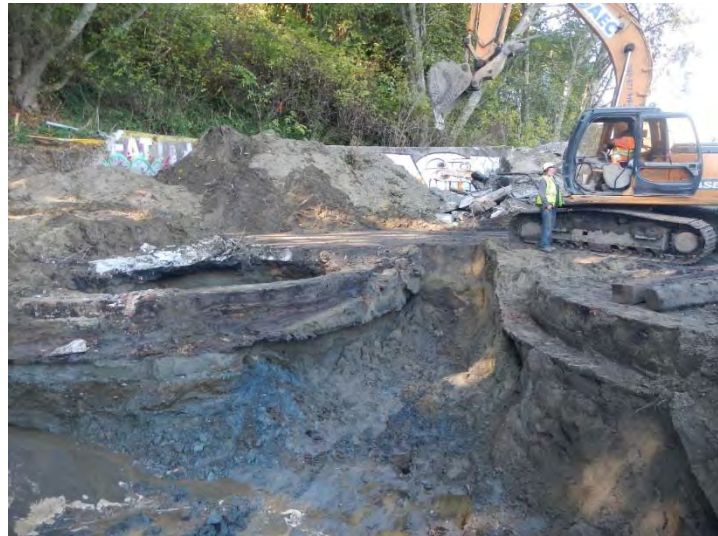
TPH Area excavation. From left to right showing second and first rows of kilns
(Photo courtesy of SWCA Environmental Consultants)

In accordance with the EDR (GeoEngineers 2012a), remedial excavation activities were completed laterally and vertically to the preliminary excavation limits, which were established by visual and field screening soil and sediment from the excavation sidewalls and base. Once the preliminary limits were reached, verification soil and sediment samples were collected from the excavation sidewalls and base for laboratory chemical analyses. The soil and sediment verification samples were generally collected at depths ranging from 2 to 11 feet below ground surface or below mudline. Excavation activities continued, as necessary, until chemical analytical results of verification soil and sediment samples indicated that contaminant concentrations were less than site-specific soil and sediment cleanup levels.

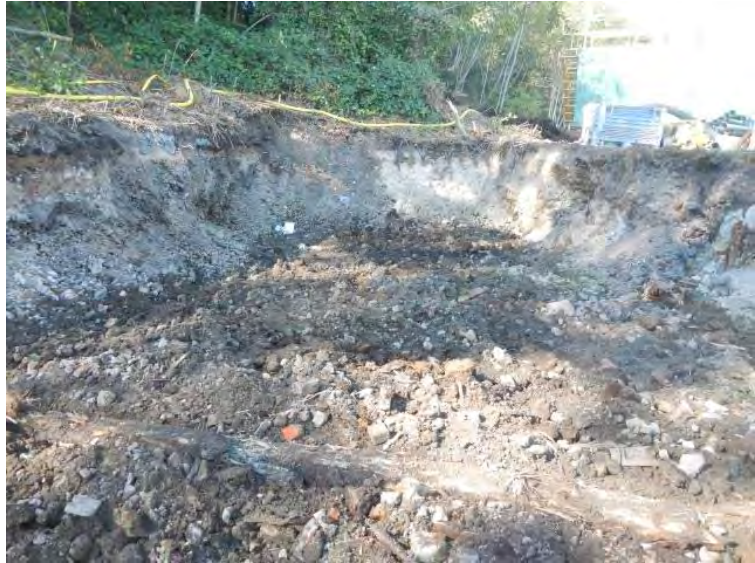
Northwest extent of Metals Area excavation (see Figure 7)

In accordance with the EDR (GeoEngineers 2012a), remedial excavation activities in the metals excavation area were completed to the lateral and vertical limits presented in Sheets C1.0 through C1. Five of the Remedial Design Drawings (Appendix E of the EDR). Once the preliminary limits were reached, verification soil samples were collected from the excavation sidewalls and base for laboratory chemical analyses. Excavation activities continued, as necessary, until chemical analytical results of verification soil samples indicated that contaminant concentrations were less than site-specific soil cleanup levels or if the depth

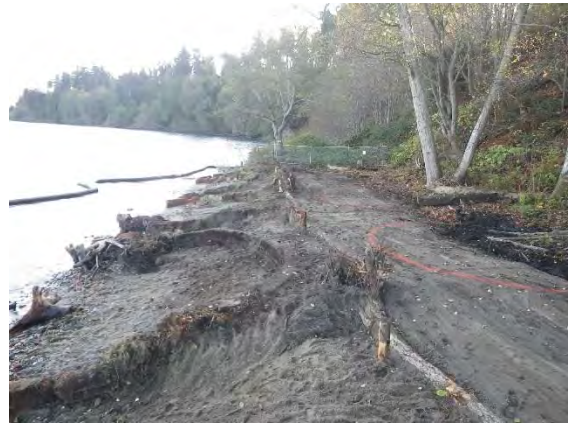
Large wood debris between two rows of kilns (photo courtesy of SWCA Environmental Consultants)

Changes to the proposed beach grading were made at the southern end of Site after the second, western, row of charcoal kiln foundations was located. The revised plan was implemented to protect the second row of kilns and included centering the row of large woody debris (LWD) between the two rows of kilns and adjusting the beach grade by adding beach material below the LWD and topsoil above the LWD.

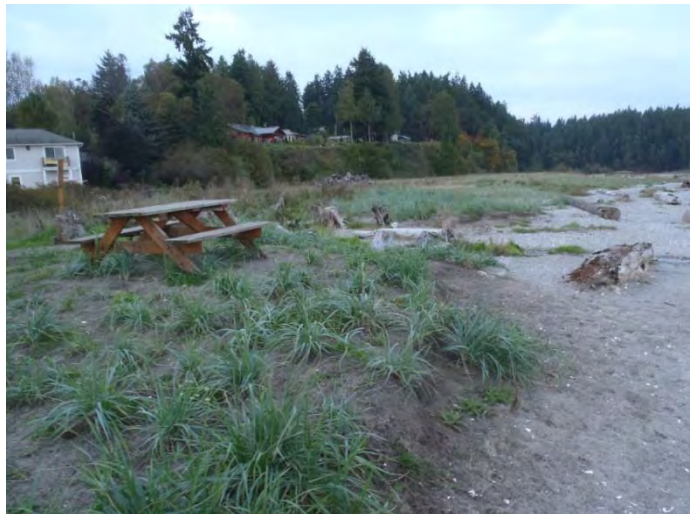
Dune grass plantings along restored shoreline. Additional habitat restoration photos in Appendix I.

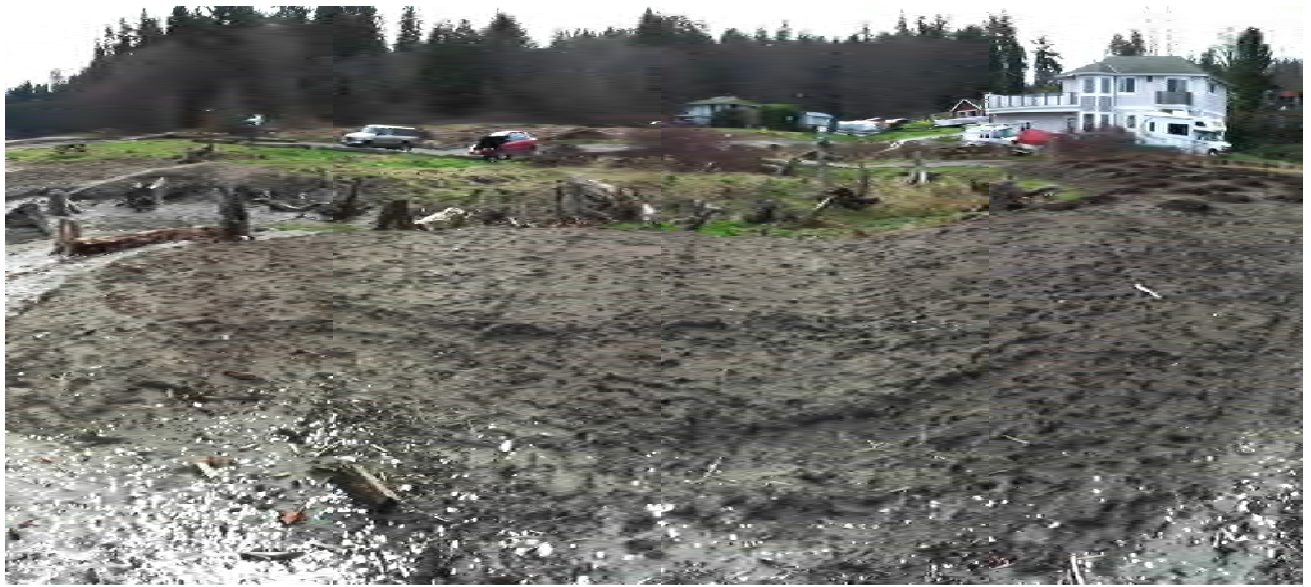
Figure A-2

Photograph 9
Restored portion of the northern drainage swale
viewed from the north.
