CULTURAL RESOURCES ASSESSMENT
FOR THE
IRONDALE IRON AND STEEL PLANT (45JE358) HISTORIC
DISTRICT (DT128) REMEDIATION AND RESTORATION PROJECT
JEFFERSON COUNTY, WASHINGTON

Report Number 21578

Northwest Archaeological Associates / SWCA
5418 - 20th Avenue NW, Suite 200
Seattle, Washington 98107

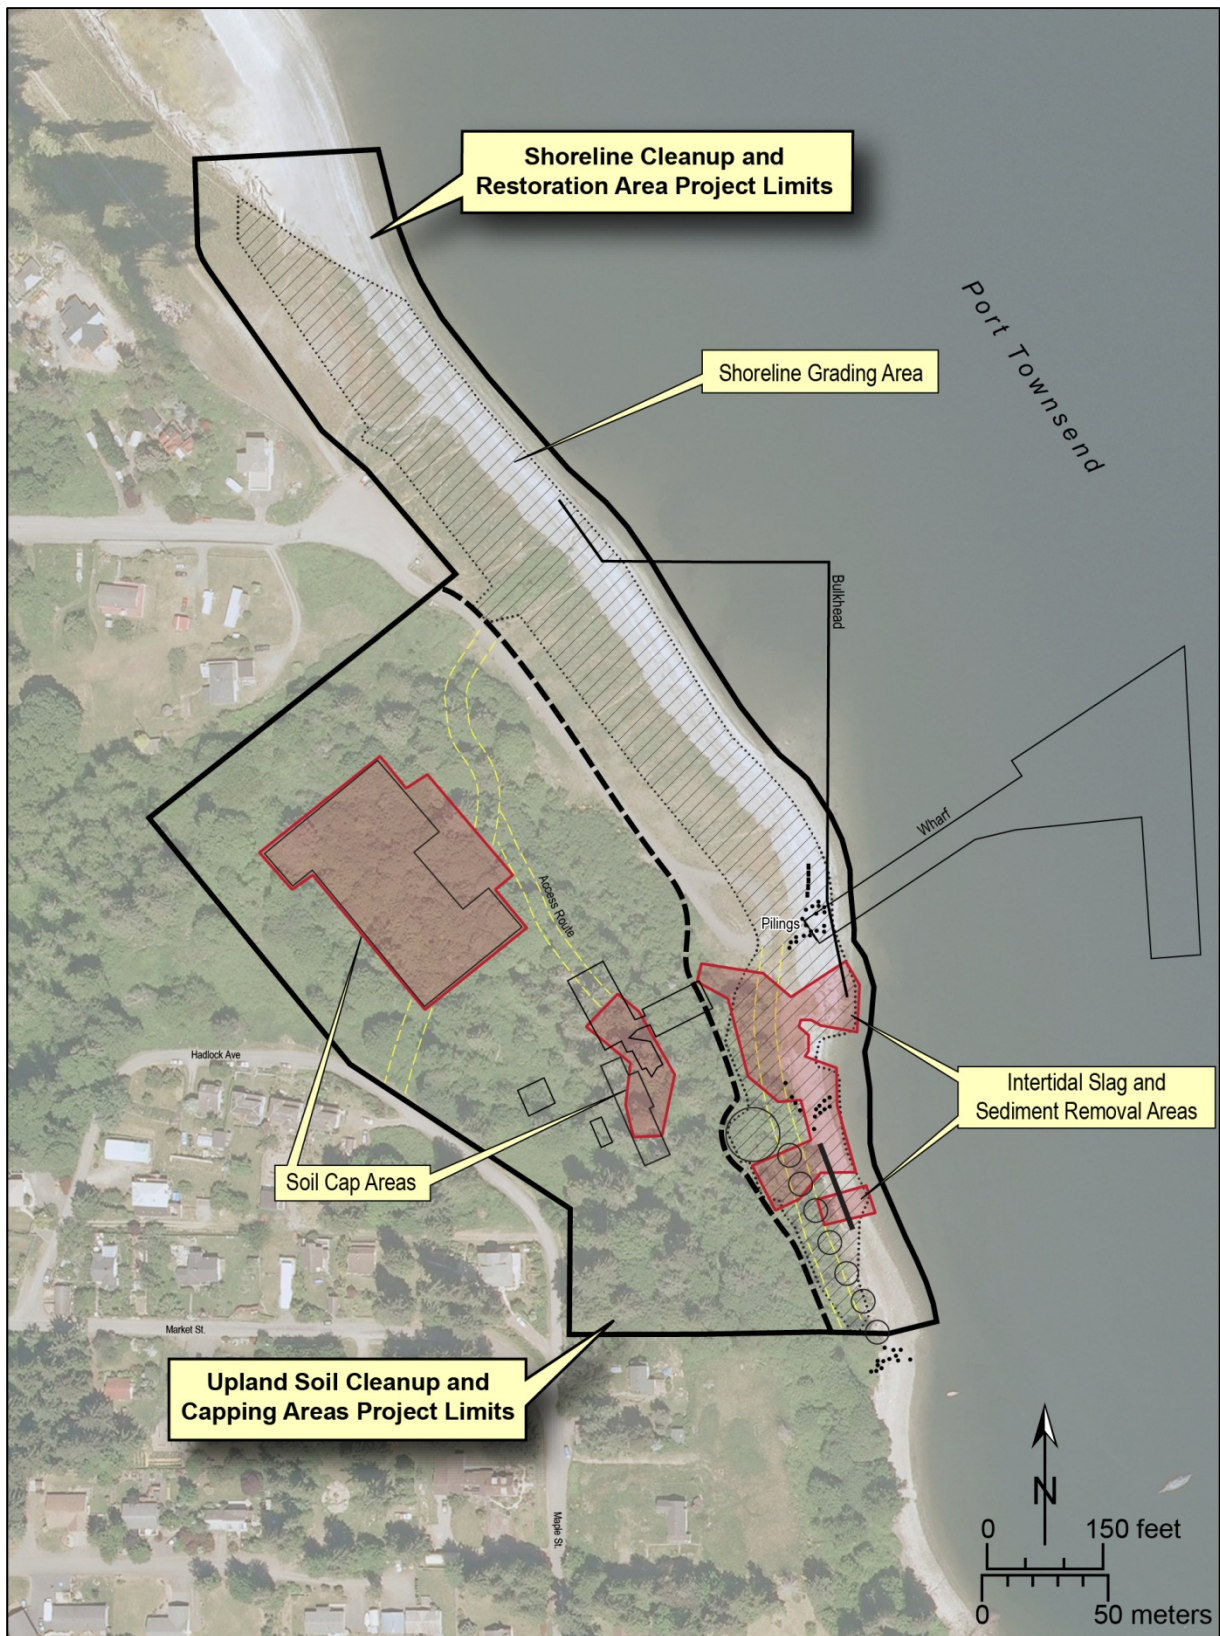
Figure 2. Irondale Iron and Steel Plant Historic District project area.

Geotechnical testing carried out for the Irondale cleanup project shows that the average depth of the fill in the bench area is seven feet (Morton et al. 2009). Removal of fill by grading will take place north of the sediment remediation and slag removal areas (Figure 2). Shoreline grading will remove some fill material and blend the Irondale beach into the completed WDFW project to join the restoration project areas and even out the shoreline slope. It is not expected to expose native sediments, nor encounter pre-contact cultural deposits.

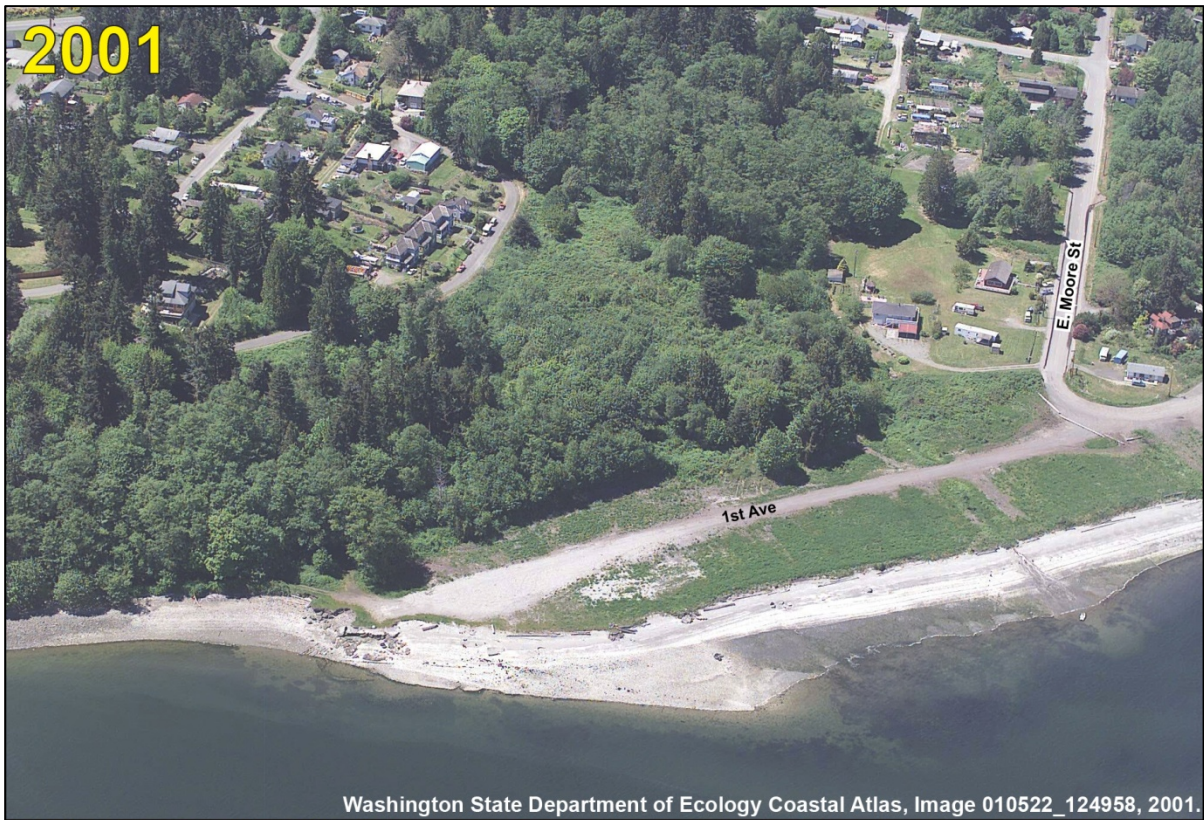
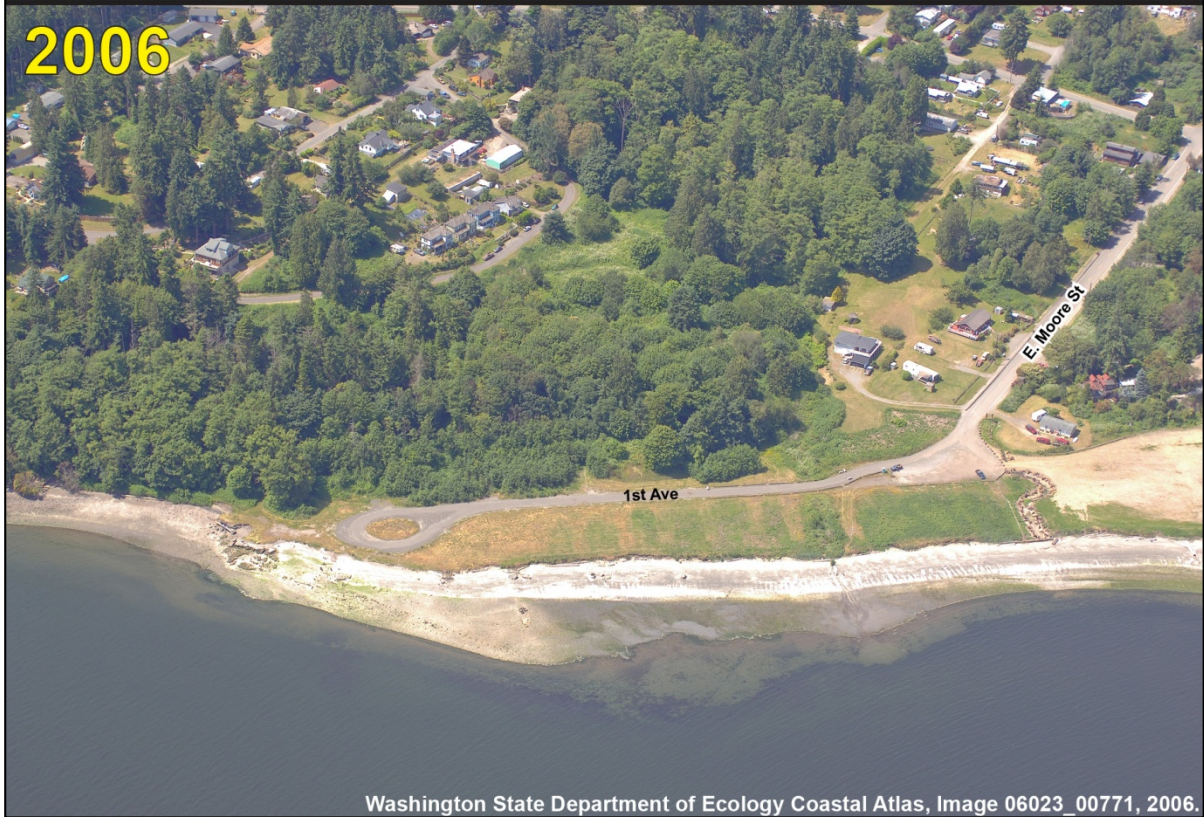
During the early 1900s, fill was placed on the beach below the bluff to extend the shoreline outward to provide additional staging and storage room for iron and steel plant operations. According to historic accounts, a cribbing structure was built along the base of the bluff, and fill was placed along the shoreline all the way to Chimacum Creek (Smith 2011b:22) (Figure 10) resulting in formation of an artificial bench beyond the original tidal zone (Figure 3). This artificial surface extends north into the "fill recruitment bench" on Washington Department of Fish and Wildlife (WDFW) lands, the area of archaeological testing in 2005 prior to beach restoration that has since been completed (Willis 2005) (Figure 5; Figures 11, 12, 13).

Figure 11. WDFW restoration project north of Irondale, in 2001 before restoration work, and in 2006 after restoration work.

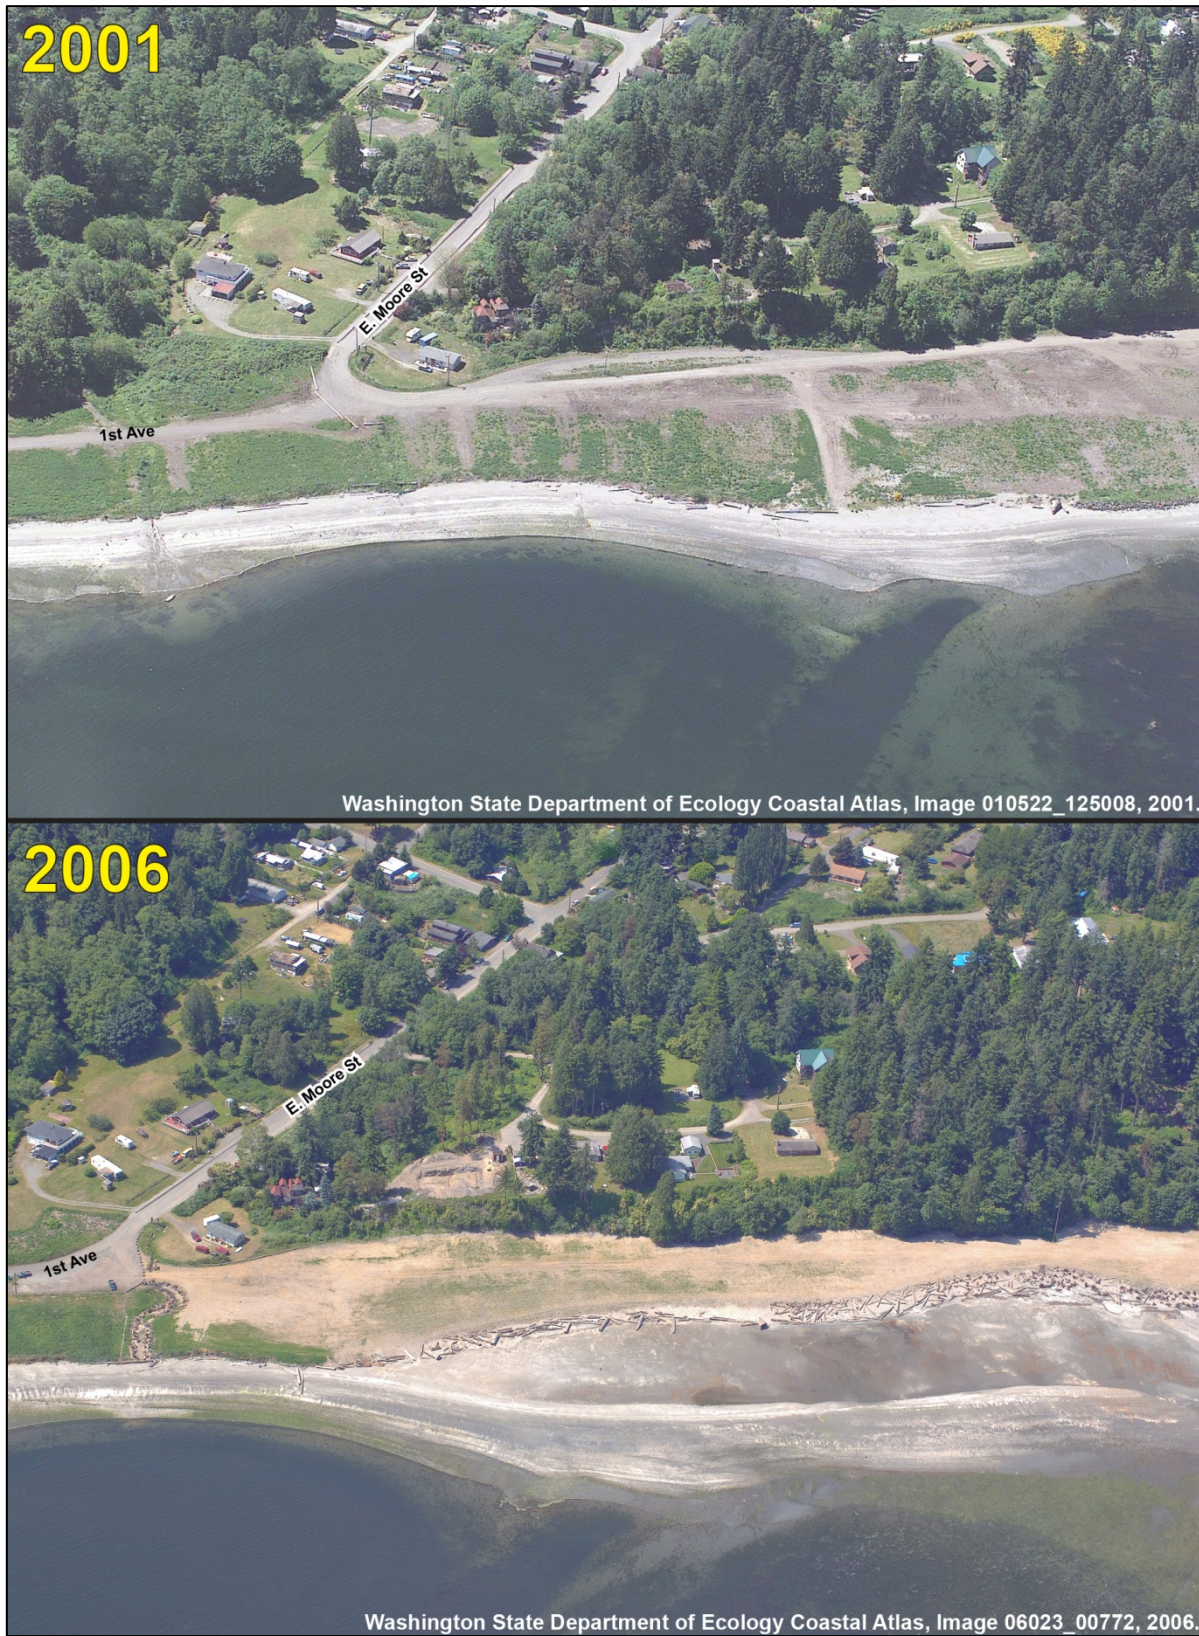
Figure 12. WDFW restoration project north of Irondale, in 2001 before restoration work, and in 2006 after restoration work.

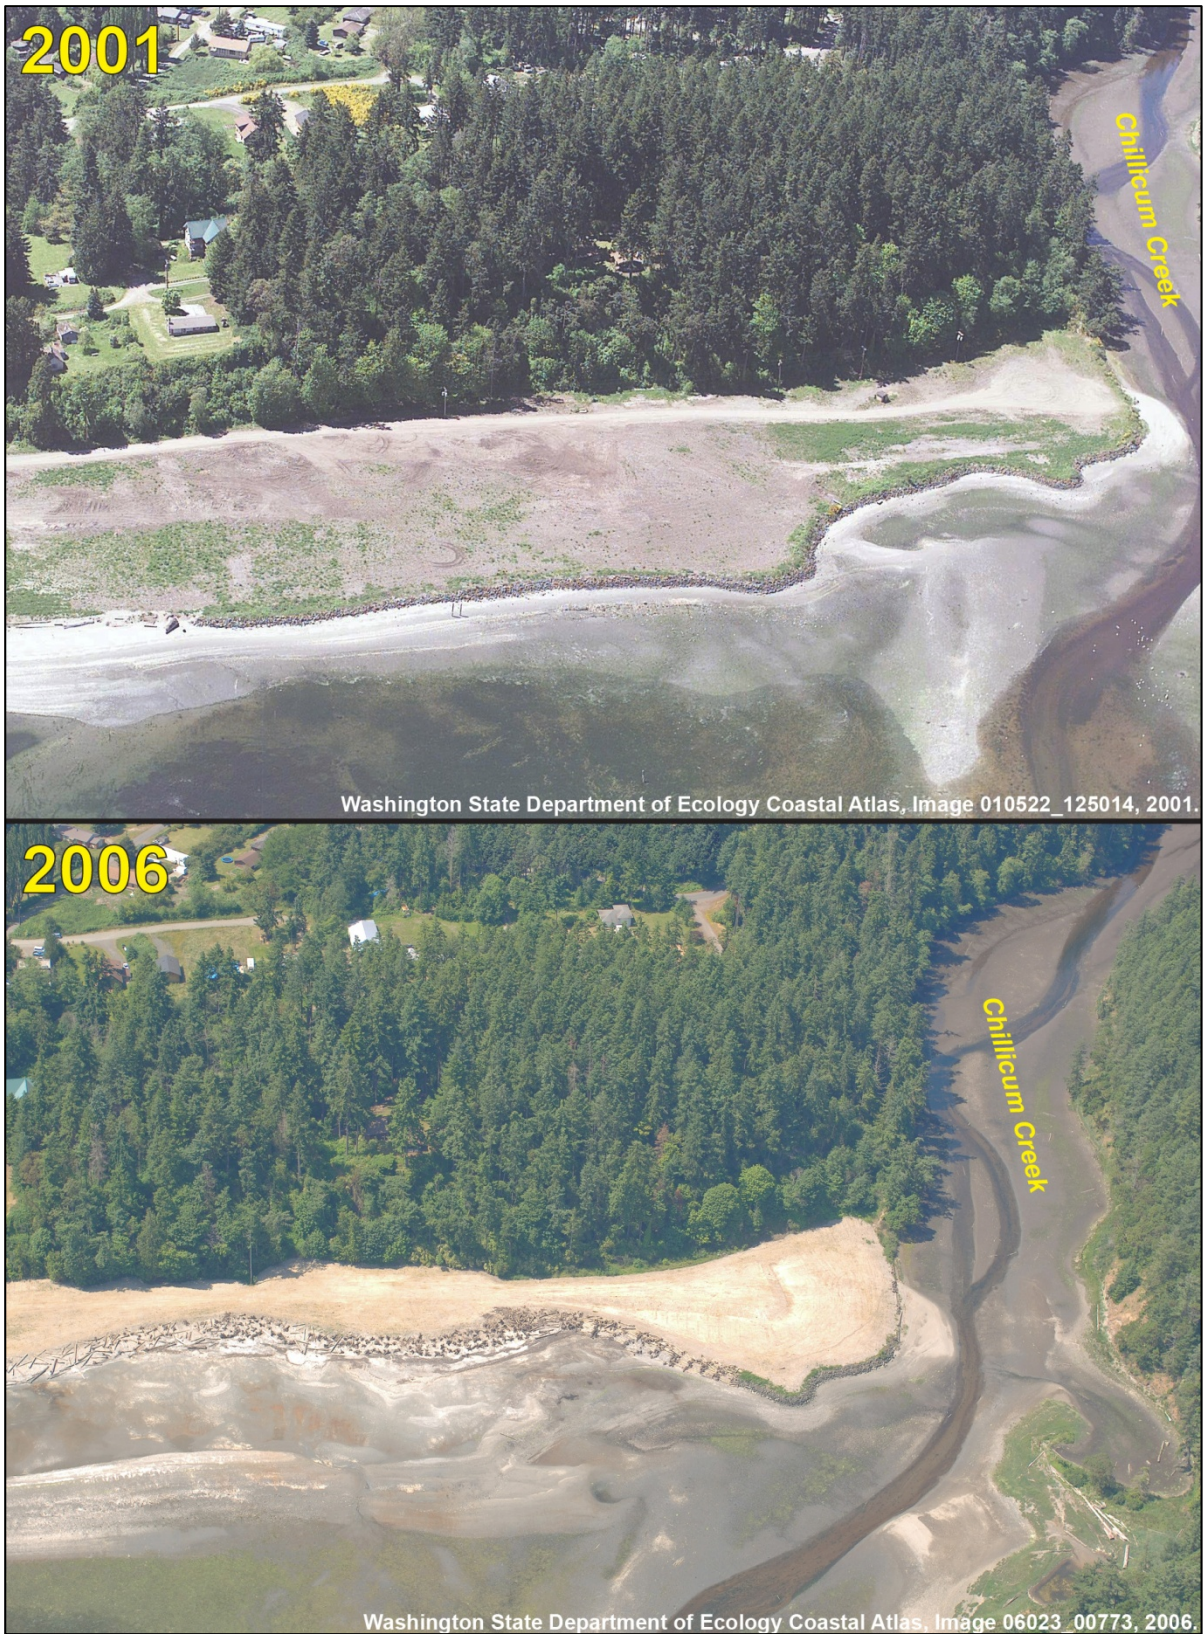
Figure 13. WDFW restoration project north of Irondale, in 2001 before restoration work, and in 2006 after restoration work.
