**Post-Cleanup Groundwater Confirmation
Sampling Event**

King County Housing Authority
Former Park Lake Homes Maintenance Center
9800 8th Avenue SW
Seattle, Washington

File No. 1329-003-20

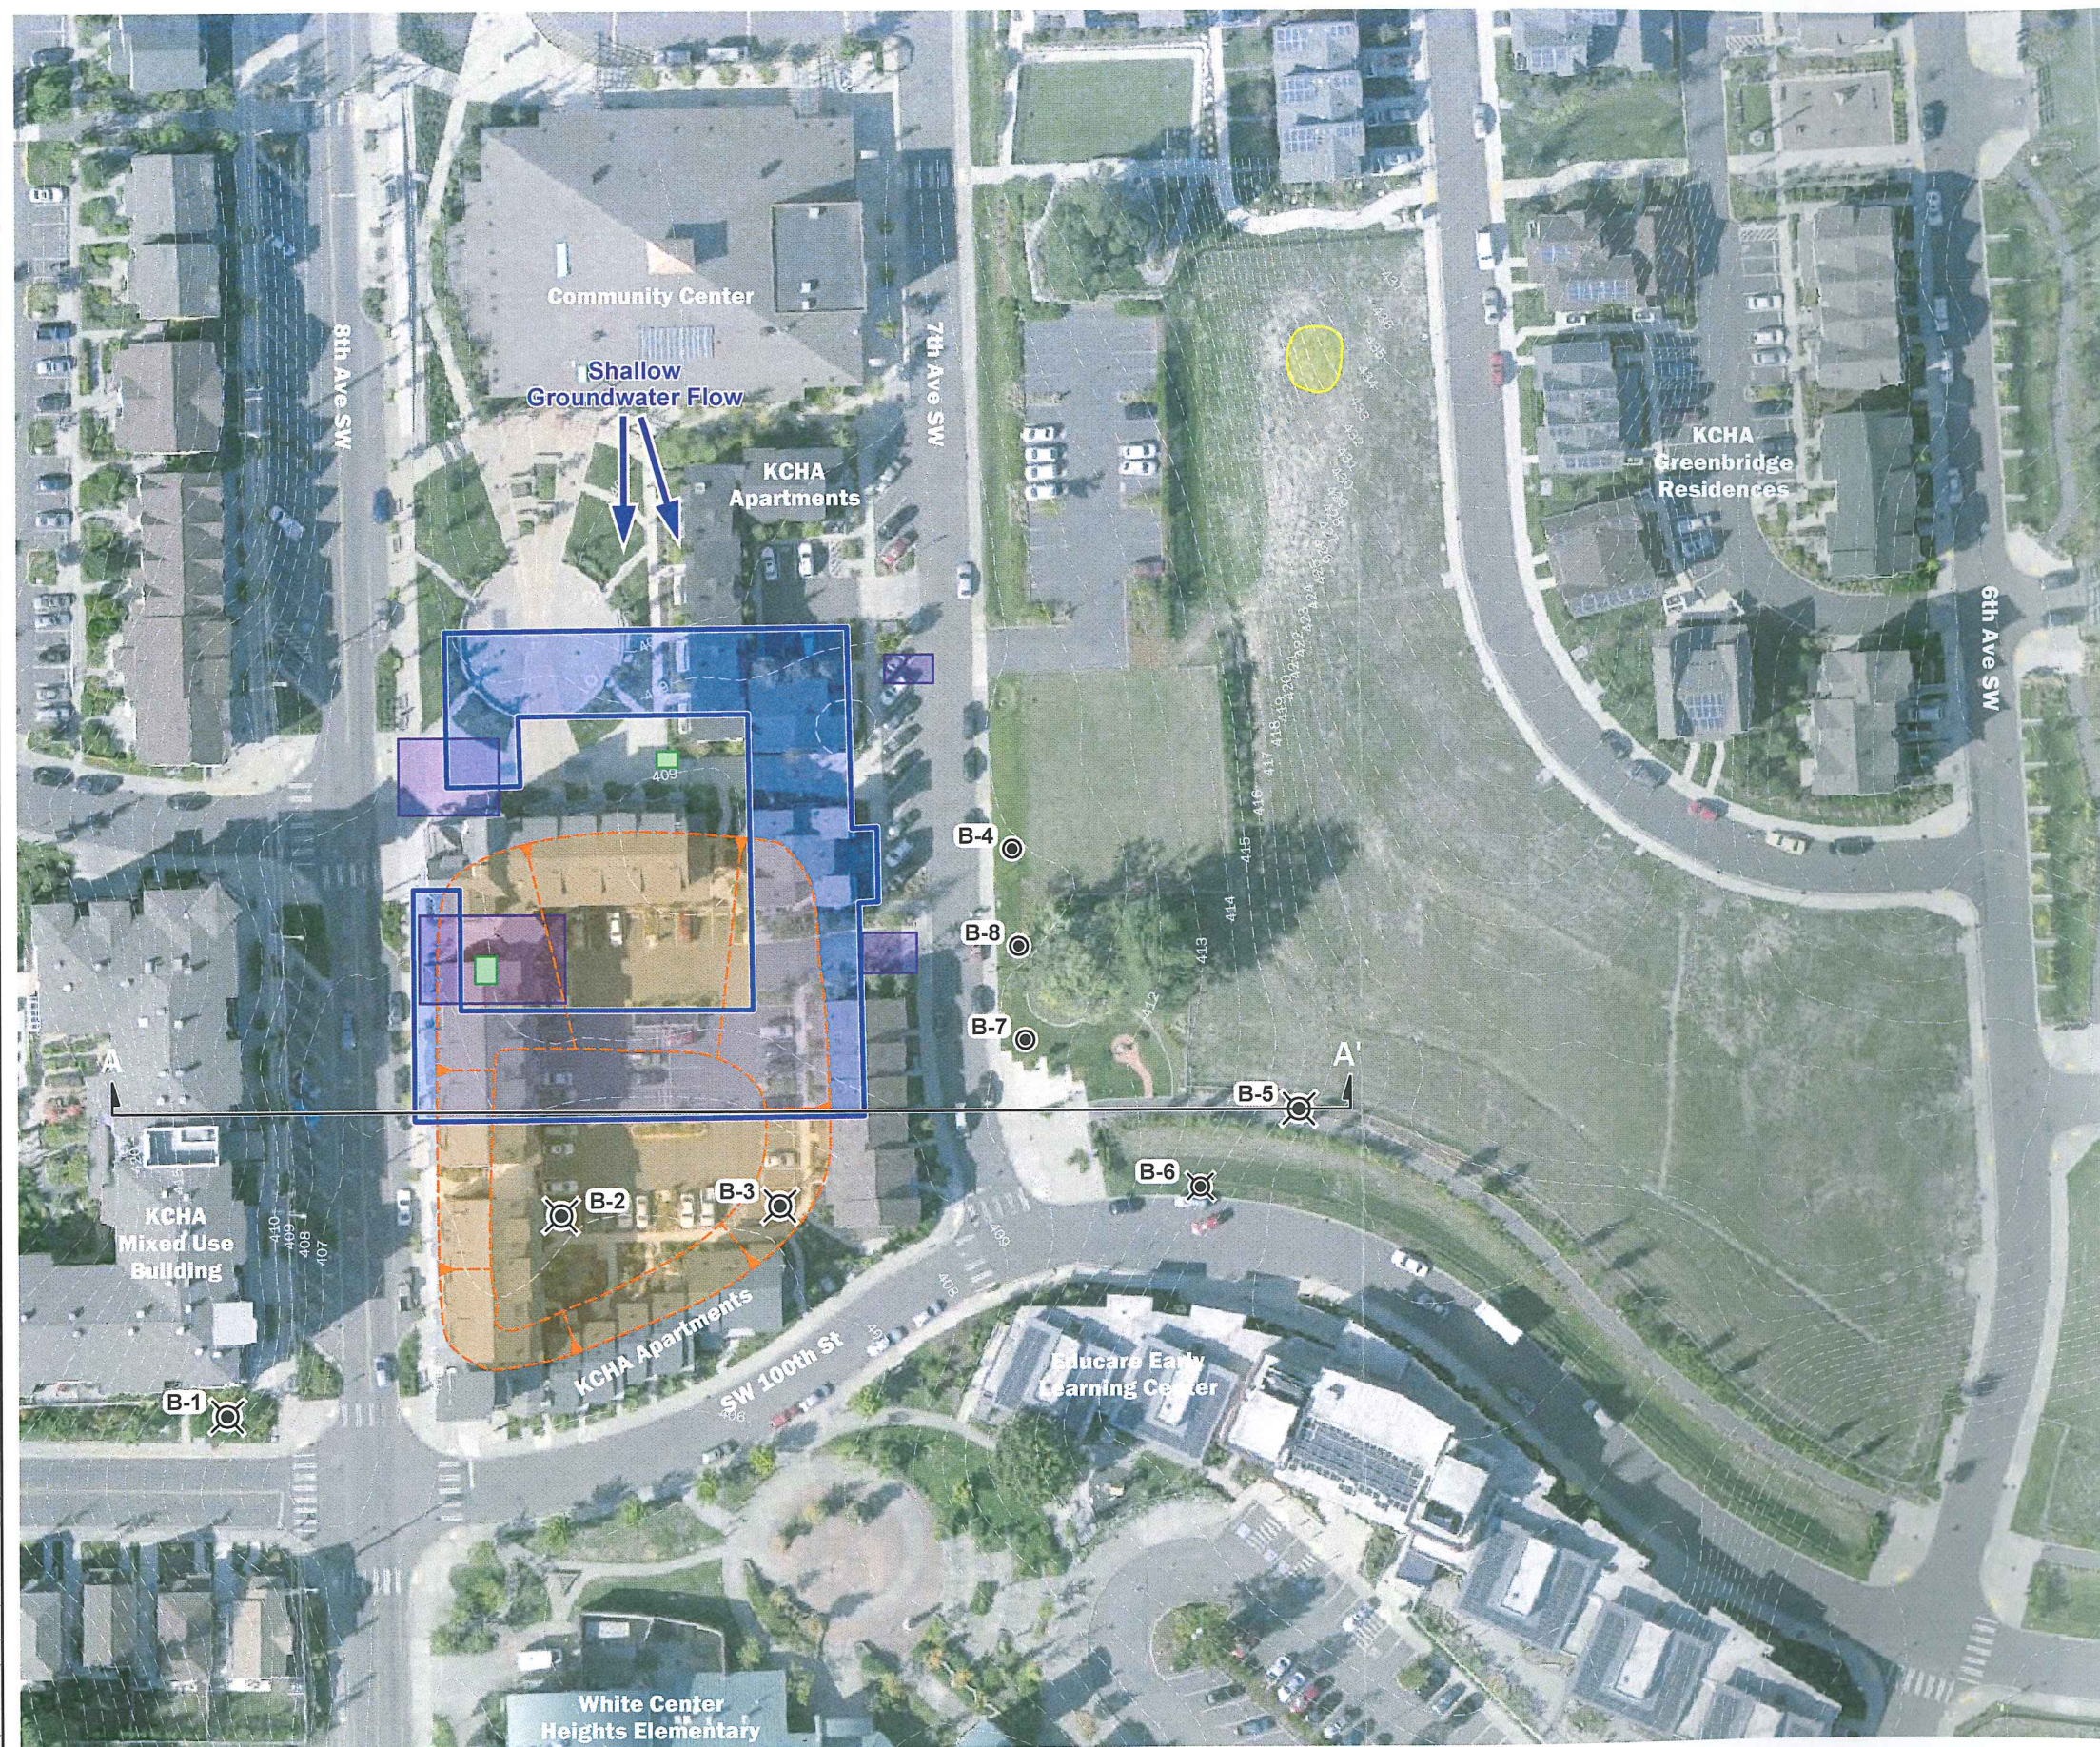
Figure 2

Eight direct-push borings (B-1 through B-8) were completed on September 30, 2015 to obtain groundwater samples for chemical analytical testing. The exploration locations were selected to be downgradient of the former maintenance center source areas, in areas where potentially impacted groundwater (if it exists) would most likely be encountered, and east of the former maintenance center (Figure 2). The borings were situated to the southwest, south and southeast of the former source areas to assess both the estimated eastern and western extent of the aquitard, and the quality and distribution of potentially-impacted groundwater (if present). Additional borings were situated directly east of the former Park Lake Homes maintenance center to assess the potential for groundwater contaminant migration (if any) to the east.

The direct push exploration locations are shown in Figure 2. Field procedures and boring logs are presented in Appendix A. Soil encountered in the borings generally consisted of hard to very dense, gray or brown fine to medium sandy silt and silty sand with varying amounts of gravel and cobbles. Soil obtained from the direct push boring continuous cores was field screened for evidence of petroleum hydrocarbons and volatiles. Field screening results are indicated in the boring logs (Appendix A) and the cross-section in Figure 3. Field screening results did not indicate evidence of contaminated soil in the borings. There are no historical potential sources of soil contamination at the 2015 direct push locations; therefore, soil chemical analytical testing was not warranted.

**Site Plan
Current Layout**

GeoEngineers completed a Phase I ESA of Park Lake Homes Site I for KCHA in 2002 (GeoEngineers 2003). Potential sources of contamination were identified in connection with the maintenance center, including two previous underground storage tank (USTs), floor drains/dry wells, a maintenance trench, an hydraulic hoist, and maintenance activities in the building that may have used or stored petroleum or other chemicals. One of the USTs had previously been removed by KCHA at an unknown date; its removal was confirmed by a 2004 geophysical survey [GeoEngineers 2004]. The second UST (1,000-gallon gasoline UST) had previously been removed in December 1998 (Bayley 1999). Former UST locations are indicated in Figure 2.

An isolated area of shallow petroleum-impacted soil was encountered northeast of the former maintenance center in 2007, during mass grading activities by KCHA (Figure 2). The isolated area of impacted soil, approximately 225 cubic yards, was excavated by KCHA (GeoEngineers 2010a and 2010b). The source of the petroleum release at this location was not confirmed but was suspected to have likely been associated with either historic residential vehicle activity, construction equipment or localized fill (GeoEngineers 2010a and 2010b). Excavation confirmation samples were obtained in 2007 after removal of the 225 cubic yards of impacted soil; concentrations of diesel- and oil-range petroleum hydrocarbons in the samples were less than 100 milligrams per kilogram (mg/kg), significantly less than the MTCA cleanup of 2,000 mg/kg. There was no evidence of groundwater at this location.
