# PHASE I ENVIRONMENTAL SITE ASSESSMENT

**Yarrow Bay Marina – Eastern Parcel  
5207 Lake Washington Boulevard Northeast  
Kirkland, Washington 98033**

August 17, 2006

**Sound Environmental Strategies Corporation**  
2400 Airport Way South, Suite 200  
Seattle, Washington 98134-2020

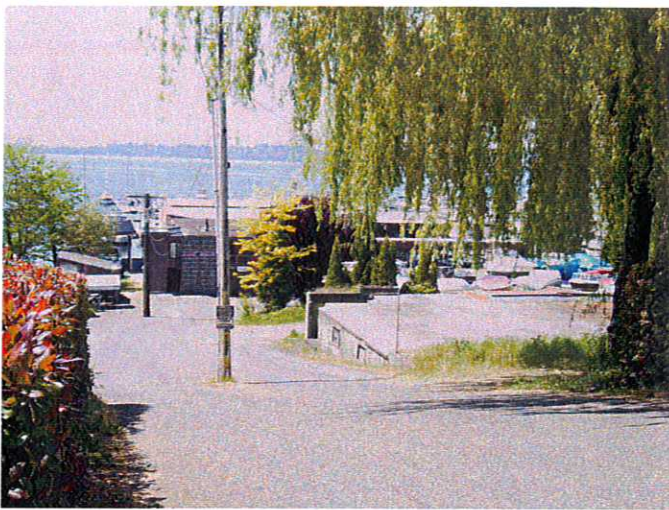
Photograph 1. View of the southern property boundary.

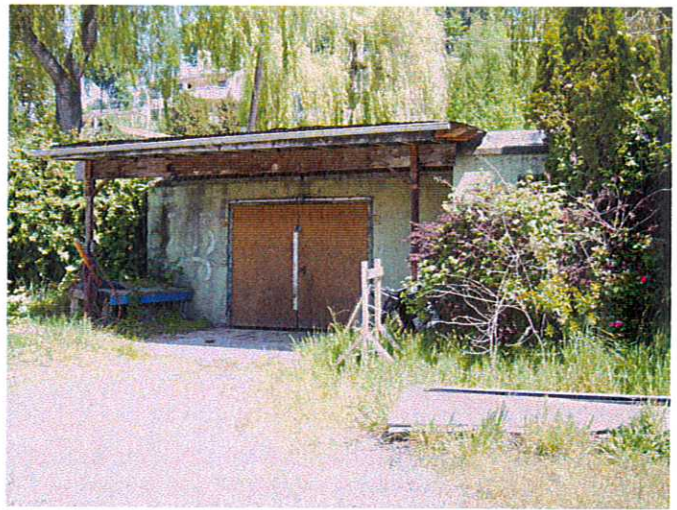
- The property was primarily used as a boat storage facility.
- What appears to be the basement of the 1950-vintage single-family residence occupies the eastern portion of the property. Although the basement is locked, Mr. Bortko stated that it is used for storage of non-hazardous materials.

Photograph 2. Locked entrance to the basement of the 1950-vintage single-family residence.

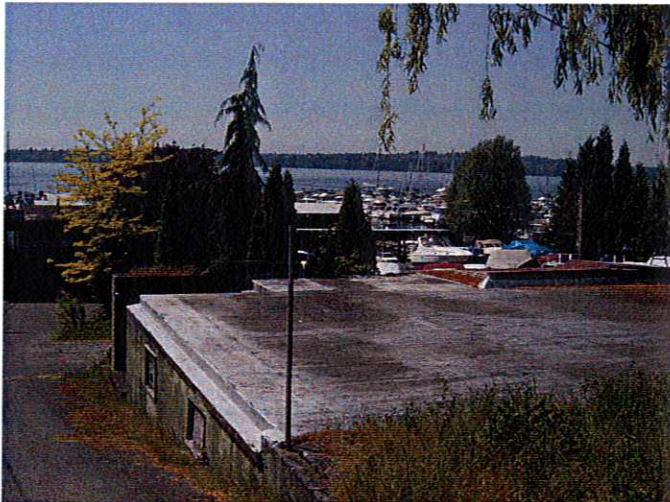
- What appears to be a vent line for a possible heating oil storage tank protrudes from the south wall of the 1950-vintage basement.
- An empty 55-gallon drum was located adjacent to the west of the basement, as was an empty aboveground storage tank (AST), which, according to Mr. Bortko, was temporarily used for waste oil storage until a new AST was purchased. No spills, stains, or evidence of stressed vegetation were observed in the vicinity of the drum or AST.

- A possible old vent line for a heating oil tank noted in the vicinity of the 1950-vintage basement.

Photograph 3. Potential vent line protruding from the southern side of the 1950-vintage basement.

If some degree of confidence is desired regarding potential impacts to the environmental quality of soil or groundwater beneath the property from the REC, subsurface sampling and laboratory testing would be required. Recommended areas for subsurface investigation include the southern edge of the 1950-vintage basement.

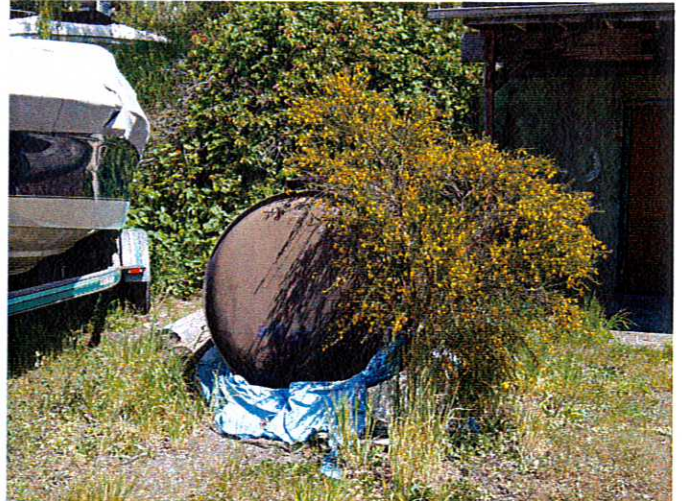
Photograph 4. Old waste oil storage tank located outside of the basement.

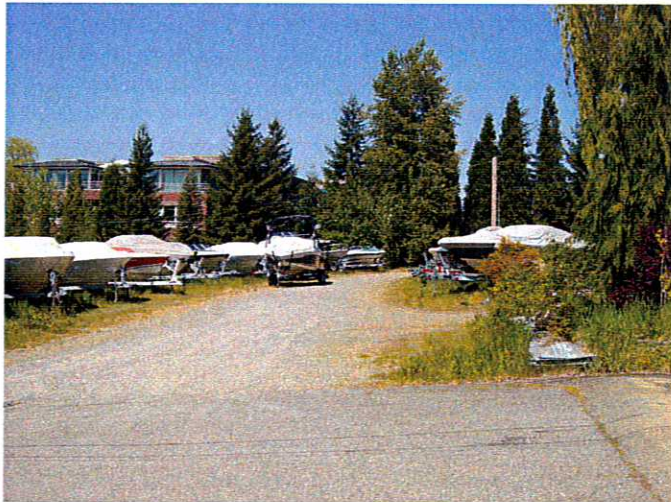
Photograph 5. Gravel-covered boat storage lot facing north.

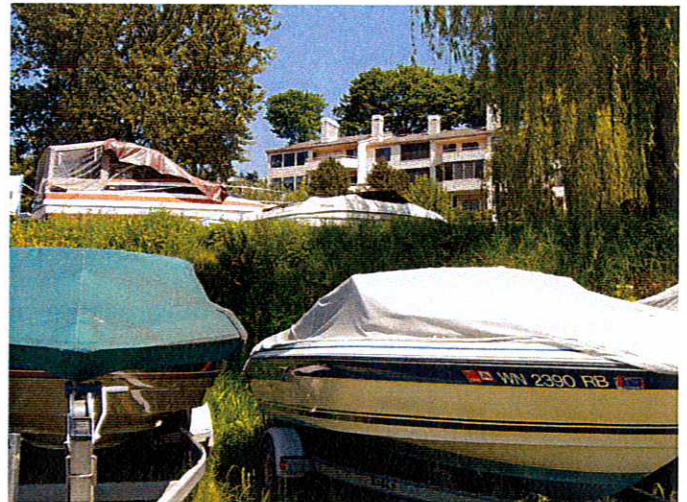
Photograph 6. View of the property from its western property boundary.

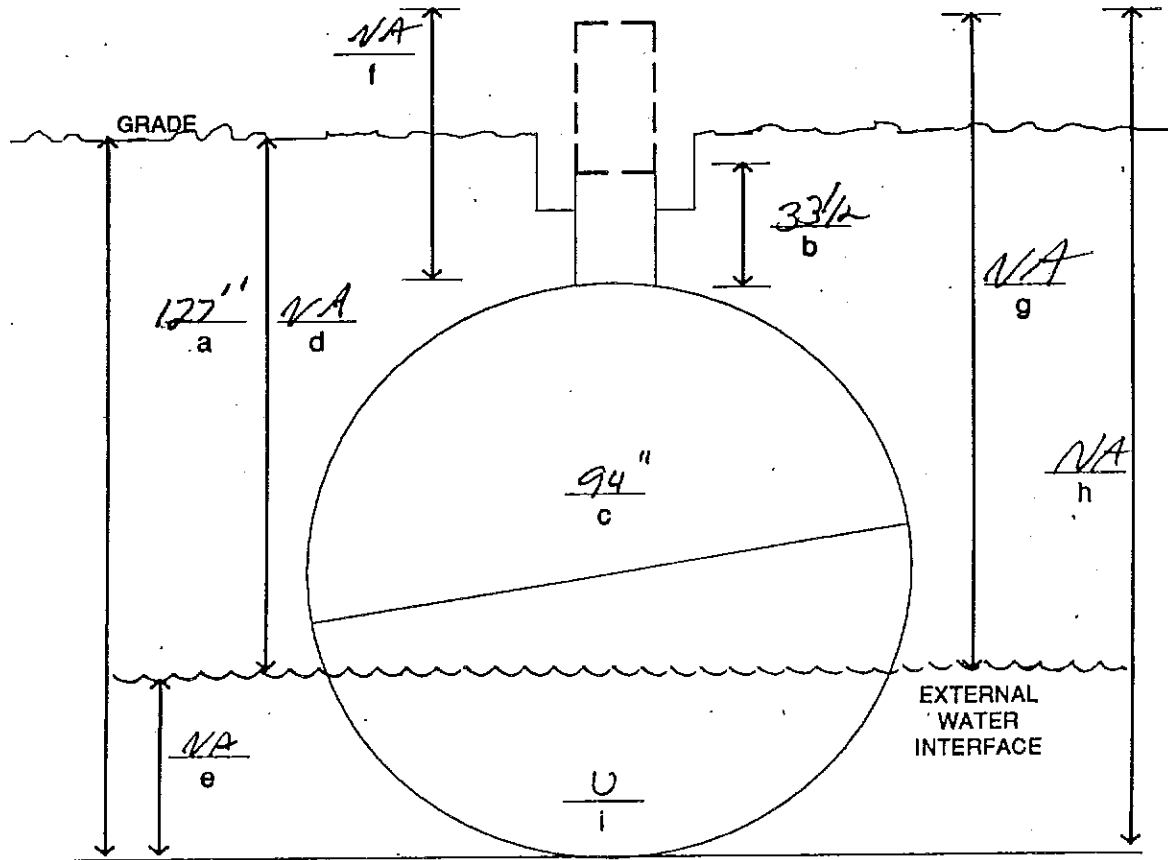
18. TANK DIMENSIONS

- (a) = GRADE TO TANK BOTTOM
- (b) = EXISTING FILL PIPE
- (c) = TANK DIAMETER
- (d) = GRADE TO WATER INTERFACE
- (e) = WATER ABOVE TANK BOTTOM
- (f) = COMPENSATING HEAD
- (g) = TEST LEVEL TO WATER INTERFACE
- (h) = TEST LEVEL TO TANK BOTTOM
- (i) = WATER IN TANK

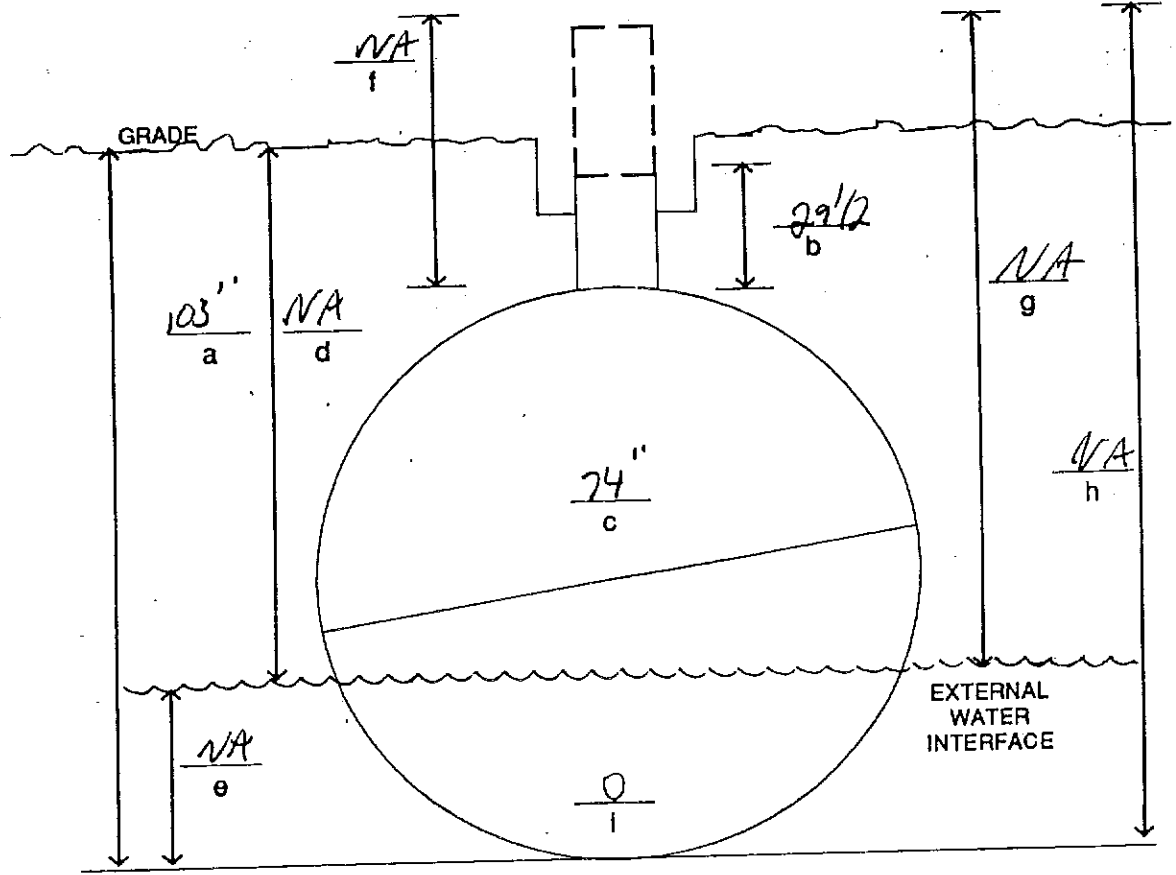
**18. TANK DIMENSIONS**

- (a) = GRADE TO TANK BOTTOM
- (b) = EXISTING FILL PIPE
- (c) = TANK DIAMETER
- (d) = GRADE TO WATER INTERFACE
- (e) = WATER ABOVE TANK BOTTOM
- (f) = COMPENSATING HEAD
- (g) = TEST LEVEL TO WATER INTERFACE
- (h) = TEST LEVEL TO TANK BOTTOM
- (i) = WATER IN TANK

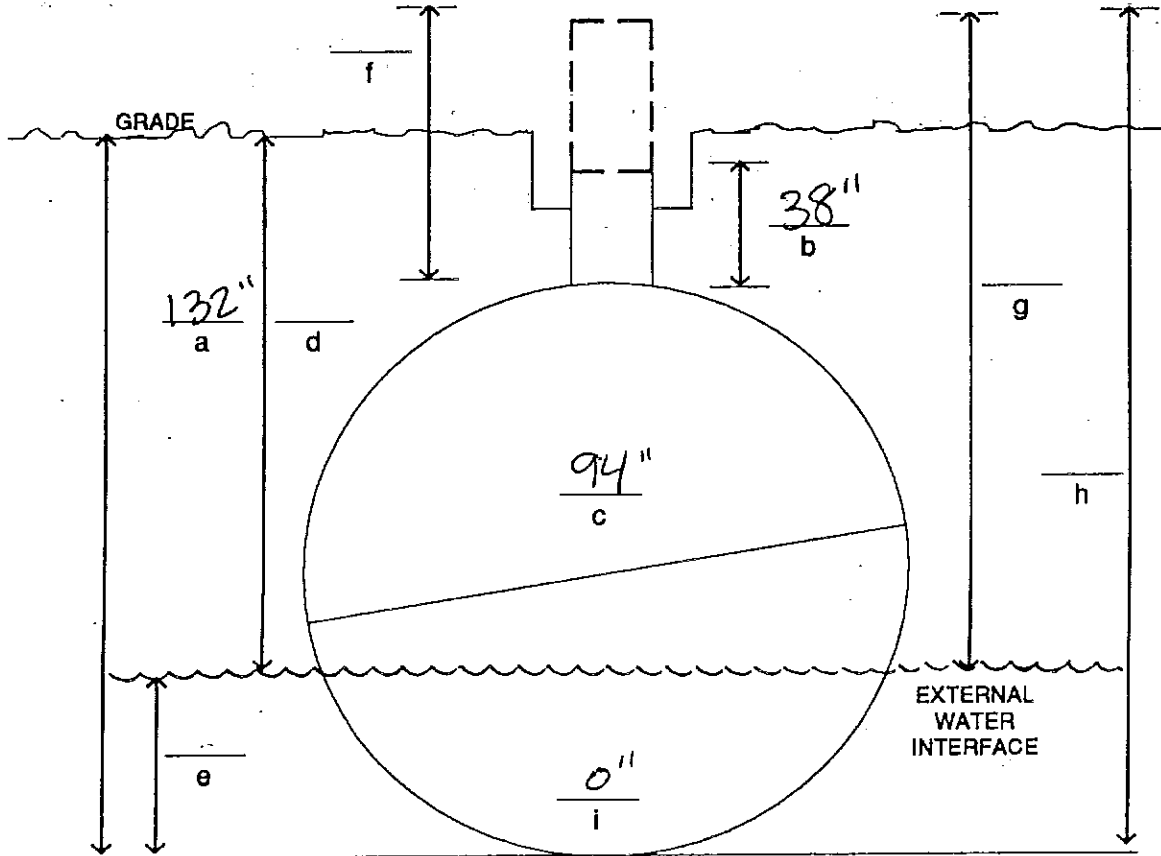
**18. TANK DIMENSIONS**

- (a) = GRADE TO TANK BOTTOM
- (b) = EXISTING FILL PIPE
- (c) = TANK DIAMETER
- (d) = GRADE TO WATER INTERFACE
- (e) = WATER ABOVE TANK BOTTOM
- (f) = COMPENSATING HEAD
- (g) = TEST LEVEL TO WATER INTERFACE
- (h) = TEST LEVEL TO TANK BOTTOM
- (i) = WATER IN TANK

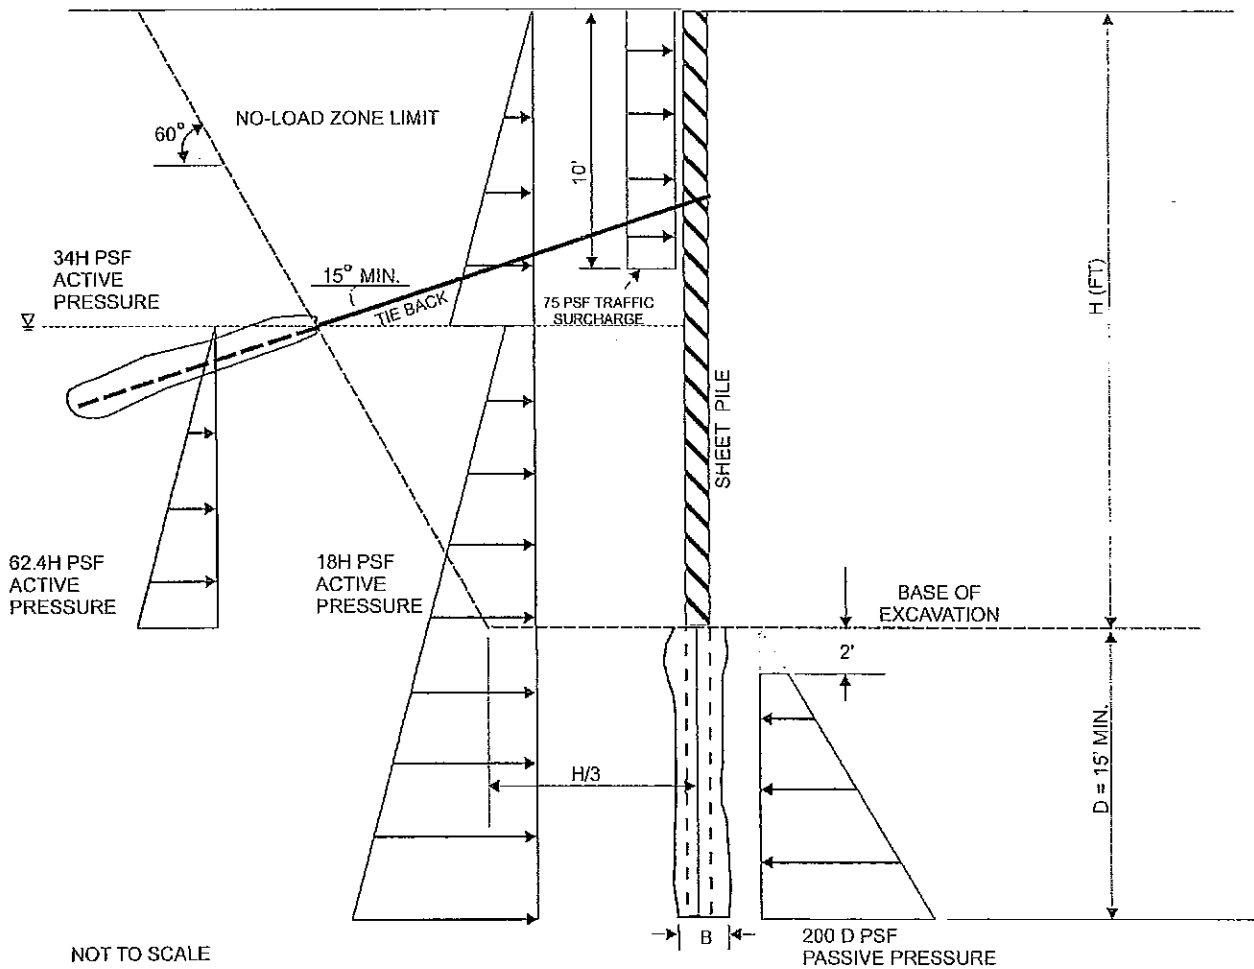
1. Diagram is illustrative of perimeter shoring walls.
2. Sheet pile embedment depth "D" should consider necessary kickout and overturning resistance.
3. All tiebacks should be prestressed to 130 percent of design load and locked off at 100 percent of design load. Tieback anchor zone is to be located behind the no-load zone. Two or three tiebacks should be proof-tested to 200 percent of design load per Post-Tensioning Institute guidelines. Sufficient tendons should be provided for test loads.
4. Allowable tieback - soil adhesion = 1000 psf in glacially consolidated soil; includes factor of safety of 2.
5. Passive pressures include a factor of safety of 2.
6. Diagram does not include pressures due to surface surcharges from any adjacent structures. These pressures must be provided by the structural engineer if applicable.

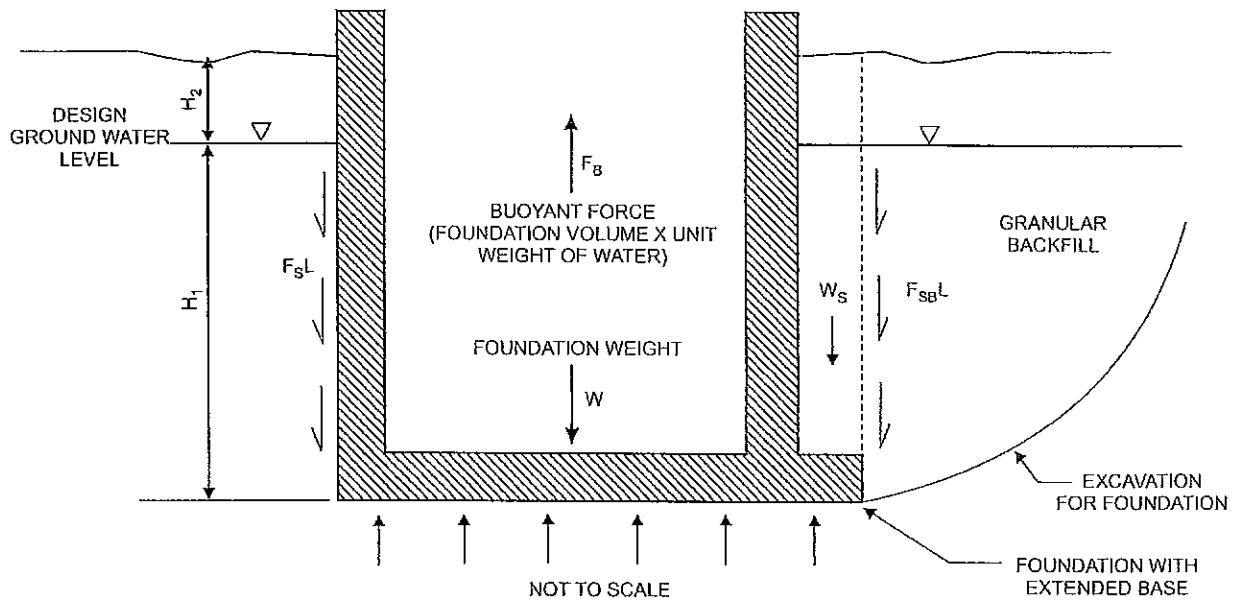
Uplift on foundation bottom could result in high moments in bottom slab.

$$\text{FACTOR OF SAFETY} = \frac{W + F_S L}{F_B}$$
