Subsurface Investigation Report

Naches Pit Stop

10121 Highway 12

AEG Project #: 16-102
Date of Report: July 08, 2016

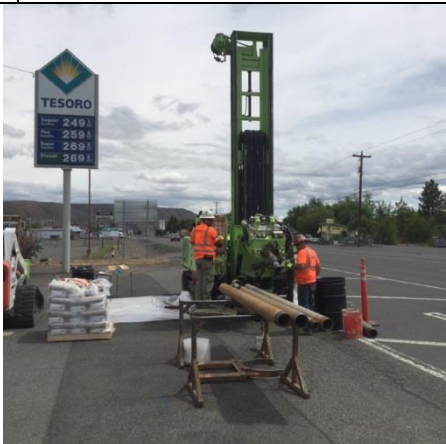
<p>Photo #3:</p>	<p>Photo looking east at the location of monitoring well MW-6.</p>		<p>Photo #4:</p> <p>Photo looking at soil cuttings from monitoring well MW-6.</p>

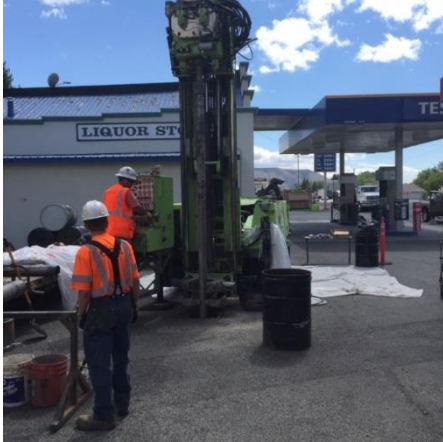
<p>Photo # 7</p>	<p>Photo looking east at the location of monitoring well MW-4.</p>	<p>Photo # 8</p>	<p>Photo looking at soil cuttings from monitoring well MW-4.</p>

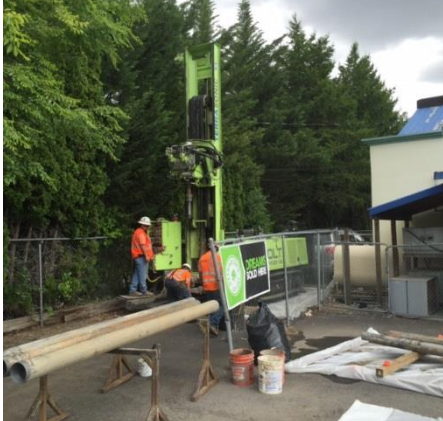
<p>Photo # 9</p>	<p>Photo looking northeast at the location of monitoring well MW-8.</p>	<p>Photo # 10</p>	<p>Photo looking at soil cuttings from monitoring well MW-8.</p>

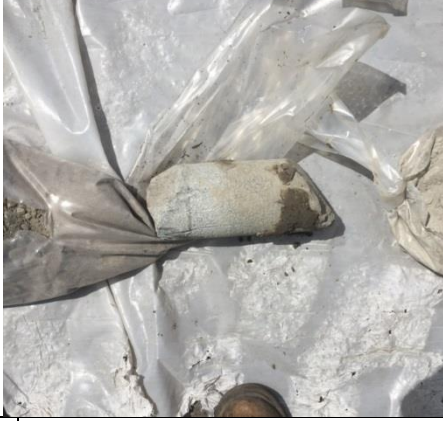
<p>Photo # 11</p>	<p>Photo looking at rock core from monitoring well MW-4.</p>	<p>Photo # 12</p>	<p>Photo looking at typical surface monument of monitoring well MW-5.</p>
