Supplemental Investigation & Remedial Excavation

**Progress Rail Spill Incident # 12-0773
4012 SR 509 South Frontage Road
Tacoma, Pierce County, Washington**

March 11, 2014

Terracon Project No. 81127060

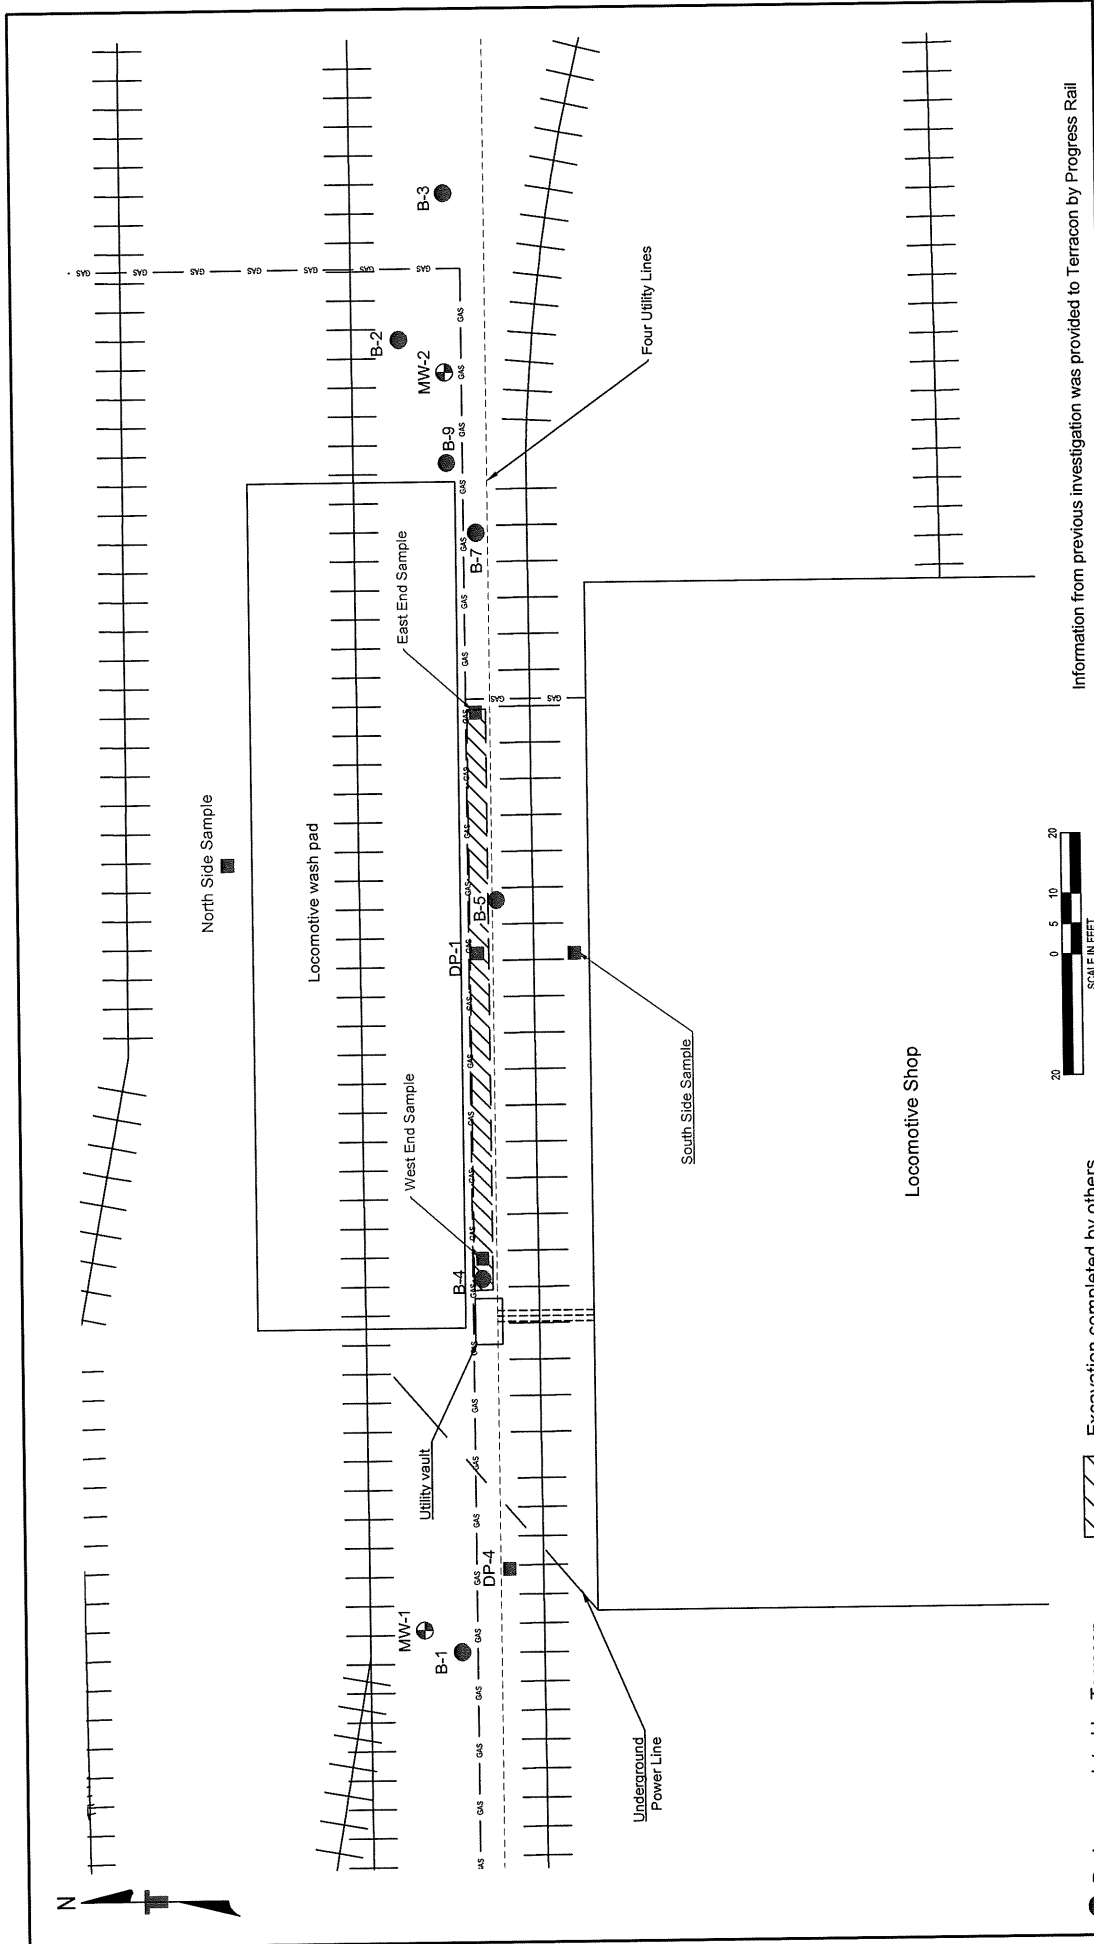
FIG. No. 2

Information from previous investigation was provided to Terracon by Progress Rail

- Boring completed by Terracon
- Monitoring well completed by Terracon
- Boring completed by others
- Excavation completed by others

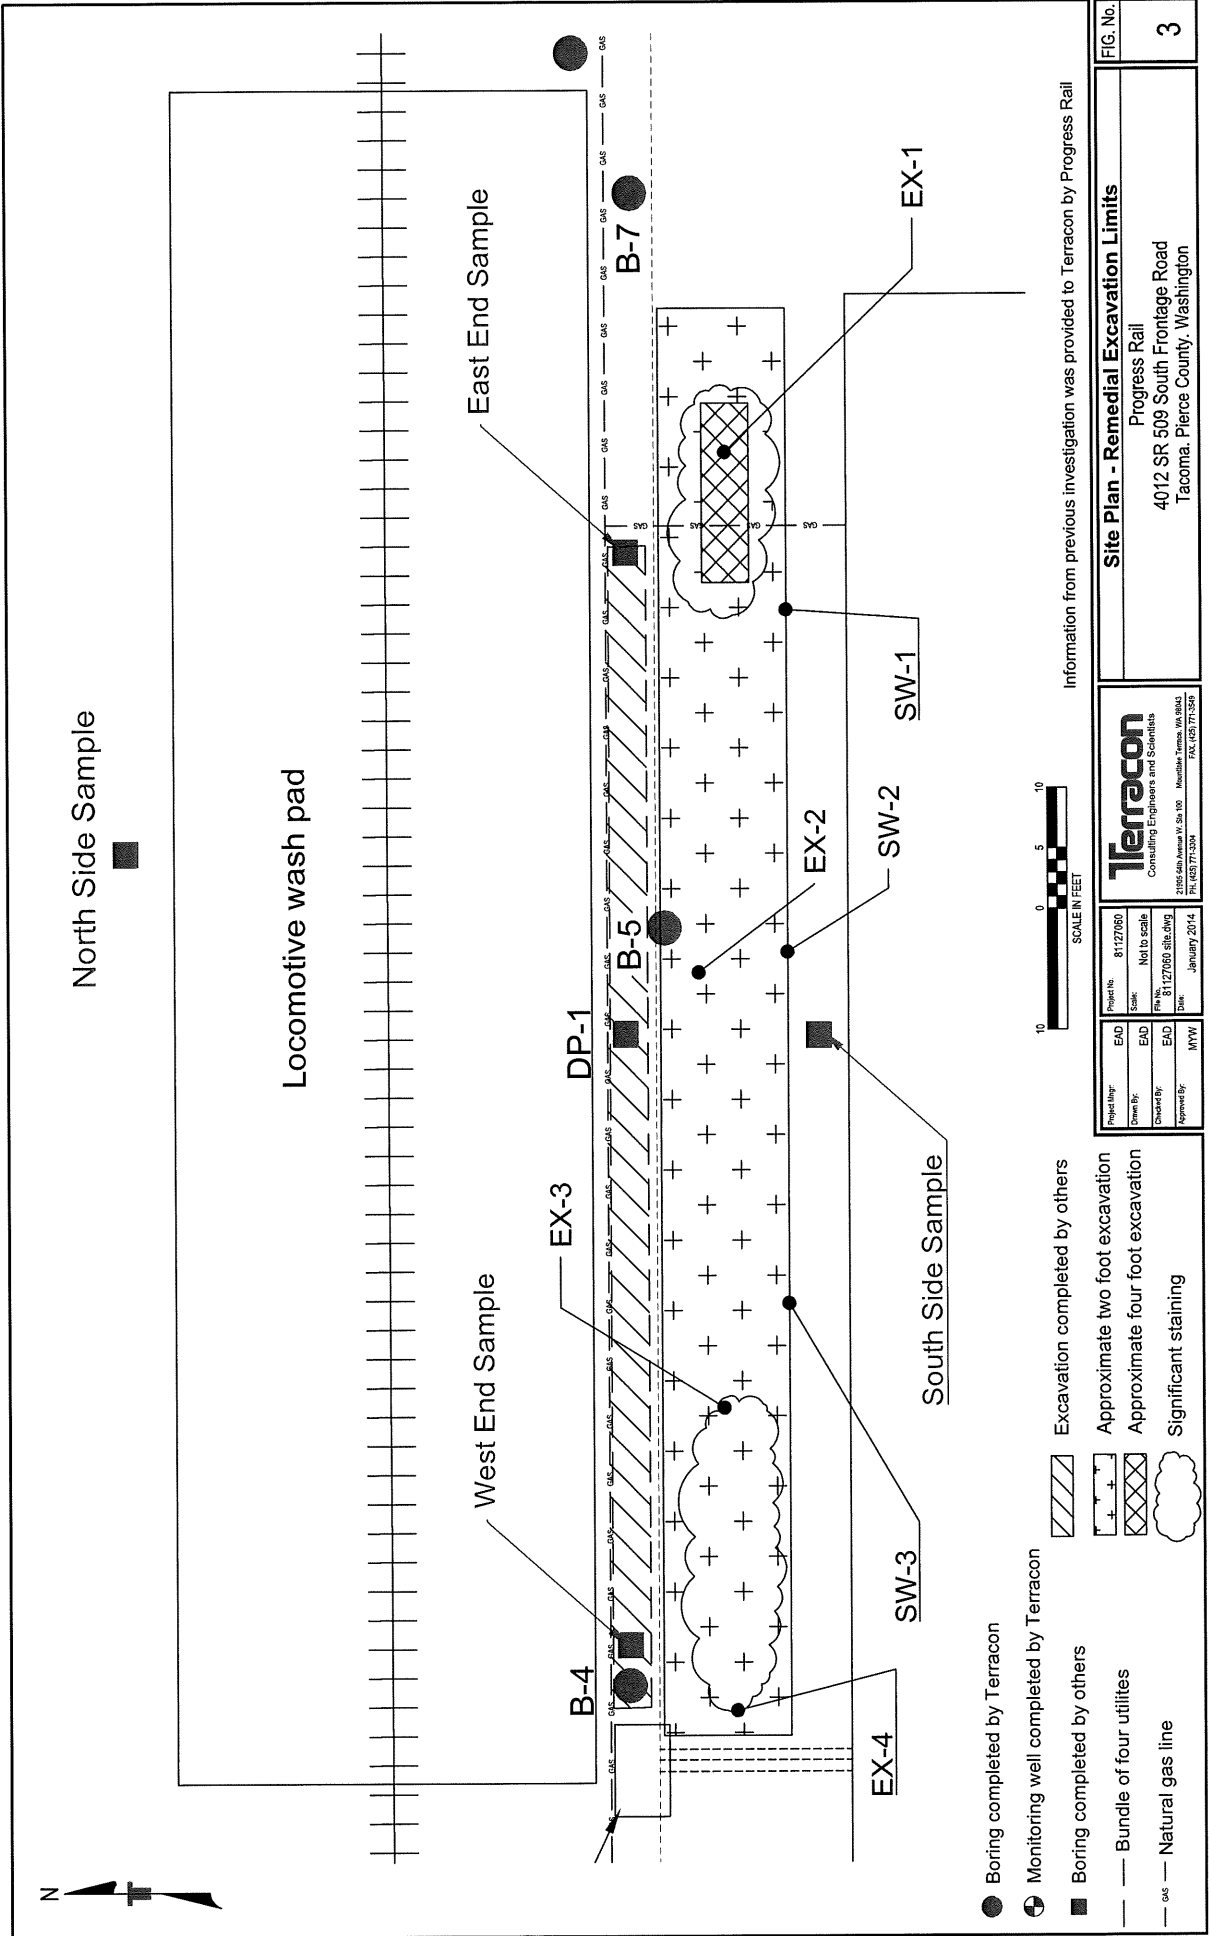
Site Plan - Remedial Excavation Limits
 Progress Rail
 4012 SR 509 South Frontage Road
 Tacoma, Pierce County, Washington

- Excavation completed by others
- Approximate two foot excavation
- Approximate four foot excavation
- Significant staining

Terracon collected a total of seven confirmation soil samples during excavation activities, which included four samples from the base of the excavation area and three samples from the excavation southern sidewalls. The confirmation bottom samples were collected in areas where contamination had been observed and the sidewall samples were collected to confirm the PCS did not continue south, into the sidewalls at depths where the PCS was removed. The northern portion of the excavation was at grade with the wash pad and extended to approximately where the initial spill excavation had been completed (Figure 3).

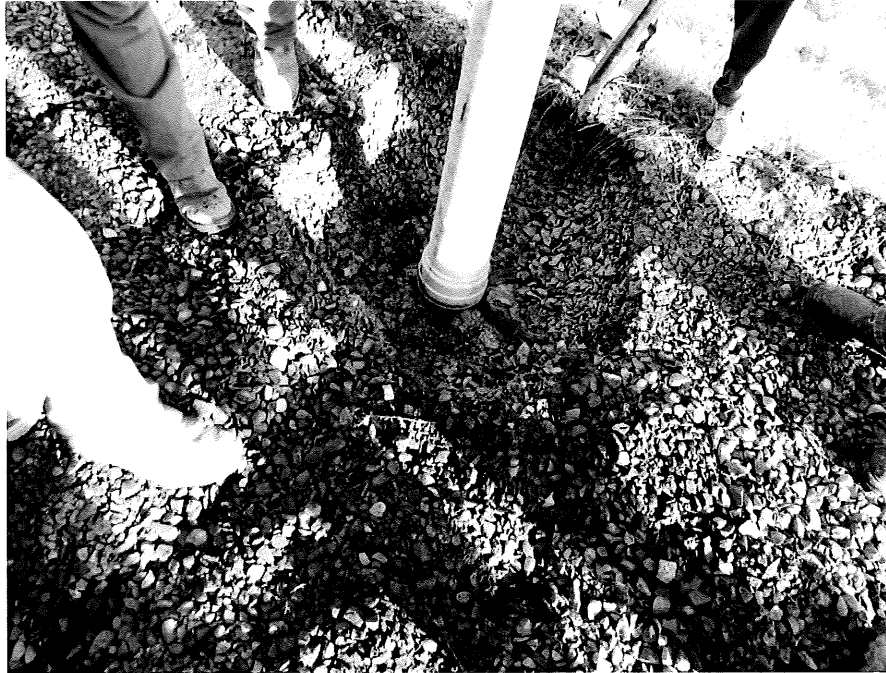
Photograph No. 1: View of the vector truck removing gravel and soil for exposing utilities.

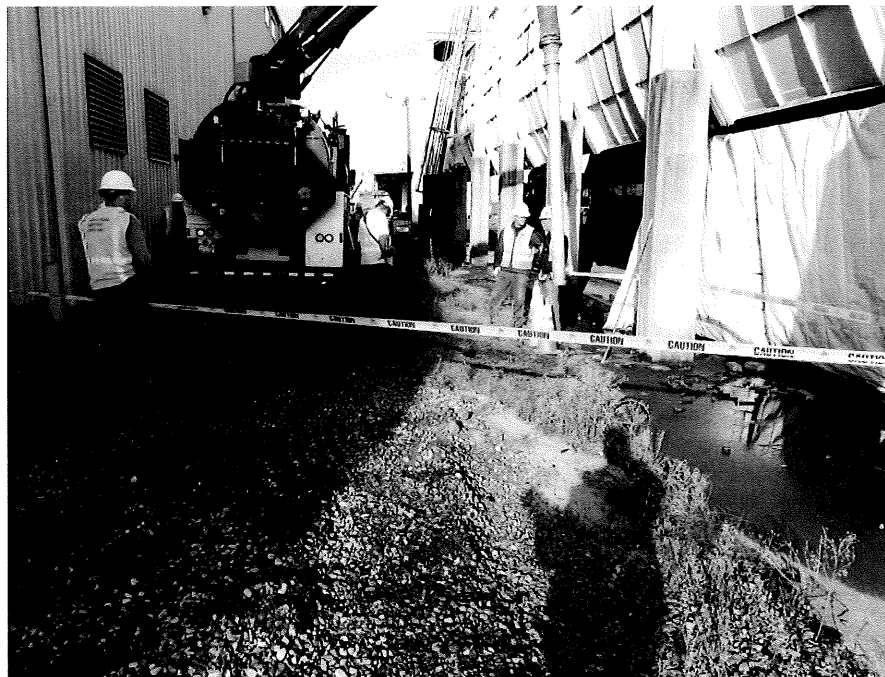
Photograph No. 2: View of NRC completing additional potholes to verify utility locations, facing west.

After the utility line depth was verified, three additional potholes were completed along the marked utilities to verify the utility depth and locations. The fourth pothole located at the western end of the proposed excavation was also observed with an apparent black oily product draining from the gravel bedding. The centrally located pot-hole did not encounter apparent free product draining from the gravel bedding.

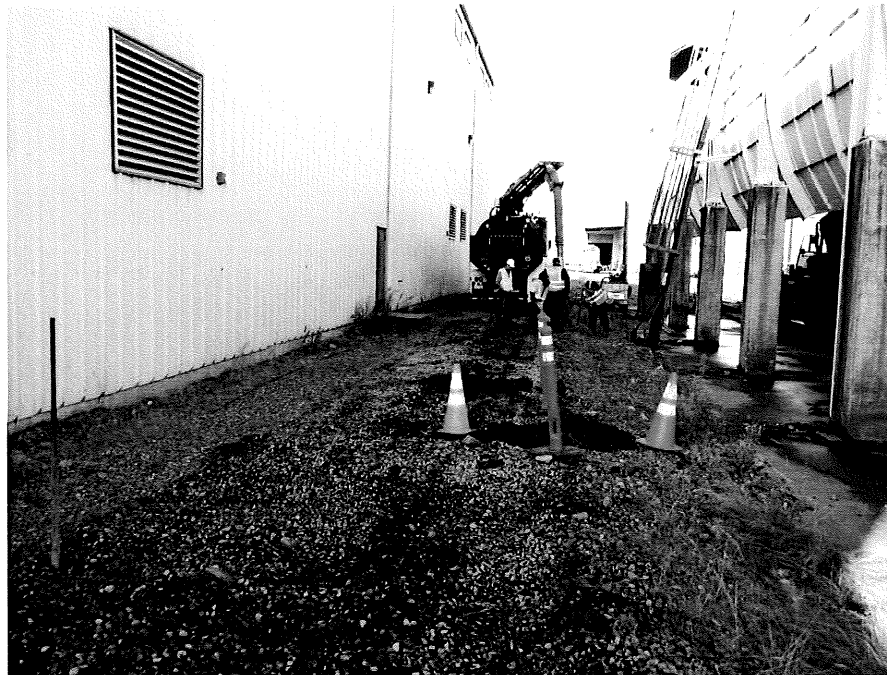
Photograph No. 3: View of the track gravel area with the tracks removed, gradually sloping to the north (wash pad located on right side of photo).

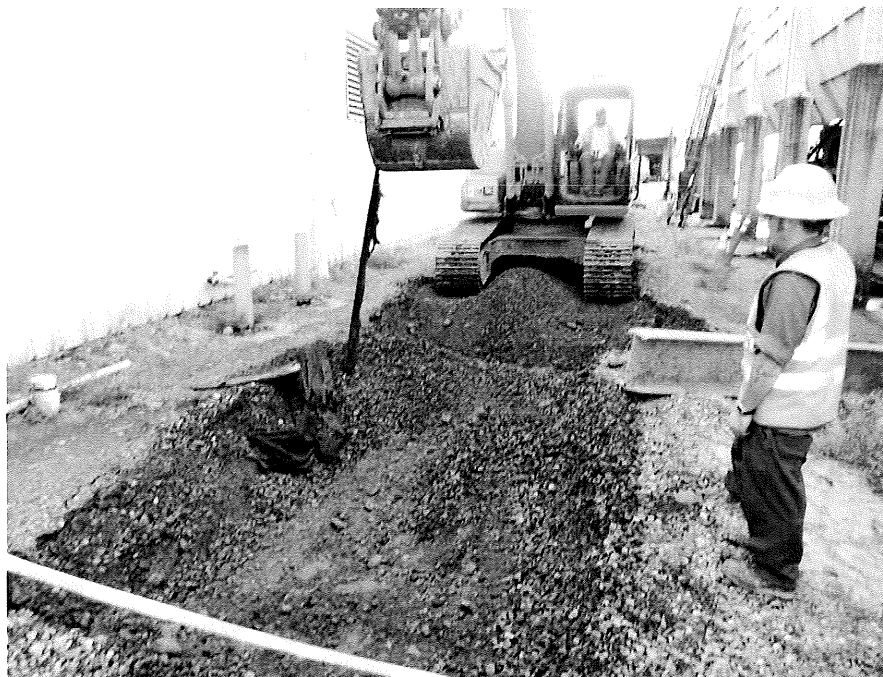
Photograph No. 4: View of the gravel, filter fabric and soils being excavated on the east end of the excavation area.

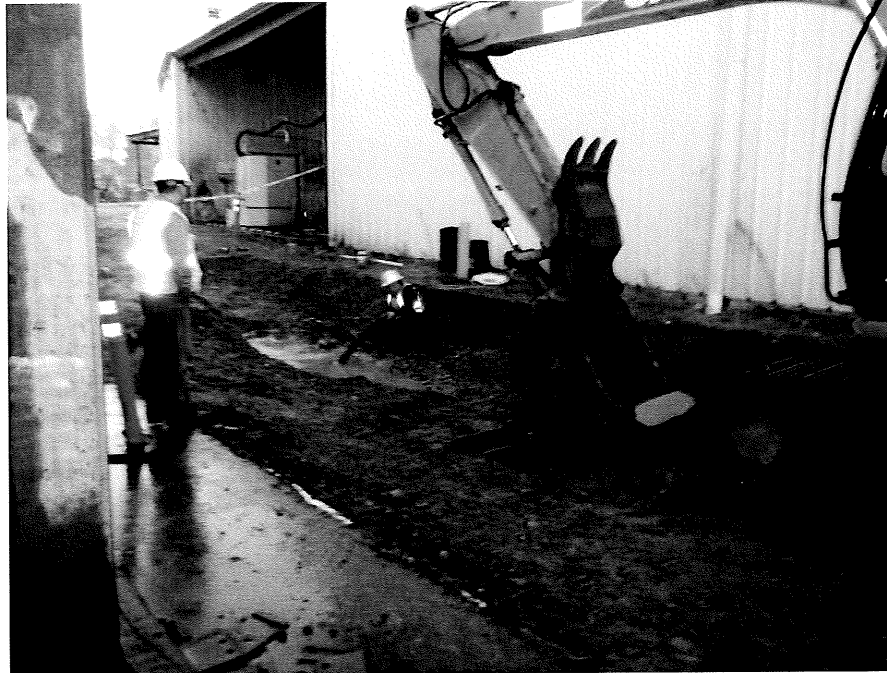
Photograph No. 5: View of the storm water being pumped from the approximate 4 foot excavation on the eastern end of excavation area.

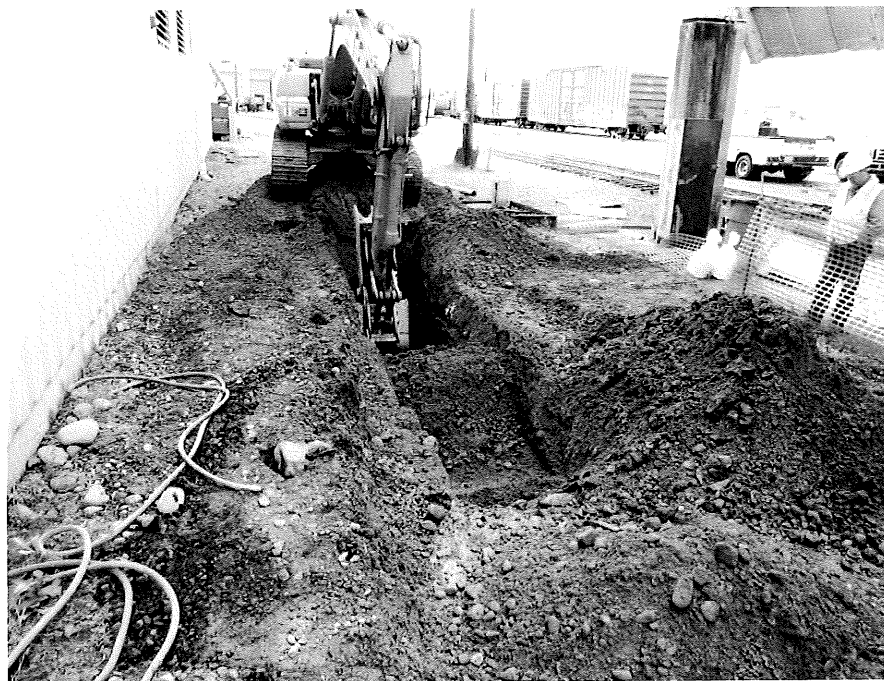
Photograph No. 6: View of the trenching activities for direct application of the remedial amendment.

Diesel and oil-range TPH concentrations have been documented in the groundwater. Therefore, the ORC-A®, which is a formulation of calcium oxyhydroxide which, upon hydration, releases oxygen and forms simple calcium hydroxide and water was added to the saturated zone. The installation of ORC-A® allows for an efficient, long-term (over a 12-month time period, depending on site conditions) release of oxygen providing the optimal conditions for sustained aerobic biodegradation.

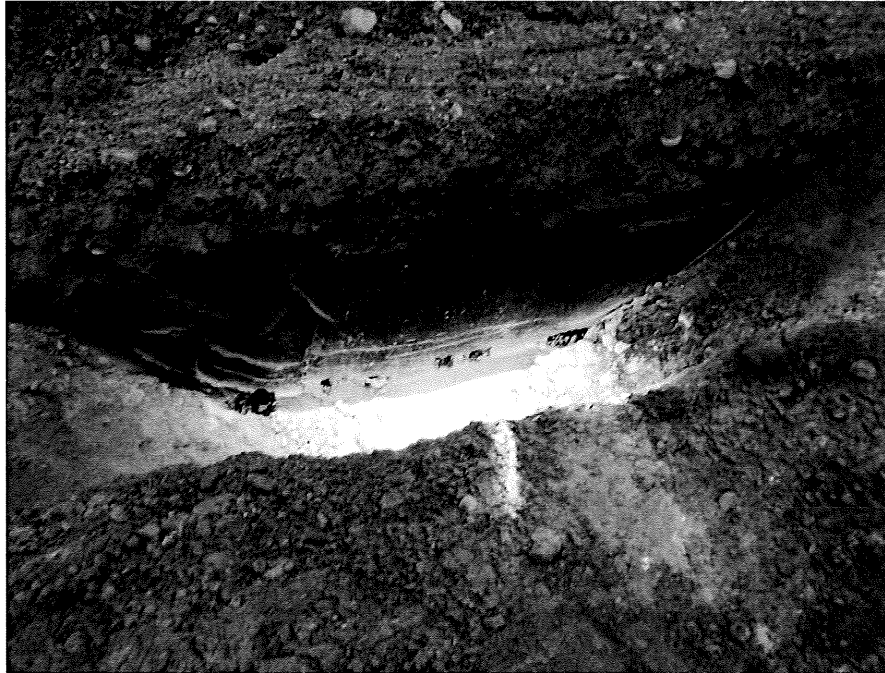
Photograph No. 7: View of the application of the remedial amendment prior to hydrating and mixing. Water is observed seeping in from lower sidewall.

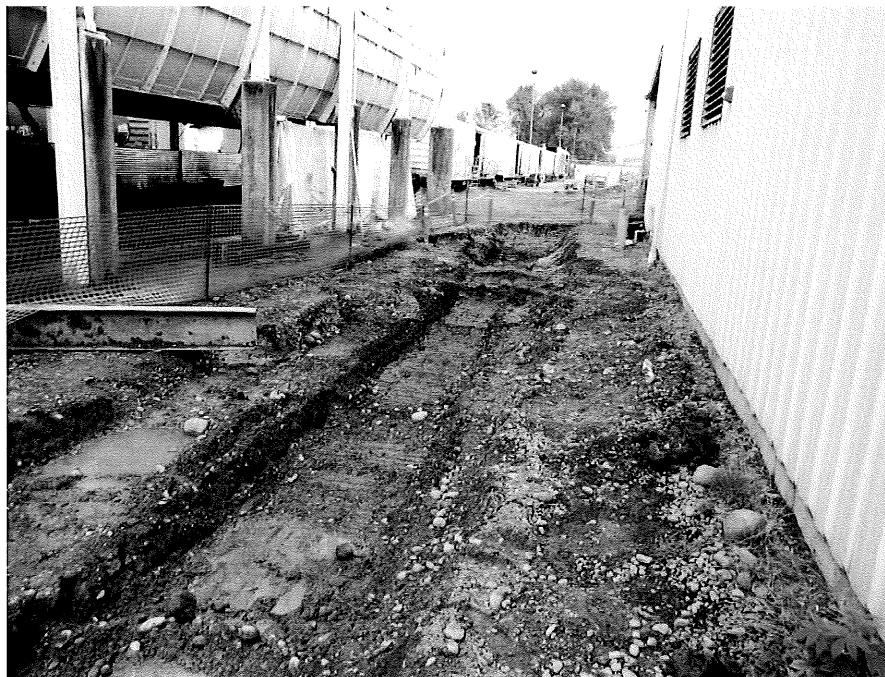
Photograph No. 8: View of the trench area backfilled, facing east.

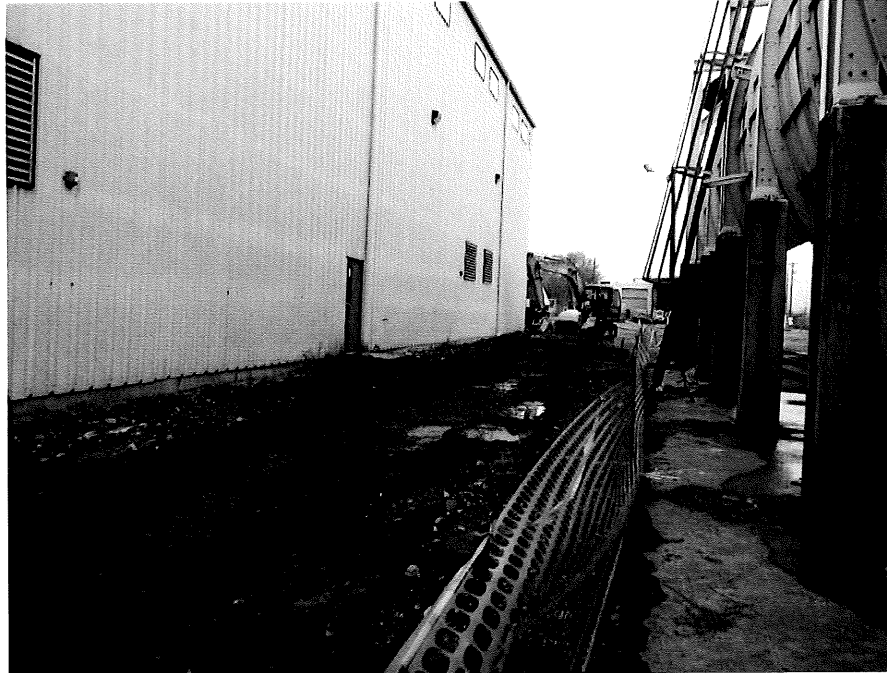
Photograph No. 9: View of the excavation area facing west.

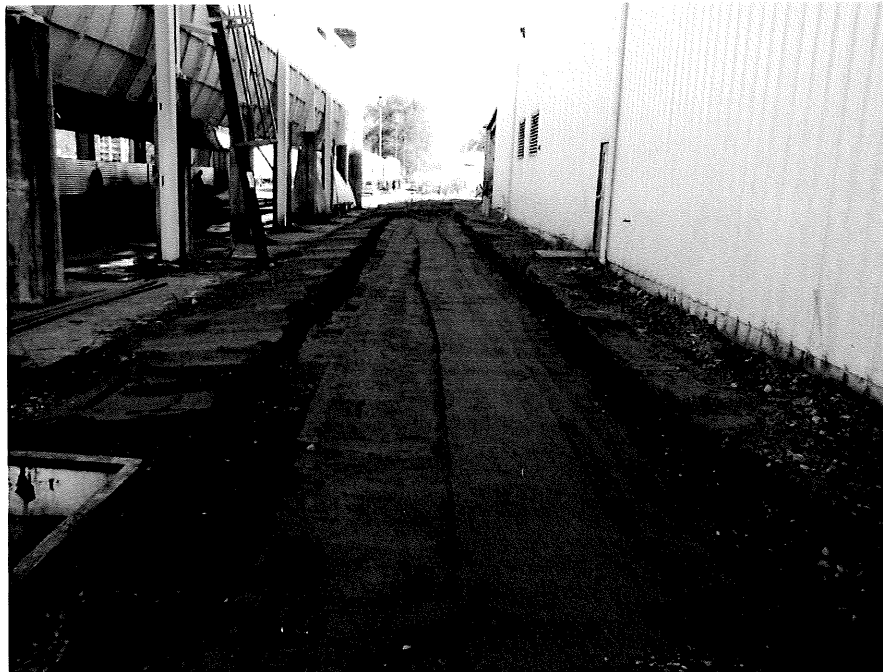
Photograph No. 10: View of the excavation area backfilled, compacted and ready for installation of new filter fabric and gravel railroad base.
