Re: Limited Soil Sampling Summary Letter – ERTS # 646894
Progress Rail Services
4012 SR 509 S Frontage Rd.
Tacoma, Washington 98421
Terracon Project No. 81127060

Limited Soil Sampling
4012 SR 509 S. Frontage Road ■ Tacoma, Washington
April 8, 2014 ■ Terracon Project No. 81127060

Site Diagram
 Progress Rail - ERTS # 646894
 Tacoma, Pierce County, Washington
 Progress Rail Services

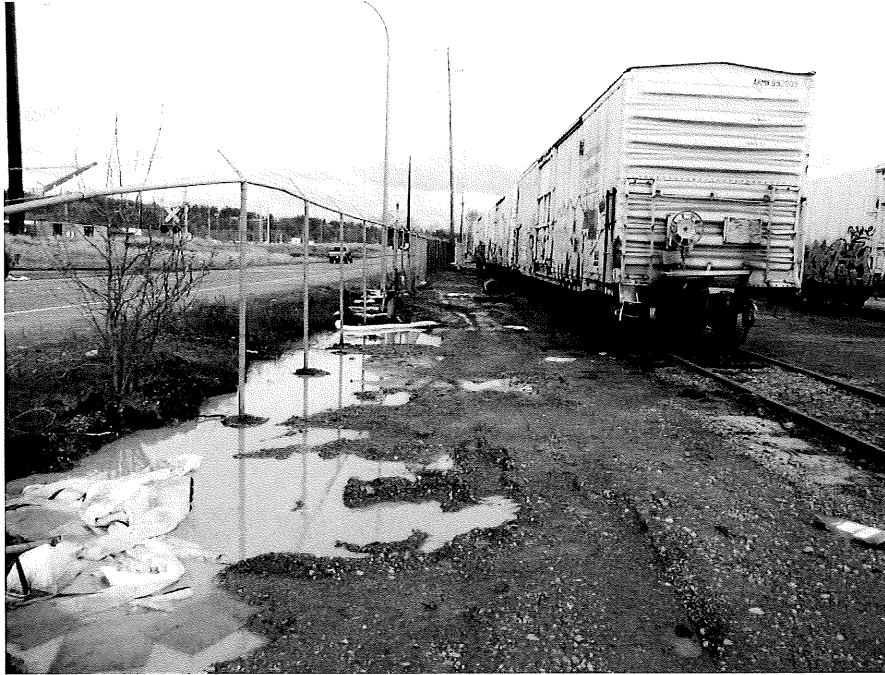
Photograph No. 1: View of the cleanup area with absorbent booms and pads, taken on February 19, 2014, facing east.

Ecology requested that over the next few days that absorbent pads and booms be placed throughout the spill area to absorb any residual diesel that may have remained from the initial cleanup efforts.

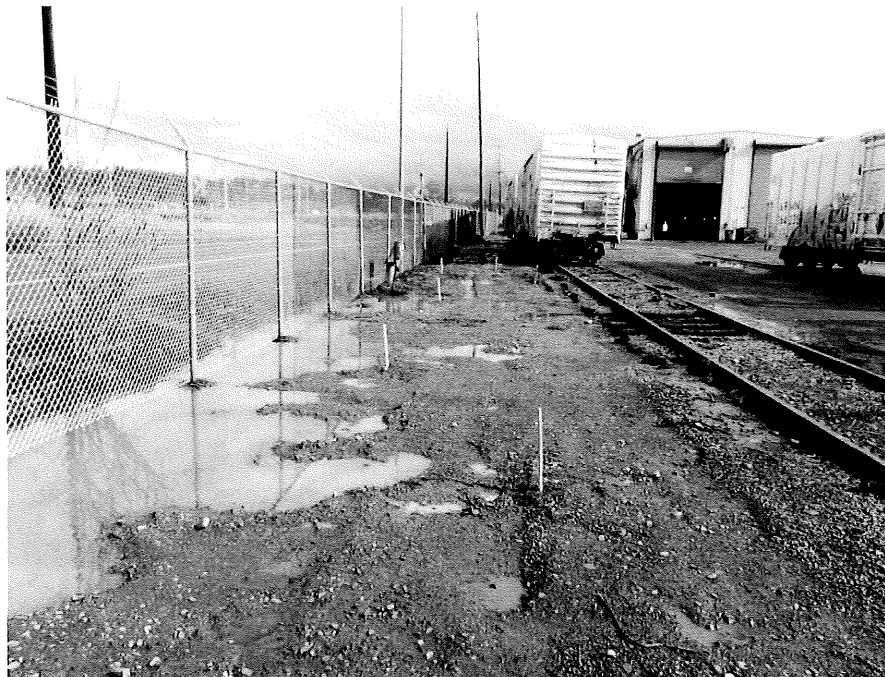
Photograph No. 2: View of the sample locations collected on March 3, 2014, facing east.

Terracon's field representatives, Eric A. Dubcak and Kyle Long, collected a total of sixteen shallow surface soil samples from the base of the NRC excavation on March 3, 2014. The samples were collected from a total of eight sample points located throughout the cleanup area (See Figure 2). A total of two samples were collected per boring, one from the shallow surface and one from a deeper interval. The deeper samples were placed on hold at the analytical laboratory pending results. Soil samples were collected utilizing hand tools (i.e. hand auger) to maximum depths of one foot below grade surface (bgs). The soils consisted of brown gravelly, silty sands in a moist to saturated condition. Due to the dense lithology encountered, the proposed depth of 18-inches below grade surface (bgs) could not be achieved utilizing the hand auger sampling methods.

Concentrations of diesel-range TPH were not reported above laboratory detection limits, except for the samples collected from boring B-6. Concentrations in samples collected from this boring were reported at 260 mg/kg and 310 mg/kg from samples collected at depths of 2 to 6 inches and 7 to 10 inches bgs, respectively. Although there were minor diesel-range TPH concentrations reported in boring B-6, they are both well below the Ecology Model Toxics Control Act (MTCA) Method A clean up level for diesel-range TPH established at 2,000 mg/kg. Additionally, these minor impacts appear to be isolated since diesel-range TPH was not detected at any of the other sampling locations.

Based on the results of this limited sampling completed and the reported cleanup activities conducted by NRC and Progress Rail, it appears that the emergency spill response cleanup was adequate in addressing the cleanup of the reported 480-gallon diesel release that occurred on February 18, 2014. Therefore, Terracon does not recommend any additional sampling at this time.
