Gaco Western LLC  
Tukwila - King Co.  
Release ID: 2576

**RE: SUMMARY OF SUBSURFACE INVESTIGATION AND PRELIMINARY  
REMEDIAL ALTERNATIVES  
GACO WESTERN, INC. FACILITY  
18700 SOUTHCENTER PARKWAY, TUKWILA, WASHINGTON  
FARALLON PN: 841-003**

# **SUMMARY OF SUBSURFACE INVESTIGATION AND PRELIMINARY REMEDIAL ALTERNATIVES GACO Western, Inc. Facility Tukwila, Washington**

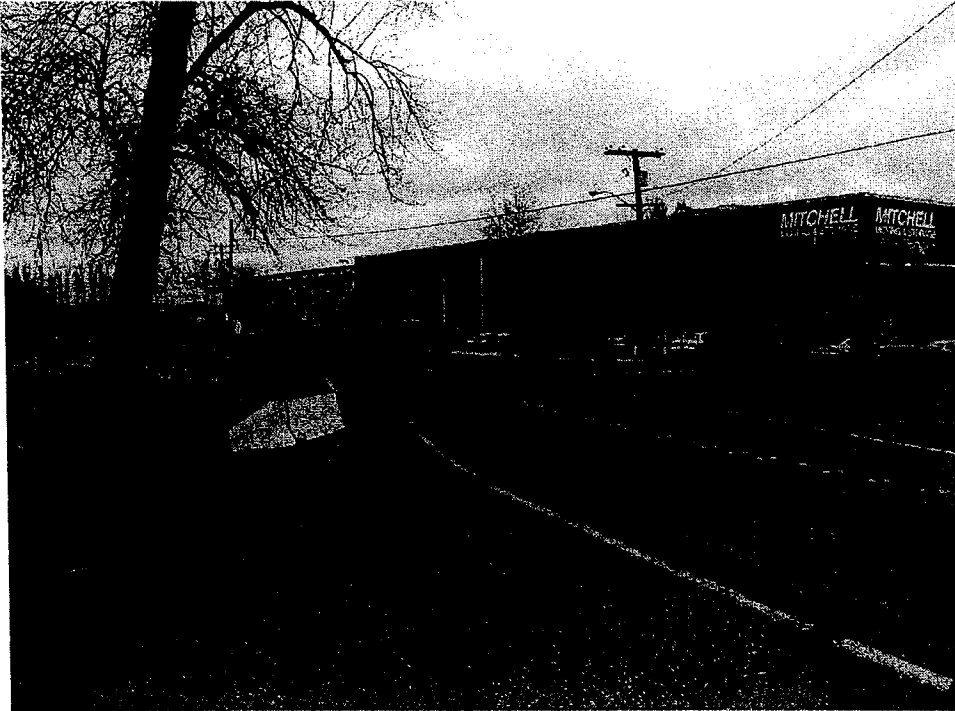
**Photo 1: Southwest Side of Building - from the southwest**

Based upon the site visit conducted on January 8, 2009, the building and asphalt cover at the Site continue to eliminate exposure to contaminated soils by ingestion and direct contact. The asphalt in some locations appears moderately degraded, but it likely continues to prevent direct human contact to contaminated soils; however, it is unknown if it prevents surface water infiltration, carrying additional contaminants remaining in the soil to the groundwater. The Site continues to operate as a commercial facility. A photo log is available as Appendix 6.6.

Based on this periodic review, the Department of Ecology has determined that the requirements of the Restrictive Covenant continue to be satisfactorily met, with the potential noted for degradation of the asphalt surface. It is the property owner's responsibility to continue to inspect the Site to ensure that the integrity of the Site surfaces is maintained. Remedial actions at the Site continue to be protective of human health and the environment, but it should be noted that there appear to be deficiencies in the record regarding establishing a conditional point of compliance for groundwater. It should also be noted that the March 26, 1996 'No Further Action' (NFA) letter from Ecology's Hazardous Waste and Toxics Reduction Program is not the equivalent of an NFA letter from Ecology's Voluntary Cleanup Program (VCP). The 1996 NFA letter only applies to the conclusion of "...field investigative work set forth in MTCA Agreed Order (DE 92HS-N28S)...", not completion of the entire cleanup action. It seems advisable for Gaco Western to enter the VCP to obtain a current NFA letter if such a letter is warranted.
