**June 2016 Groundwater Monitoring  
Columbia Park West Marina  
Richland, Washington**

**RE: GROUNDWATER MONITORING, COLUMBIA PARK WEST MARINA,  
ECOLOGY SITE 84244226, RICHLAND, WASHINGTON**

**JUNE 2016 GROUNDWATER MONITORING  
COLUMBIA PARK WEST MARINA  
RICHLAND, WASHINGTON**

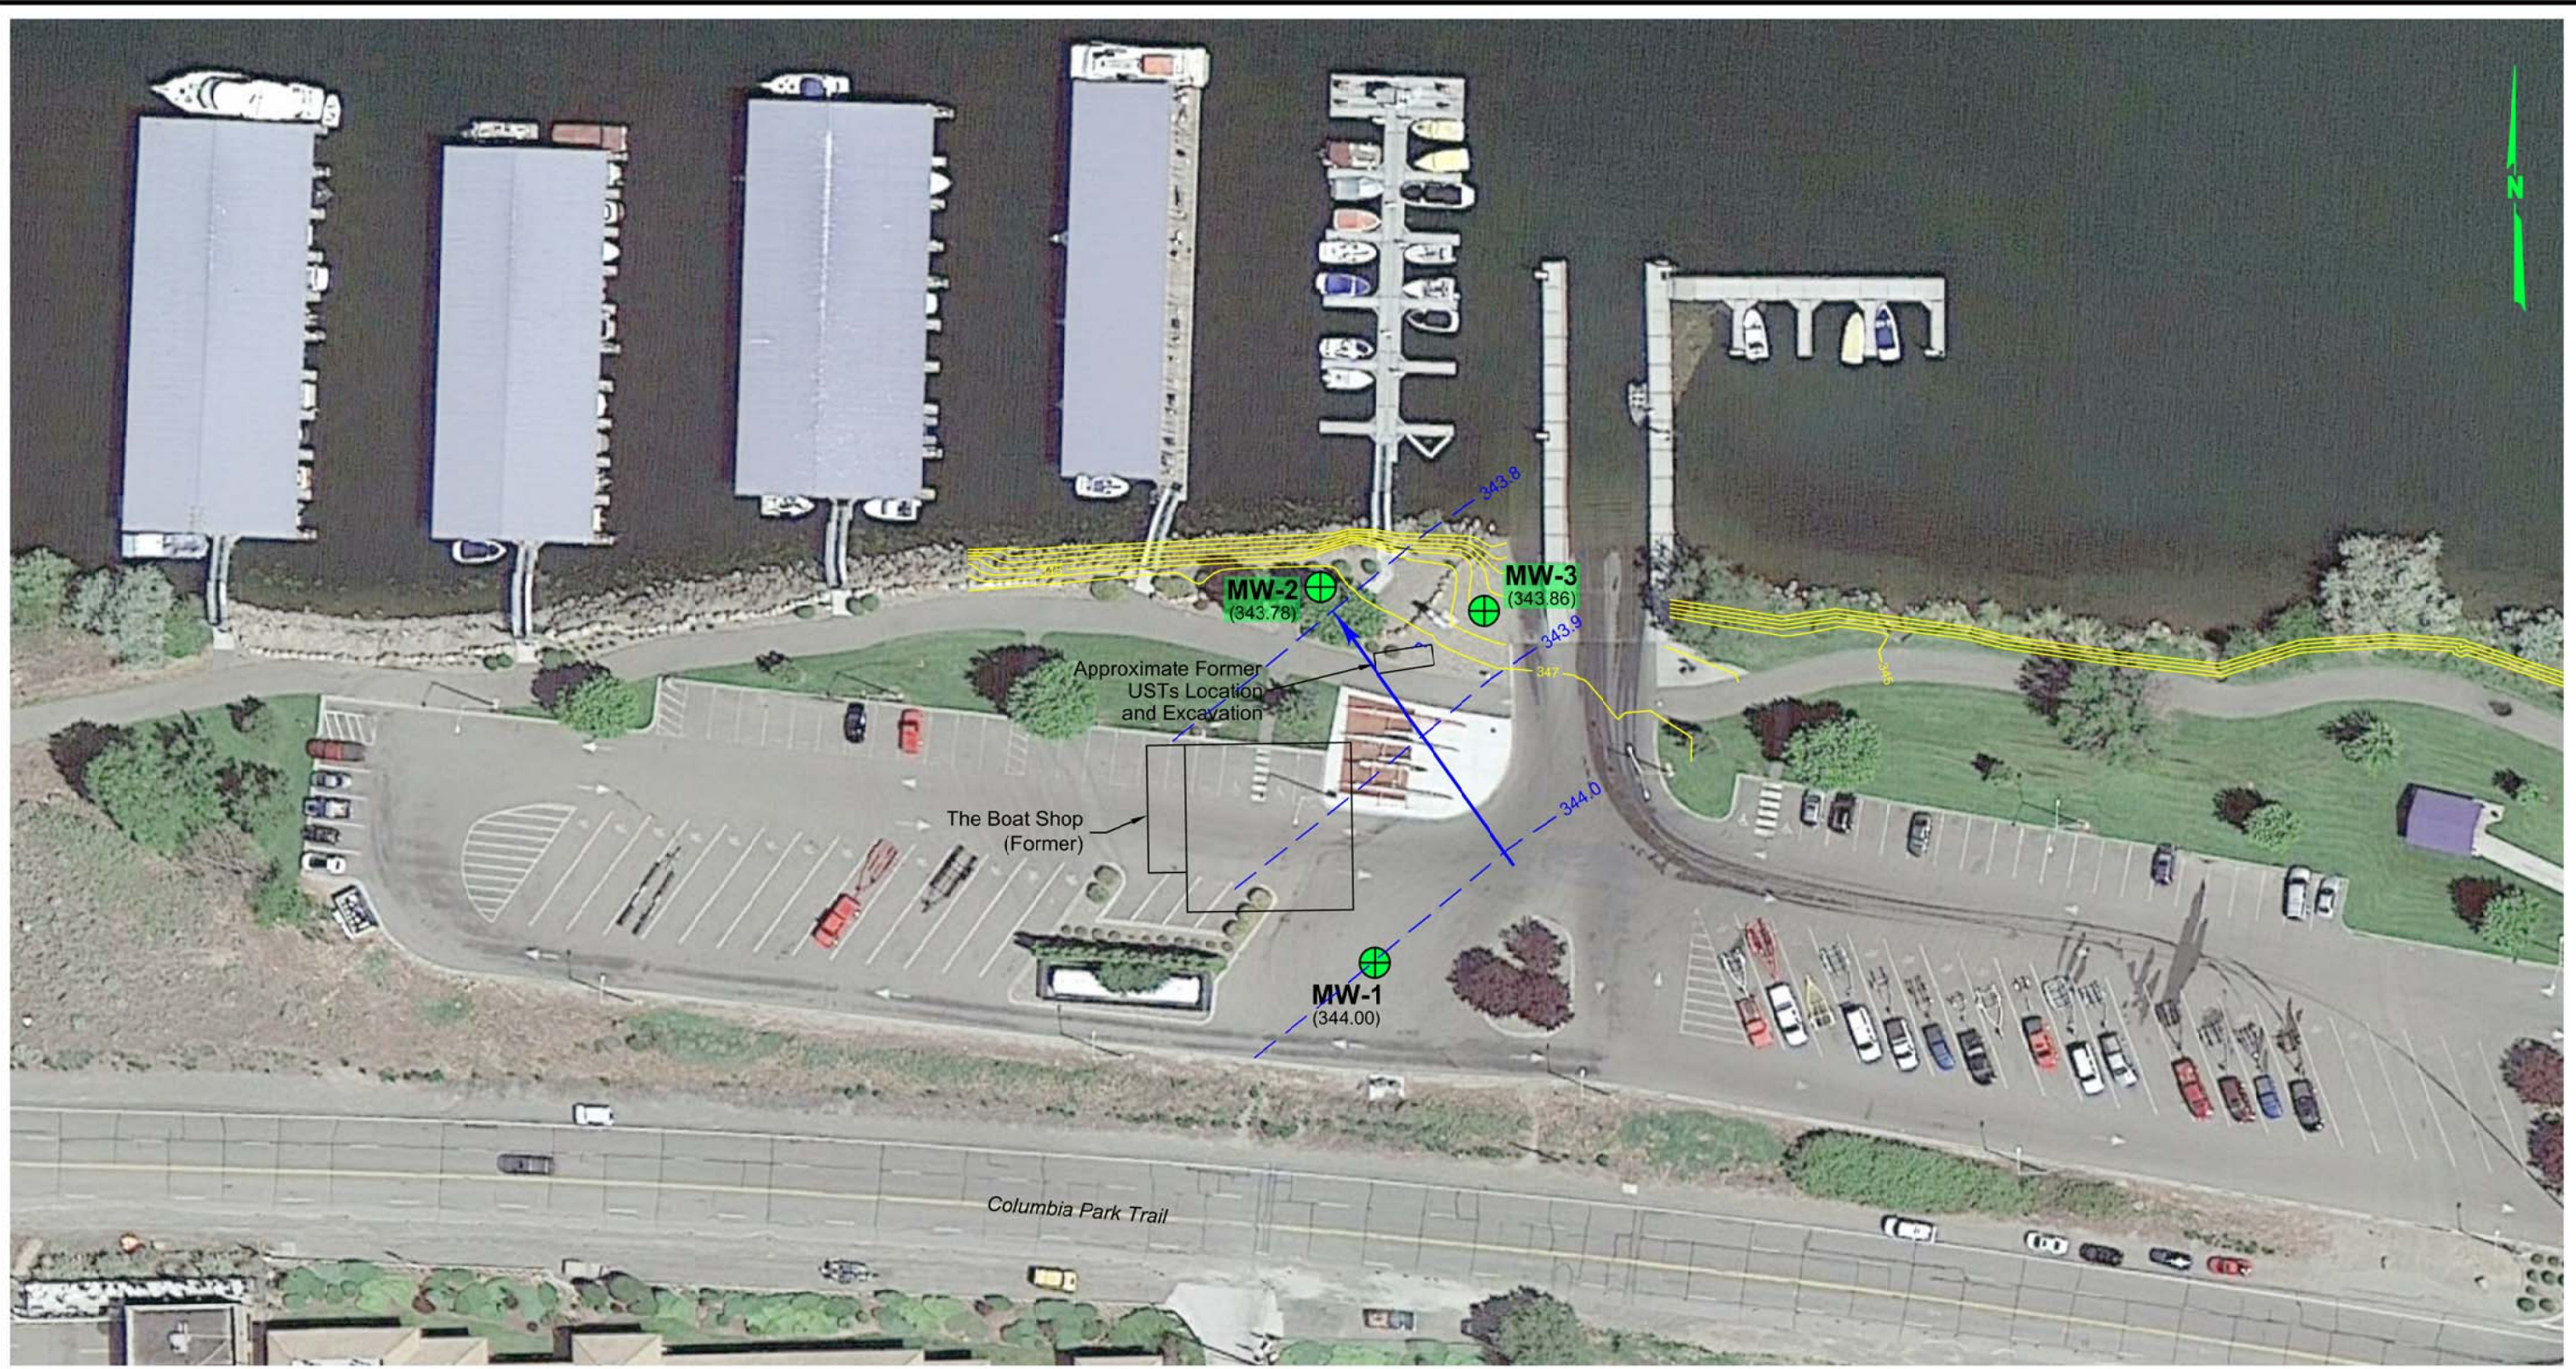
**FIG. 2**

Groundwater elevation measurements from the previous and current monitoring events are summarized in Table 1. Figure 2 shows approximate groundwater elevation contours and the groundwater flow direction on June 29, 2016, which was toward the northwest.

- MW-1** Monitoring Well Designation and Approximate Location (Groundwater Elevation in Feet, 6-29-16)
- 343.8 Approximate Groundwater Elevation
- Approximate Groundwater Flow Direction

**SITE PLAN AND  
MONITORING WELL LOCATIONS**

According to a tank closure report (White Shield, 1994) two 1,000-gallon leaded gasoline USTs were removed in April 1994. Based on drawings and descriptions in the report, the tanks and dispensers were located approximately 40 feet south of the Columbia River and west of the boat launch ramp. The estimated former UST and The Boat Shop locations are shown on Figure 2.
