PERIODIC REVIEW REPORT FINAL

Wolfe and Parks Properties Facility Site ID#: 7937547 Cleanup Site ID#: 342

149 & 167 East Main Avenue Morton, Washington 98356

TOXICS CLEANUP PROGRAM

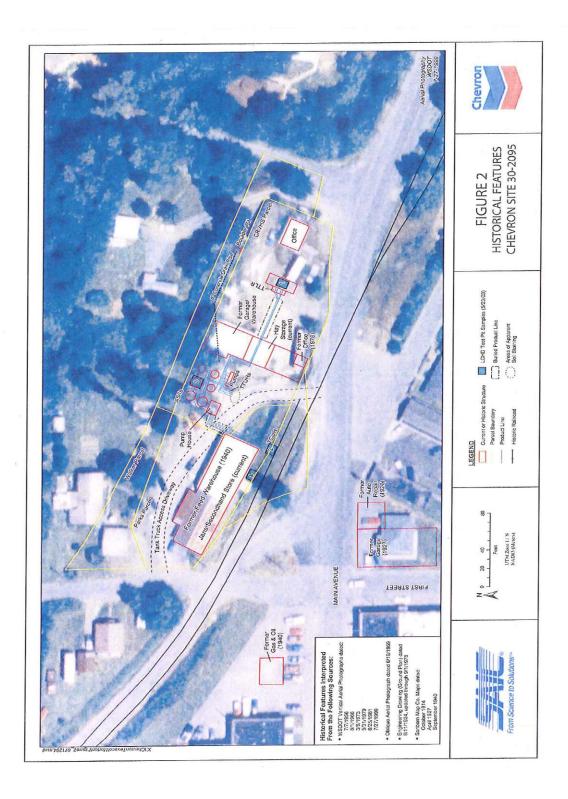
6.3 Site Historical Features

The Site is located at 149 and 167 Main Avenue, Morton in Lewis County, Washington. The Site was a former bulk terminal located near the northeast corner of the intersection of Main Avenue and First Street in Morton, Washington. The terminal was fenced and included six above-ground storage tanks (ASTs; two 19,000-gallon, one 13,000-gallon, and three 6,000-gallon tanks) for storing gasoline, diesel, kerosene, and heating oil. The terminal also included tank truck and rail car unloading headers (TTUHs and TCUHs), tank truck loading racks (TTLRs), and a pump house. Other structures included a 2,500 square-foot building, portions of which were used as a garage, a warehouse for storage of drummed petroleum products (oil and grease), product load-out, and 300 square-foot office space. Figure 2 in Appendix 6.3 shows the Site historical features.

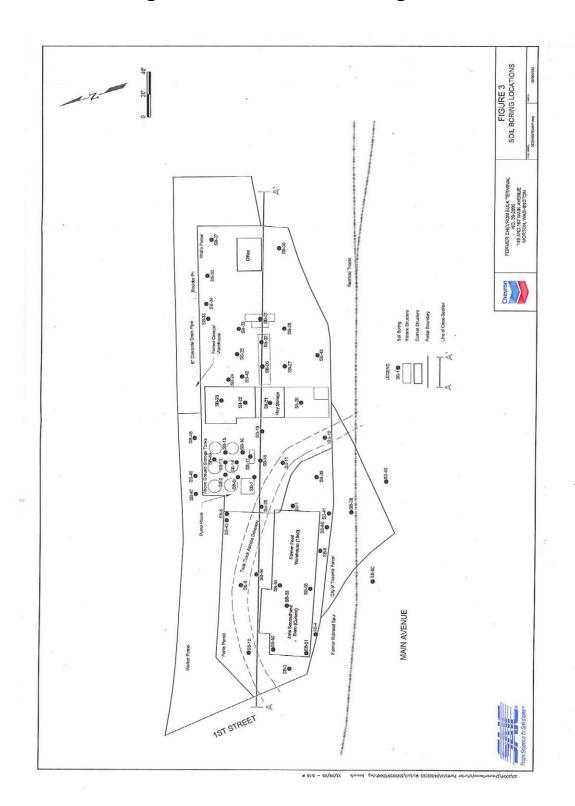
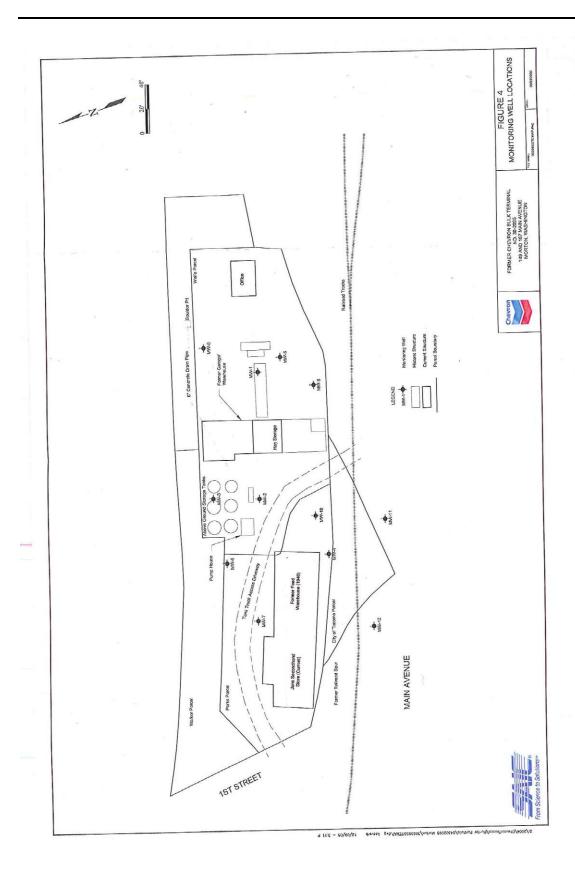
6.3 Soil Boring and Grundwater Monitoring Well Locations

Soil and groundwater investigations were conducted from May through October of 2004 to define the nature and extent of contamination. As a part of this investigation a total of 55 soil borings and 12 groundwater monitoring wells were installed. Soil borings and groundwater monitoring wells locations are included as Appendix 6.4. TPH-G is the most widespread contamination at the Site occurring in concentrations above MTCA Method A cleanup levels throughout the ASTs area, between the AST area and the railroad tracks, beneath the northern portion of the warehouse, and to the south and southeast of the warehouse.

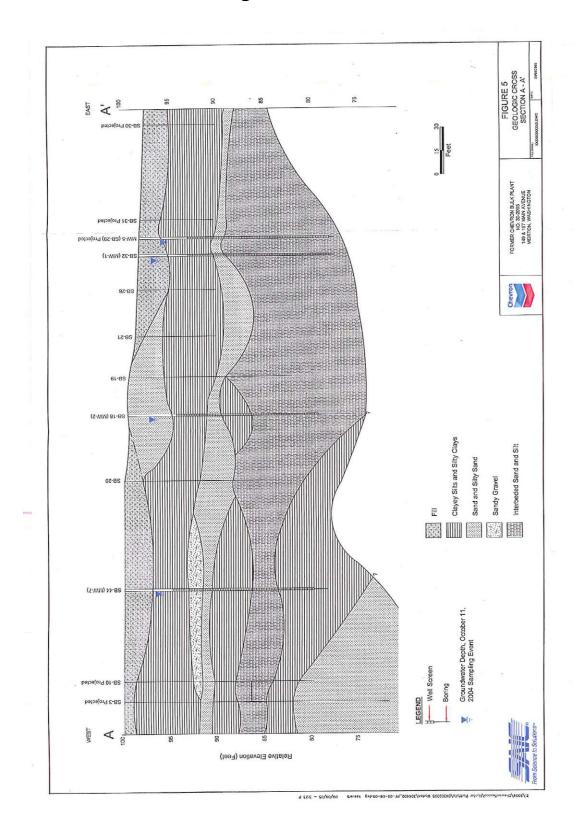
6.5 Site Eastwest Geologic Cross-Section A-A'

Soil boring logs indicated that the Site is underlain by unconsolidated materials consisting of fill and alluvial deposits. The uppermost unit at the Site is fill that typically ranges between one to four feet in thickness, but is absent in places. The fill consists of poorly sorted silt, and gravel. Below the fill is a sequence of mottled silts and clays, organic-rich in places, that is split by a thin sand and/or sandy gravel. The coarse-grained unit occurs at a depth of between 8 to 12 feet and is continuous across a portion of the Site. The lower units that have been investigated at the Site consists mostly of thinly interstratified silts and sands. Groundwater is generally present between 5 to 10 feet below the ground surface in the vicinity of the Site. An east-west geologic cross-section is included as Appendix 6.5.

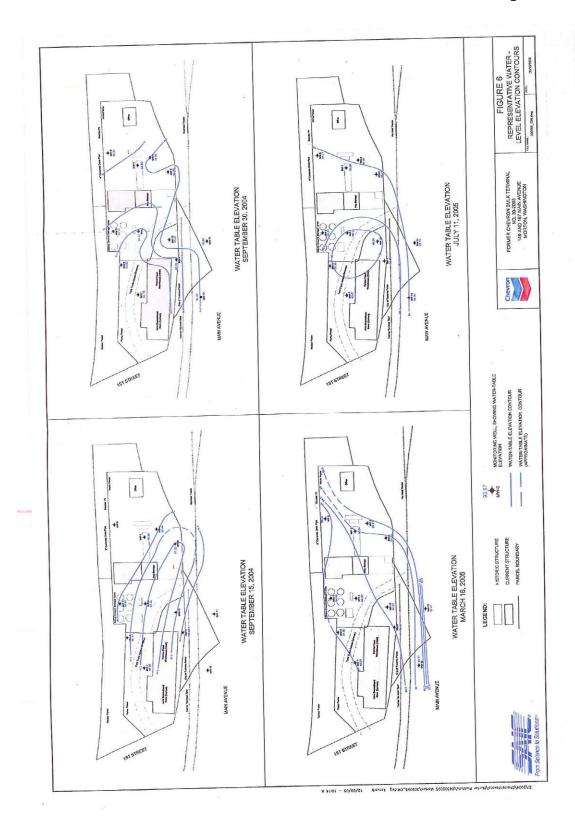
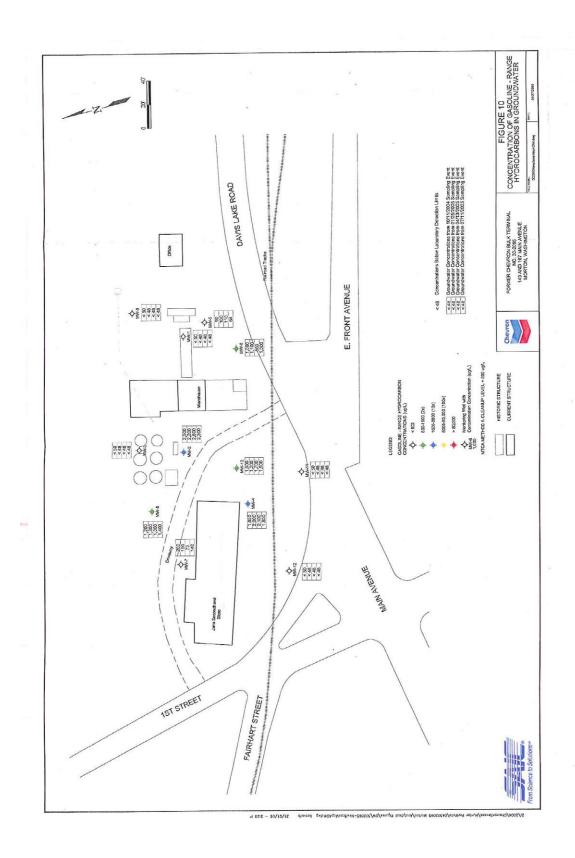
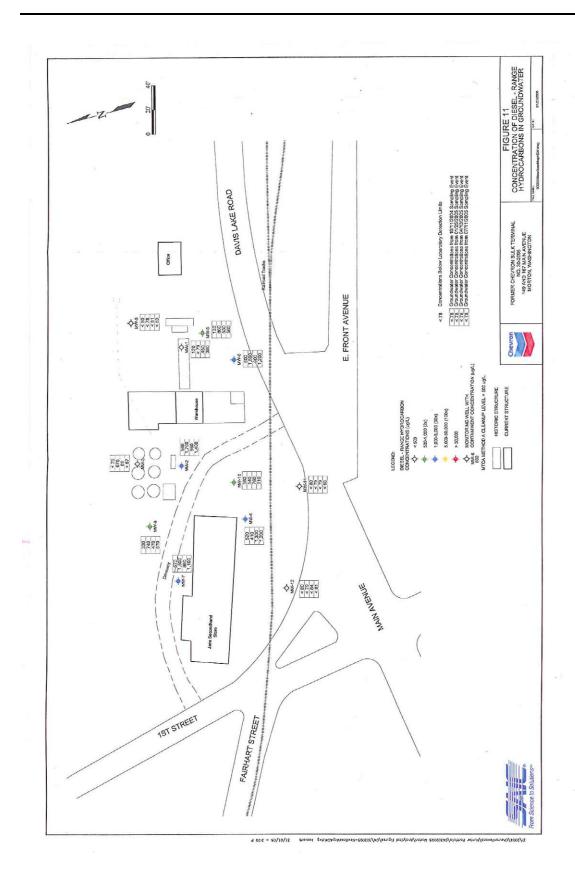
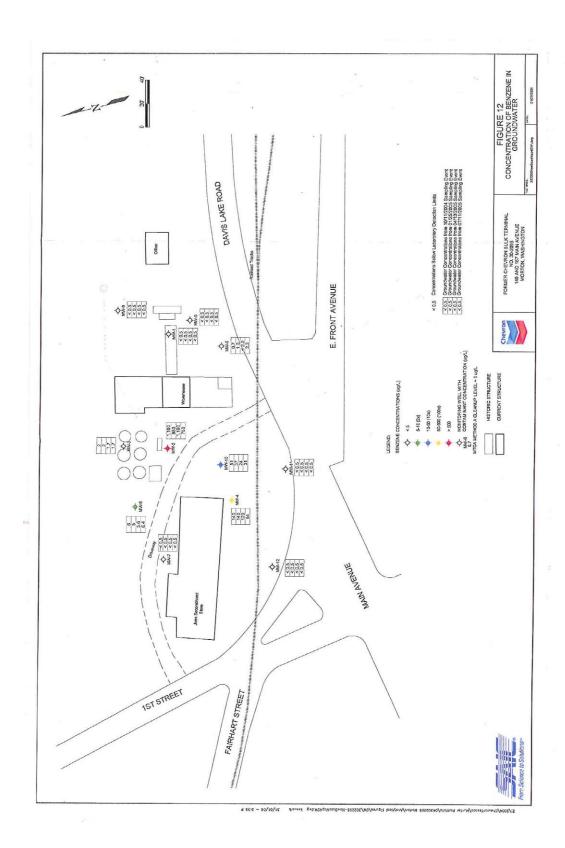
6.7 Water Level Elevation Contours and Groundwater Sample Results

Four rounds of quarterly groundwater monitoring was conducted from October 2004 through July 2004 for defining the extent of groundwater contamination. All the groundwater samples were analyzed for the same parameters as soil samples. Based on the results, TPH-G, TPH-D, TPH-O, and benzene were identified as COPCs at the Site. The groundwater sample results indicated that TPH-G, TPH-D, and benzene concentrations ranged from 860 micrograms per liter (μ g/l) to 2,800 μ g/l; 630 μ g/l to 1,800 μ g/l; and 5.6 μ g/l to 1,100 μ g/l, respectively. These concentrations exceeded their MTCA Method A cleanup levels of 800 μ g/l; 500 μ g/l; and 15 μ g/l, respectively. Groundwater monitoring well locations, water level elevations and groundwater sample results are included as Appendix 6.7.

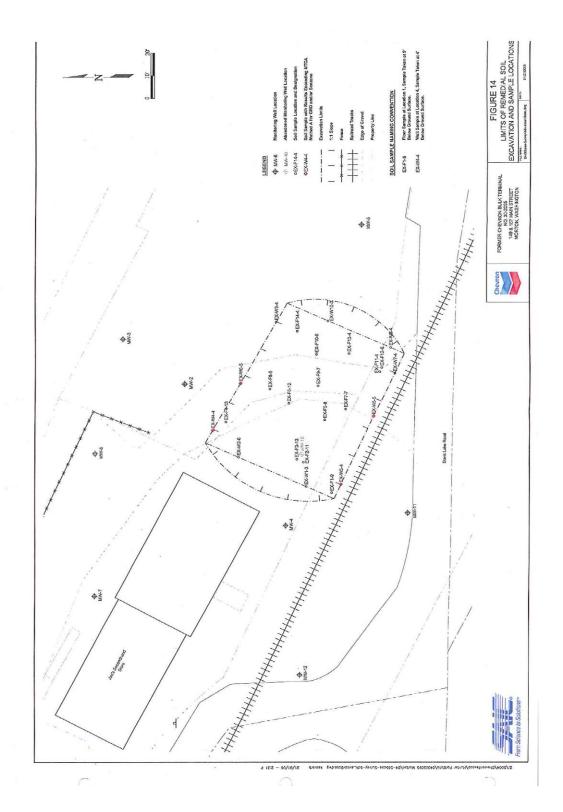
6.8 Interim Action Remedial Excavation Area and Confirmation Soil Sample Results

An interim action was performed in October 2005. The interim action involved removing approximately 1,290 tons (860 cubic yards) of petroleum-contaminated soil from the southcentral portion of the Site in order to accommodate the movement of an historical railroad depot onto the CRVHS property. This action consisted of the excavation of contaminated soil beneath the footprint of the depot, properly disposing of the excavated soil, collecting and analyzing performance monitoring samples using an onsite mobile laboratory, and backfilling the excavation with clean, compacted material. The completed excavation measured approximately 60 feet by 70 feet and ranged in depth between 4 feet (east end) and 13 feet (west end) below ground surface. All the excavated soil was transported to Rinker Materials Northwest in Everett, Washington, where it was treated using the low-temperature thermal desorption. The results of confirmation soil samples collected at floor of the excavation were all below the MTCA Method A cleanup levels. TPH-G and benzene were detected above MTCA Method A cleanup levels in some of the sidewall samples beyond the depot footprint. However, the interim action was not intended to remove petroleum-contaminated soil beyond the depot footprint. The remaining soil contamination was addressed as part of the final cleanup action at the Site. The approximate extent of soil excavation and the confirmation soil sample results are included as Appendix 6.8.

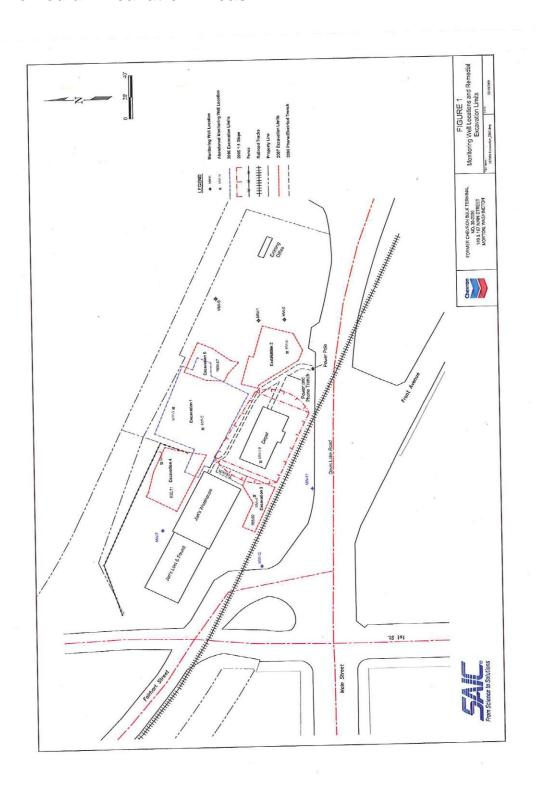
6.8A: Remedial Excavation Areas

In November 2006, the final cleanup action was conducted under an Enforcement Order No. DE 3683. As a part of this action, a total of approximately 600 cubic yards of contaminated soil was excavated exceeding the remediation level for direct contact/ingestion by human pathway (MTCA Method B cleanup level of 2,225 mg/kg for total petroleum hydrocarbons and 250 mg/kg lead) and soil exceeding remediation level for the vapor pathway (0.03 mg/kg benzene). All the excavated soil was transported to the Waste Management Inc. landfill in Hillsboro. Oregon for disposal. The groundwater was treated with the addition of ORC into the excavation. The addition of ORC to the contaminated groundwater accelerates the natural biodegradation process by increasing the oxygen levels in the groundwater. In addition, two heating oil above ground storage tanks were also removed and associated stained soil was excavated for disposal. Approximately 9,700 square feet of area of the Site was paved with asphalt over the soils left on Site posing risk to ecological receptors (i.e., contaminant concentrations exceeding TEE cleanup levels as presented in Table 1 above). A long term groundwater monitoring plan was implemented at the Site. Figures showing the approximate extent of soil excavation areas, extent of petroleum contaminated soils left in place and asphalt paved areas are included as Appendix 6.9A and 6.9B, respectively.

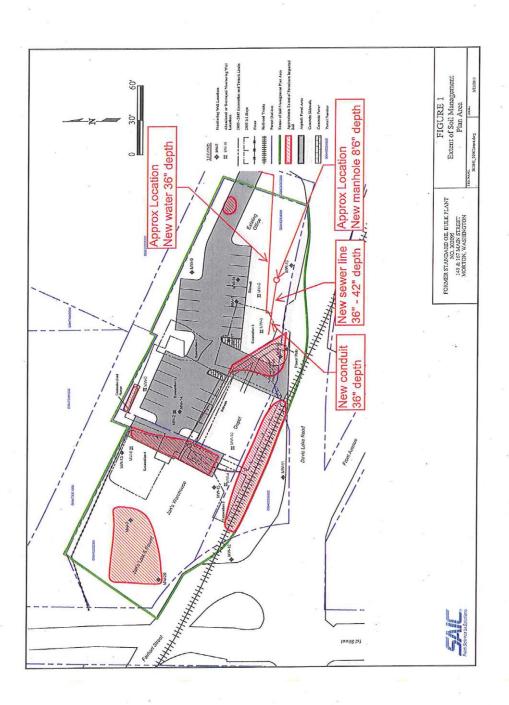
6.8B: Approximate Extent of Soil Contamination Left on the Site/Soil Management Area

Soils remain at the Site with TPH-G, TPH-D and benzene concentrations exceeding MTCA Method A cleanup levels. The contaminated soils remain contained beneath asphalt pavement and buildings. The TPH-G concentration in groundwater exceeds MTCA Method A cleanup level. The presence of institutional controls including the restrictions on groundwater use will protect human health and the environment from residual soil and groundwater contamination present on the Site. Compliance groundwater monitoring is being conducted at the Site on a quarterly basis.

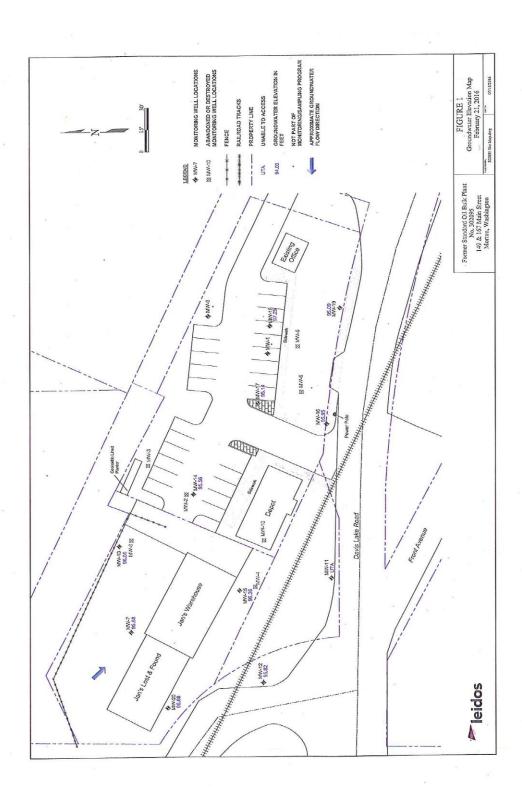
6.9 Compliance Groundwater Monitoring Well Locations and Monitoring Results for Monitoring Wells MW-7, MW-15 and MW-16

As part of the approved Compliance Groundwater Monitoring Plan (October 2008), a total of eleven wells were selected for the long term compliance groundwater monitoring. Since the implementation of the final remedial action in October 2008, a total of thirty (30) rounds of quarterly groundwater monitoring have been conducted at the Site. All the groundwater samples were analyzed for the parameters as discussed in section 2.3.3 above. During this eight years of monitoring, only TPH-G and TPH-D were detected above MTCA Method A cleanup levels in three groundwater monitoring wells (MW-7, MW-15 and MW-16). No other contaminants were detected in any of the other eight monitoring wells. Results of the latest round of quarterly groundwater monitoring conducted in February 2016 indicated the exceedance of TPH-G in only one monitoring well (MW-16) at a concentration of 1,800 µg/l. None of the other analyzed constituents were detected at concentrations above MTCA Method A cleanup levels. During this round the depth of groundwater varied from 3 feet to 5 feet and the approximate groundwater flow was towards southeasterly direction. Groundwater monitoring well locations, approximate groundwater flow direction and monitoring results are included as Appendix 6.9.

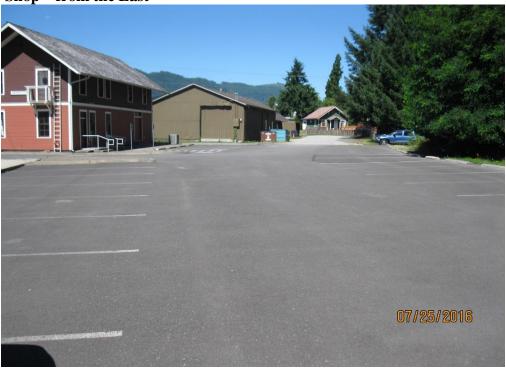
Photo 1: Asphalt Pavement, Train Depot Museum and Jan's Lost & Found Thrift Shop – from the East

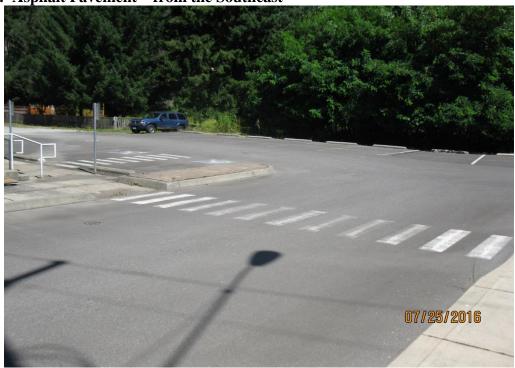
Photo 2: Asphalt Pavement – from the Southeast

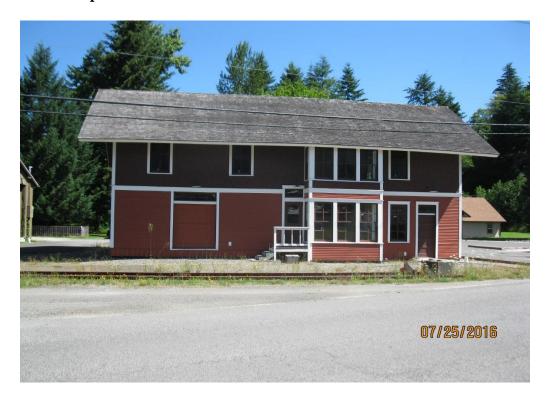
Photo 3: Train Depot Museum and – from the South

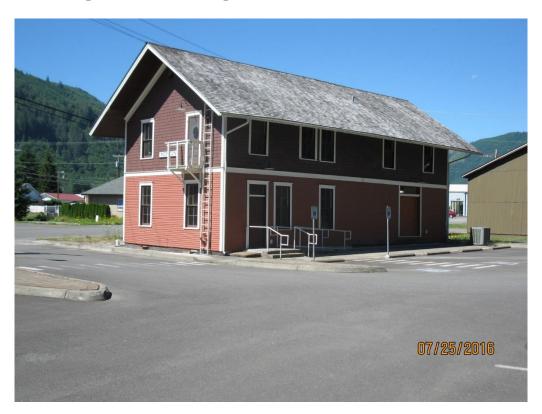
Photo 4: Train Depot Museum and Asphalt Pavement – from the Northeast

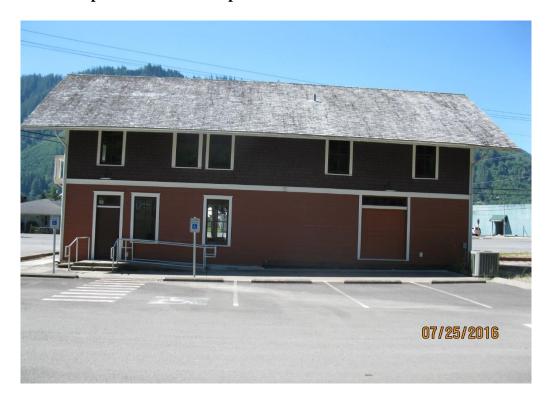
Photo 5: Train Depot Museum and Asphalt Pavement – from the North

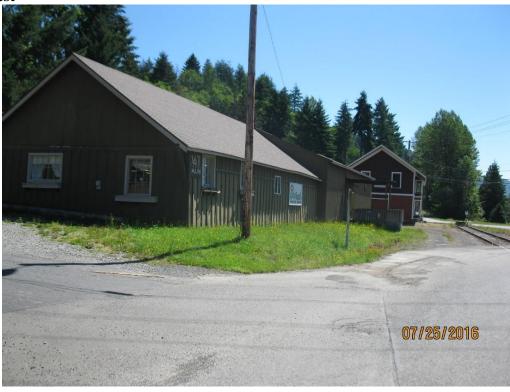
Photo 6: Jan's Lost & Found Thrift Shop and the Train Depot Museum-from the Southwest

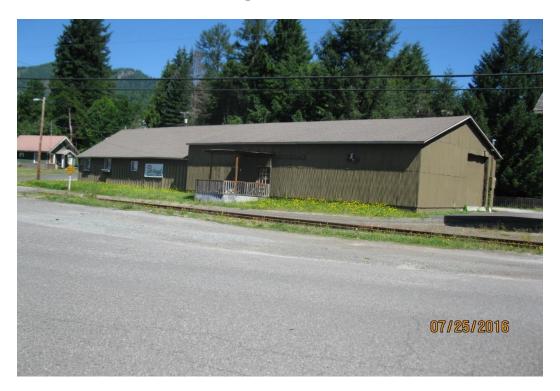
Photo 7: Jan's Lost & Found Thrift Shop – from the Southeast

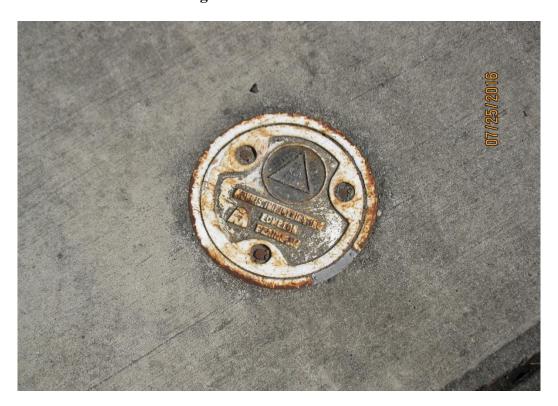
Photo 8: Groundwater Monitoring Well MW-09
