Unocal Edmonds Bulk Fuel Terminal
Years of Operation: 1923 to 1991

**Interim Actions were
conducted between
2001 and 2008**

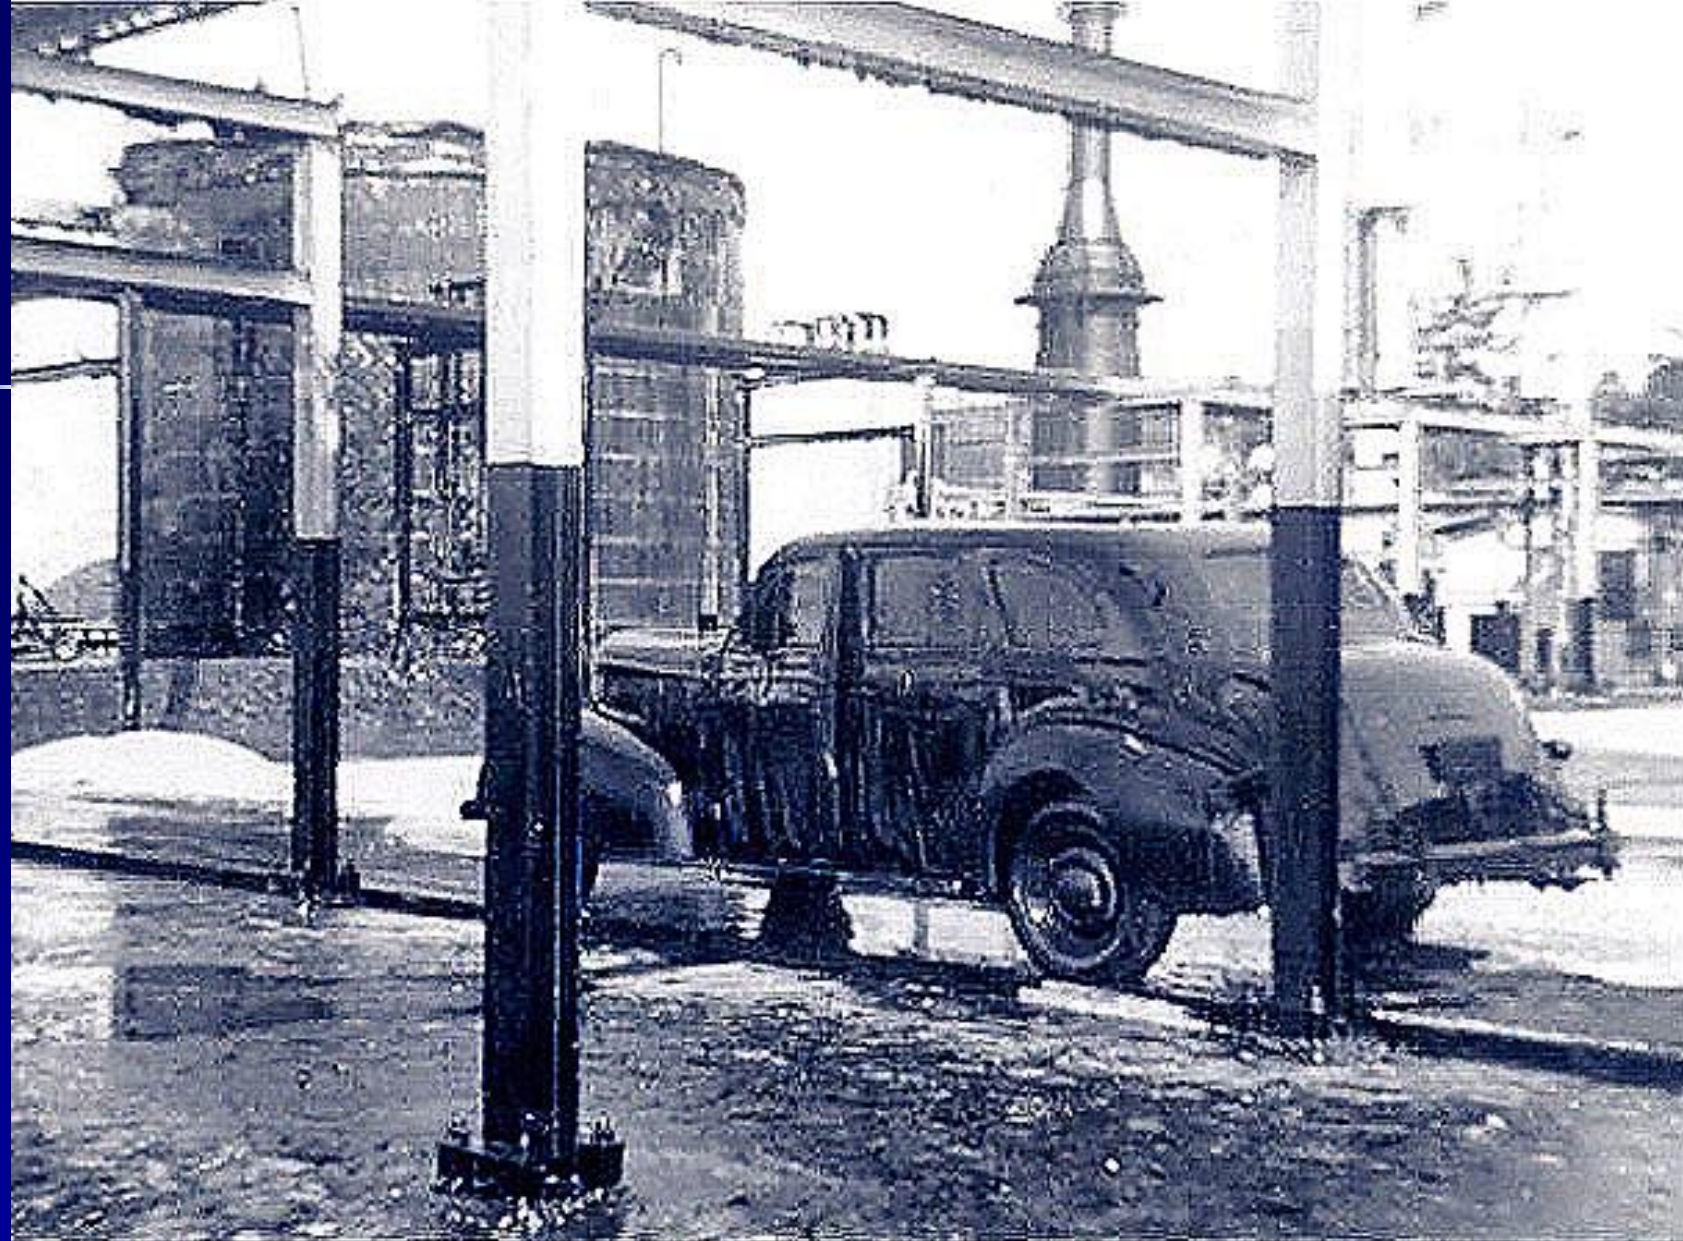
131:43e

Tanks occasionally erupted or "boiled over". In this you can see the result of parking your car too close to a tank - a nice asphalt coating.

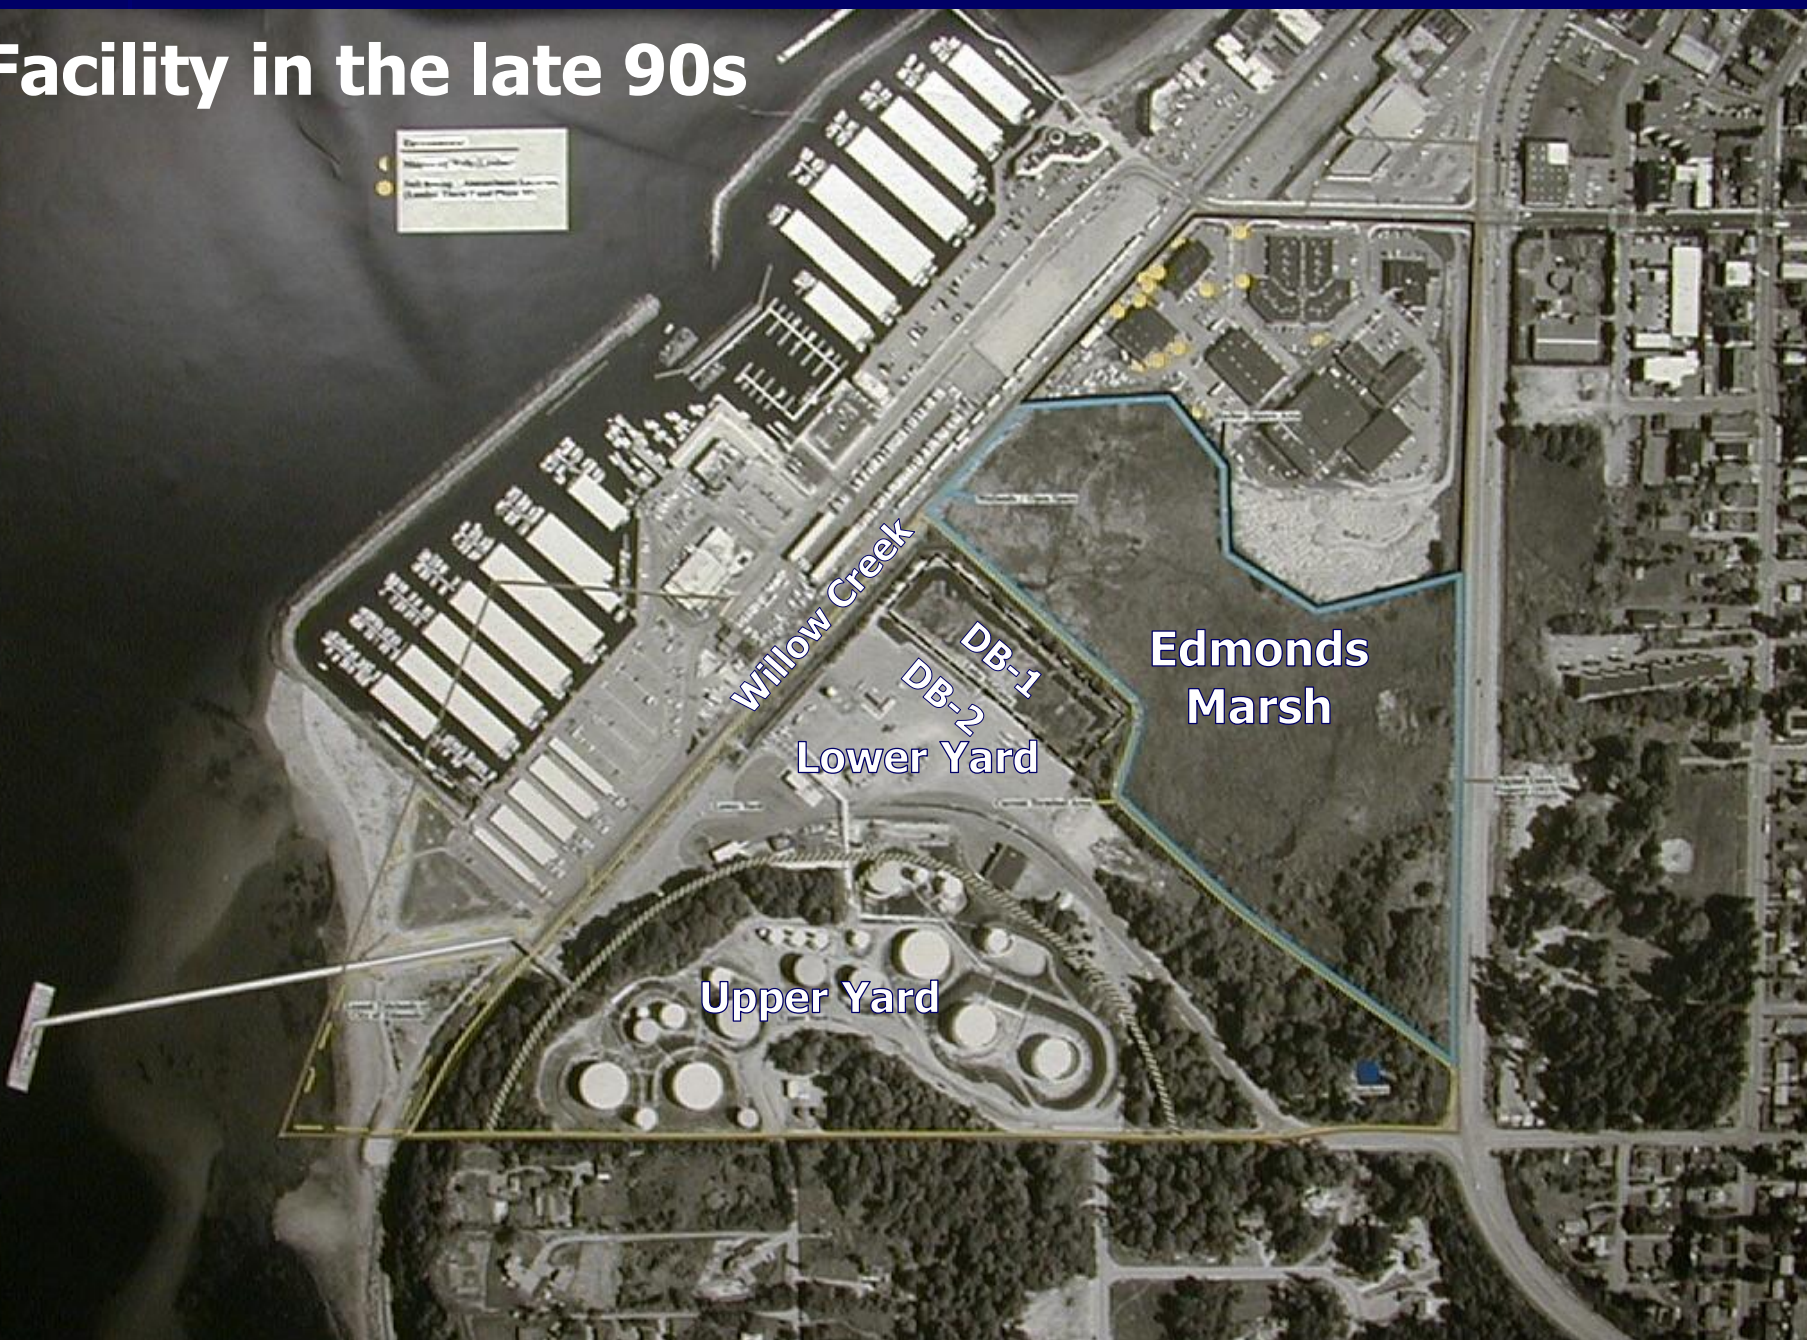
Willow Creek

DB-1
DB-2
Lower Yard

Edmonds Marsh

Upper Yard

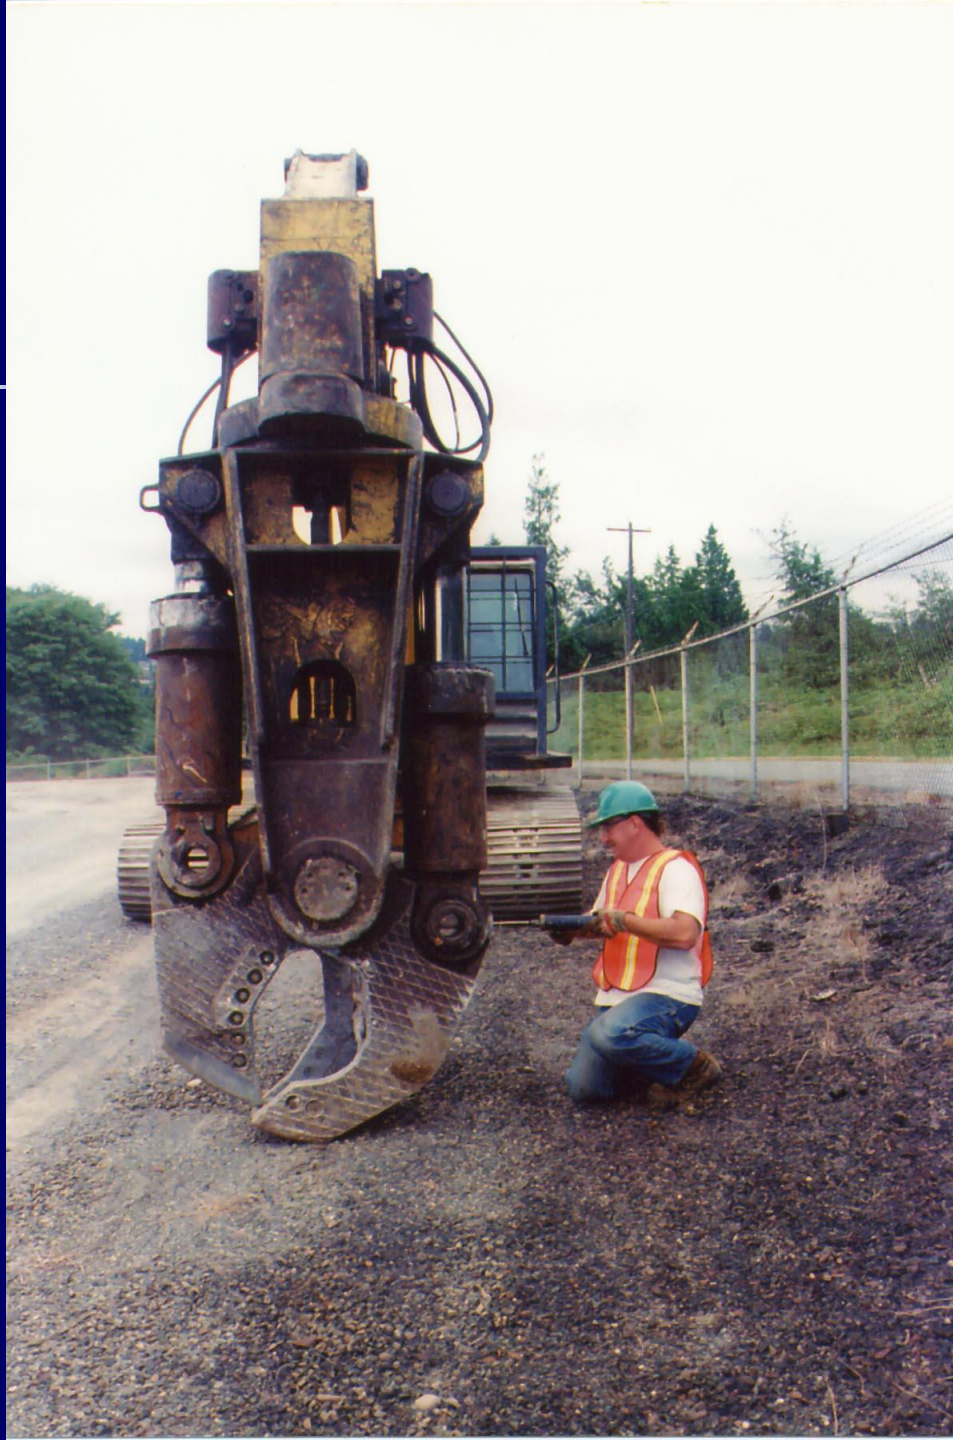
**The bulk tanks
were cut up
and trucked to
the scrap yard**

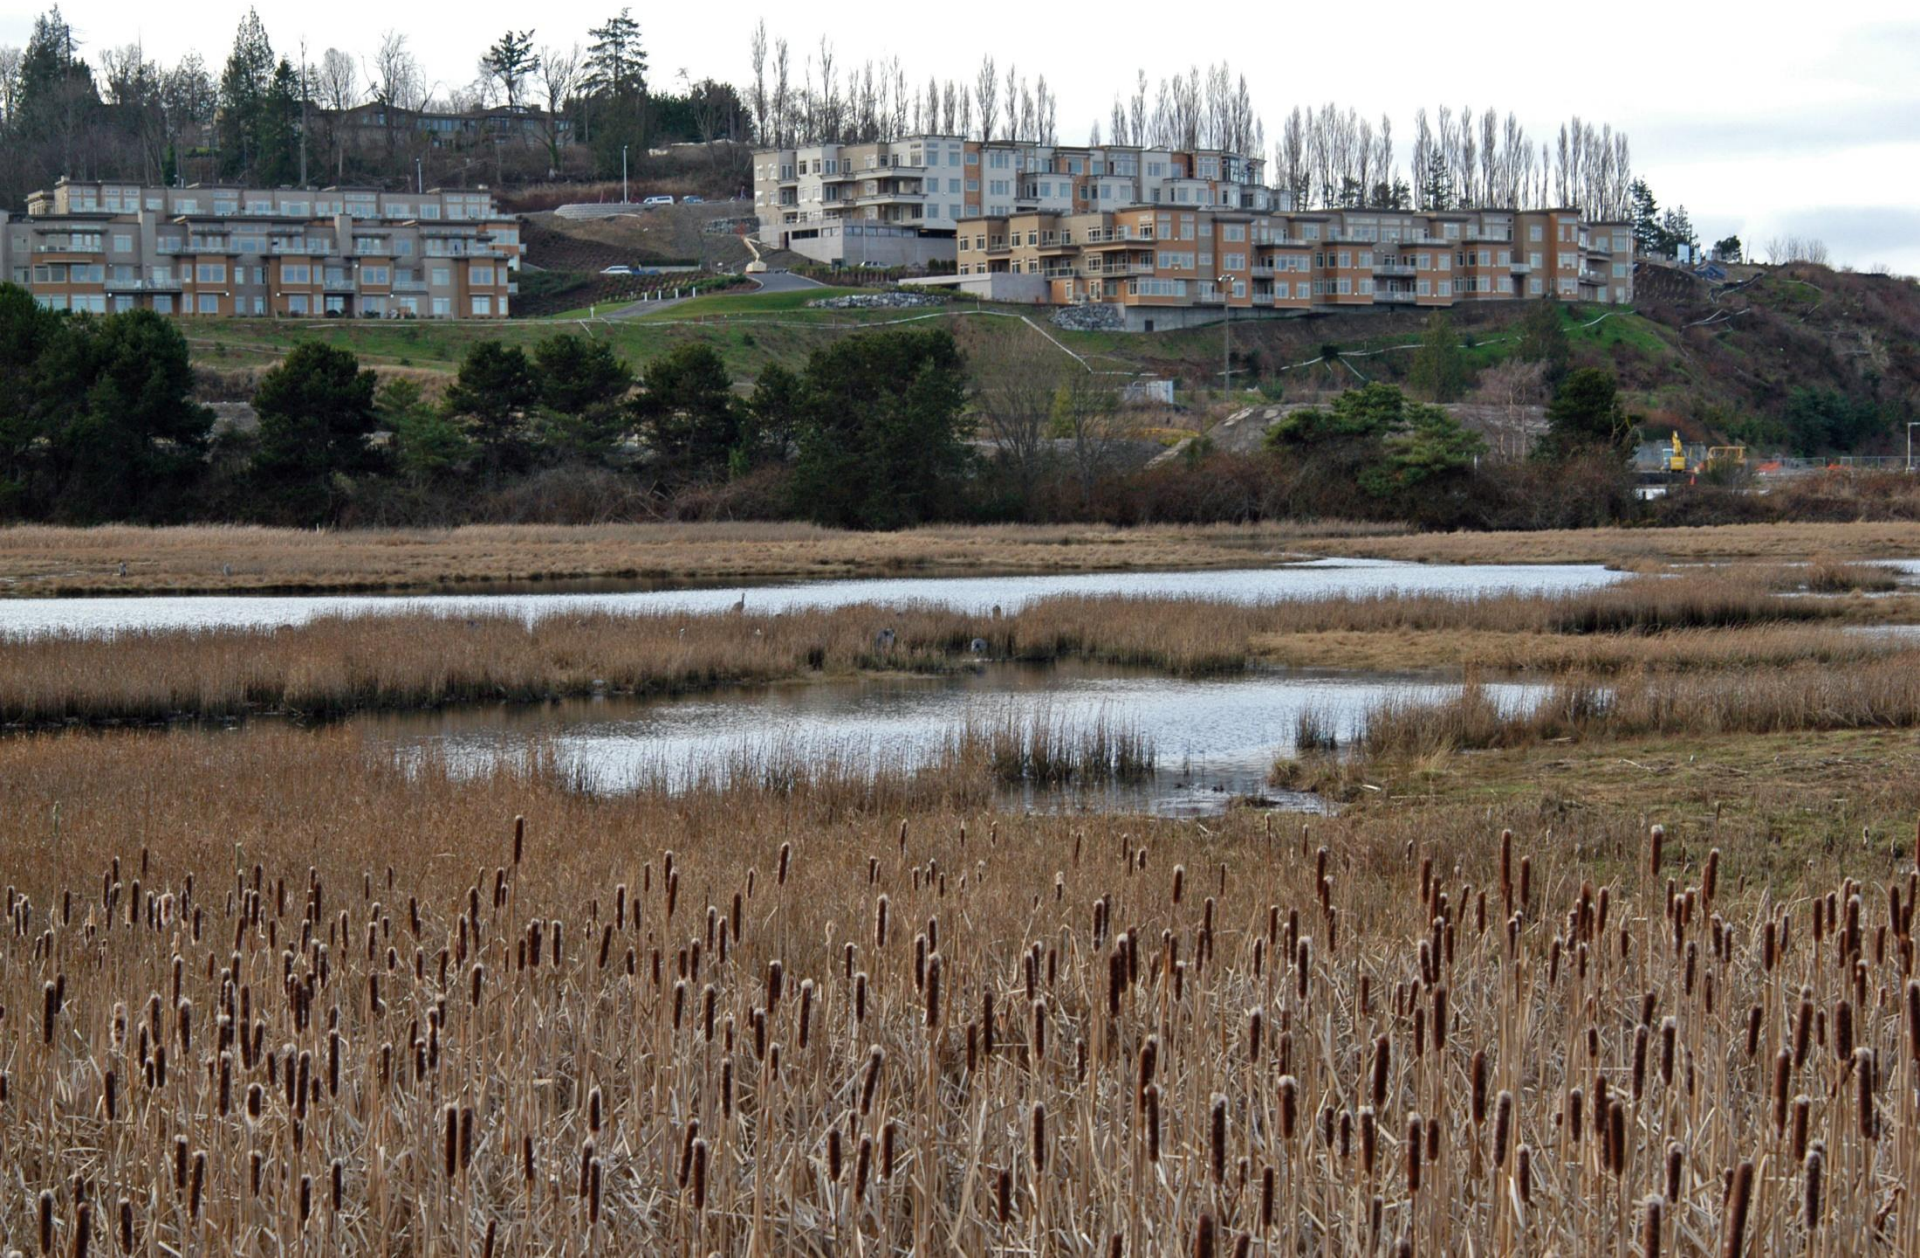
February 2007

Contaminated soil was removed from the upper yard

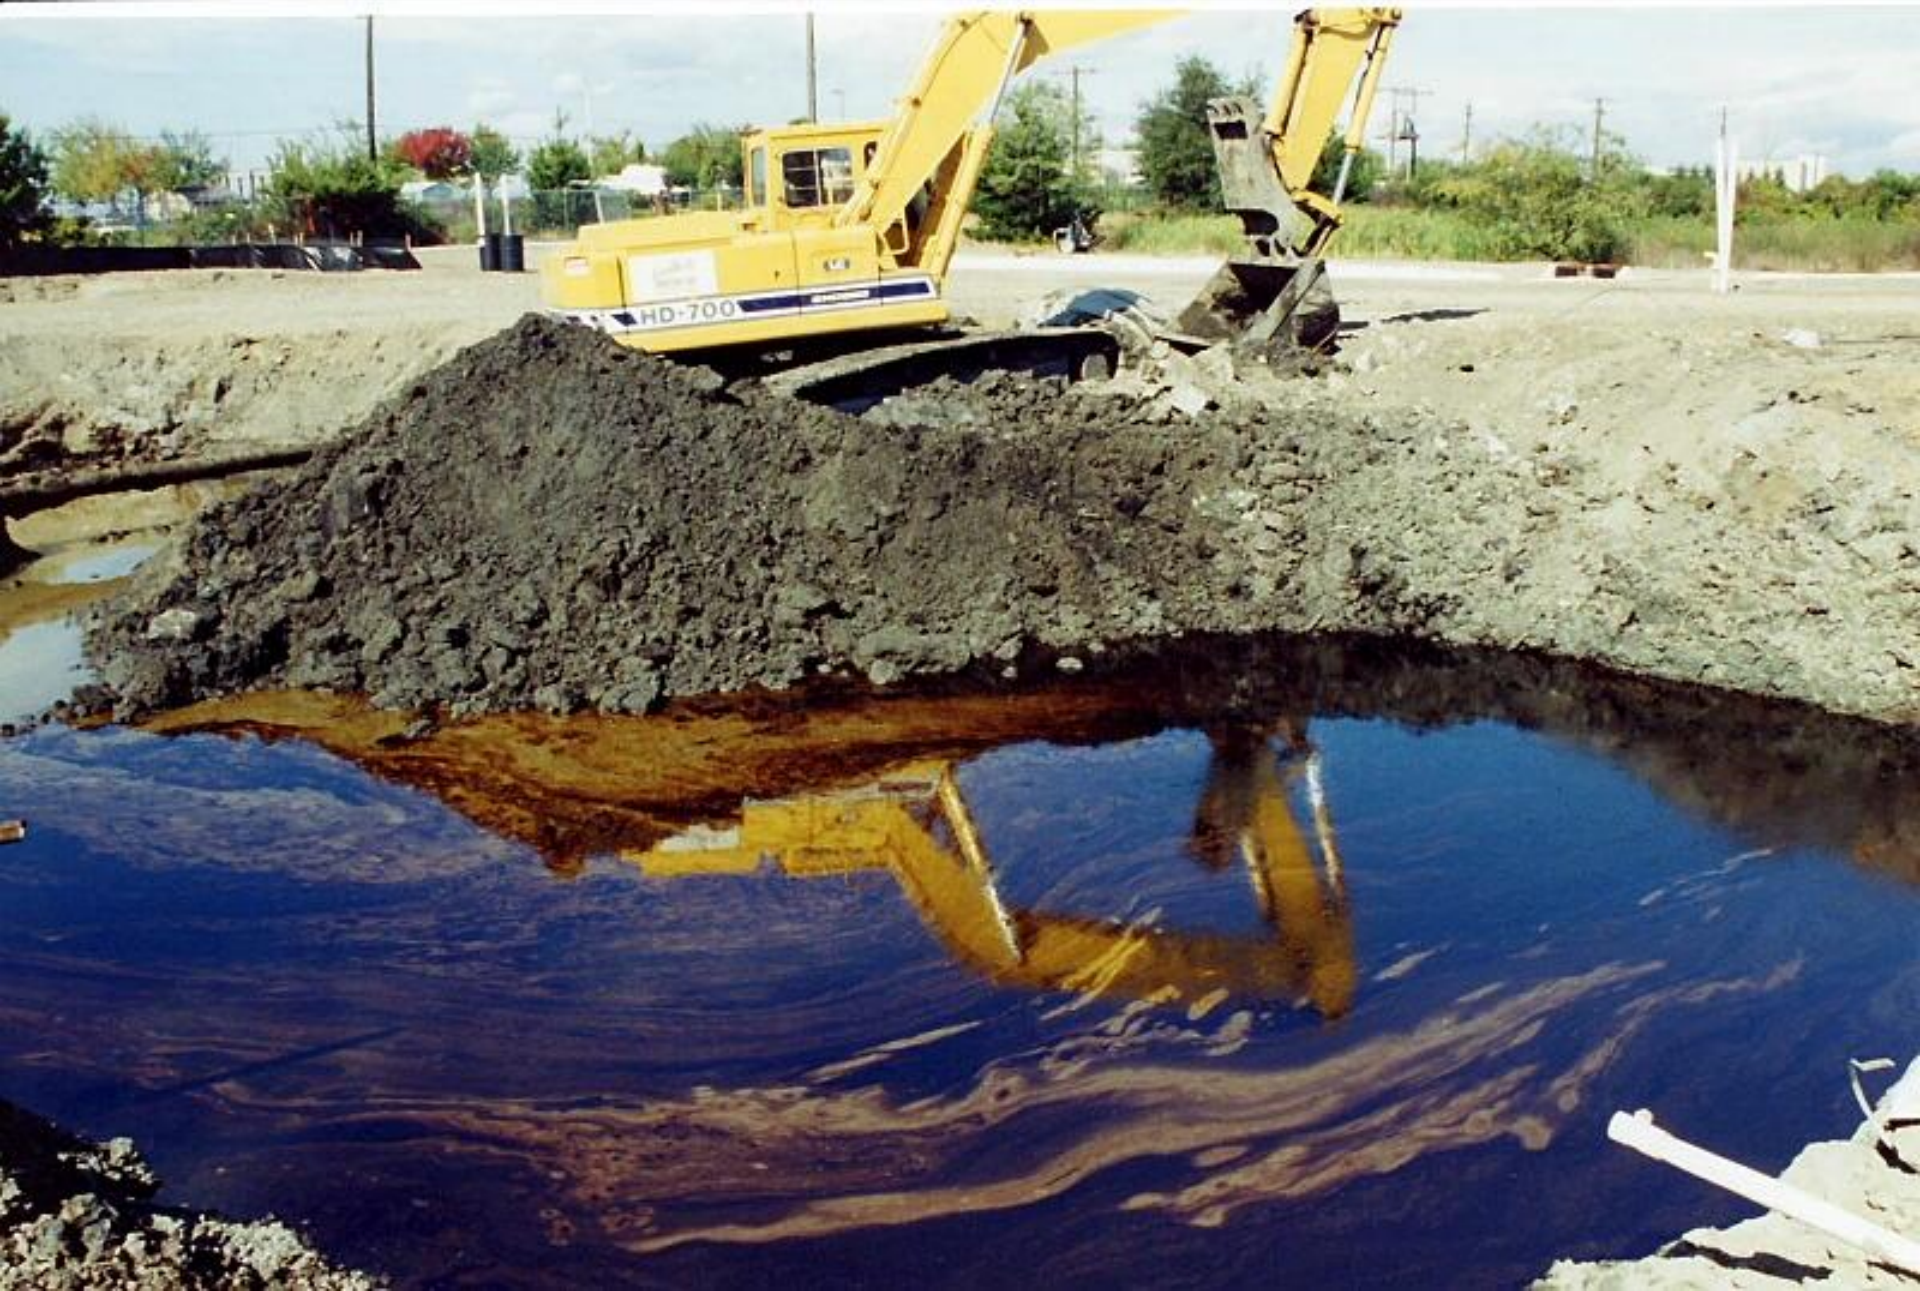
Oil was removed from the groundwater table

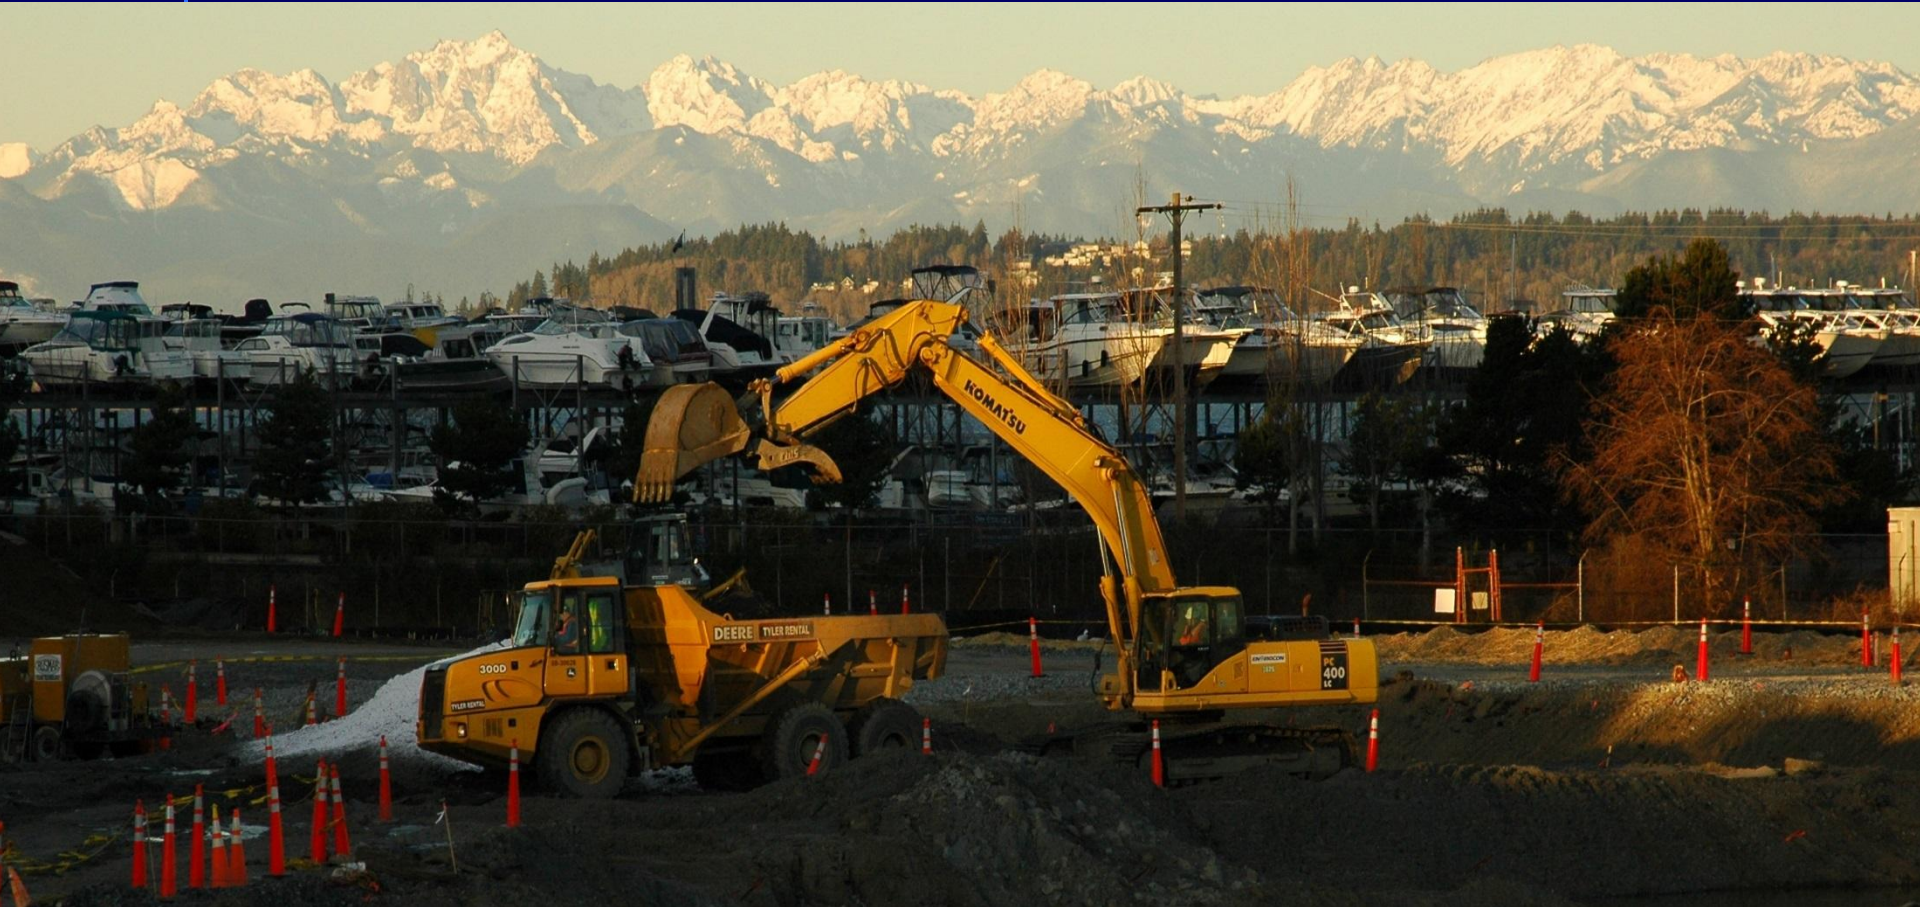
Contaminated Soil was excavated ...

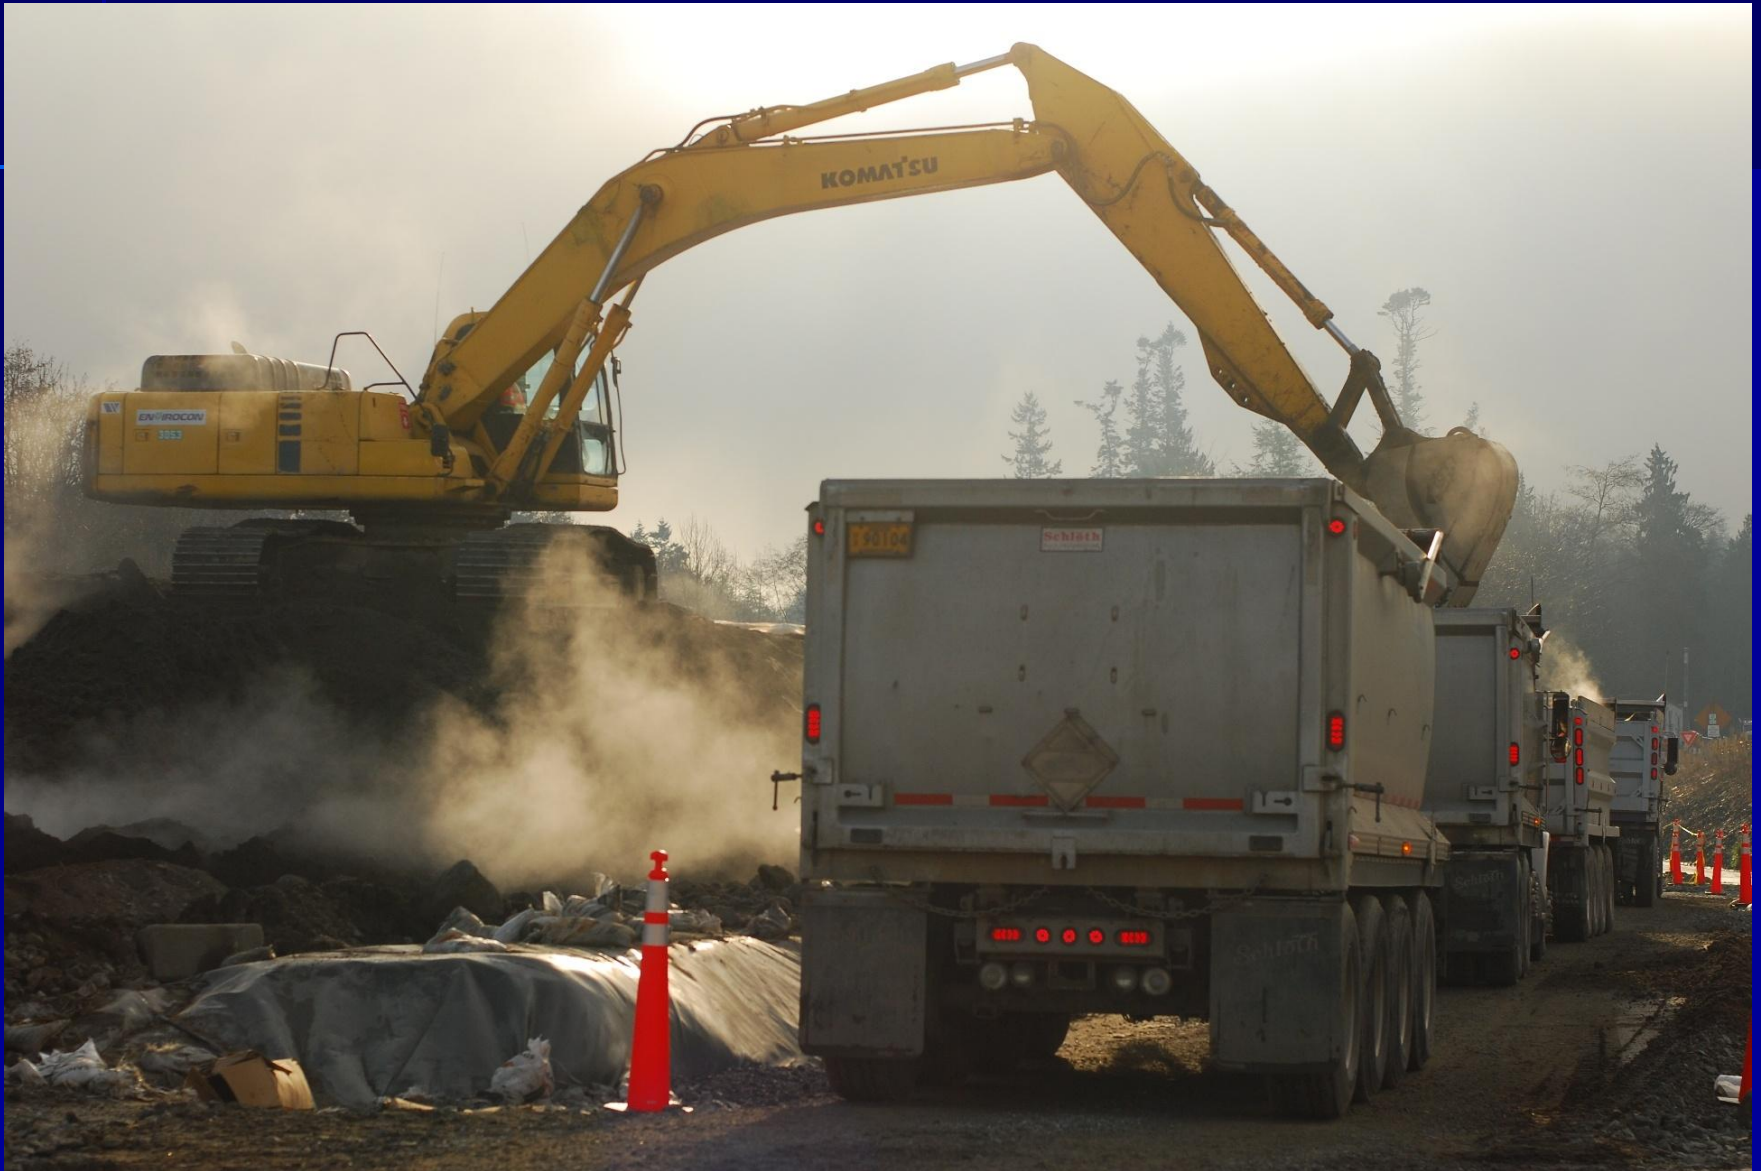
... stockpiled and sent off site.

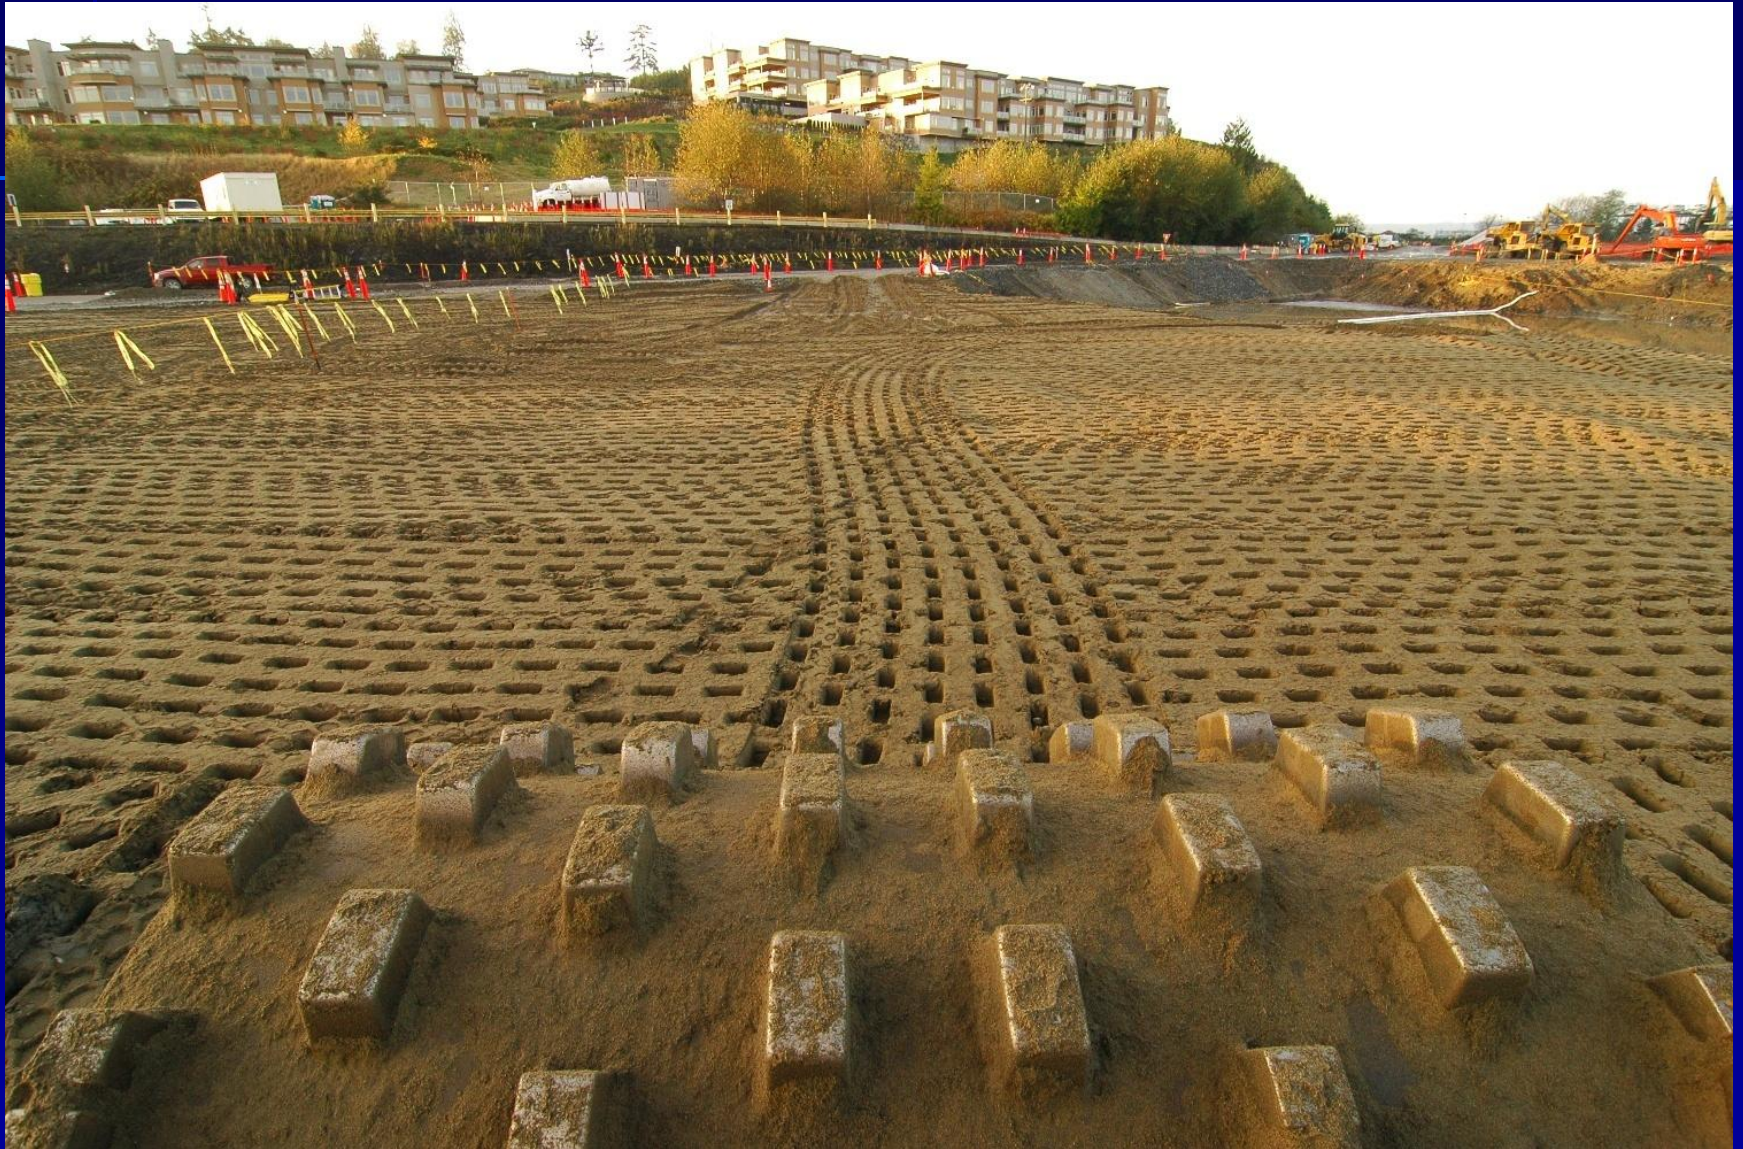
Excavations were backfilled.

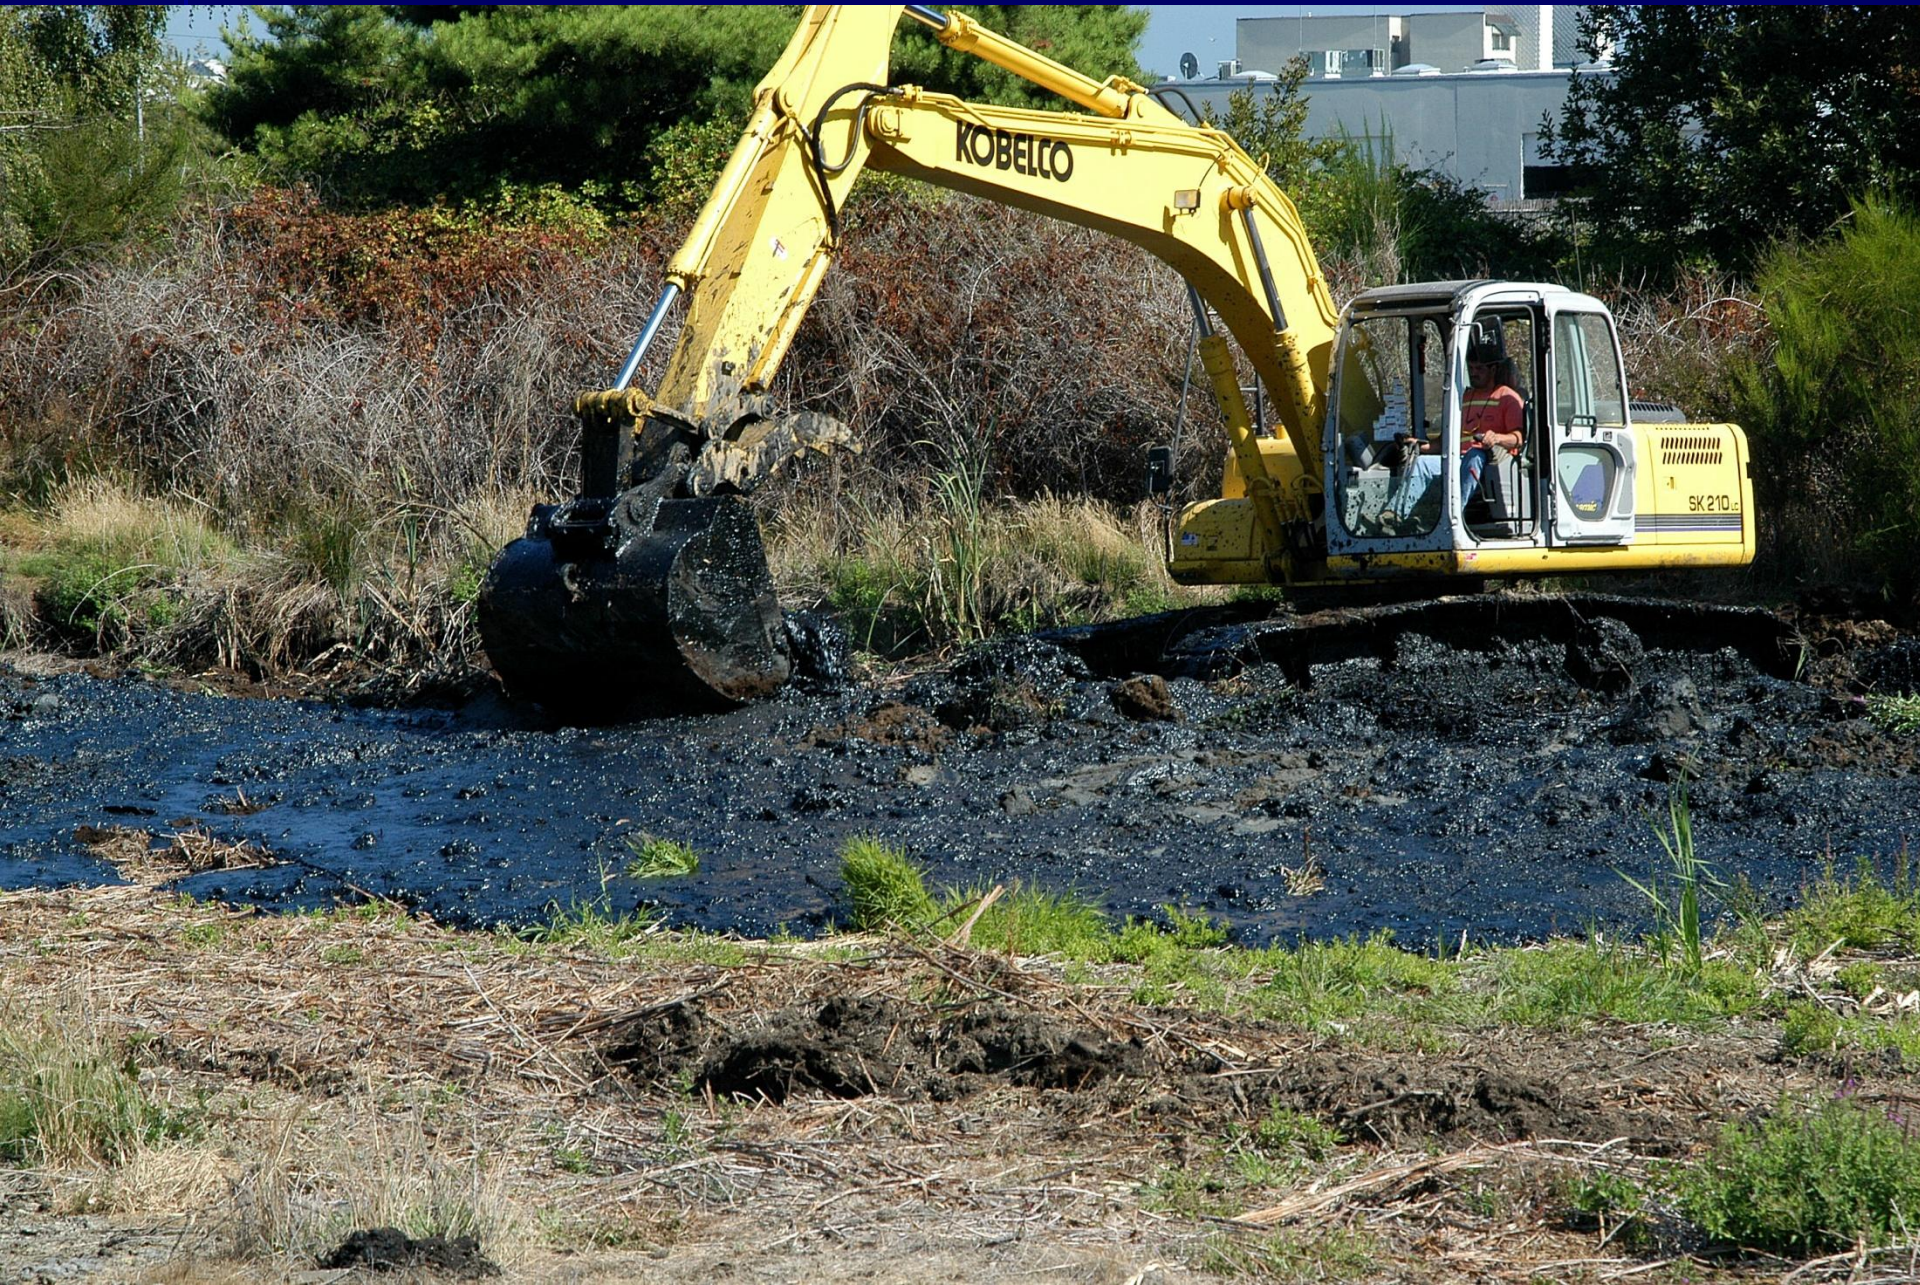
Off-specification asphalt was removed from Detention Basin 1

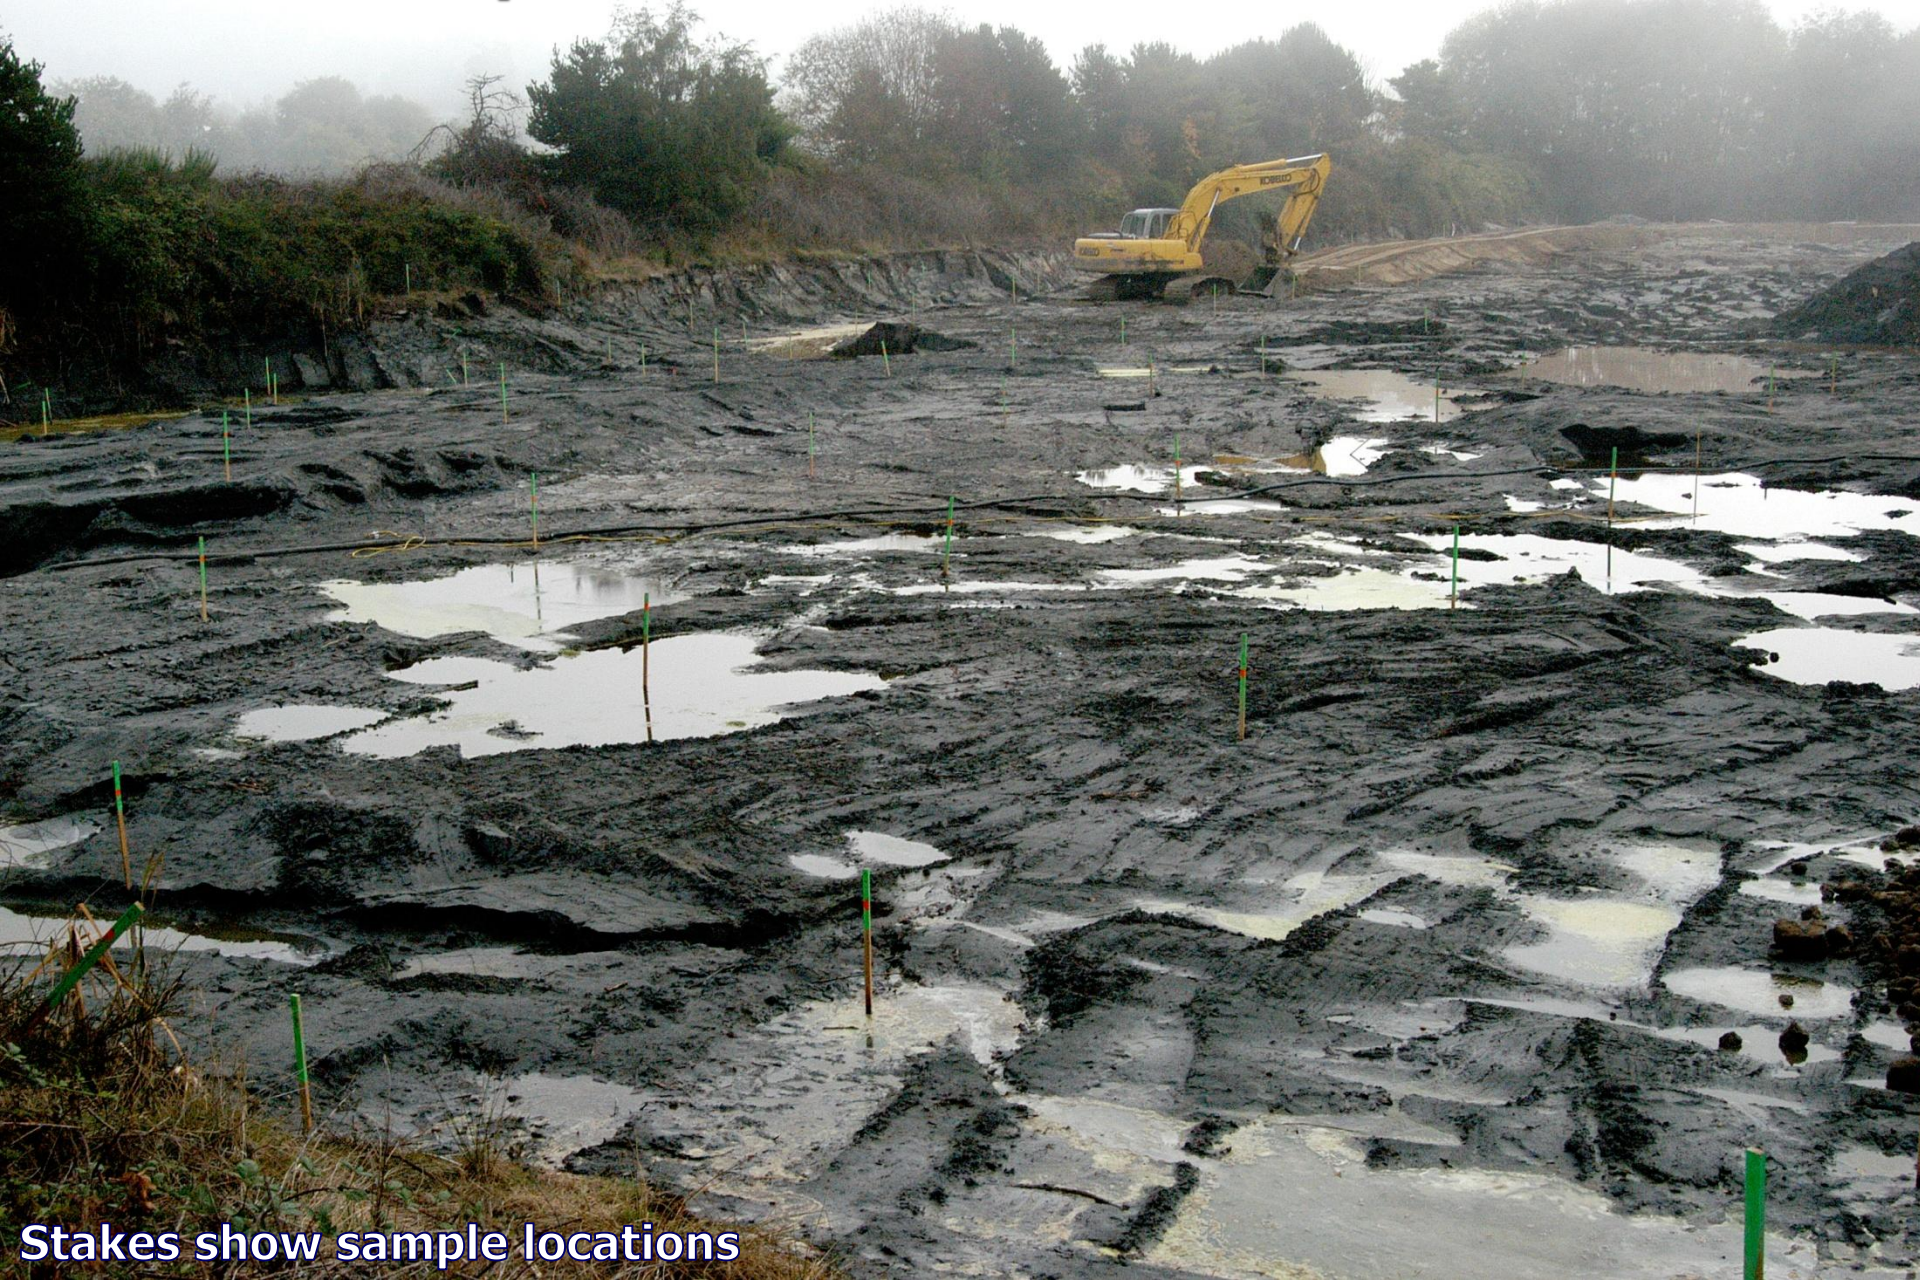
Samples were collected to confirm the contamination was removed to required concentrations

Stakes show sample locations
