Unocal Edmonds Bulk Fuel Terminal
Years of Operation: 1923 to 1991

**Interim Actions were
conducted between
2001 and 2008**

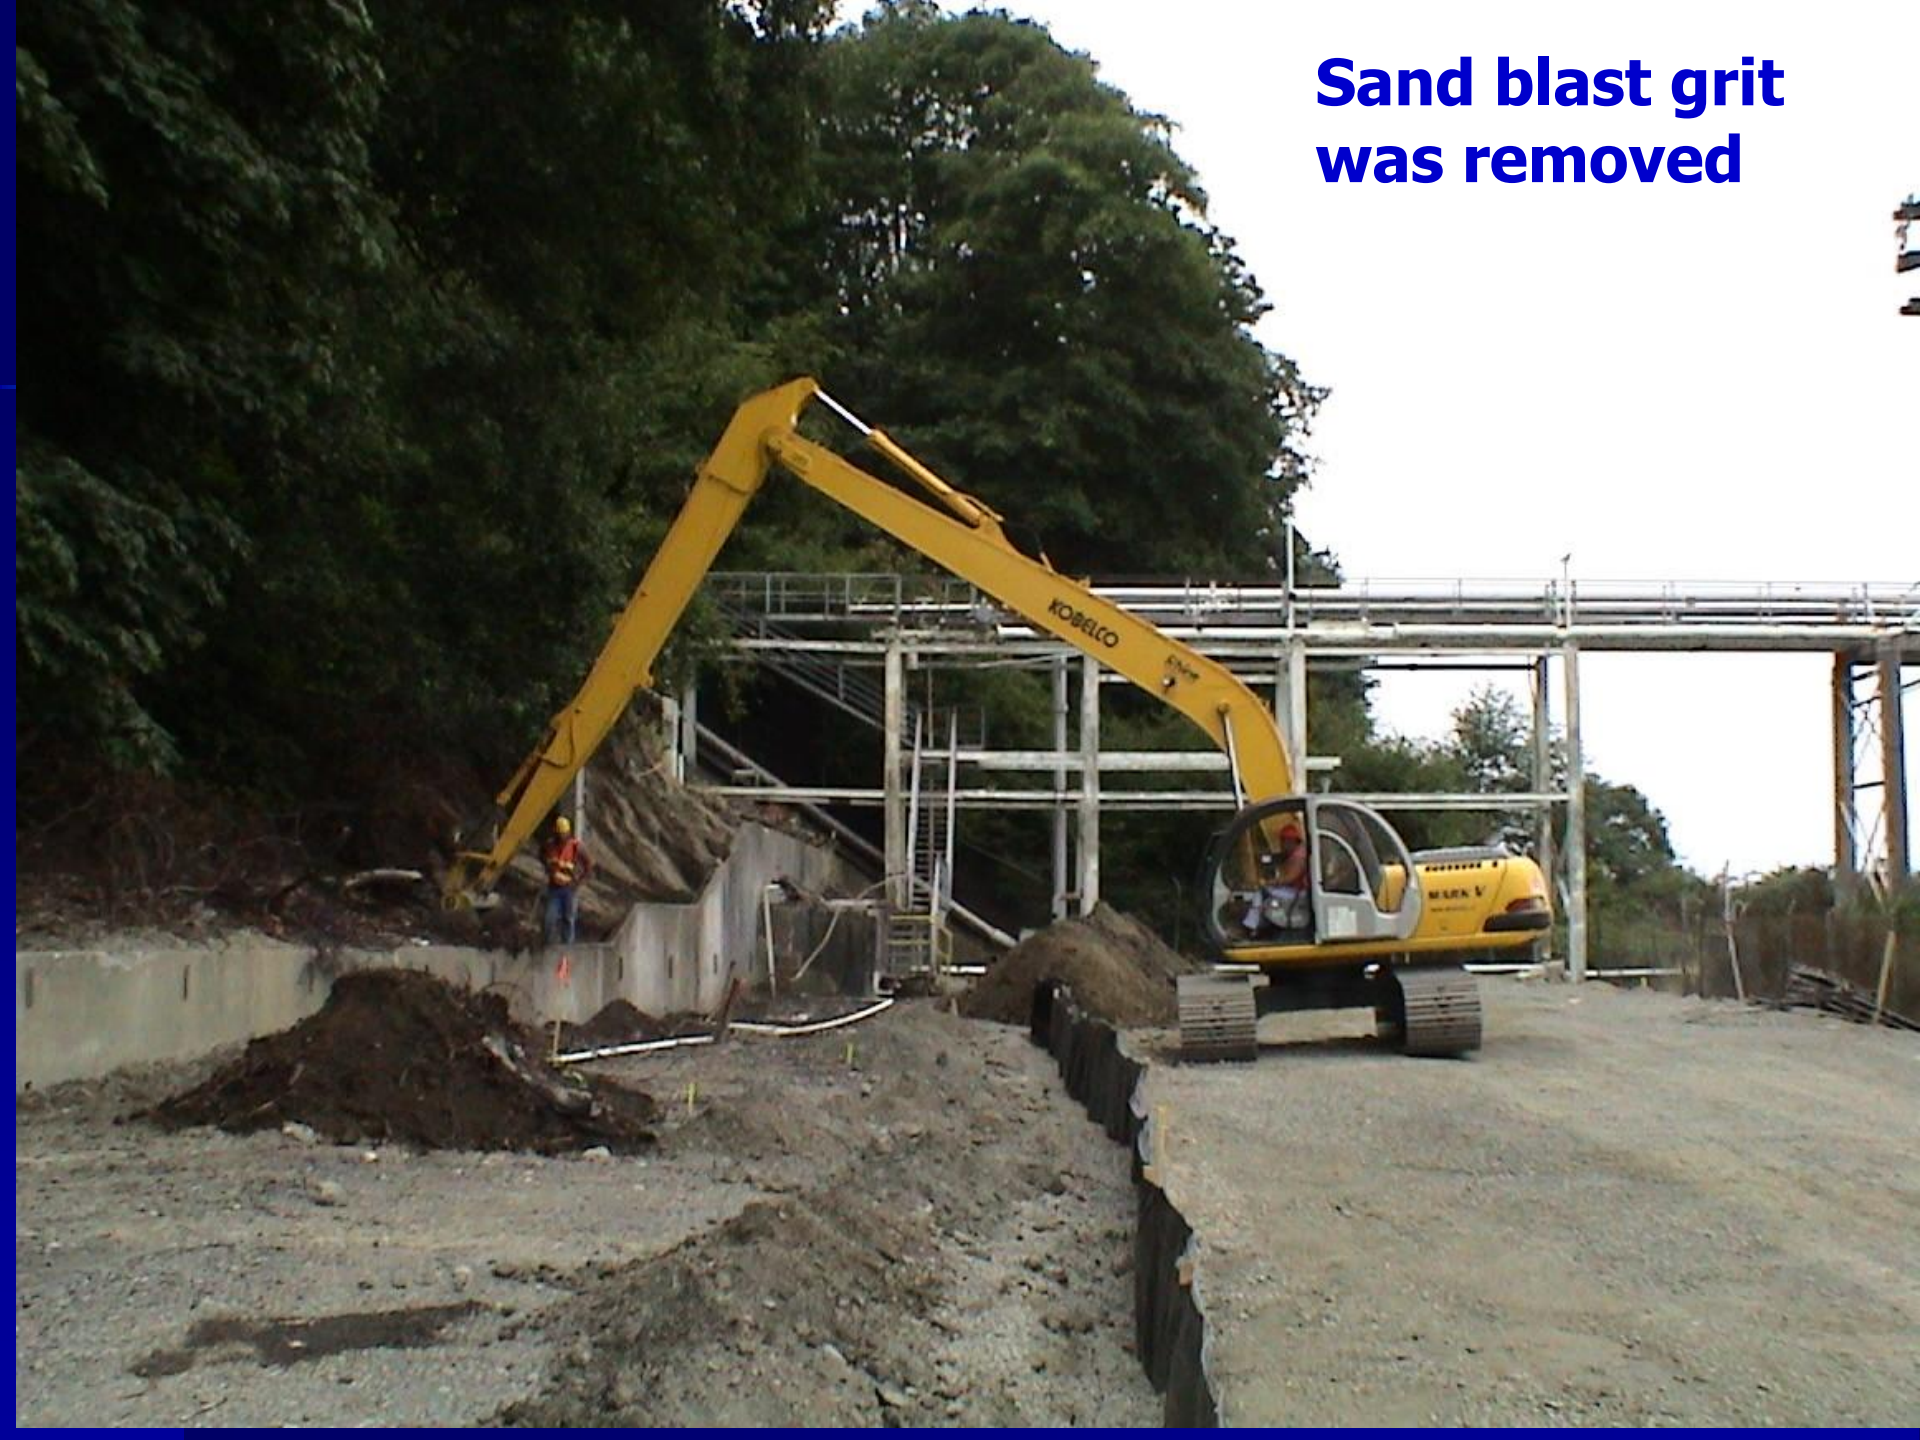
**Sand blast grit
was removed**

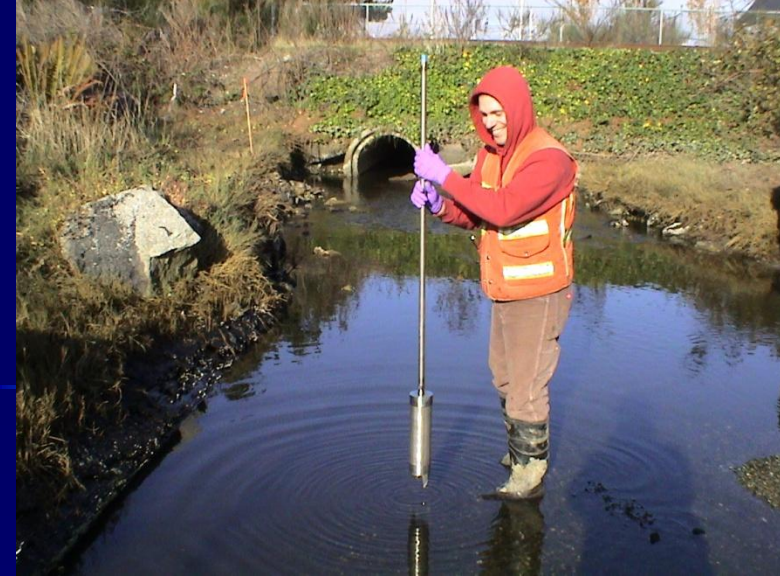
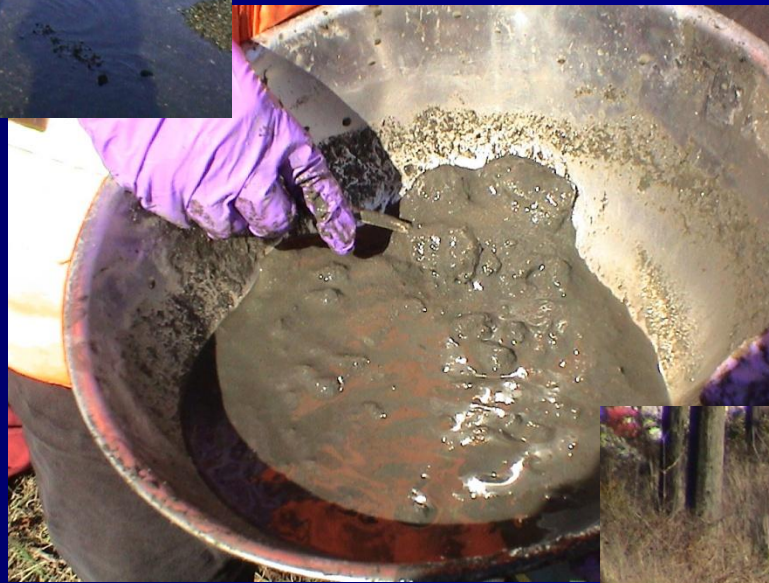
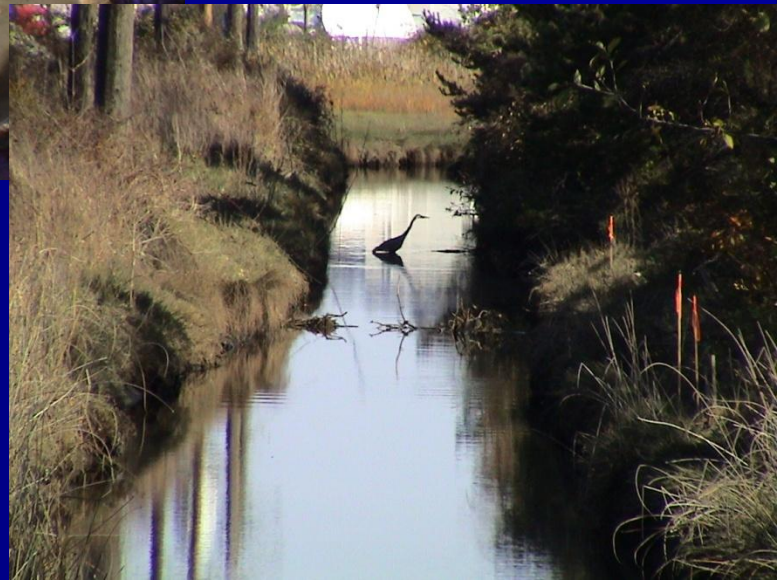
Sediments in Willow Creek were sampled and sediment excavated where necessary

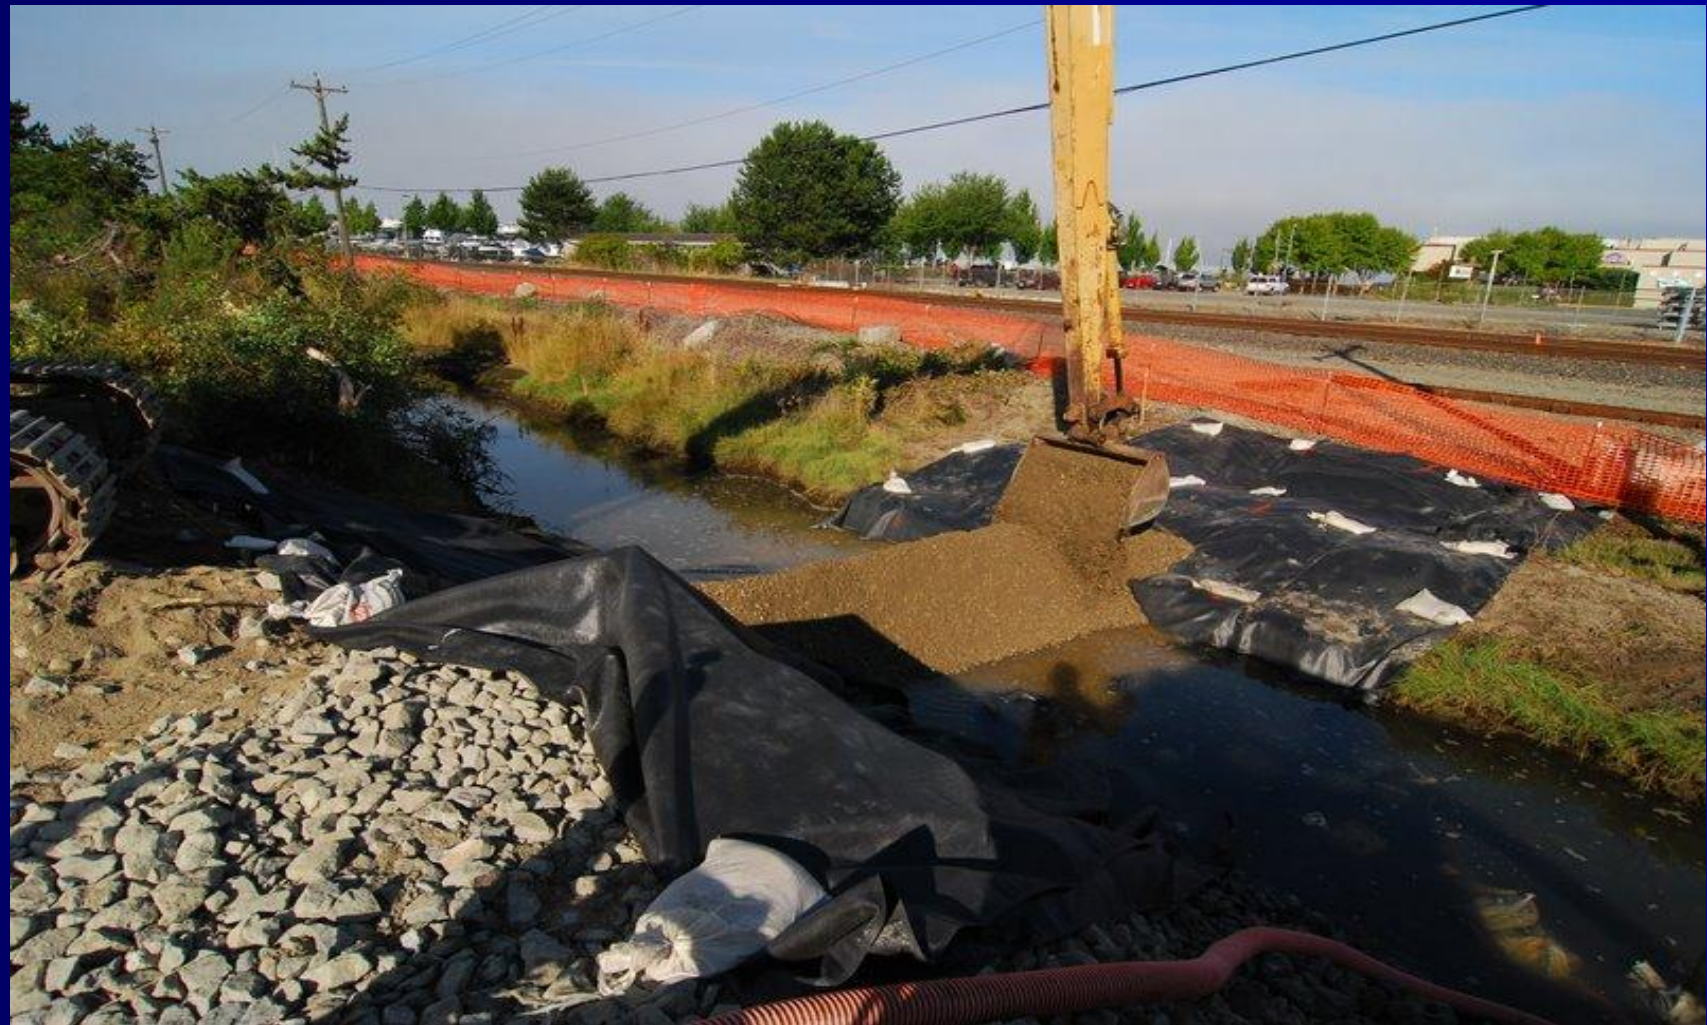
Coffer dams were built for the sediment cleanup ...

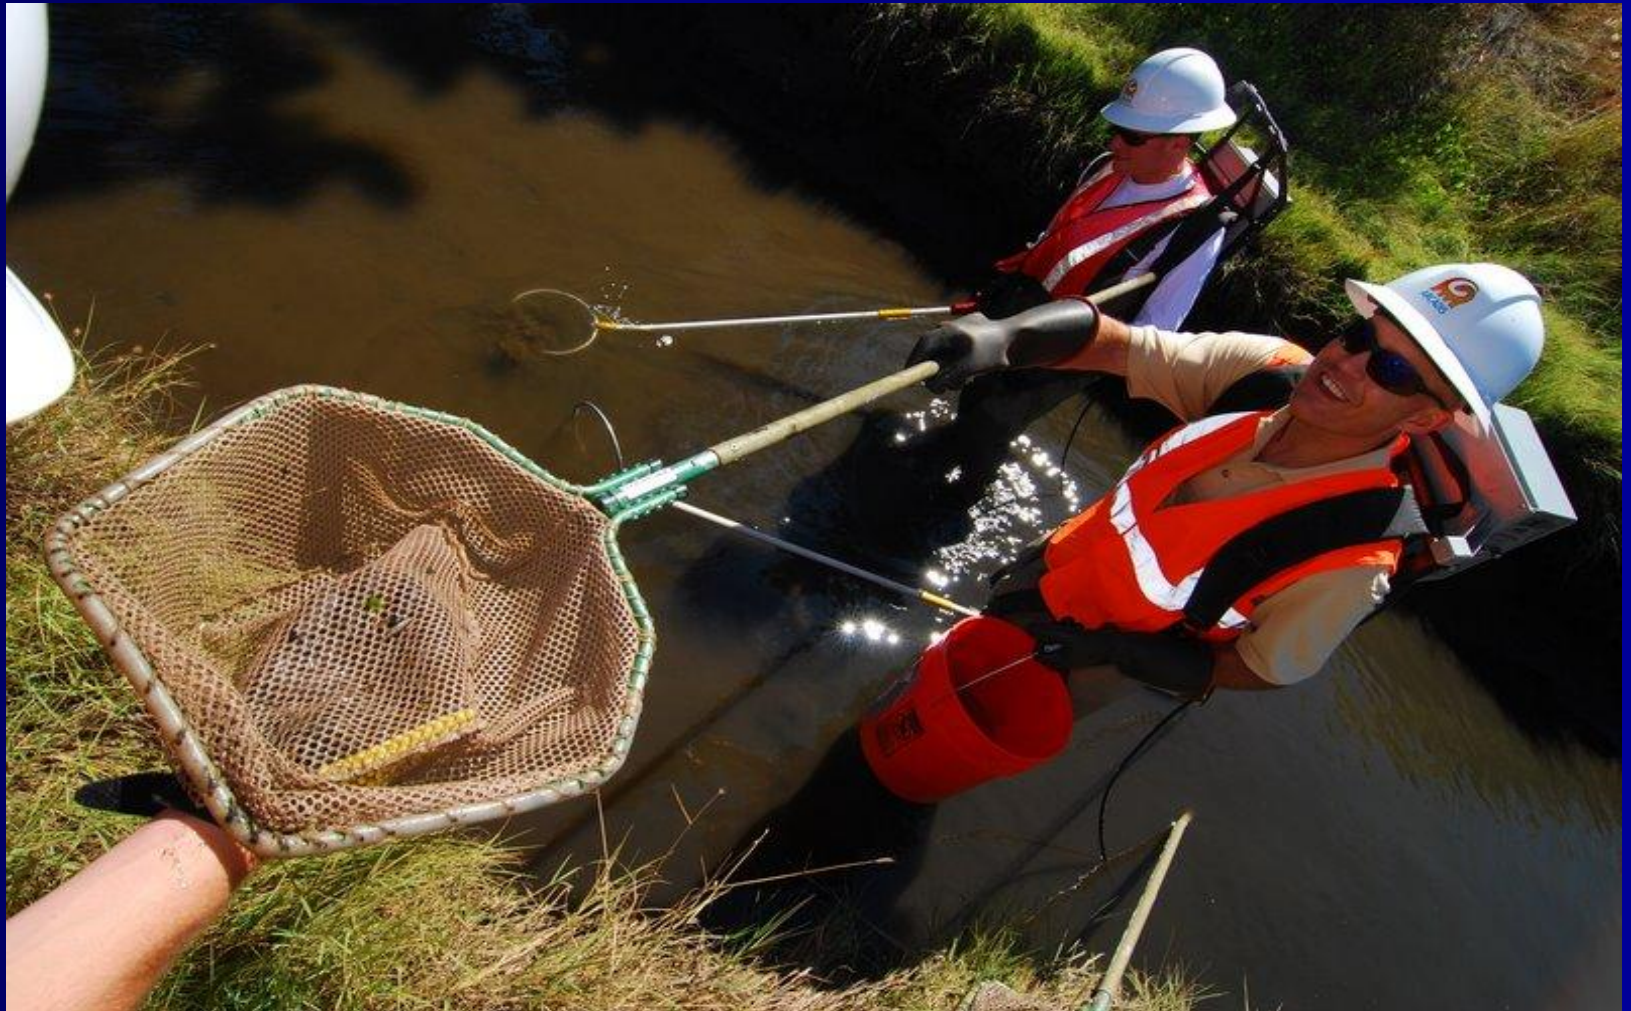
Fish were relocated to Edmonds Marsh...

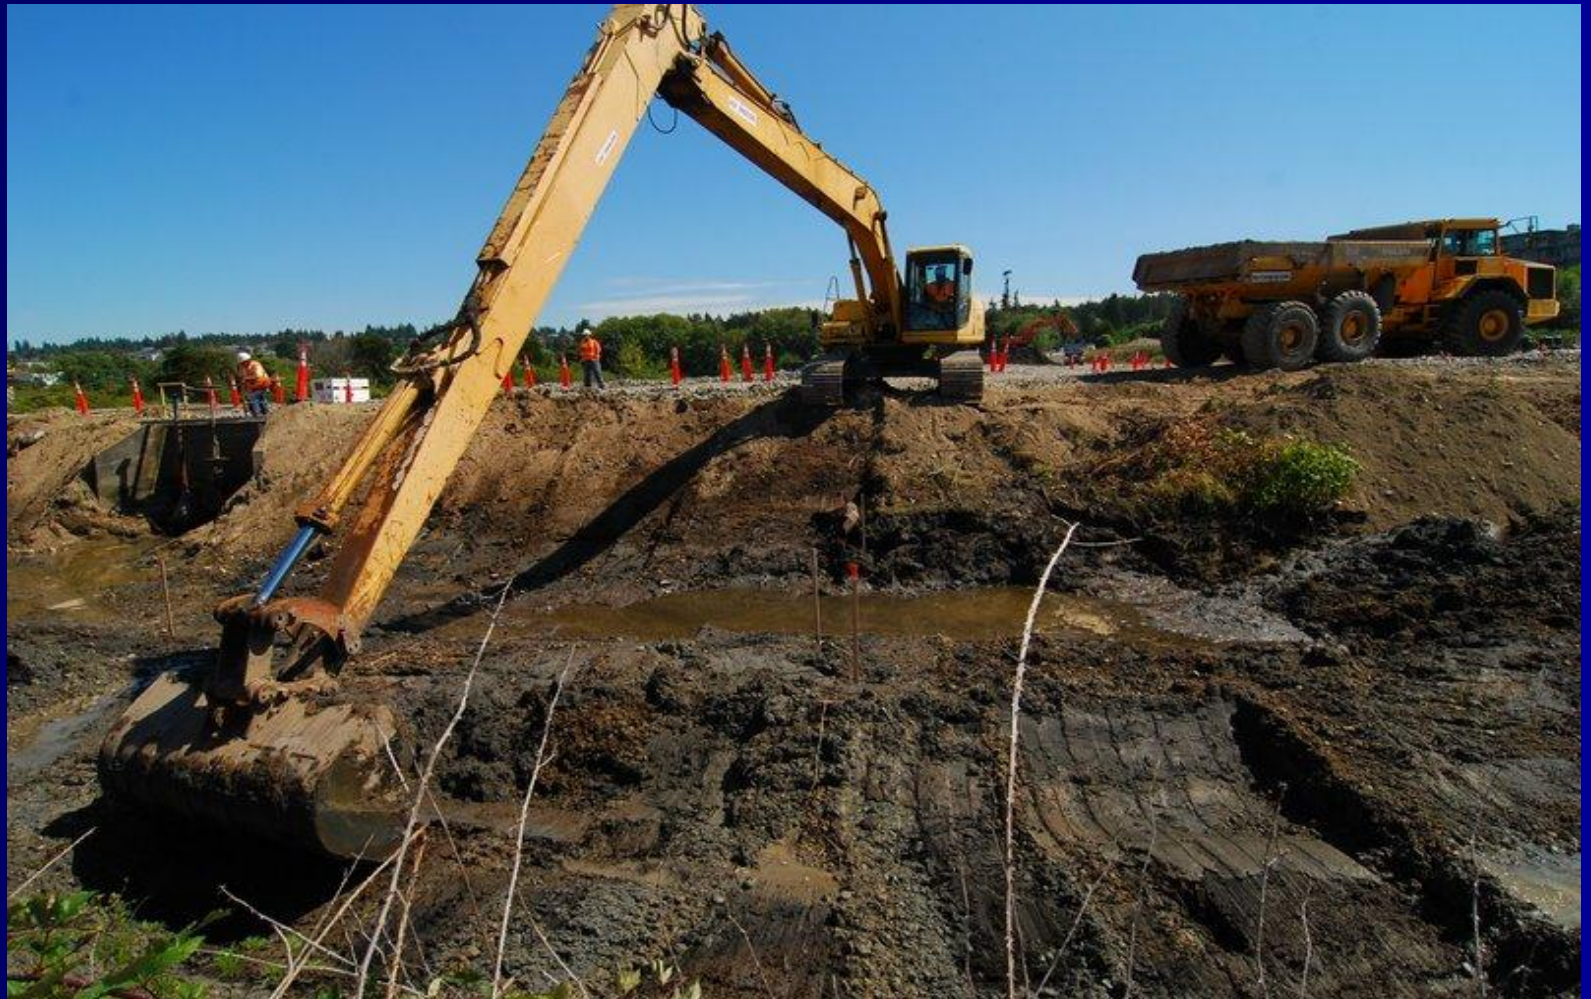
Sediment was removed...

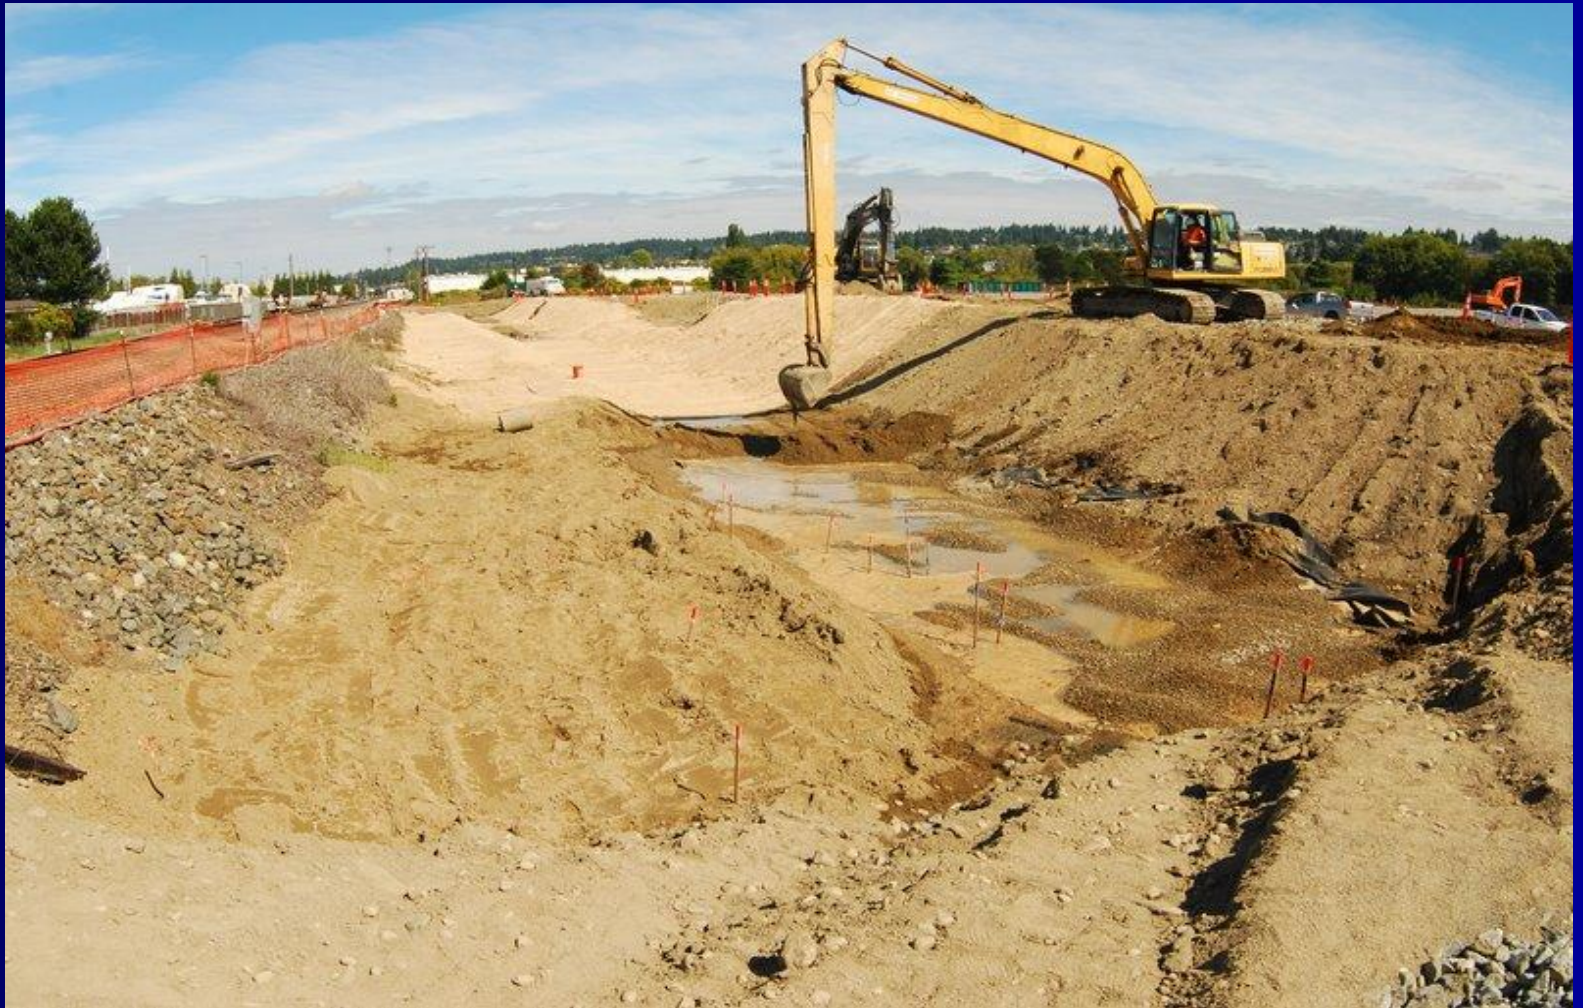
And the creek was restored.

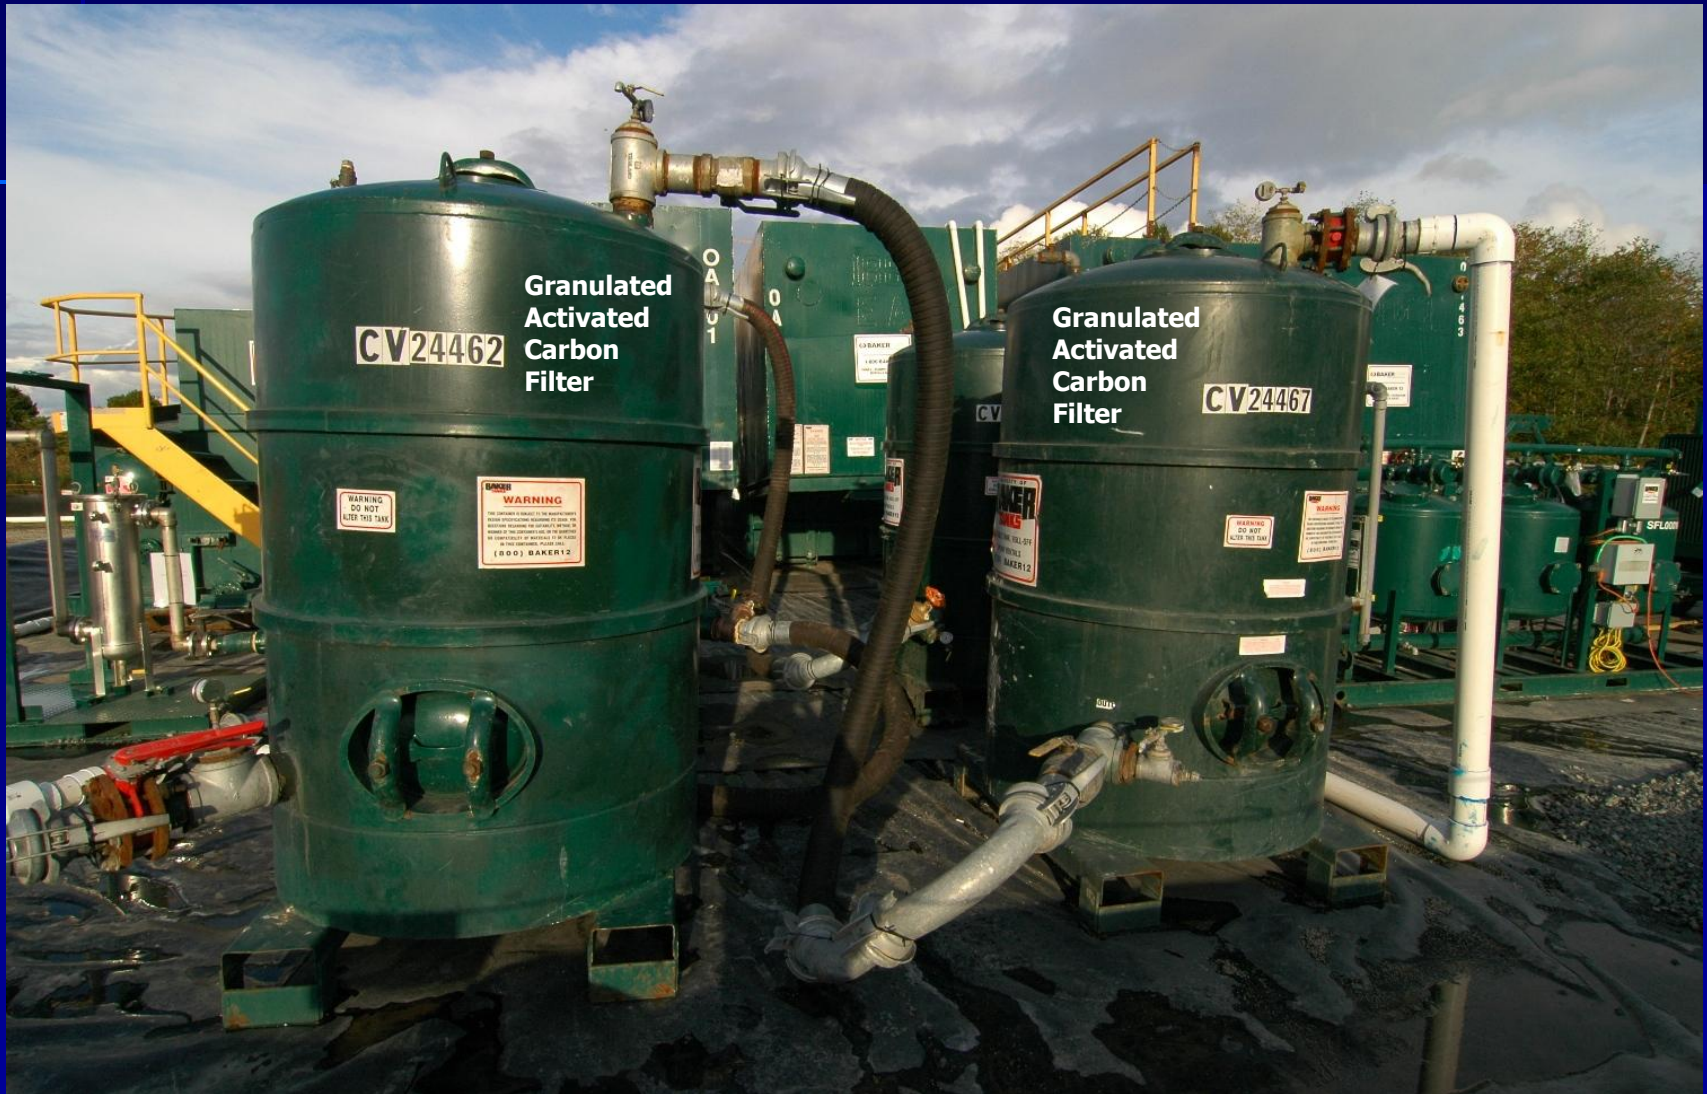
Water Treatment Plant

Over 5 Million gallons of groundwater treated and discharged below permit limits
