PRELIMINARY ASSESSMENT REPORT

NAS Seattle (Sand Point) King County, Washington

DERP-FUDS NO. F10WA0031

U.S. Army Corps of Engineers – Seattle District
Environmental Management Branch

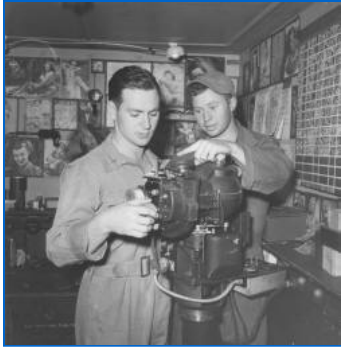
This is the calibration stand that Mr. Hurry was talking about. Just click on the image for a larger picture. If you know where I can find a calibration stand for our museum please let me know at taigh@twinbeech.com.

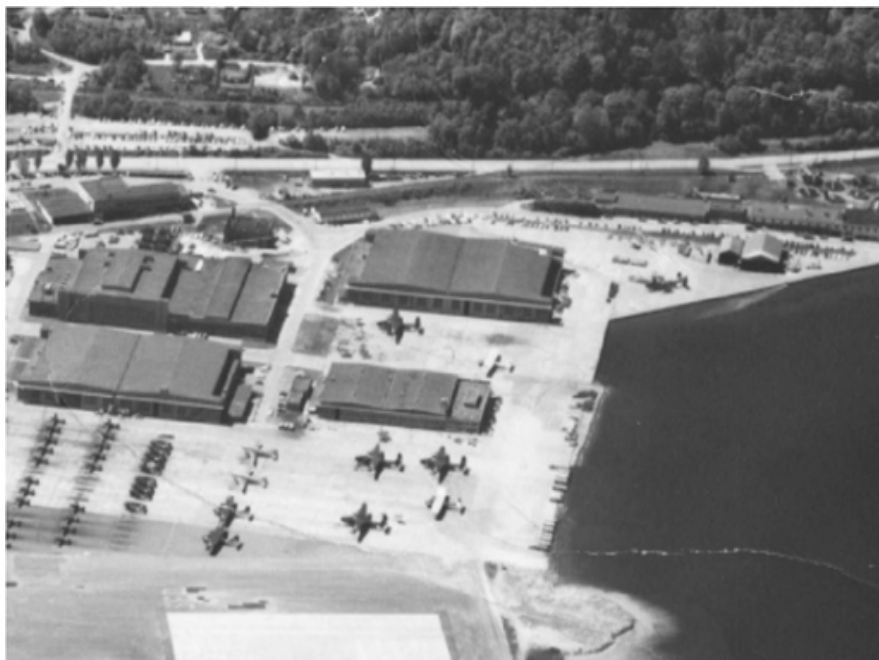
Figure 2: Photograph of Naval Air Station Seattle in the 1940s

Former NAVSTA PS was initially named Naval Air Station (NAS) Seattle. Portions of the facility were built in 1925 on land donated by King County. Many of the major buildings were constructed prior to World War II, including Building 2 (1929) and Building 27 (1937). Further building construction and remodeling took place in later years, including an addition of the South Shed to Building 27 in 1944. During World War II, NAS Seattle supported air transport and ship outfitting personnel for the Alaskan and Western Pacific theaters of operation (Figure 2).

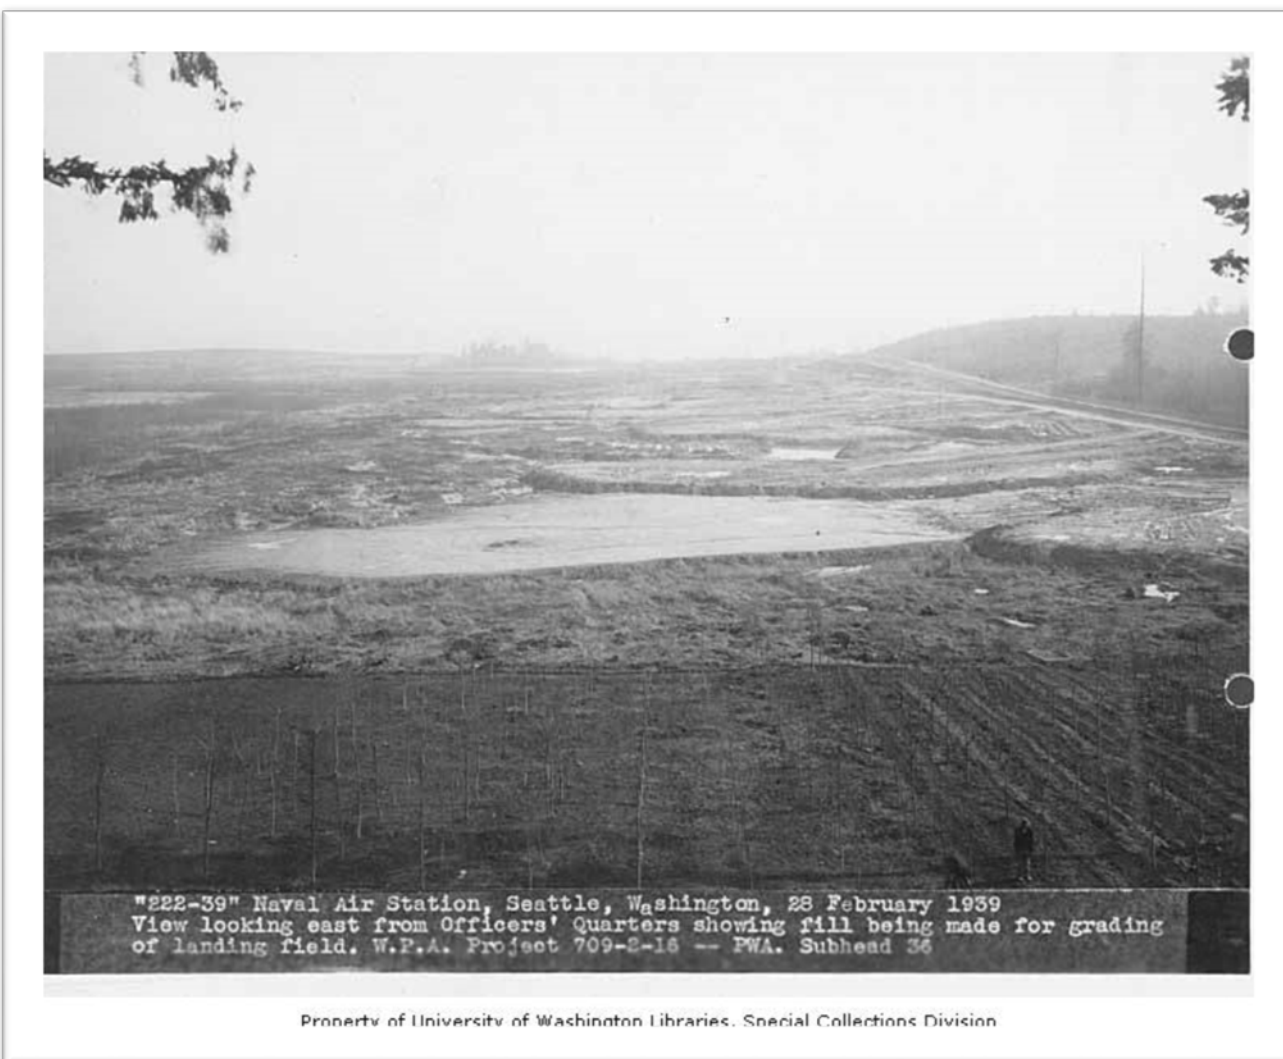
G.8. Panoramic View of Under Construction Landing Field – February 28, 1939

Notes: View looking east from Officers' Quarters showing fill being made for grading of landing field. W.P.A Project 709-2-16—PWA.

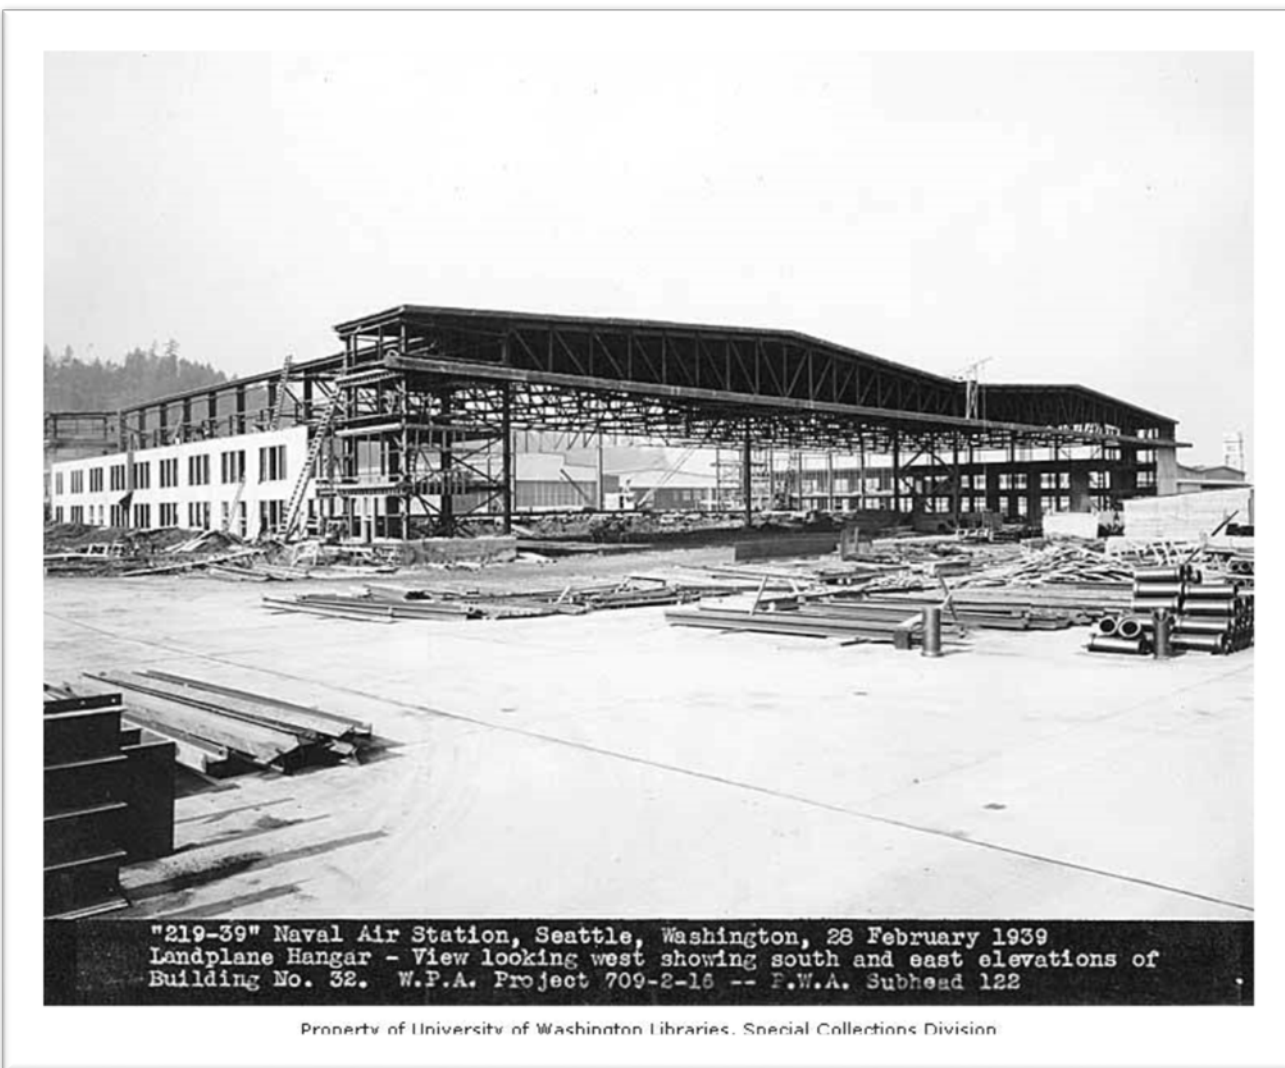
G.9. Hangar Under Construction (Building No. 32) – February 28, 1939

Notes: View looking west showing south and east elevations of Building No. 32. W.P.A Project 709-2-16—P.W.A.

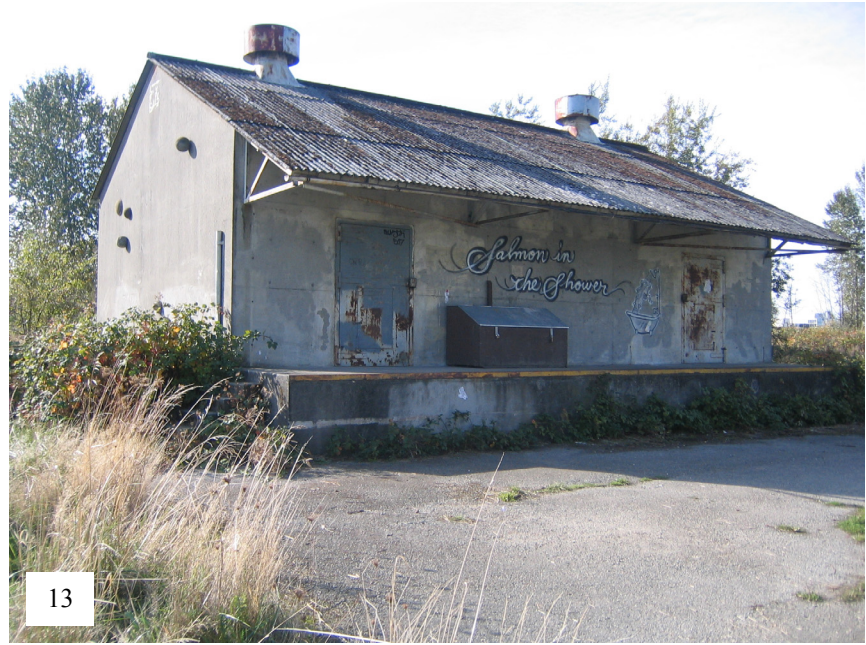
11	Sparsely vegetated area within the park along the shoreline in the vicinity of the former trash burning pits.
12	Debris visible along the park shoreline.
13	Building 312 (former Pyrotechnic Magazine), located on park property close to shoreline, looking west.
14	Magazine 19, located on park property close to shoreline, looking southwest.
15	Debris visible along the park shoreline.
16	Debris visible along the park shoreline.
17	Exposed fill material beneath shoreline vegetation on park property.
18	Play structure at Burke-Gilman Park.

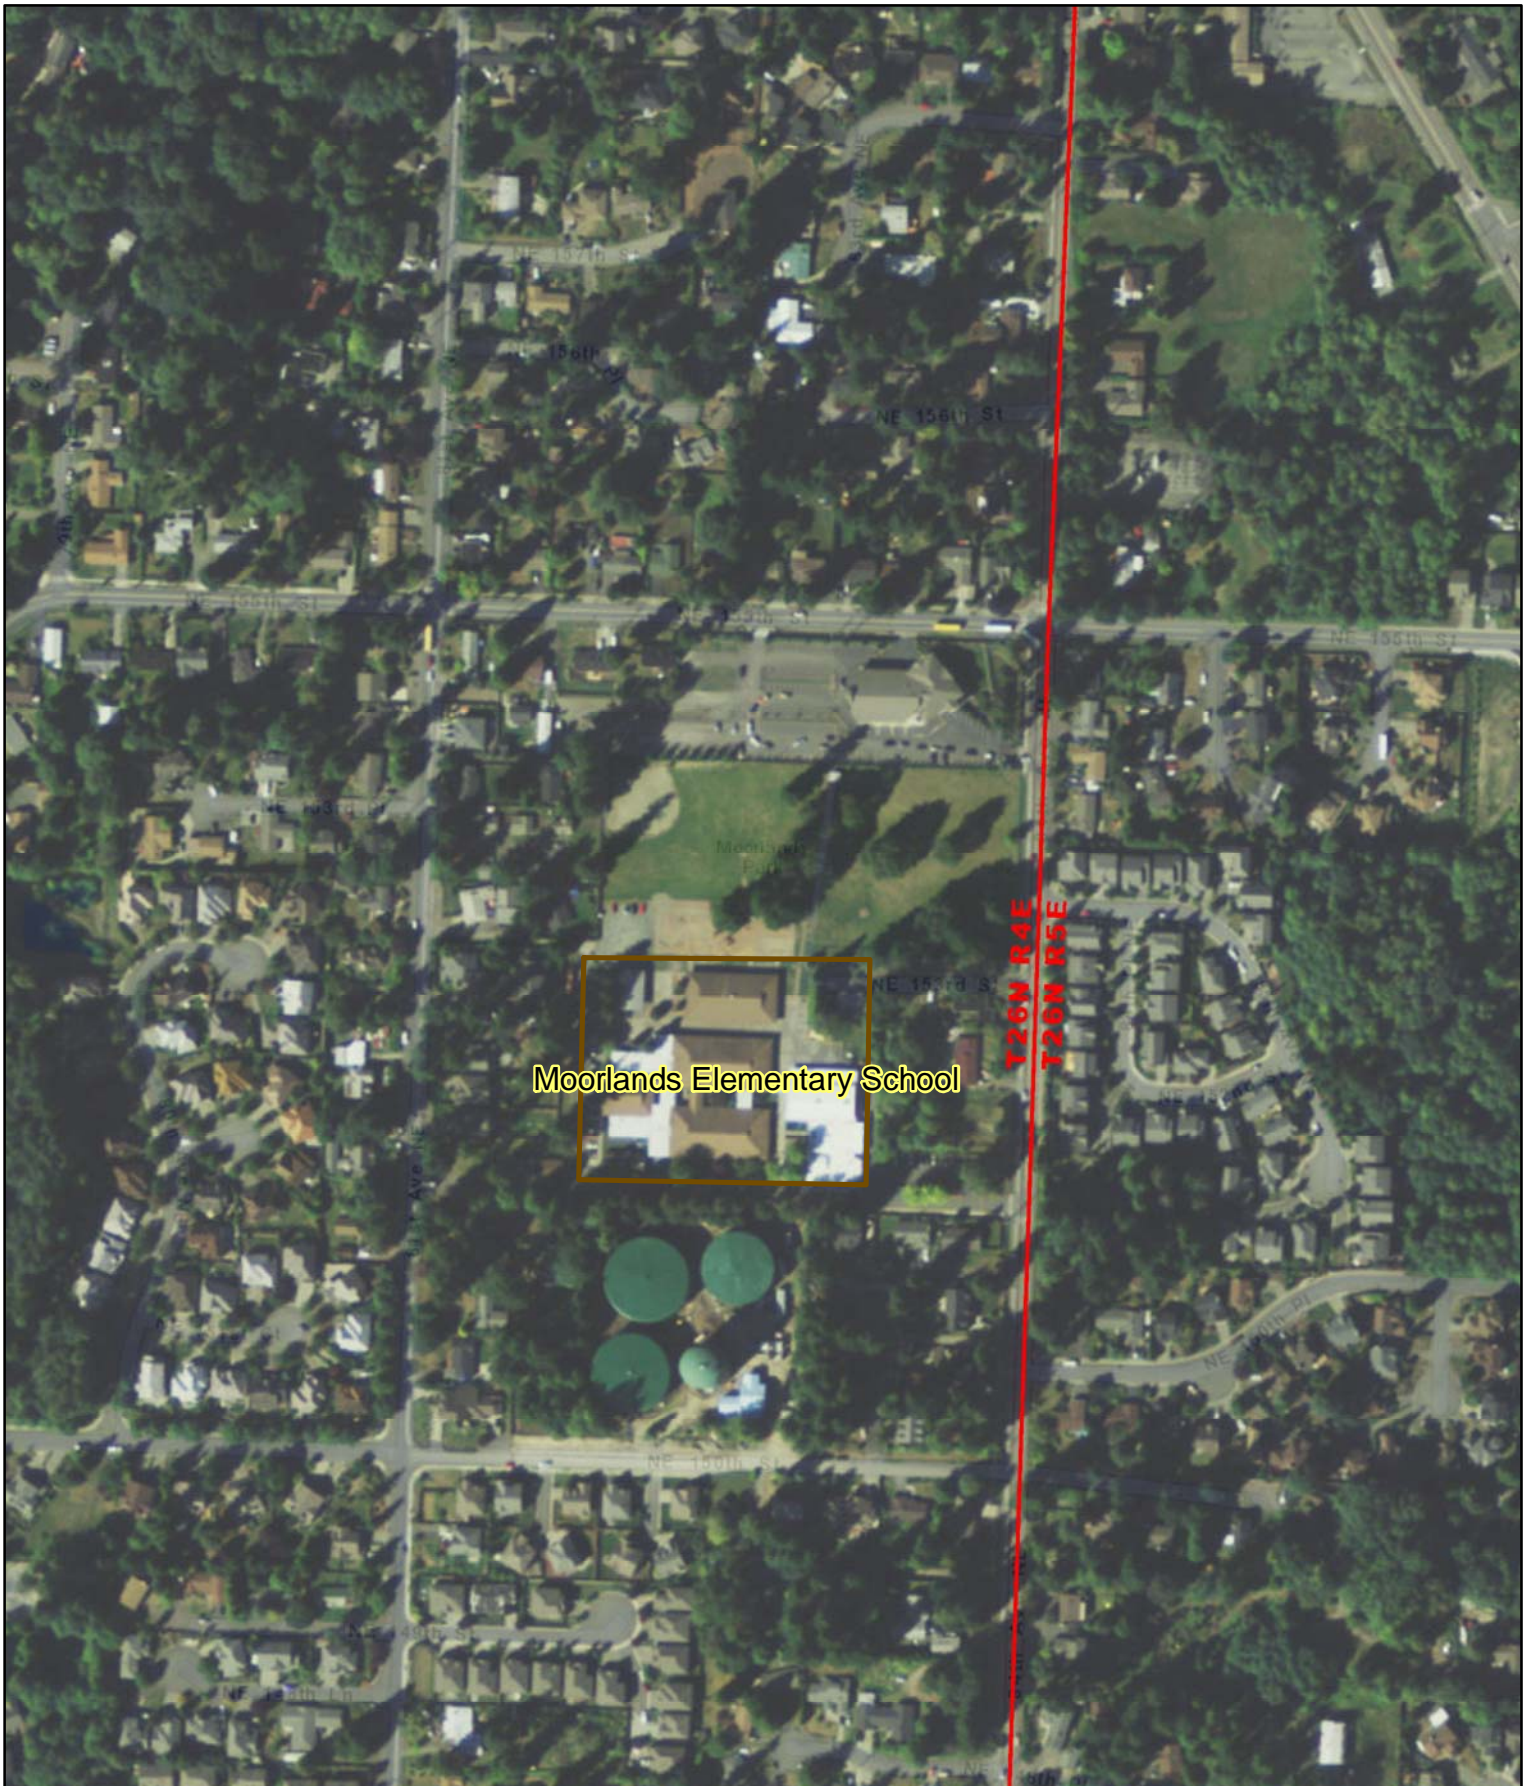
Notes: The former RACON site is now occupied by the Moorlands Elementary School

Non-contiguous former NAS Seattle property consists of: the former RACON site (Disposal Item No. 25) now occupied by Moorland Park and Moorland’s Elementary School (Figure 3-8); the former Low Frequency Navigational Aid (Disposal Item No. 26) now developed as a residential area (Figure 3-9); the former transmitter site (Disposal Item No. 27) now occupied by the Burke-Gilman Playground Park and by a Ronald McDonald House (Figure 3-10); the former water tower (Disposal Item No. 28) appears to generally be vacant land except for a structure centrally located and is surrounded by residences (Figure 3-11); a former warehouse (Disposal Item No. 30) now owned by General Services Administration (GSA) and occupied by the National Archives and Records Administration (NARA) along with property formerly associated with the warehouse (Figure 3-12); and the former Shearwater Housing tracts (Disposal Item No. 40) is now occupied by the Thornton Creek School (Figure3-13).

Regarding the noncontiguous parcels: the former RACON site (Disposal Item No. 25) is occupied by Moorland Park and Moorland's Elementary School (Figure 3-8); the former Low Frequency Navigational Aid (Disposal Item No. 26) is a residential area (Figure 3-9); the former transmitter site (Disposal Item No. 27) is occupied by the Burke-Gilman Playground Park, a Ronald McDonald House (Figure 3-10), and the Children's Center at Burke Gilman Gardens; the former water tower (Disposal Item No. 28) appears to be occupied by a residence and is surrounded by residences (Figure 3-11); a former warehouse (Disposal Item No. 30) is owned by GSA and occupied by the NARA (Figure 3-12); the former Shearwater Housing tracts (Disposal Item No. 40) is occupied by the Thornton Creek School (Figure 3-13); and, property formerly associated with the current NARA warehouse (Disposal Item No. 42) is occupied by residential housing (Figure 3-12).

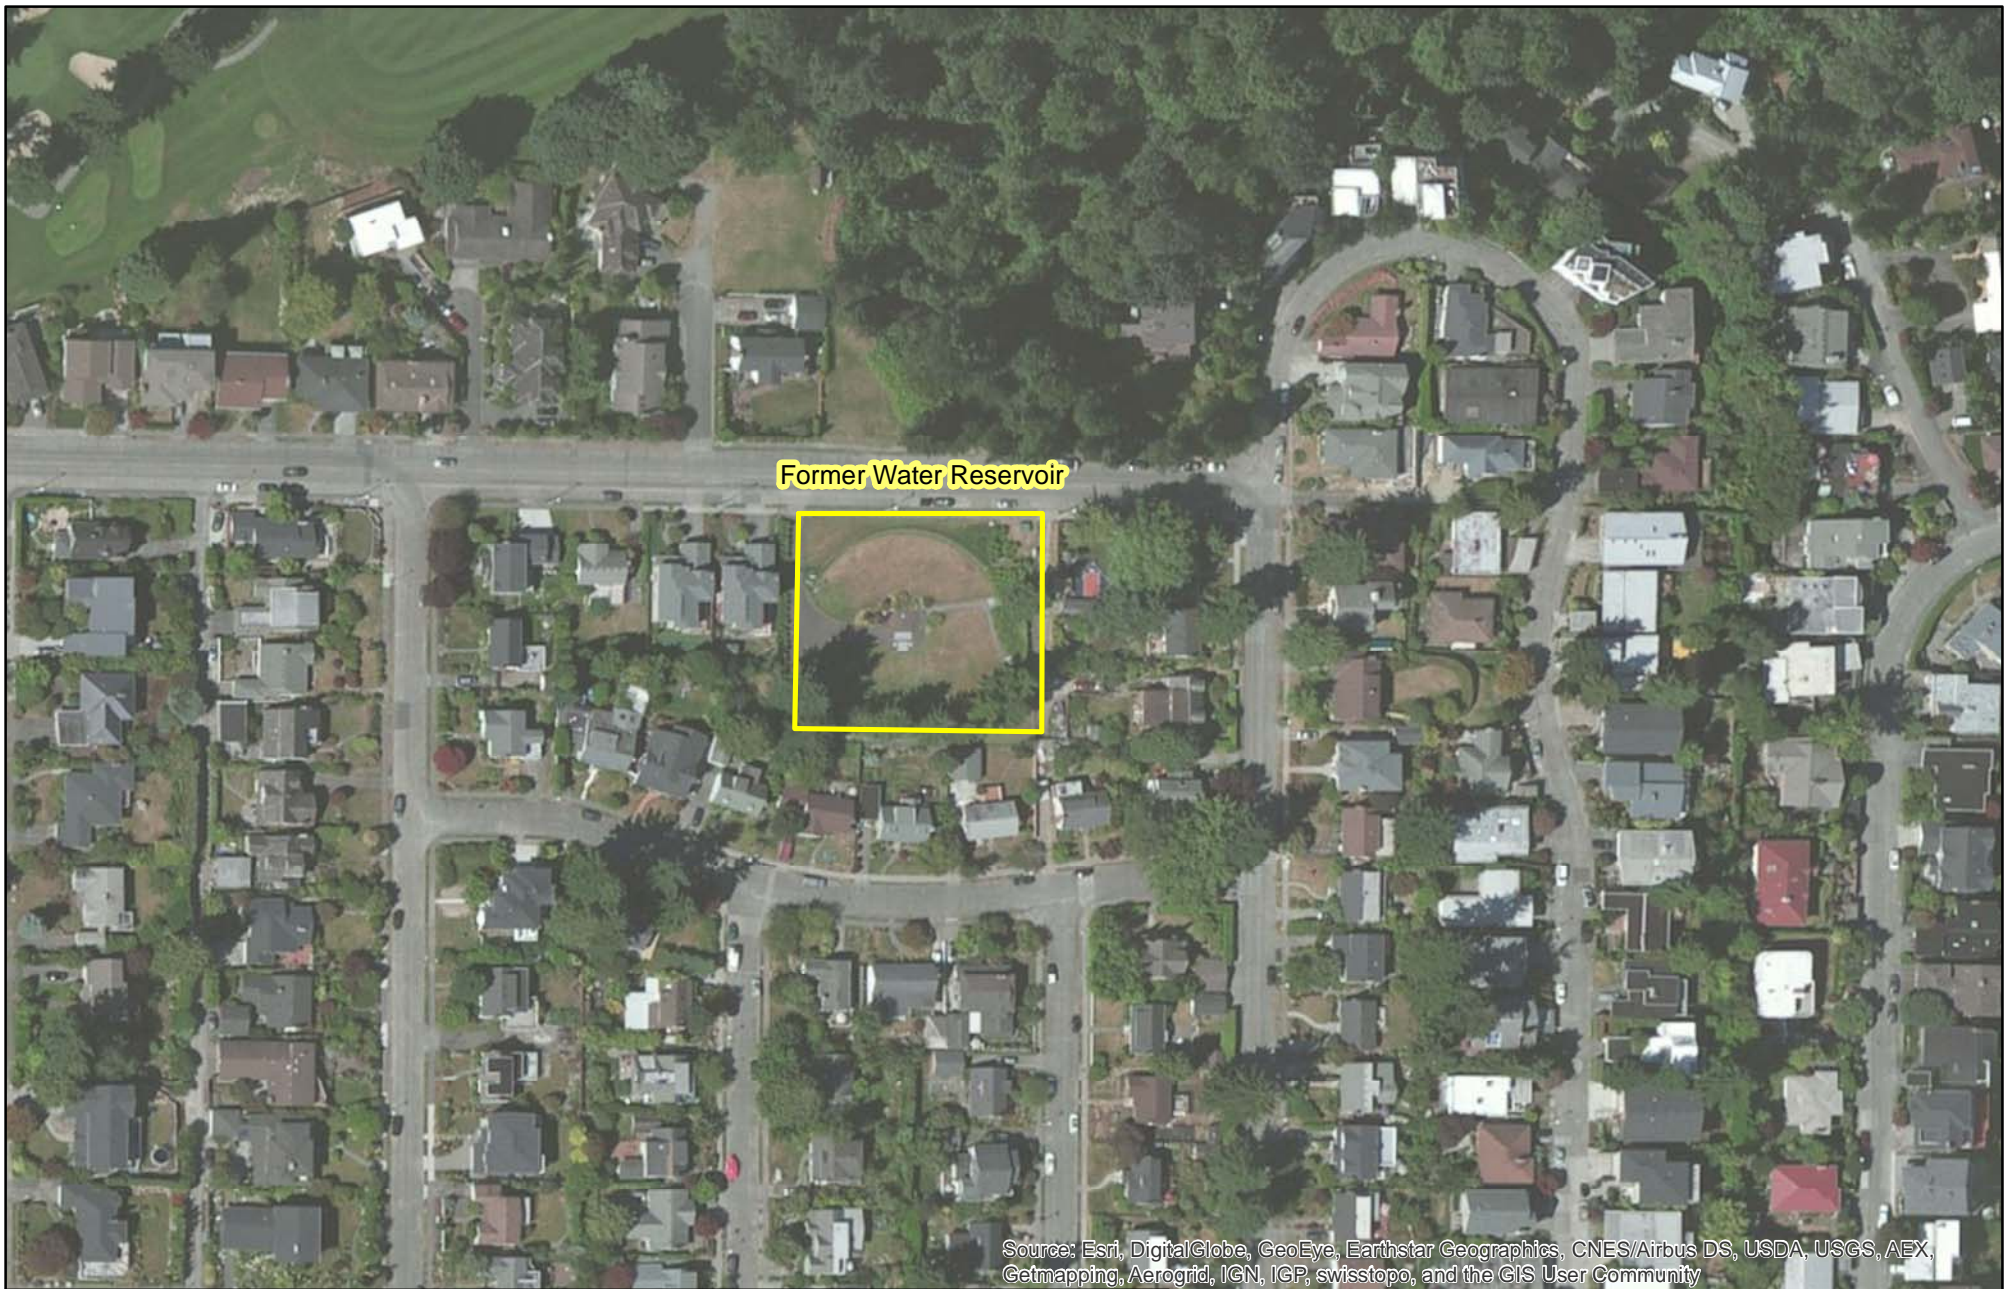
Notes: Site of former water reservoir (tower) is highlighted in yellow. The area appears vacant and is located in a residential neighborhood.

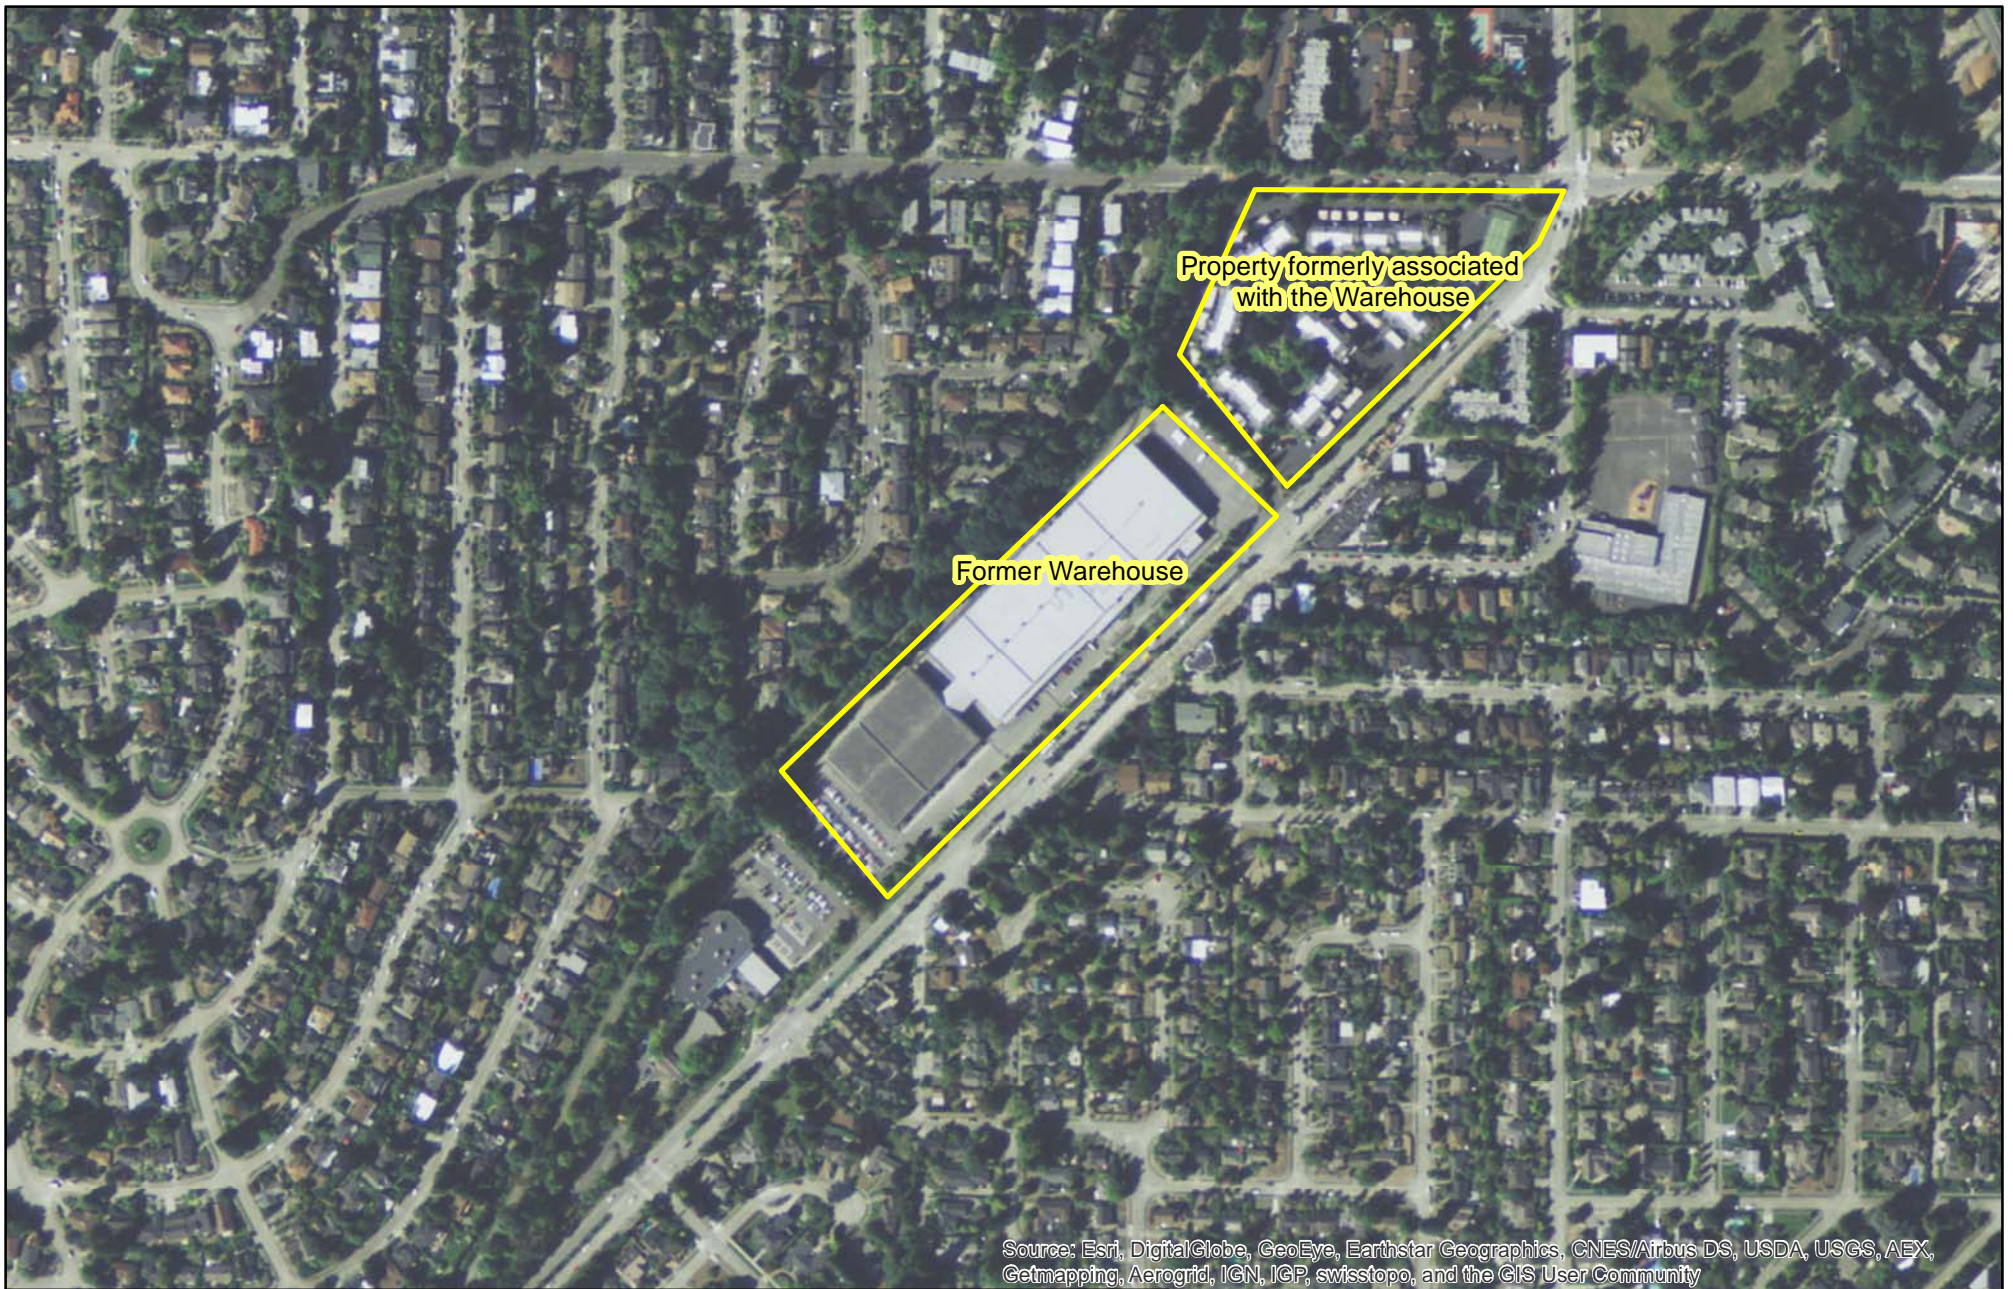
Figure 3-12
 Site of Former Warehouse
 and Adjacent Property
 PRELIMINARY ASSESSMENT REPORT
 NAS SEATTLE
 SEATTLE, WASHINGTON

Notes:
 Location of former NAS Seattle warehouse is depicted above.
 The property is now owned by National Archives and Records Administration.

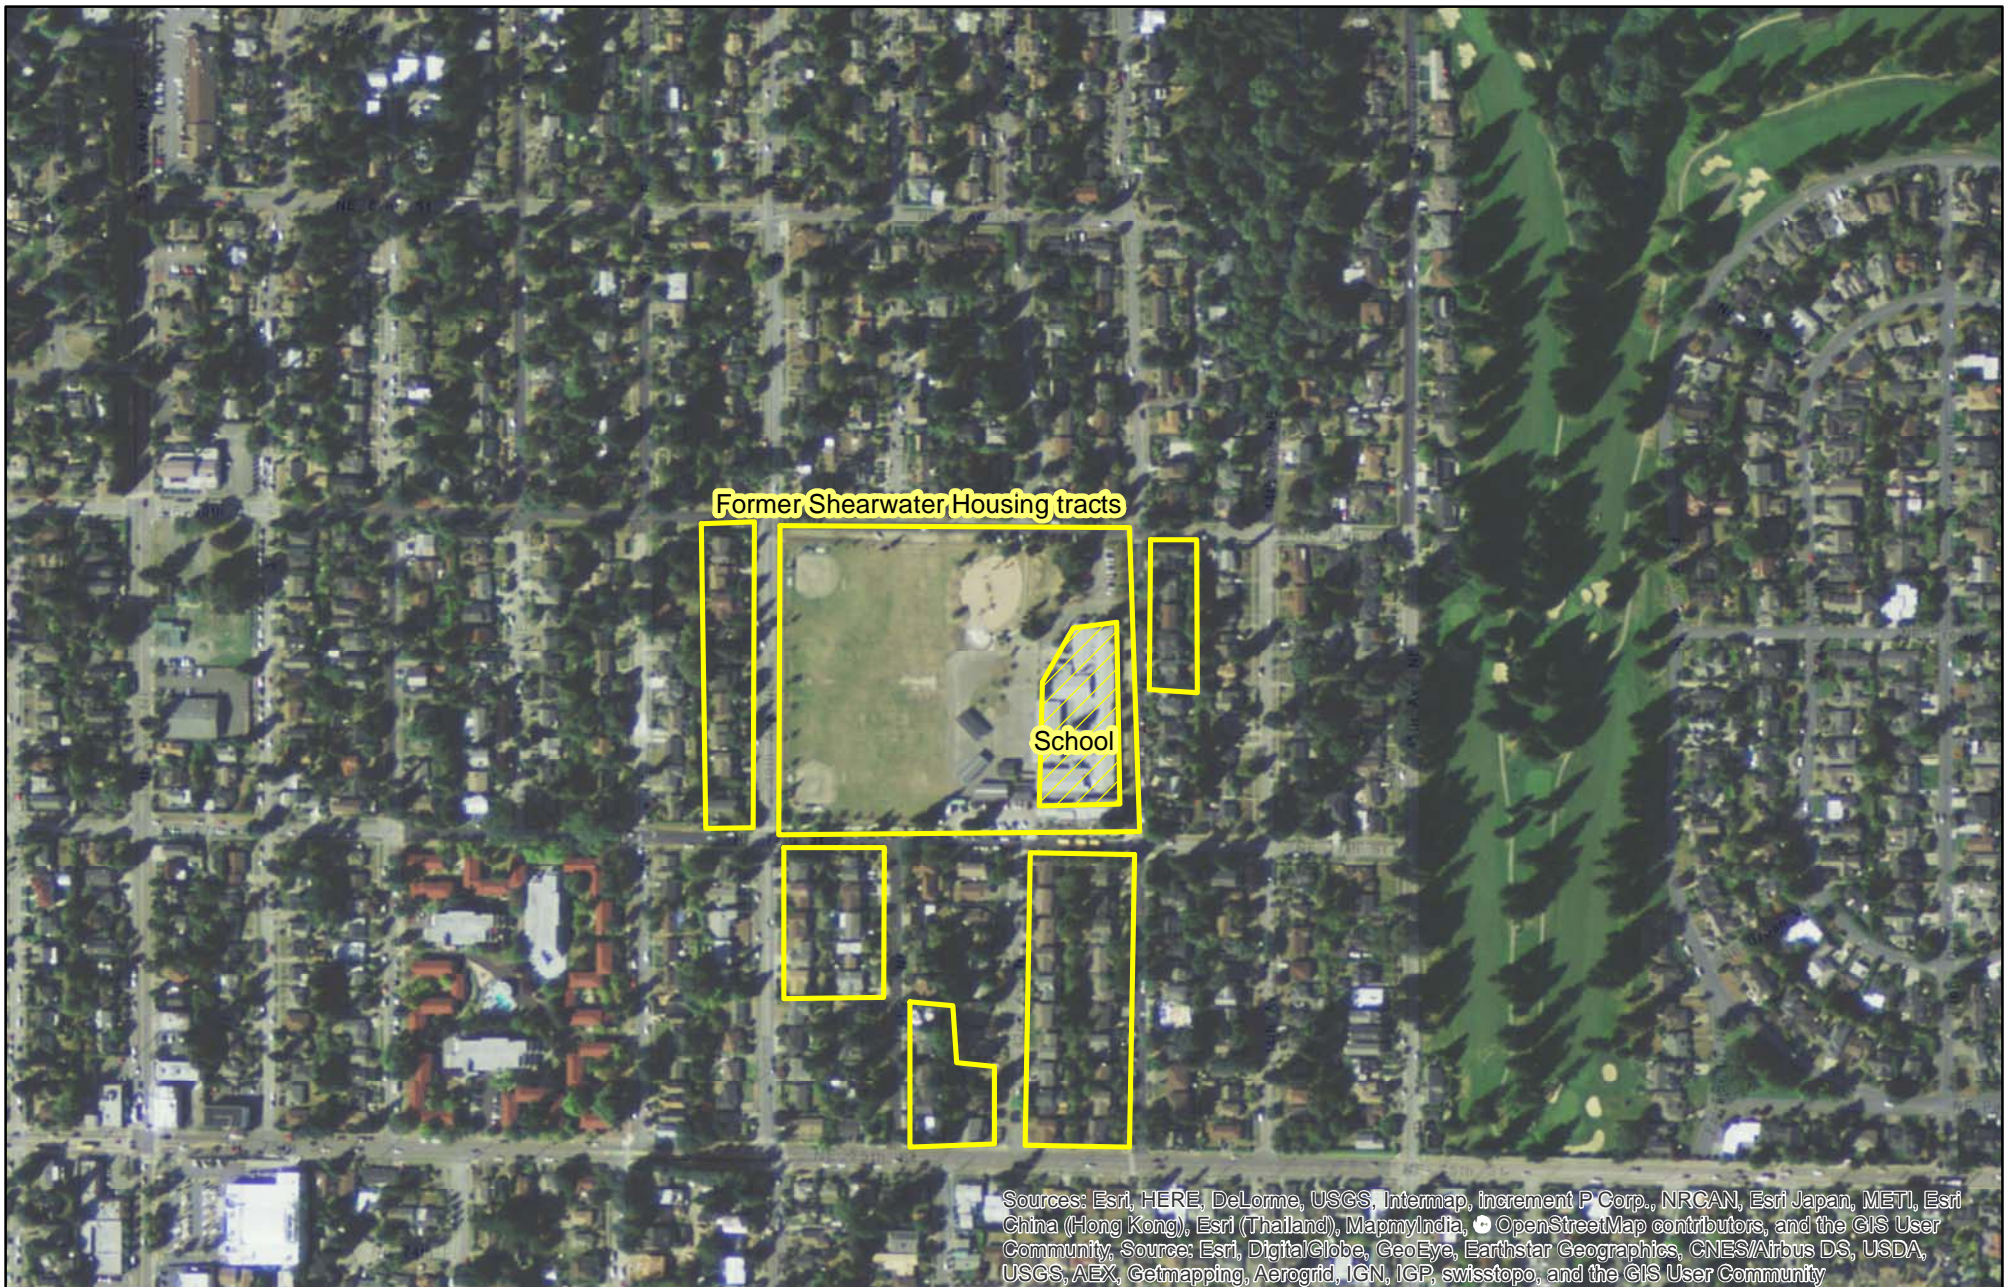
Notes: The yellow highlighted areas depict the former Shearwater Housing tracts. The DERP-FUDS eligible portion is the cross-hatched area which is now occupied by the Thornton Creek School. Surrounding area is residential.

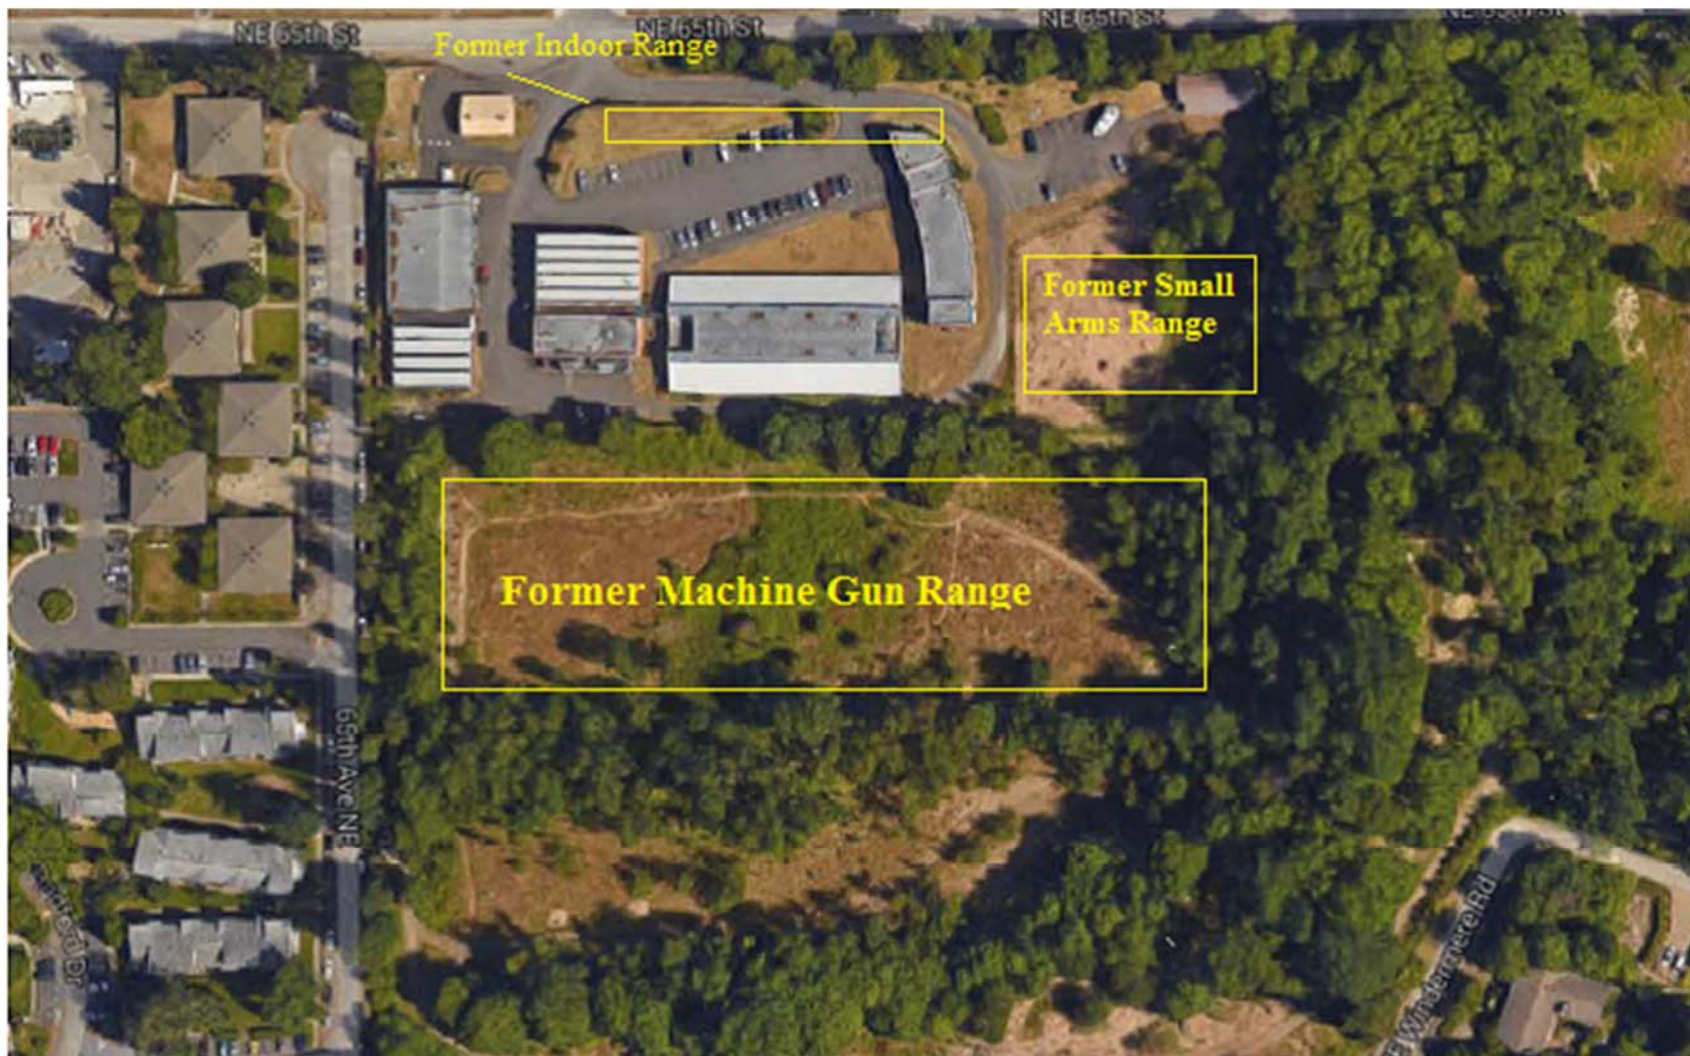
Note: Former location of Machine Gun, Small Arms, and Indoor Ranges. Source of image is Google Maps. Property boundary is approximate and for illustration only.
