**CONTRACT No. N62473-10-D-0809
CTO No. 0011**

**FINAL
AFTER ACTION REPORT**

**RADIOLOGICAL MATERIALS TIME-CRITICAL REMOVAL ACTION
AT FORMER NAVAL STATION PUGET SOUND
SEATTLE, WASHINGTON**

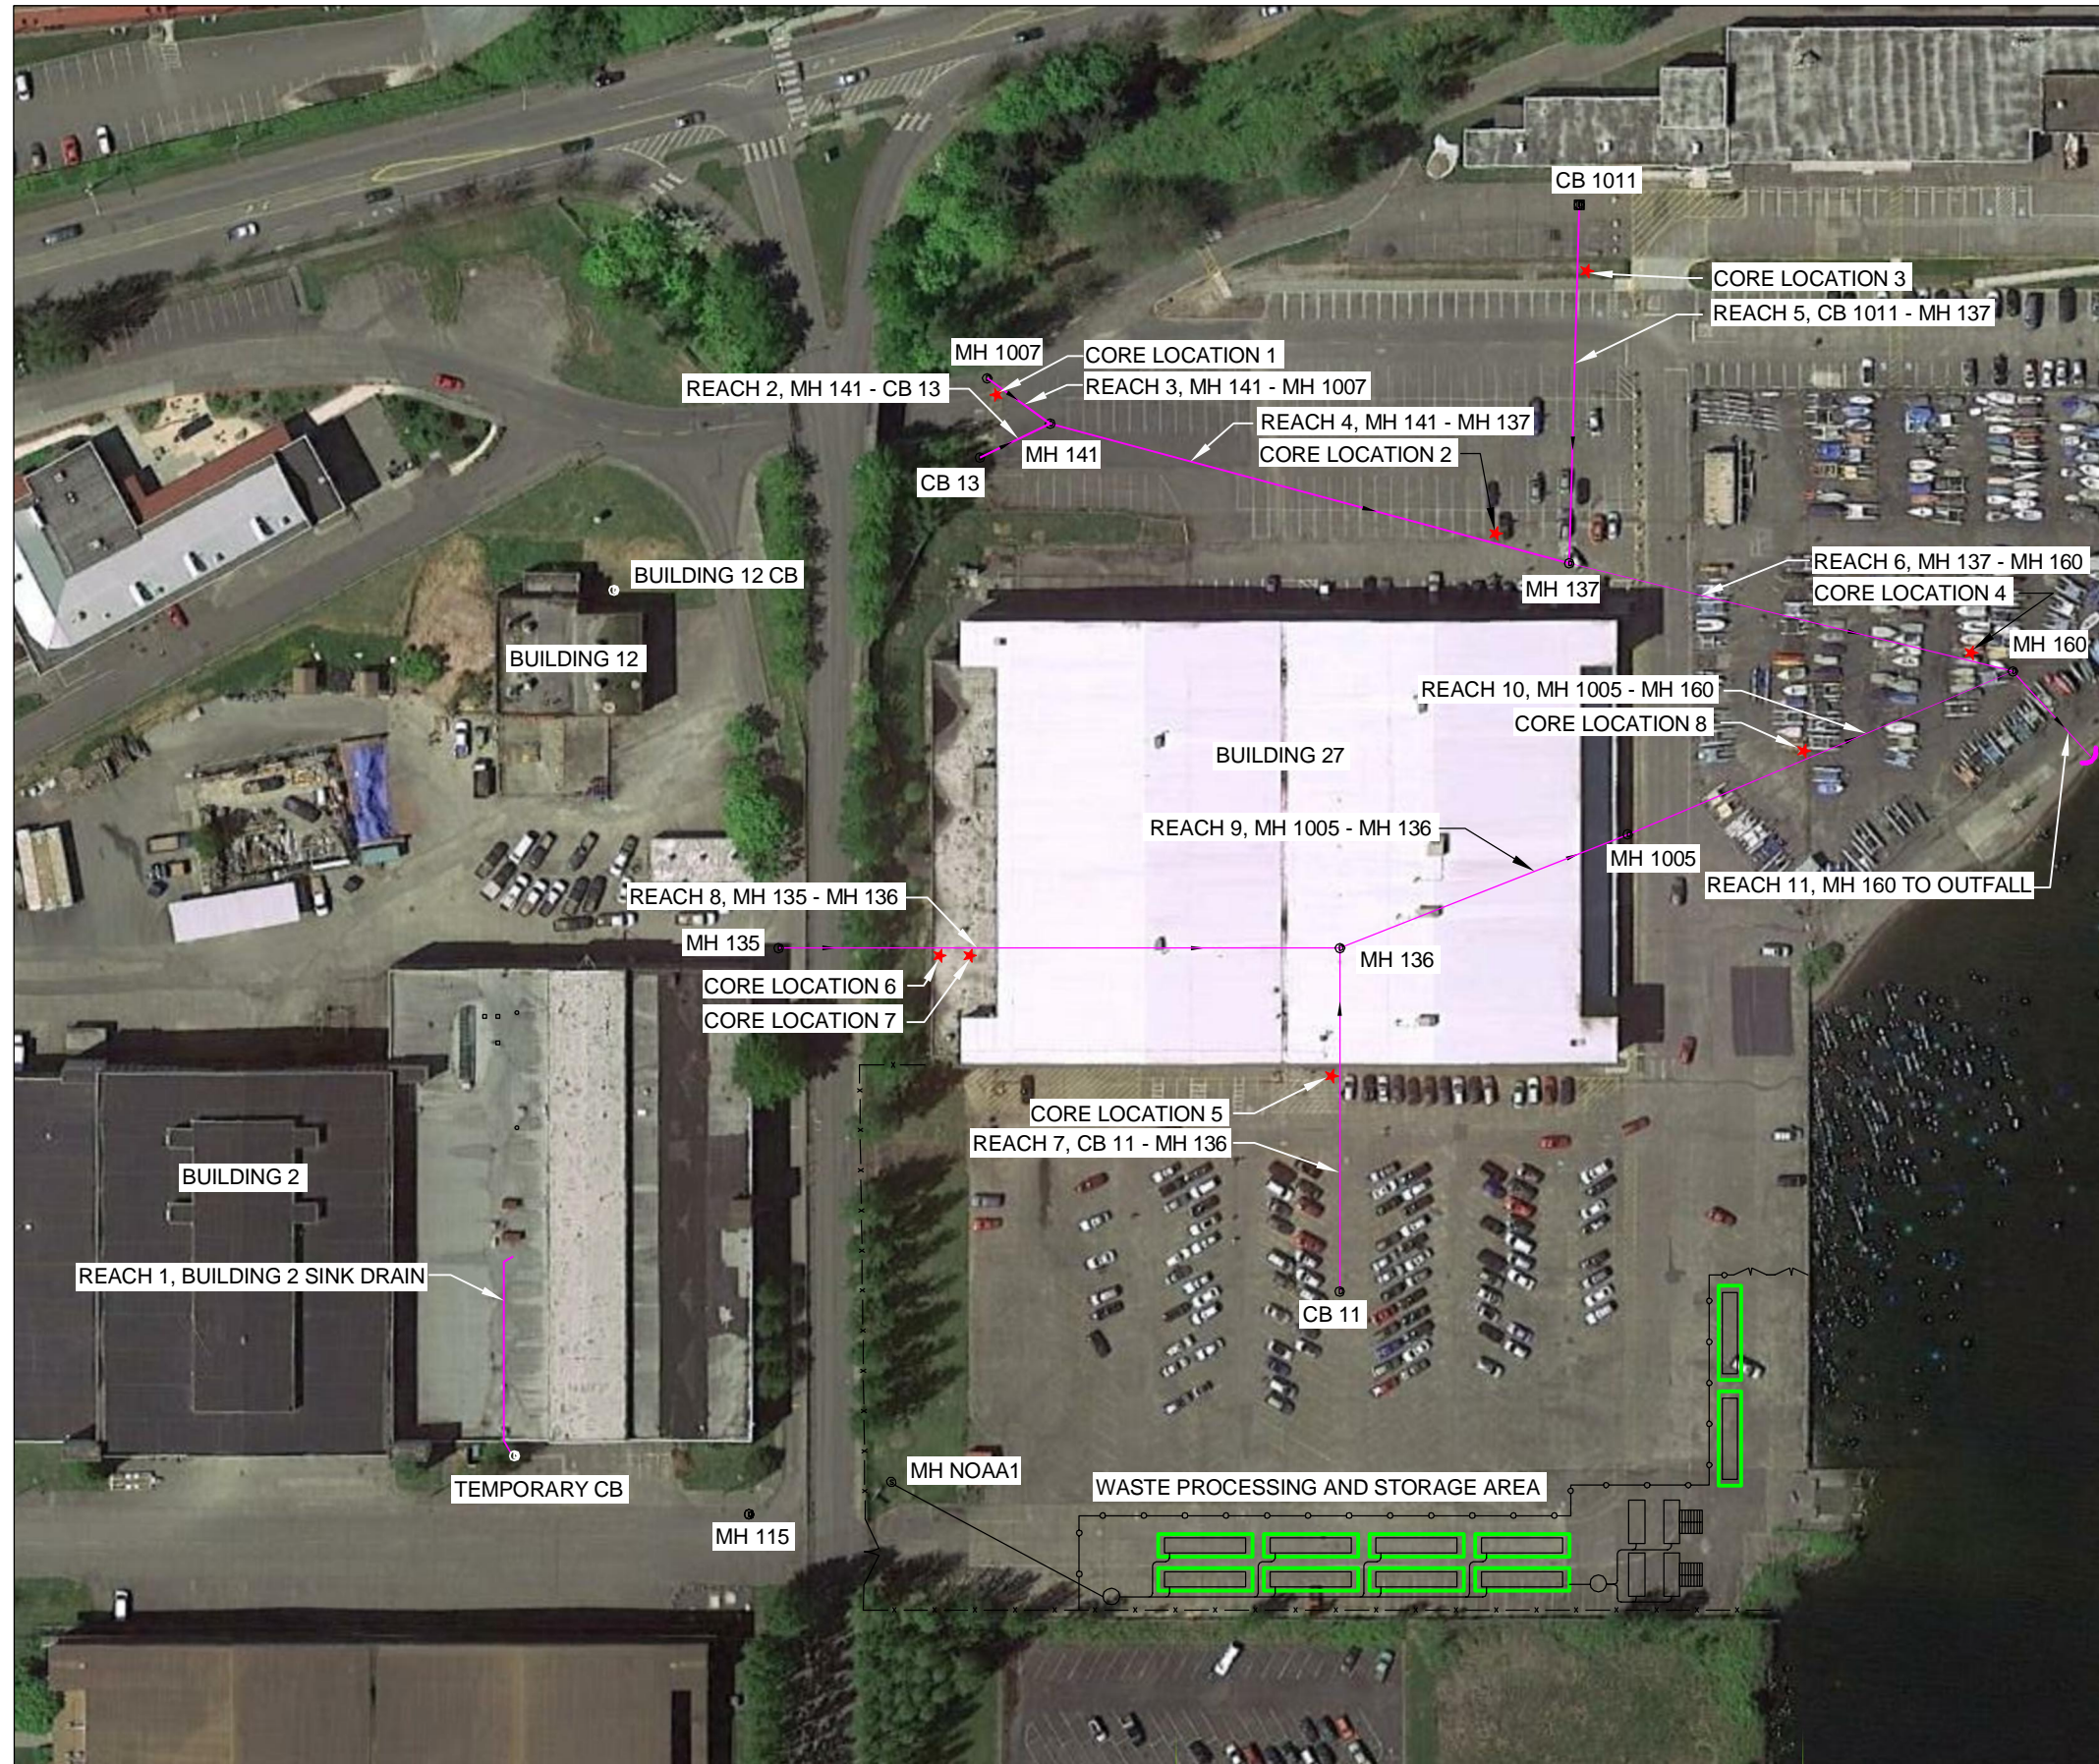
AFTER ACTION REPORT
 RADIOLOGICAL MATERIALS TIME-CRITICAL REMOVAL ACTION
 FIGURE 5-3
 STORM DRAIN CLEANING, INSPECTION, AND GAMMA SCAN
 SURVEY LOCATIONS
 FORMER NAVAL STATION PUGET SOUND, SEATTLE, WASHINGTON

Hydrojetting operations continued for the Reach 1 collector line until a video inspection confirmed that all visible sediment had been removed. Once the sediment was removed, a sewer inspection camera was used to record the condition of the sink drain line pipe. The video inspection did not identify any notable defects that would indicate the potential for release of contamination into the surrounding soil. Gamma scan surveys of the Reach 1 pipe interior were performed using a waterproof Ludlum Model 44-10-5 detector attached to a push camera. Interpreting the data collected during the gamma radiation survey presented several challenges since naturally occurring sources of gamma radiation, including Ra-226, are typically present in the environment, with radon gas and its progeny and potassium-40 as the greatest contributors to background gamma radiation concentrations. Naturally occurring radioactive materials are often present in differing concentrations within soil and construction materials, and gamma radiation levels may vary depending on whether the material is plastic, clay, or concrete. The soil depth and pipe geometry also affect background gamma radiation levels. In addition, water acts as a shield to radiation, and the presence of water may affect background radiation levels. Due to the variability of these factors within drain line systems, the selection of a single appropriate background reference area for piping was unrealistic. Consequently, the survey data set was segregated by material type and compared to the mean plus three times the standard deviation, or sigma, of its own data set.

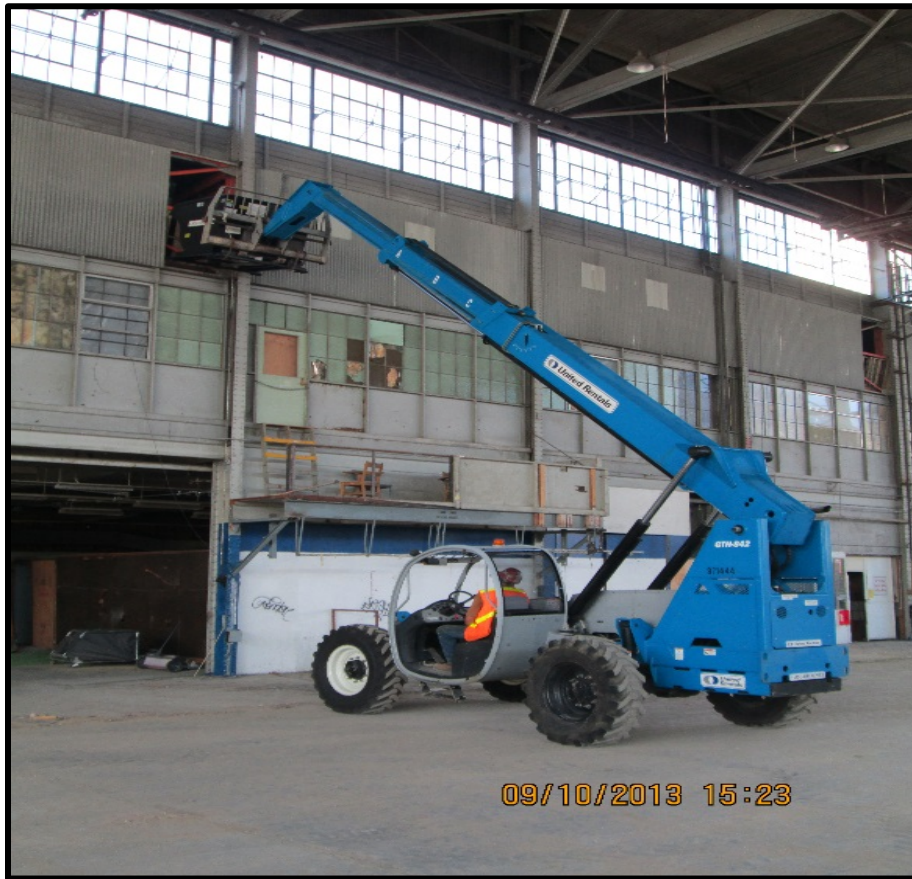
Photograph 1-1: Removing ventilation ducting from Building 2 attic space.

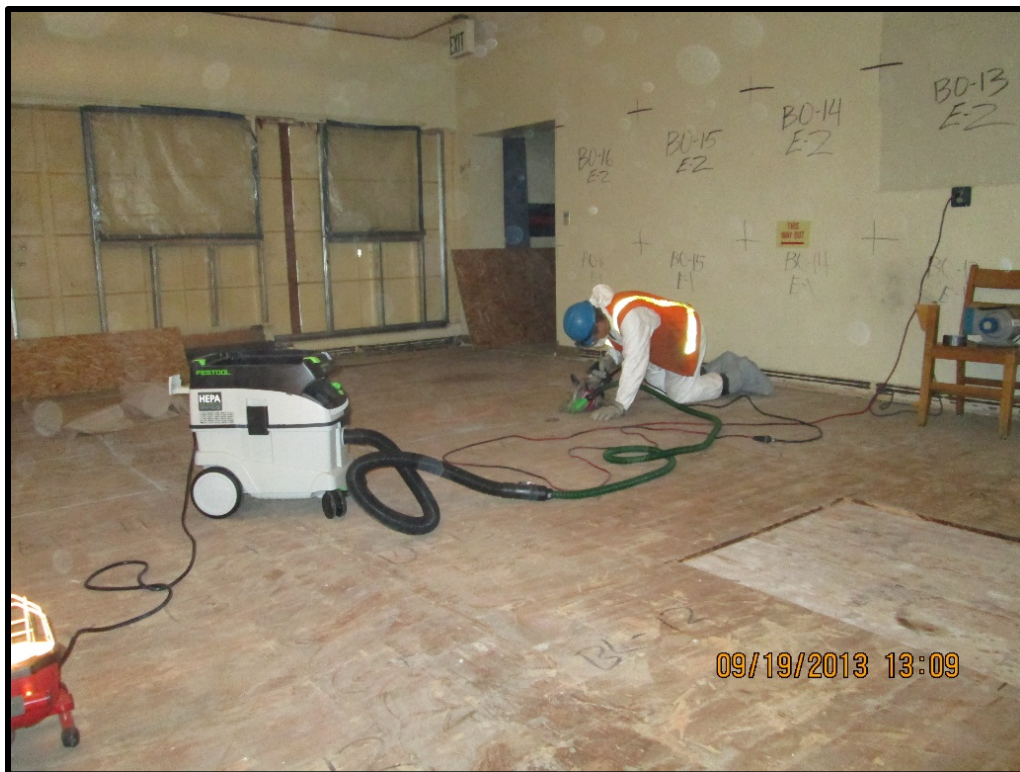
Photograph 1-2: Floor remediation in Building 2 former 1941 Instrument Shop area.

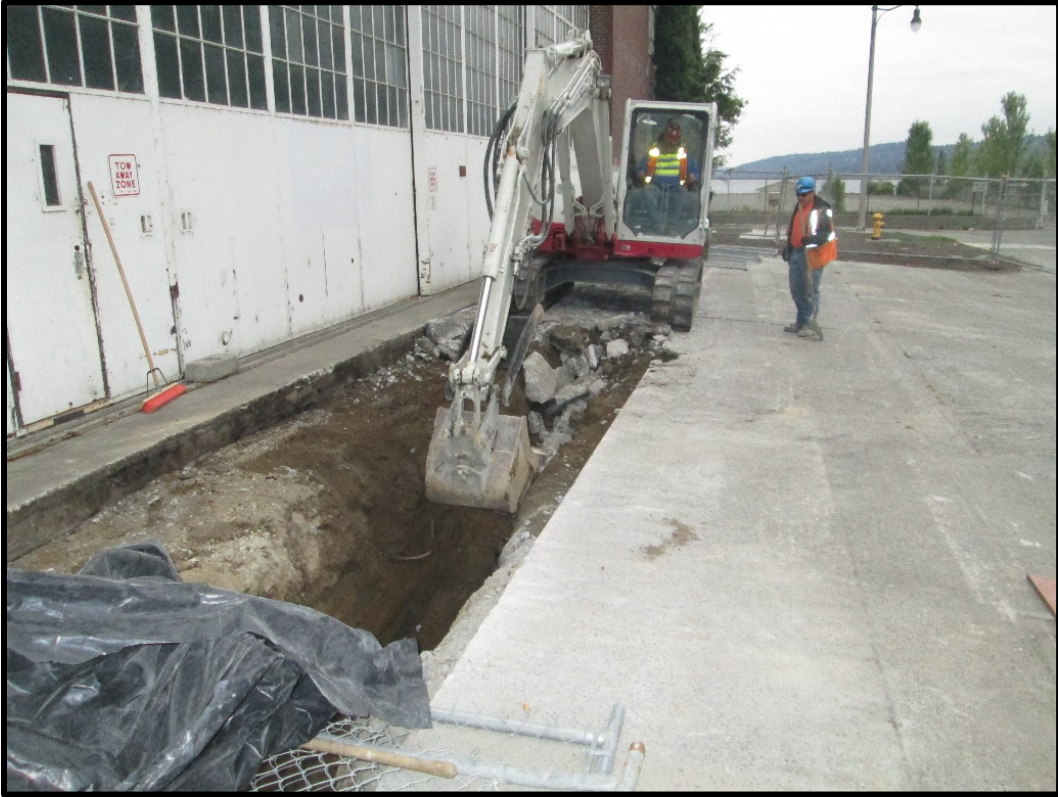
Photograph 1-3: Excavation of Building 2 sink drain line.

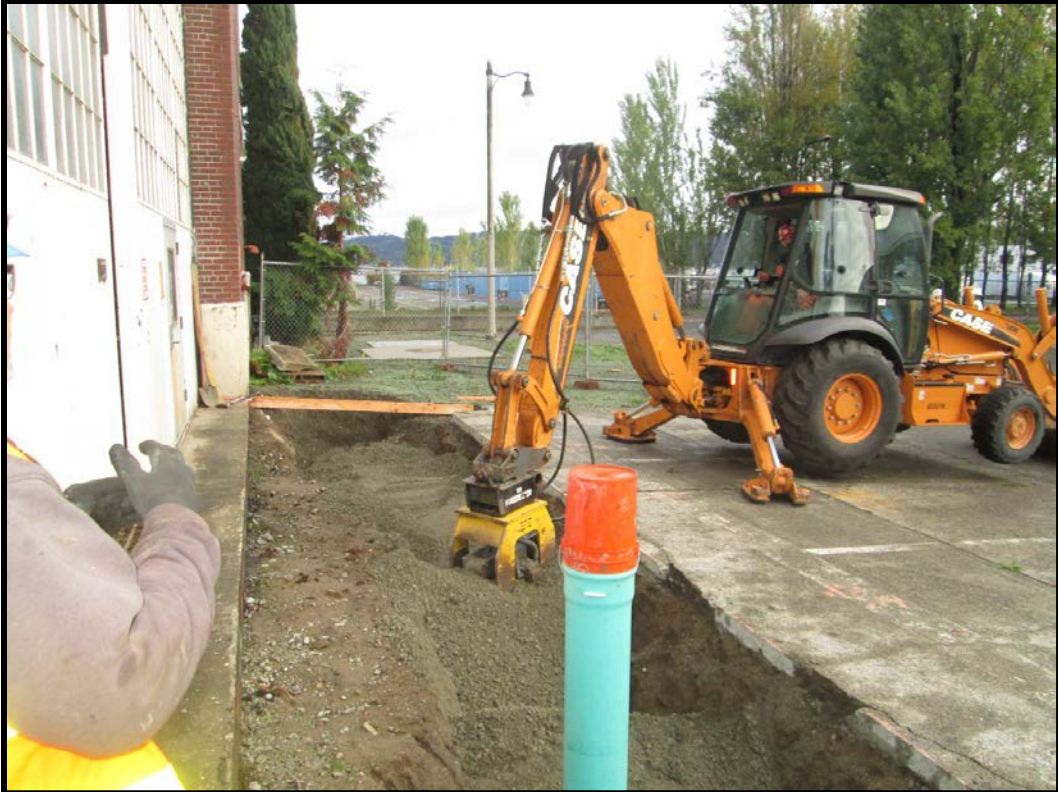
Photograph 1-4: Backfill/compaction of Building 2 sink drain line trench.

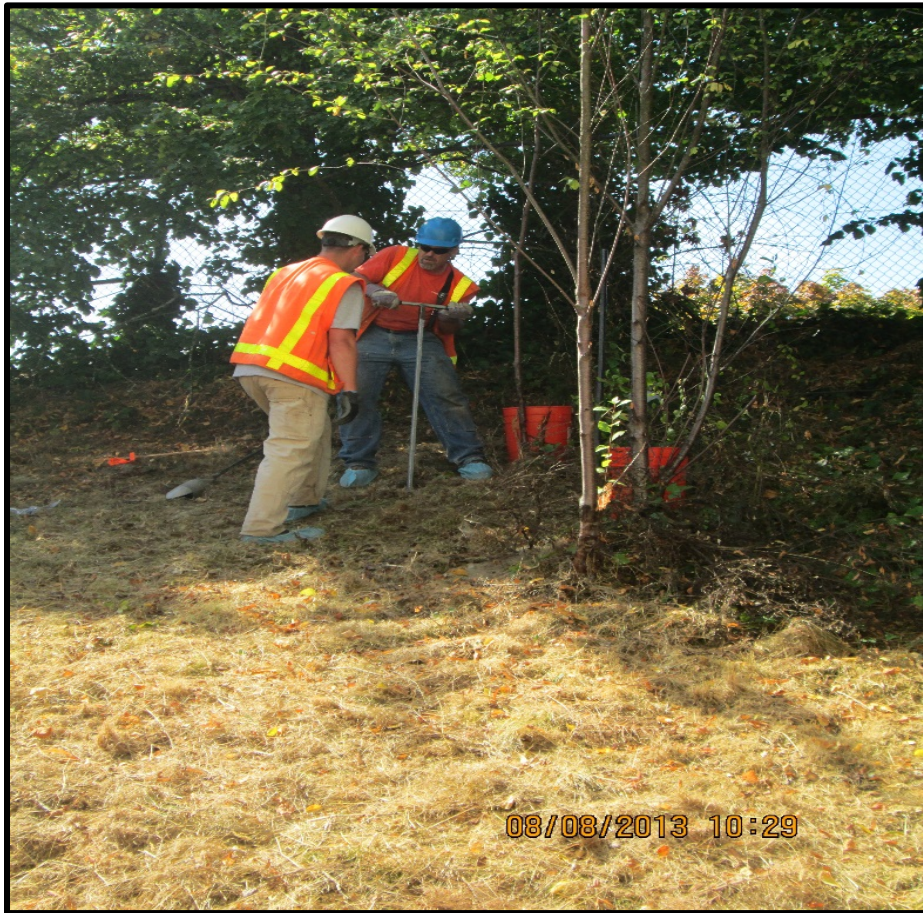
Photograph 1-5: Collecting soil characterization core sample south of Building 27.

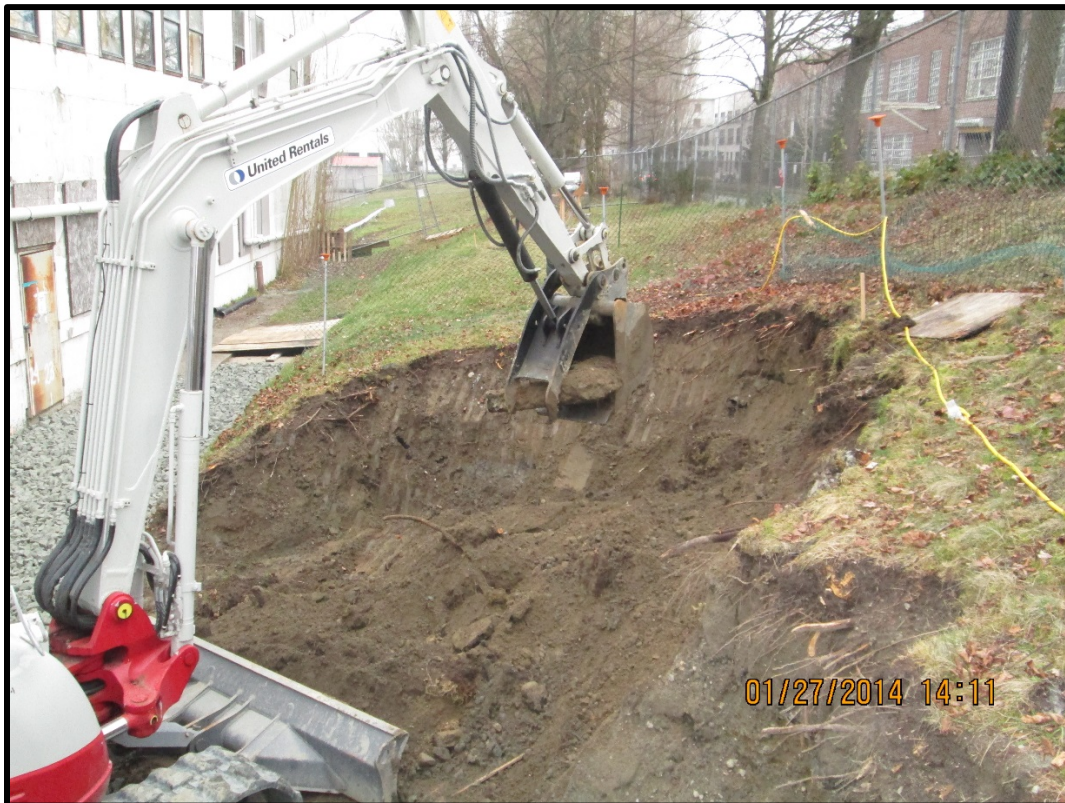
Photograph 1-6: Excavation of HS-07 south of Building 27.

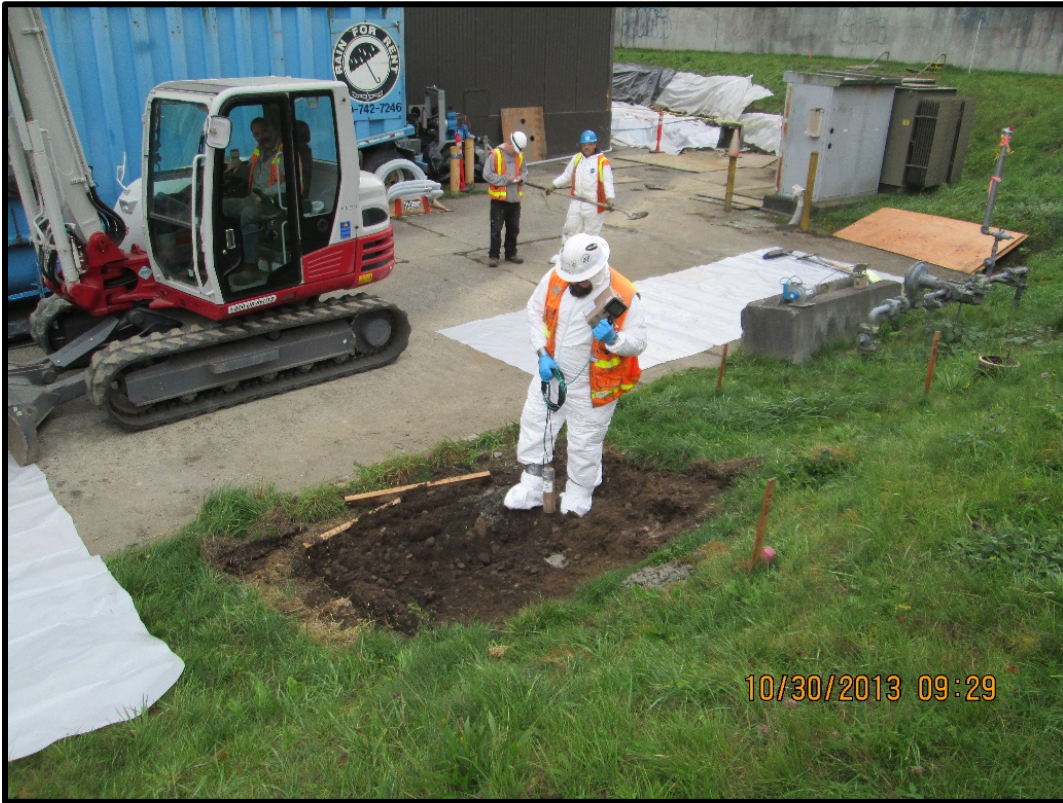
Photograph 1-7: Gamma walkover survey of hotspot excavation west of Building 27.

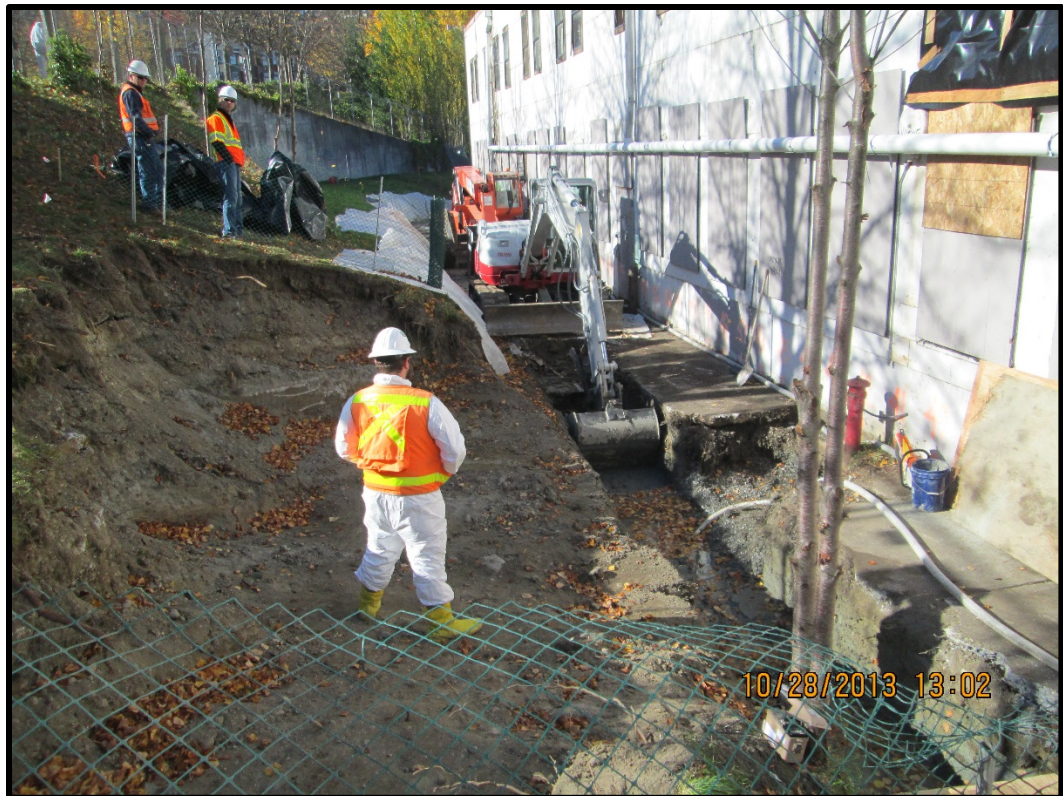
Photograph 1-8: Removal of storm drain line and soil south of Building 27.

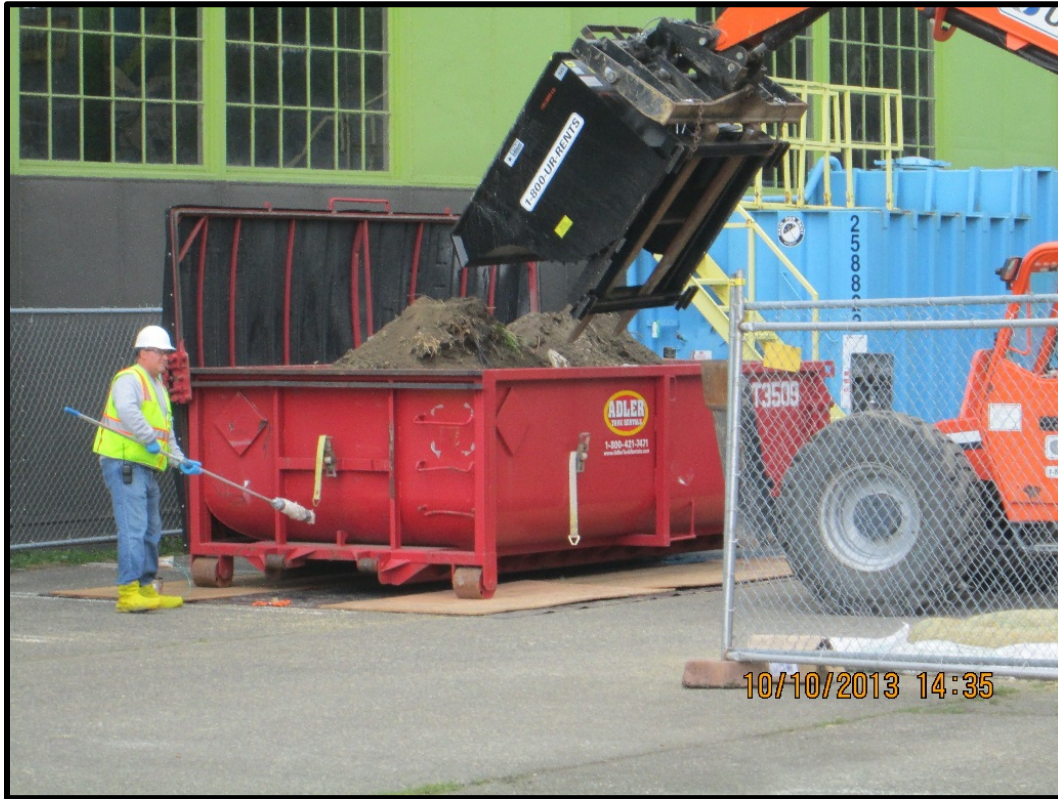
Photograph 1-9: Placement of low-level radioactive soil into a disposal bin.

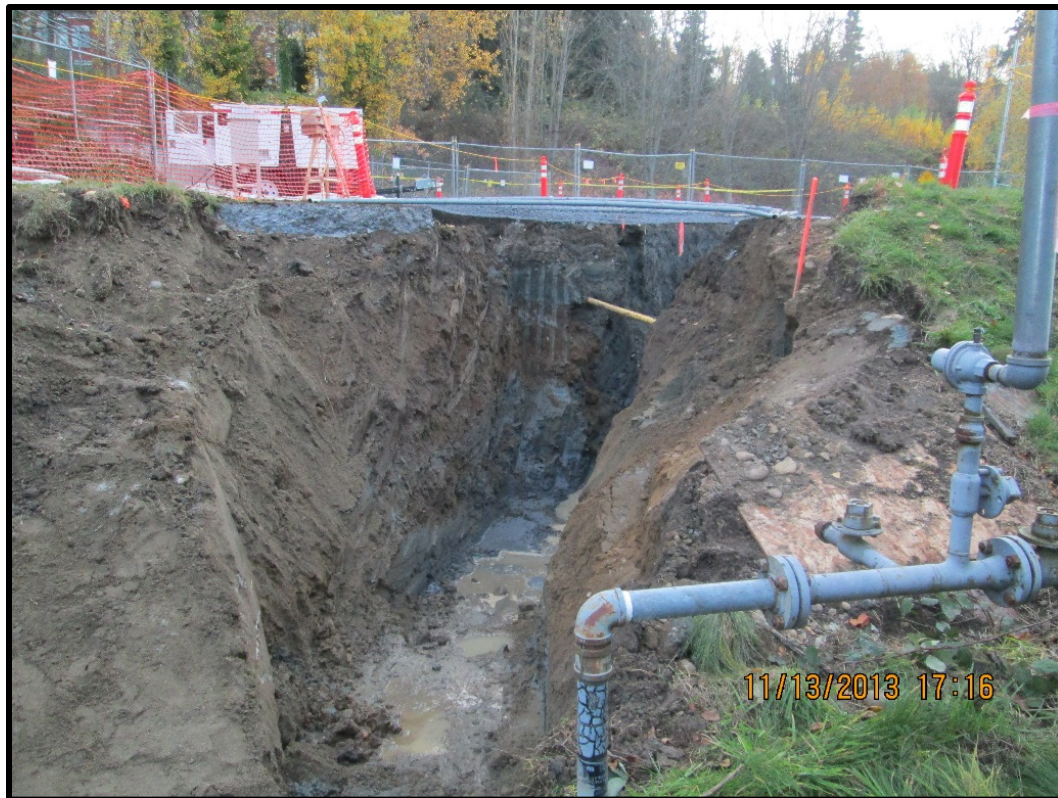
Photograph 1-10: Storm drain line to MH-141 excavation west of Building 27.

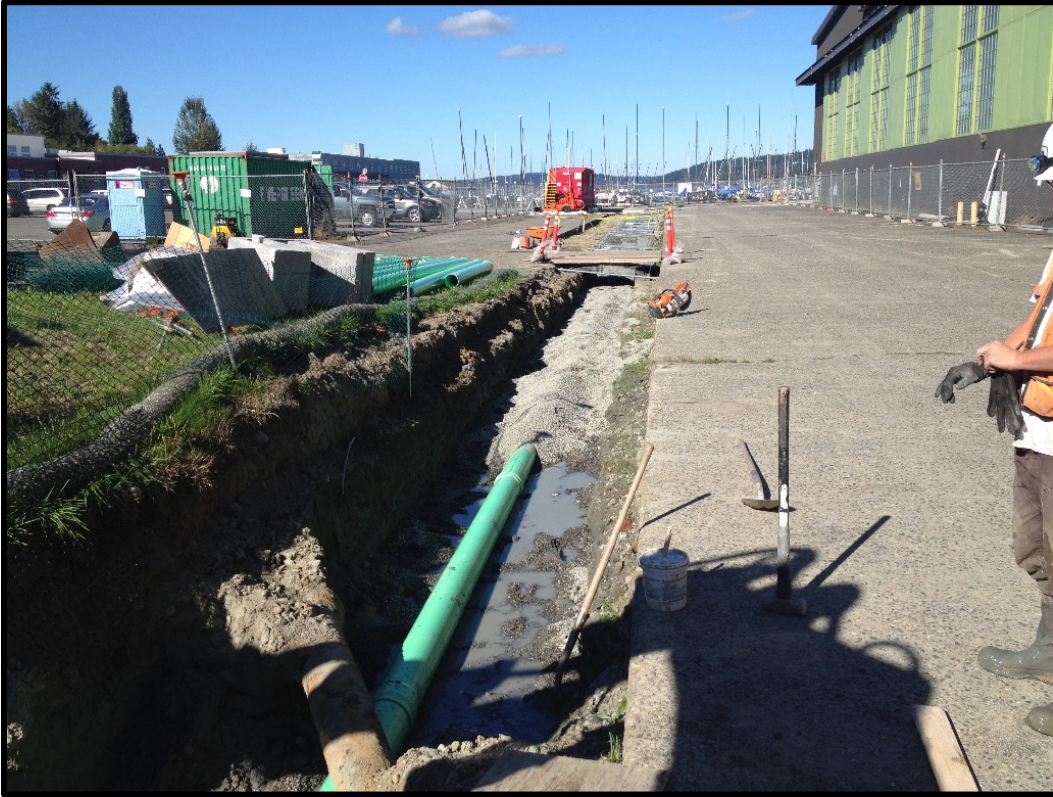
Photograph 1-11: Installation of new storm drain pipe from CB-5 to CB-8.

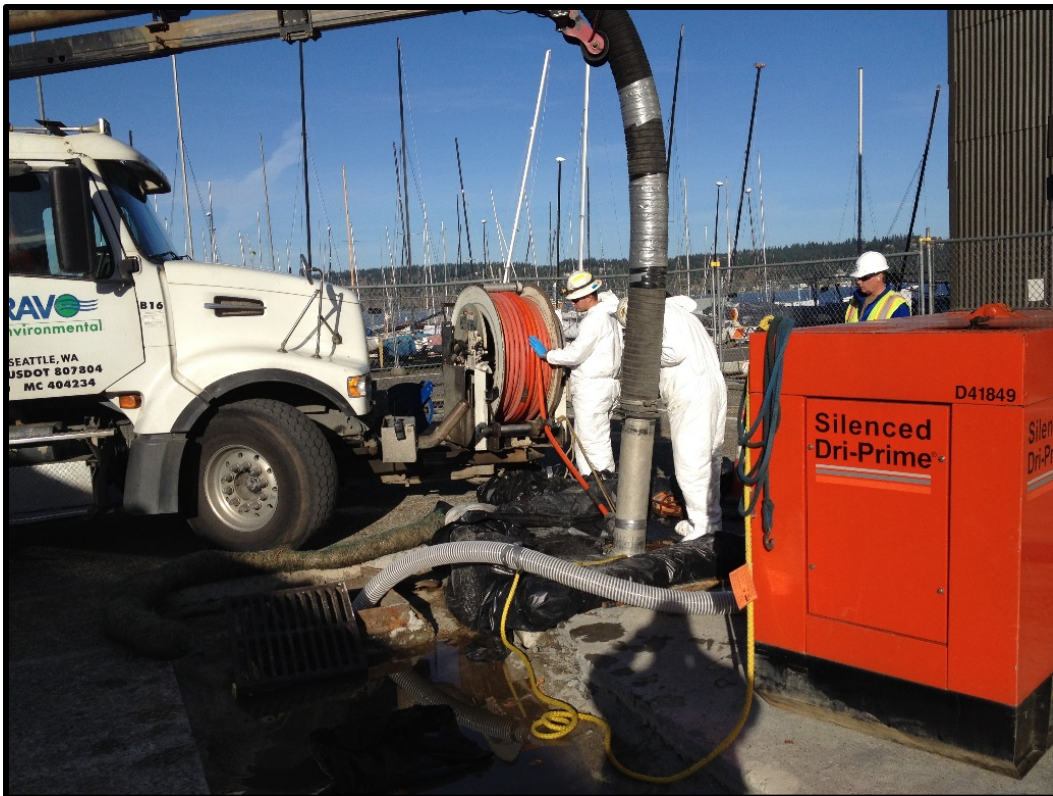
Photograph 1-12: Storm drain cleaning operation at MH-160.

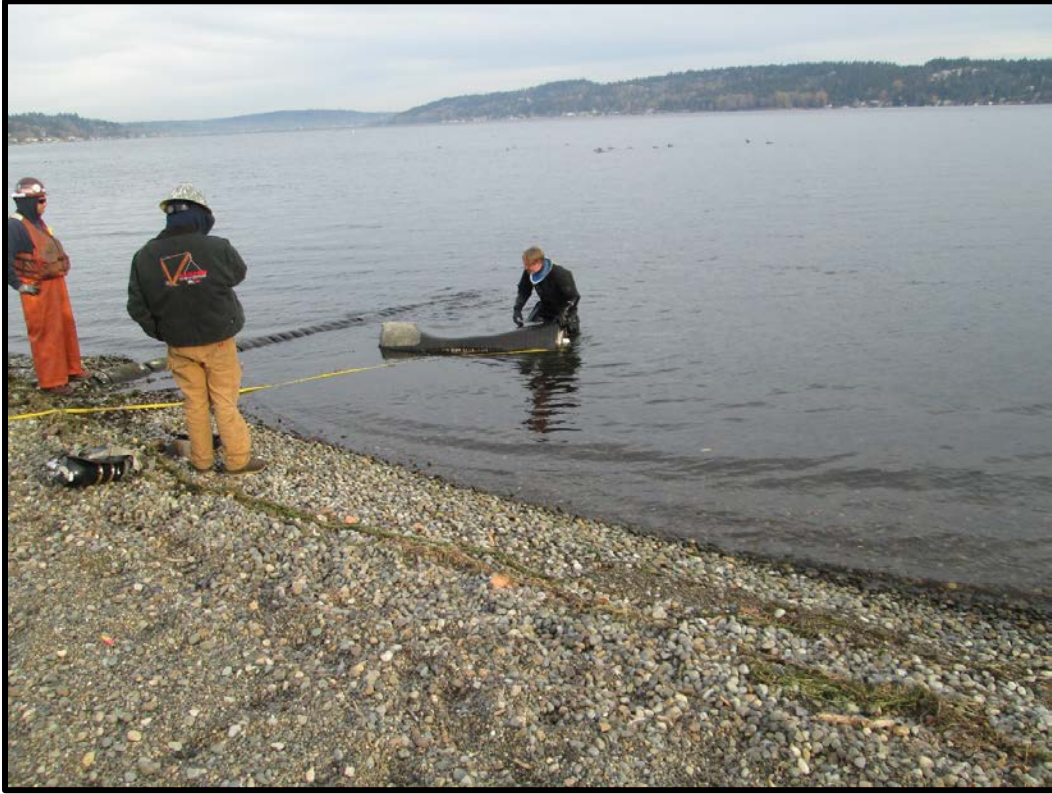
Photograph 1-13: Installation of plug in storm drain outfall to Lake Washington.

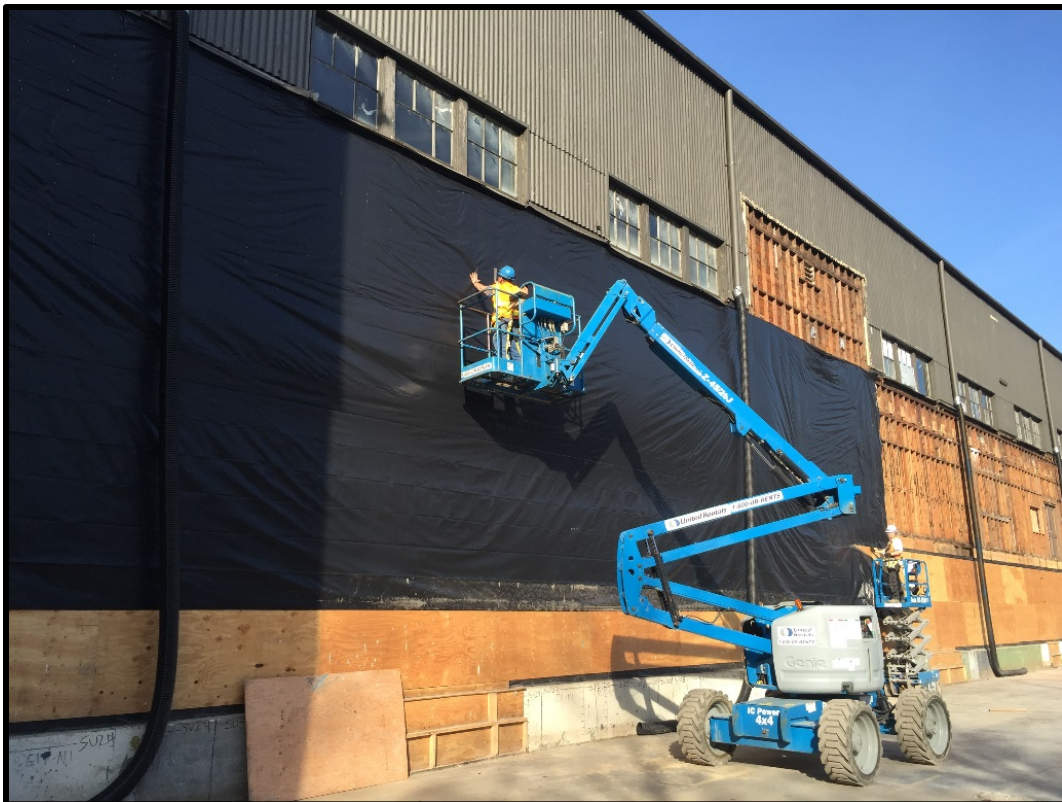
Photograph 1-14: Vapor barrier installation on Building 27 common wall.

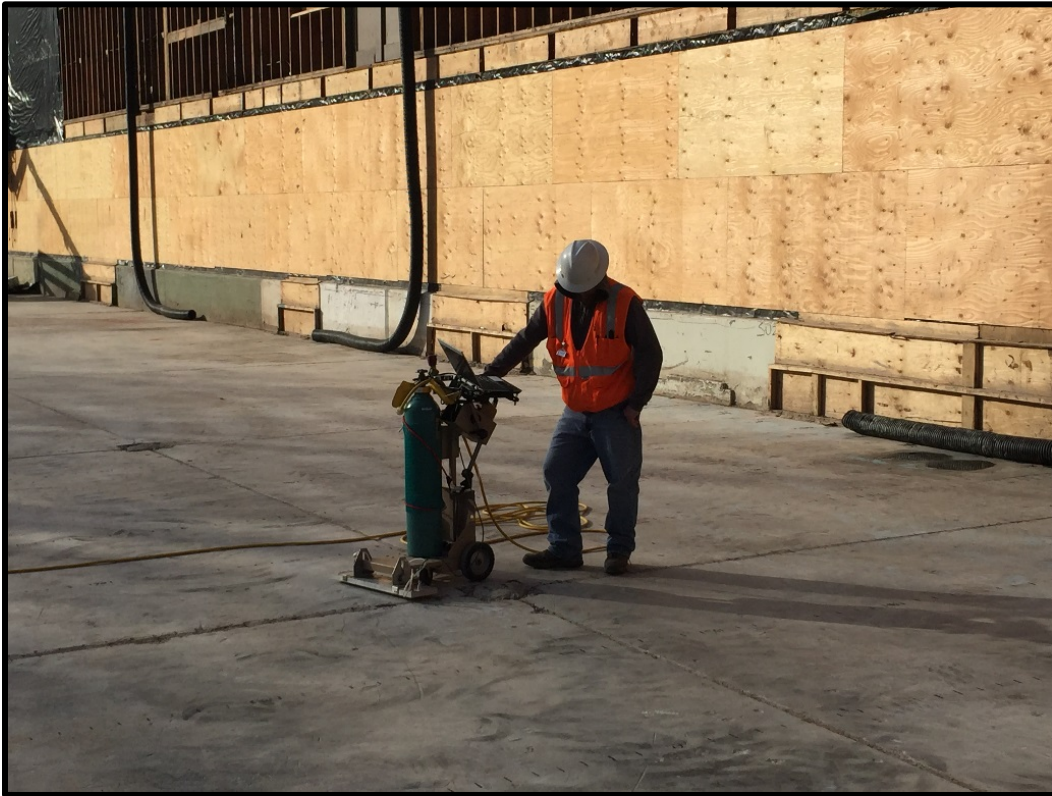
Photograph 1-15: Performing alpha/beta scan survey of the former South Shed concrete slab.

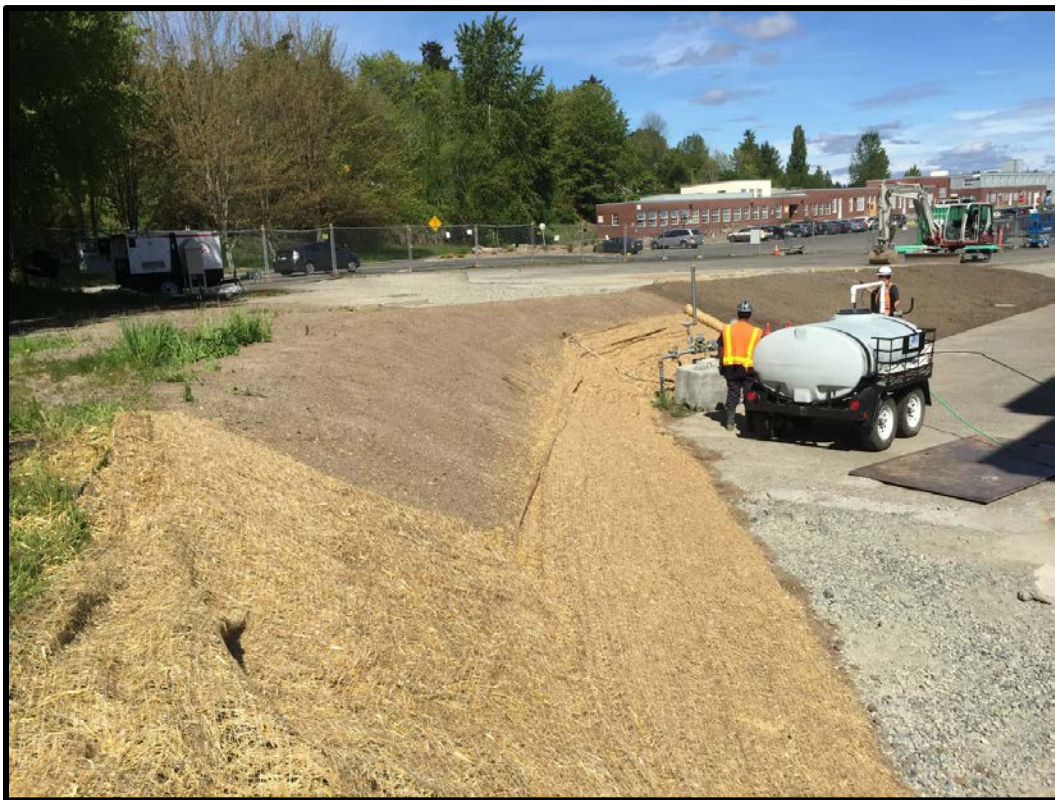
Photograph 1-16: Installation of straw matting over reseeded slopes near Building 27.
