**RE: Geophysical Survey and Preliminary Phase II Subsurface Investigation
Proposed Marysville Sonic
3710, 3724, and 3806 116th Street Northeast
Marysville, Snohomish County, Washington 98271
RGI Project No. 2015-165B**

The Riley Group, Inc. (RGI) is pleased to present our Geophysical Survey and Preliminary Phase II Subsurface Investigation (Preliminary Phase II) for the above-referenced Proposed Marysville Sonic property located at 3710, 3724, and 3806 116th Street Northeast, Marysville, Snohomish County, Washington (hereafter referred to as the Site, Figure 1).

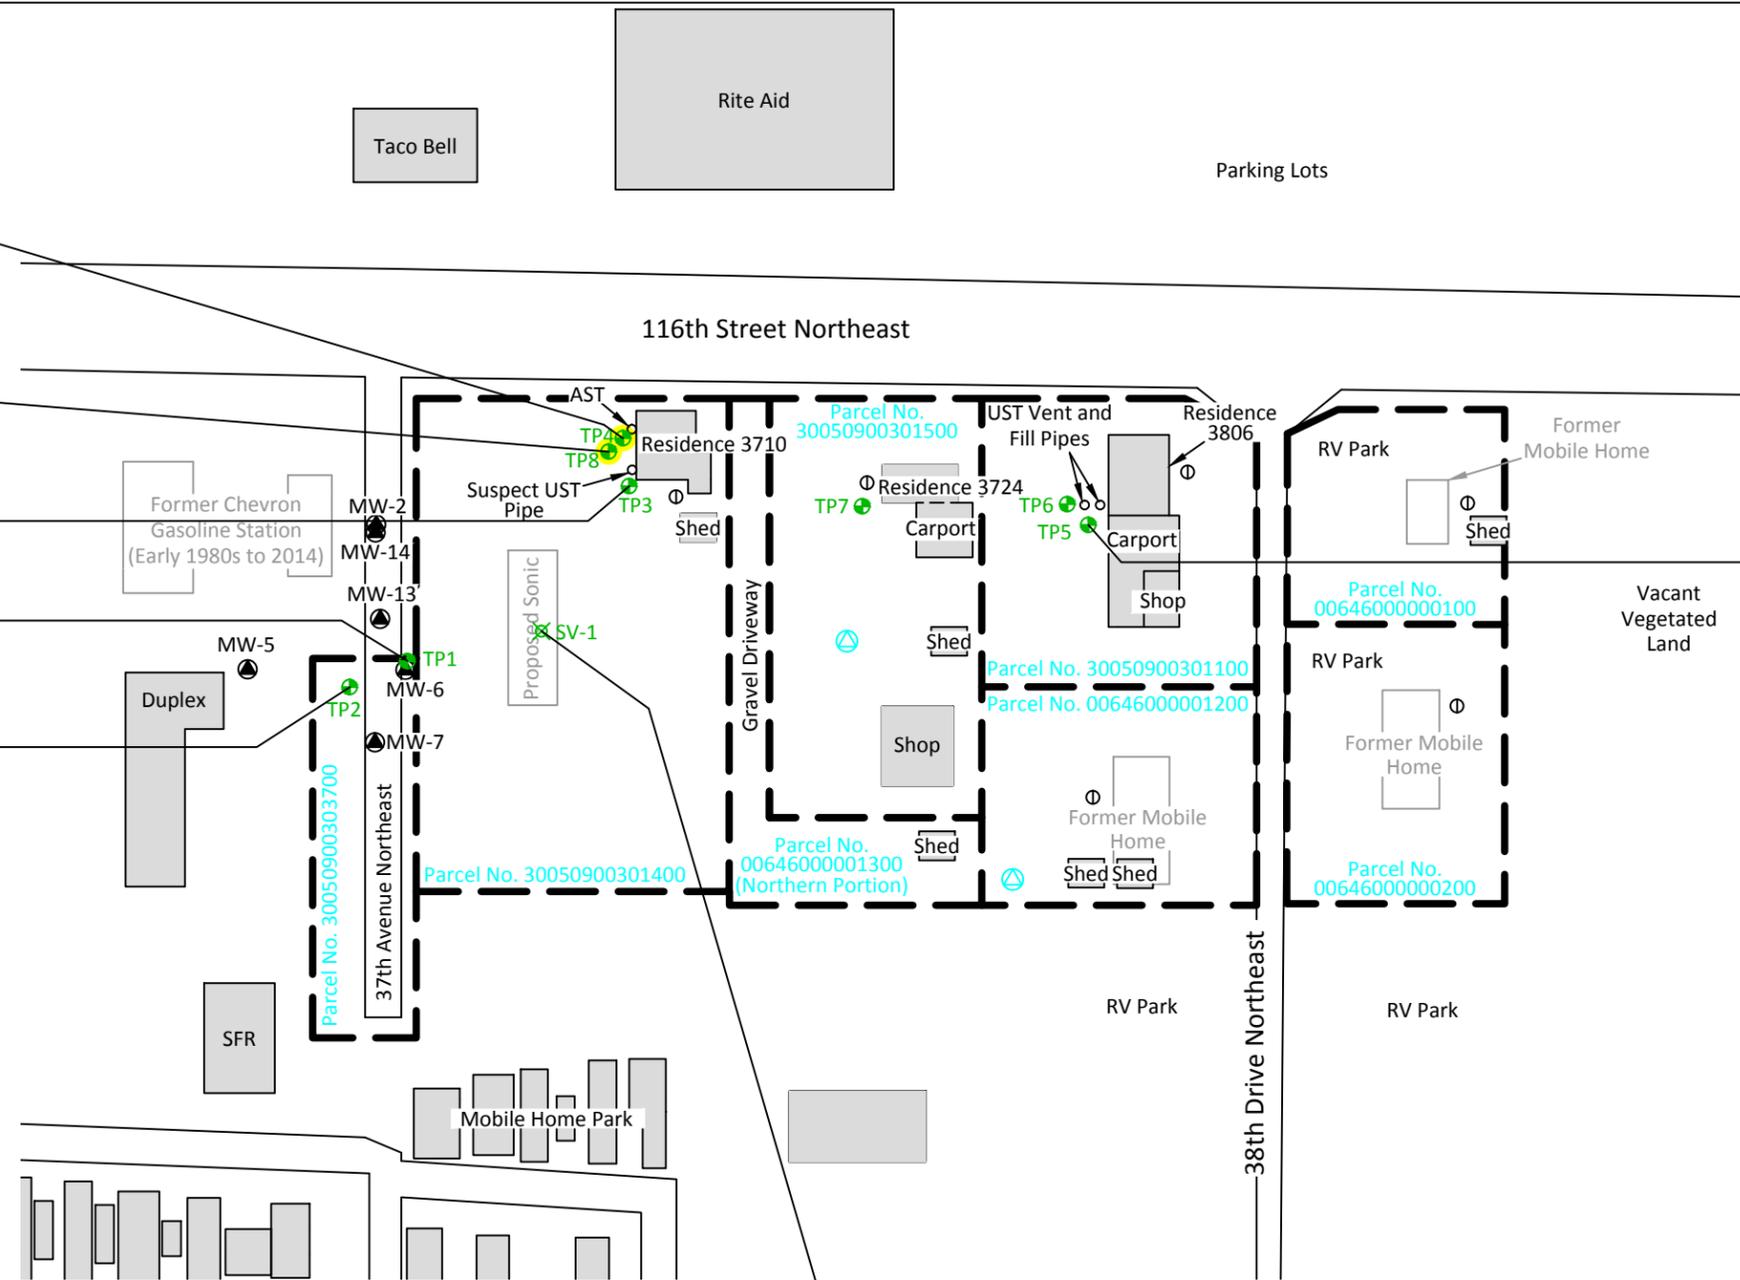
Proposed Marysville Sonic		Figure 2
RGI Project Number	2015-165B	Date Drawn: 02/2016
Site Plan Showing Test Probe Locations and Analytical Results		
Address: 3710, 3724 and 3806 116th Street Northeast, Marysville, Washington 98271

Test probes TP1 and TP2 were near the western boundary of the Site in order to evaluate the west-adjointing gasoline station. Test probes TP3, TP4, and TP8 were in the vicinity of Residence 3710. Test probes TP5 and TP6 were in the vicinity of Residence 3806. Test probe TP7 was in the vicinity of Residence 3724. Soil vapor sampling well SV-1 was in the vicinity of the proposed Sonic restaurant building. Test probe and soil vapor temporary well locations are shown on Figure 2.

Elevated PID readings up to 35 volumetric parts per million (Vppm), slight petroleum odor, and slight petroleum sheen were noted in soils at test probe TP4 at depths between approximately 10.5 and 15 feet bgs. No elevated PID readings, odors, sheens, discolorations, or other evidence of contamination were noted at any of the other test probe locations. Further details can be found in the test probe logs included in Appendix A.

Slight petroleum odor and sheen were noted in groundwater at test probe TP4.

- Soil and groundwater intercepted by our test probes in the vicinity of Residence 3710 on the Site exceeds Ecology's MTCA Method A Cleanup Levels for Unrestricted Land Uses (WAC 173-340) and MTCA Method A Cleanup Levels for Ground Water. One of the analyzed soil samples, which was collected from a depth of 12 feet bgs, exceeds the MTCA Method A soil cleanup level for diesel-range TPH. Two of the analyzed groundwater grab samples exceed the MTCA Method A groundwater cleanup level for diesel-range TPH. No USTs were found during our geophysical survey in the vicinity of Residence 3710; however the heat source has historically been heating oil. Based on these findings, RGI suspects that the petroleum contaminated soil and groundwater in the vicinity of Residence 3710 is due to a former leaking heating oil UST. The location of the suspect former heating oil UST is unknown.

- RGI recommends remediation of the petroleum contamination in the vicinity of Residence 3710 prior to or during the redevelopment of the Site. Additional subsurface investigation is warranted to better define the extent of contamination.

- RGI recommends that heating oil USTs and ASTs be properly decommissioned and removed in accordance with the applicable city, country, and/or state requirements. It should be noted that while contamination was not encountered by our test probes near the inactive heating oil UST in the vicinity of Residence 3806, the potential exists that some contamination may be encountered beneath or around the UST during its removal.
