# SECOND PERIODIC REVIEW REPORT FINAL

Xytec Clorox Lakewood Facility Site ID#: 1287 Cleanup Site ID#: 3913

Building 10 9314 47<sup>th</sup> Avenue Southwest Tacoma, Washington 98499

November 2016

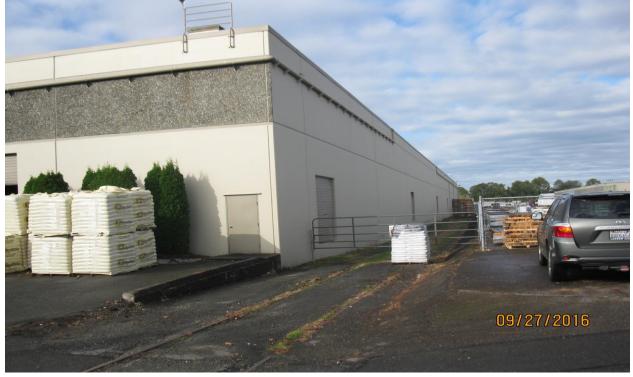
## Photo 1: Northside of Building 10 and Asphalt Pavement- from the Northeast

Based upon the Site visit conducted on September 27, 2016, the building and asphalt cover at the Site continue to eliminate exposure to contaminated soils by ingestion and direct contact. The Site continues to operate as a commercial facility. A photo log is available as Appendix 6.6.

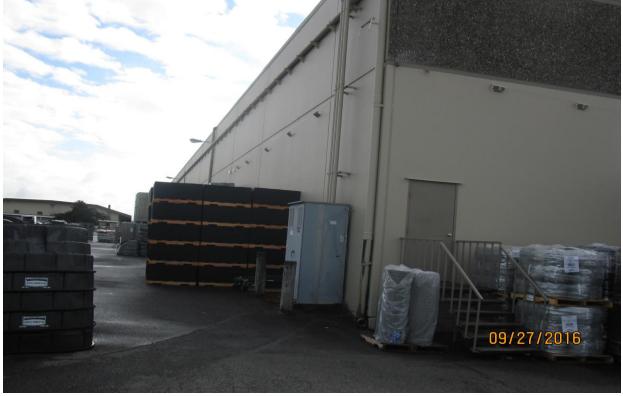
#### Photo 5: Northside of Building 10 and Asphalt Cap- from the Northwest

The Restrictive Covenant for the Site was recorded and is in place. This Restrictive Covenant prohibits activities that could result in the release of contaminants contained as part of the cleanup, unless Ecology approves of the activity, and prohibits any use of the property that is inconsistent with the Covenant. This Restrictive Covenant ensures the long term integrity of the asphalt cap.
