**RE: Independent Cleanup Action Report
Proposed Marysville Retail
3710 116th Street Northeast
Marysville, Snohomish County, Washington 98271
RGI Project No. 2015-165G**

PROJECT BACKGROUND

INDEPENDENT CLEANUP ACTION

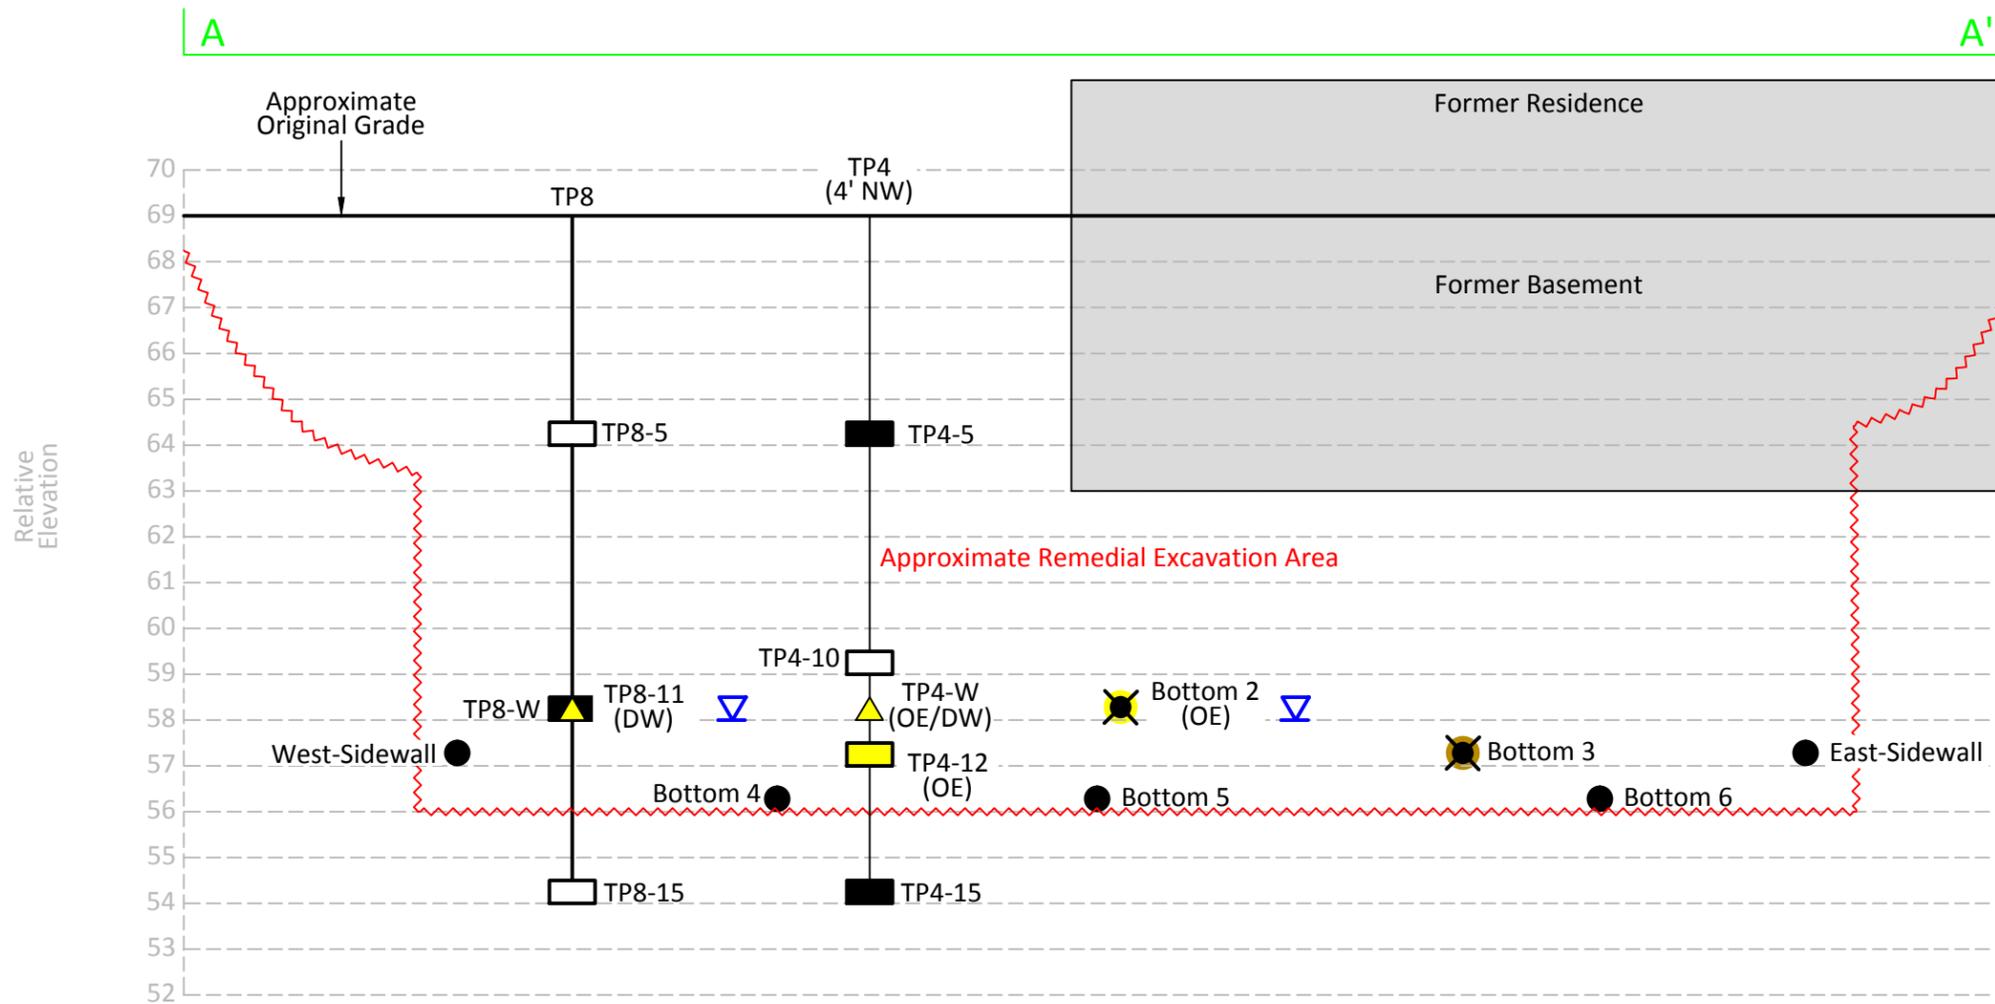
Final performance sample location with diesel-TPH (total petrol hydrocarbons):

- Not analyzed
- Not detected
- Detected below MTCA Method A cleanup levels
- Detected above MTCA Method A cleanup levels

The final lateral dimensions of the remedial excavation was approximately 20 feet by 30 feet. A total of 128.09 tons (approximately 92 cubic yards) of PCS was excavated from the Site. The approximate lateral extent of the remedial excavation area with interim and final cleanup confirmation soil sample locations is depicted on Figure 4. The final depth of the remedial excavation was approximately 12 to 13 feet bgs. The approximate vertical extent of the remedial excavation area is depicted in cross section on Figure 4. It should be noted that the sloping/benching of the excavation sidewalls extended beyond the depicted remedial excavation limits on Figure 4. The remedial excavation limits on Figures 4 and 5 depict the area of identified and removed PCS.

A total of eight cleanup confirmation soil samples were collected from the remedial excavation bottom (Bottom 4, Bottom 5, and Bottom 6) and sidewalls (North-Sidewall, East-Sidewall, South-Sidewall, Southwest-Sidewall, and West-Sidewall) at depths of 12 to 13 feet bgs (Figures 4 and 5).

Groundwater grab samples were collected from the open excavation either before or after each dewatering event in order to monitor the groundwater cleanup effort. A total of nine groundwater grab samples (GW-Grab1 through GW-Grab9) were collected between July 12 and August 25, 2016, Figure 4 and Table 2.

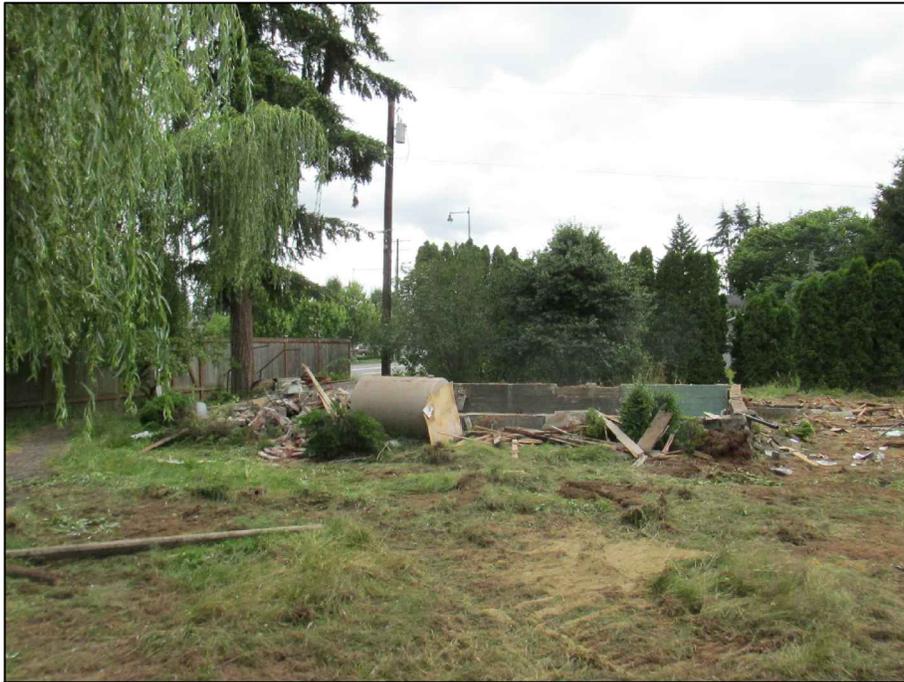
Photograph 1: View of former residence located at 3710 116th Street Northeast following building demolition and heating oil AST location (looking east).

- One heating oil aboveground storage tank (AST) was present on the west side of the Site residence at 3701 116th Avenue Northeast (Photograph 1/Appendix A). The Site residence had a full-basement, and the chimney and oil-burning furnace for the residence was located on the west side of the residence (closer to the northwest corner of the residence), Photograph 2. The oil burning furnace was situated in the basement, just south of, and was vented to, the brick chimney.

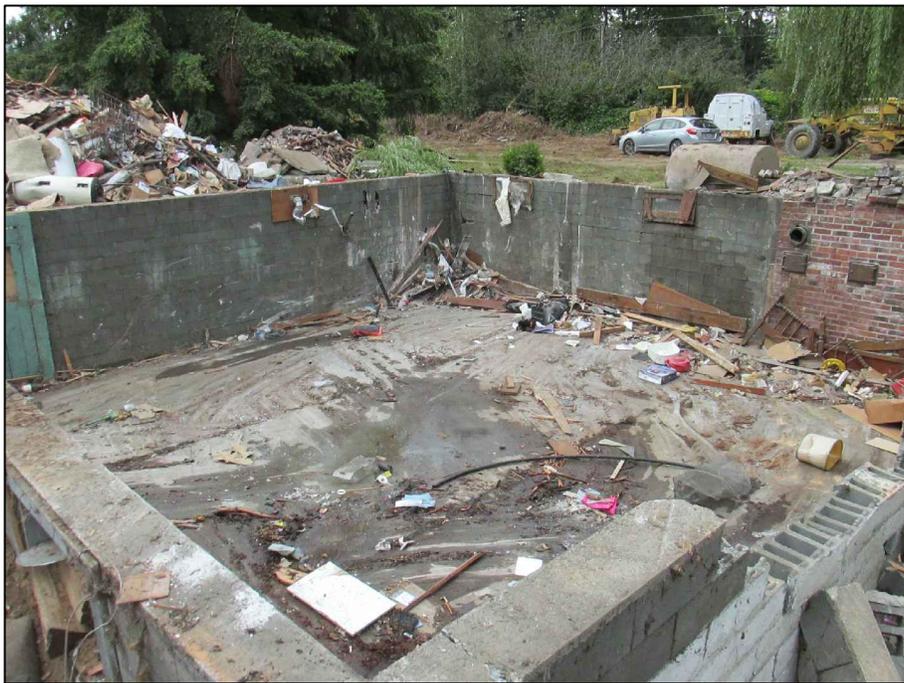
Photograph 2: View looking west-southwest at the residence basement during demolition. Chimney visible on the western side of building.

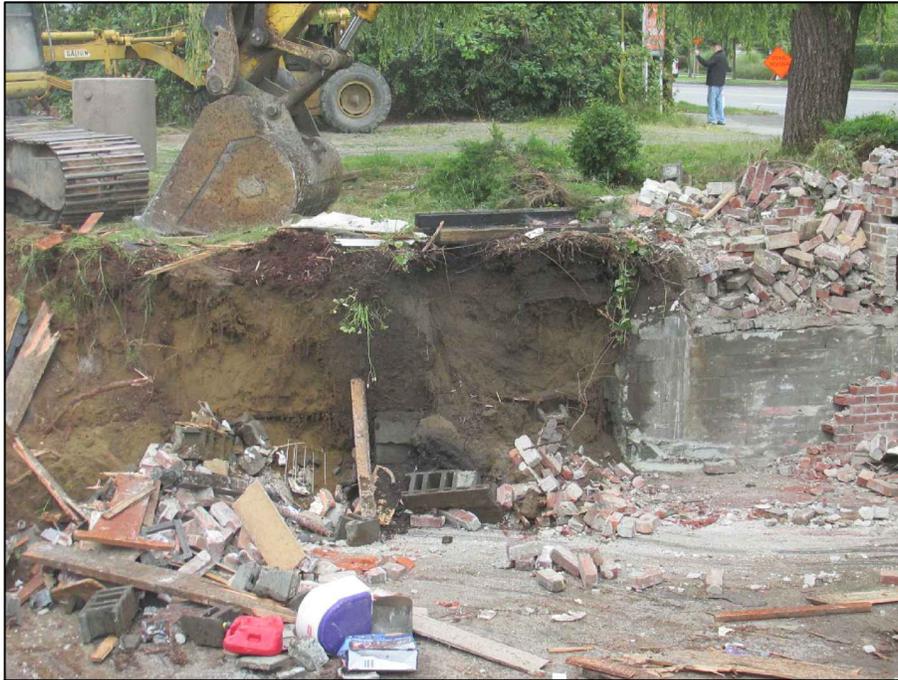
Photograph 3: View looking west at the basement's west wall during removal. Possible backfilled excavation (darker brown backfilled soils) visible just to the left (south) of chimney.

During the remedial excavation, no abandoned heating oil UST, or obvious former UST location was encountered. However, a former excavation was observed just west of the 3701 residence and south of the brick chimney (see Photograph 3). However, the apparent backfilled soils did not appear to be more contaminated than nearby native soils.

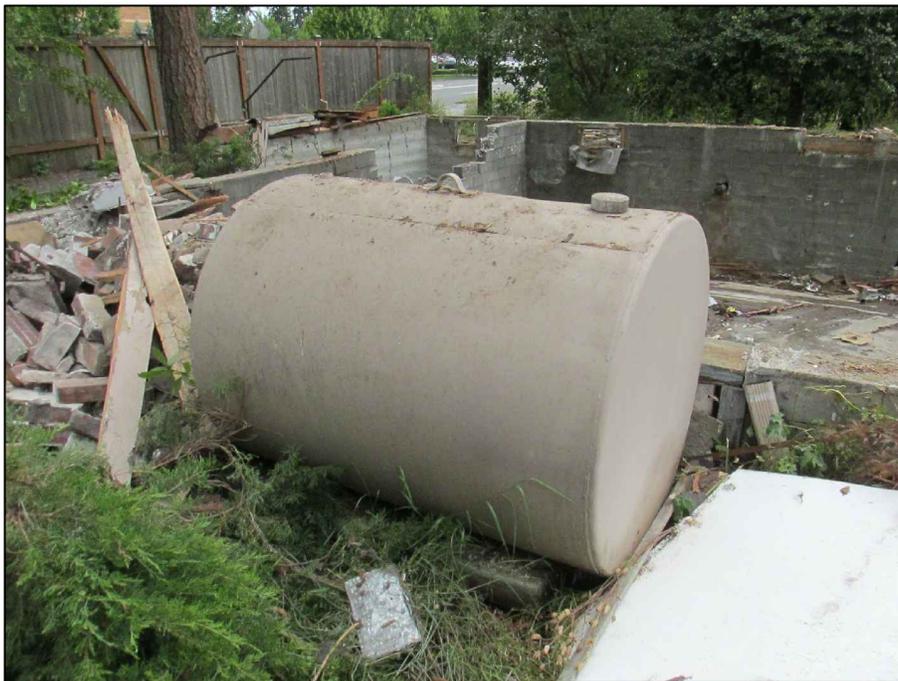
Photograph 4: View of heating oil AST in original location on the western side of former residence.

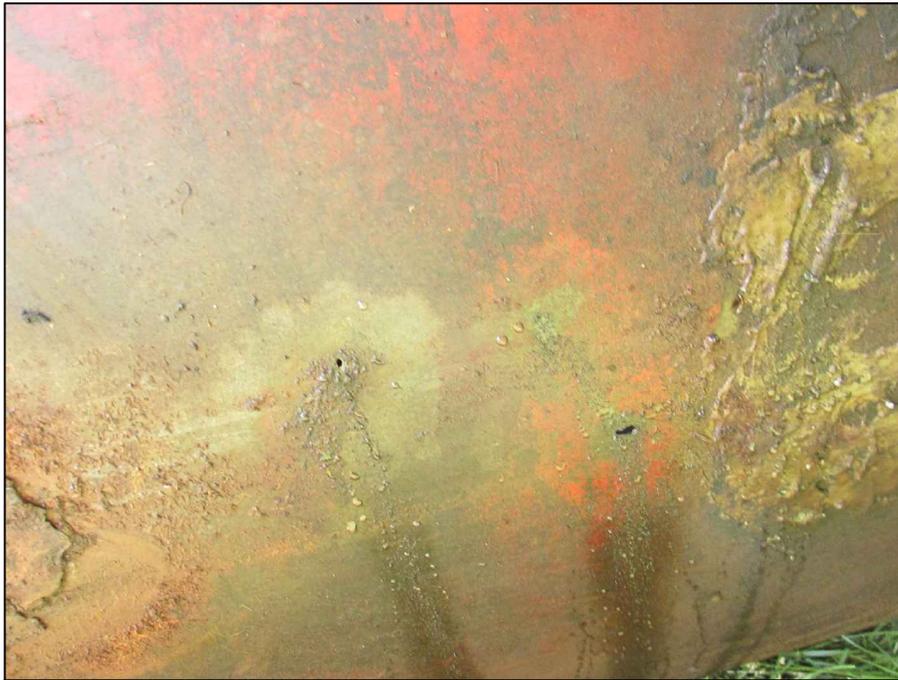
Photograph 5: Close up view of former heating oil AST with small pin holes in bottom of tank.

As indicated above, the primary source of the identified contamination remains unknown. The heating oil petroleum release to the subsurface was from either the known AST, or a possible former UST, and/or from the product delivery and/or return lines (between the tank and furnace located in the basement).

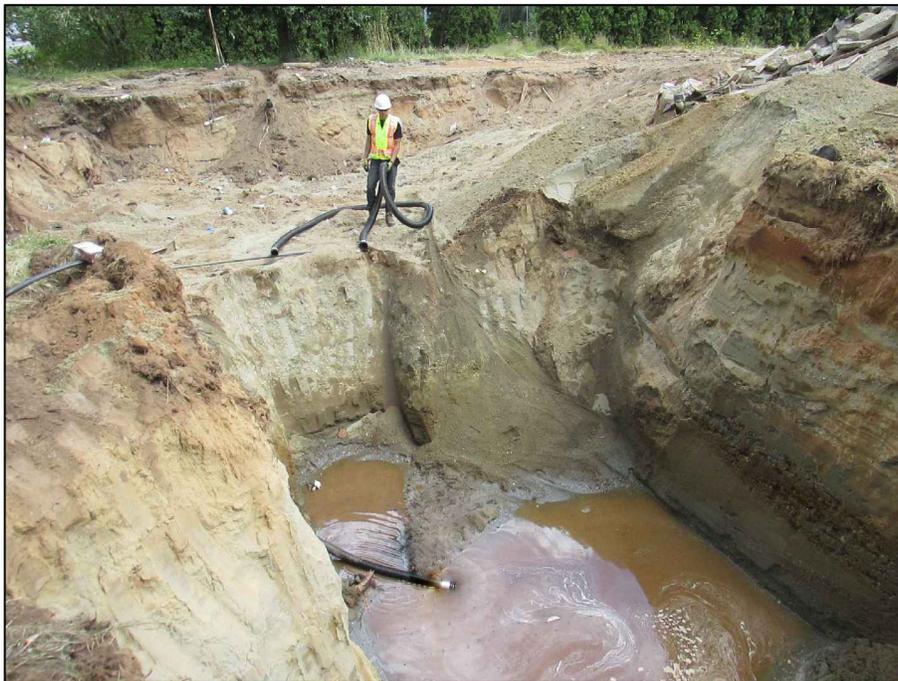
Photograph 6: View of remedial excavation limits (as of July 12, 2016) and excavation dewatering effort. Petroleum hydrocarbon (heating oil) sheen visible in photograph.

Excavation dewatering was performed during the soil remedial excavation effort in order to facilitate the excavation of PCS, as well as to remove contaminated groundwater. The groundwater level in the excavation was approximately 11 feet bgs.

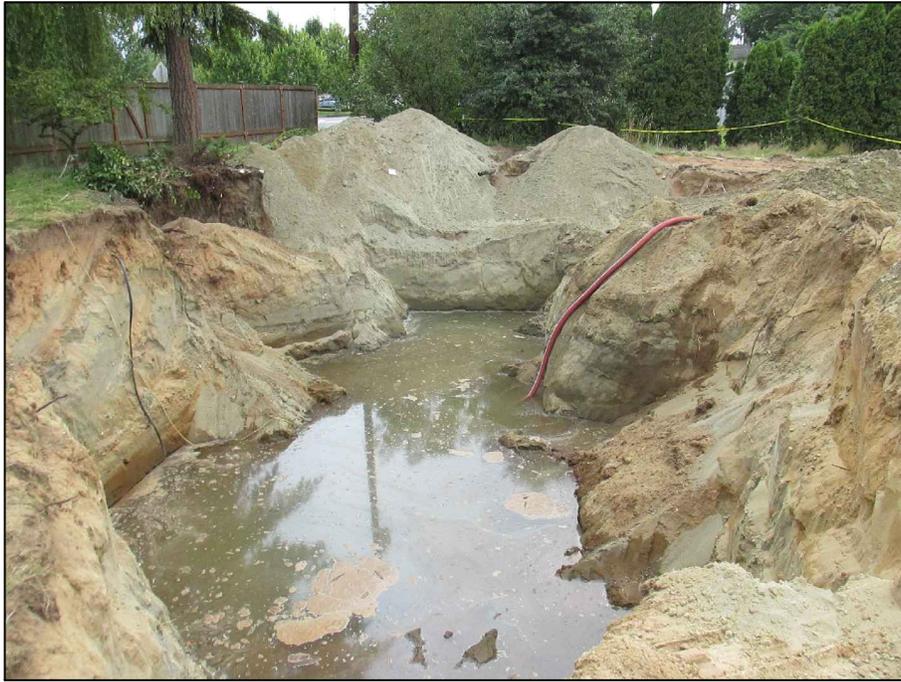
Photograph 7: View of remedial excavation just prior to excavation dewatering effort on July 15, 2016.

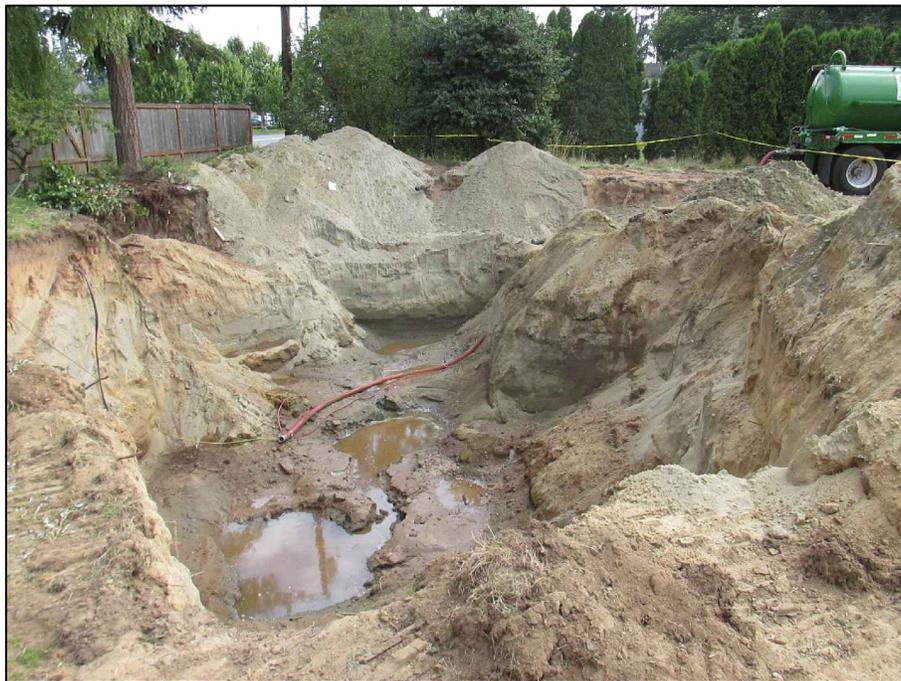
Photograph 8: View of remedial excavation following excavation dewatering effort on July 15, 2016.

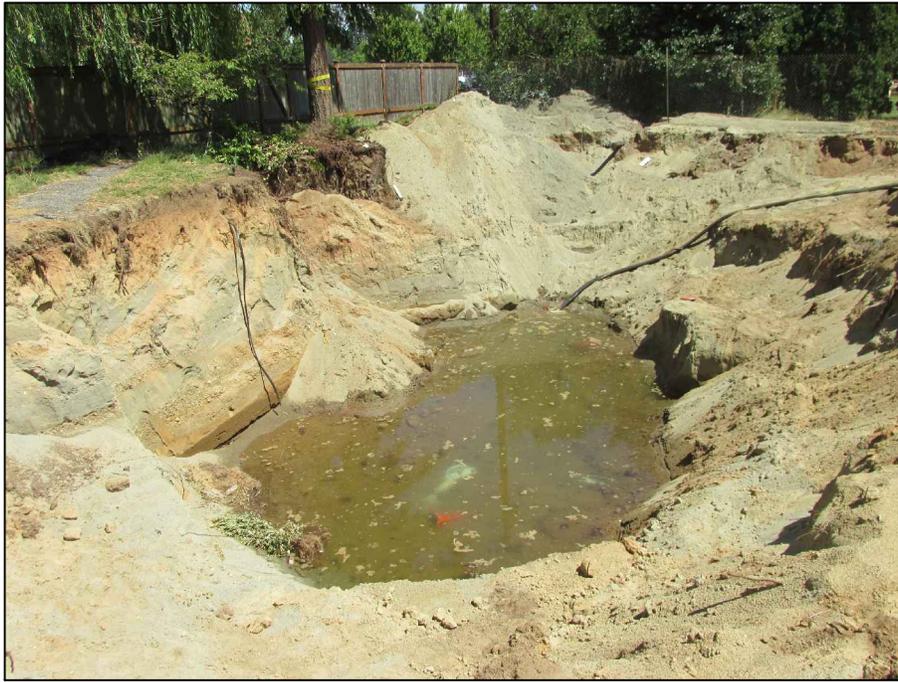
Photograph 9: View of remedial excavation just prior to excavation dewatering effort on July 20, 2016. No visible petroleum hydrocarbon sheen visible during this, or subsequent dewatering events.

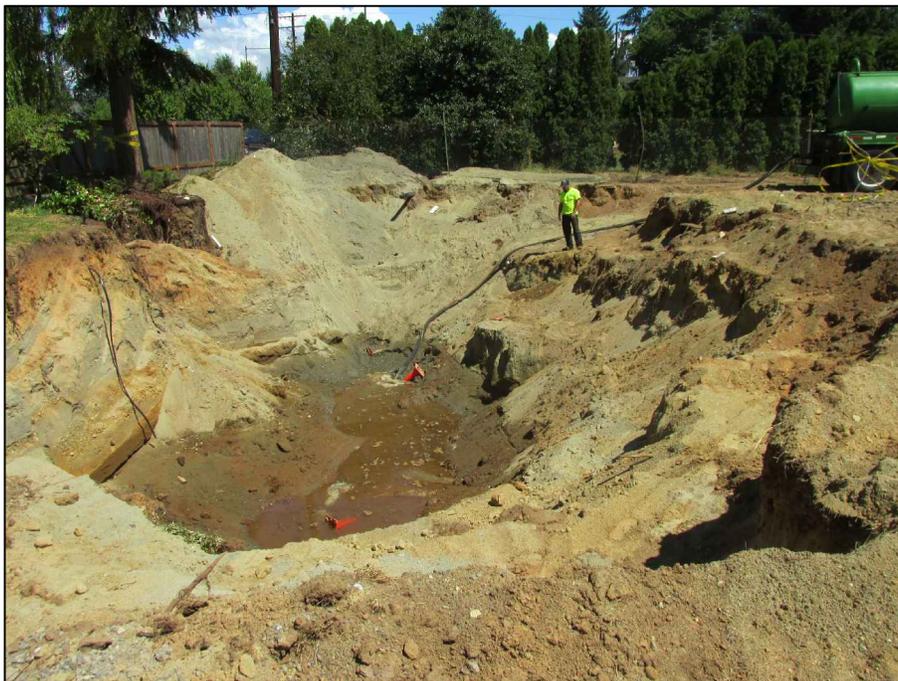
Photograph 10: View of remedial excavation following excavation dewatering effort on July 20, 2016.

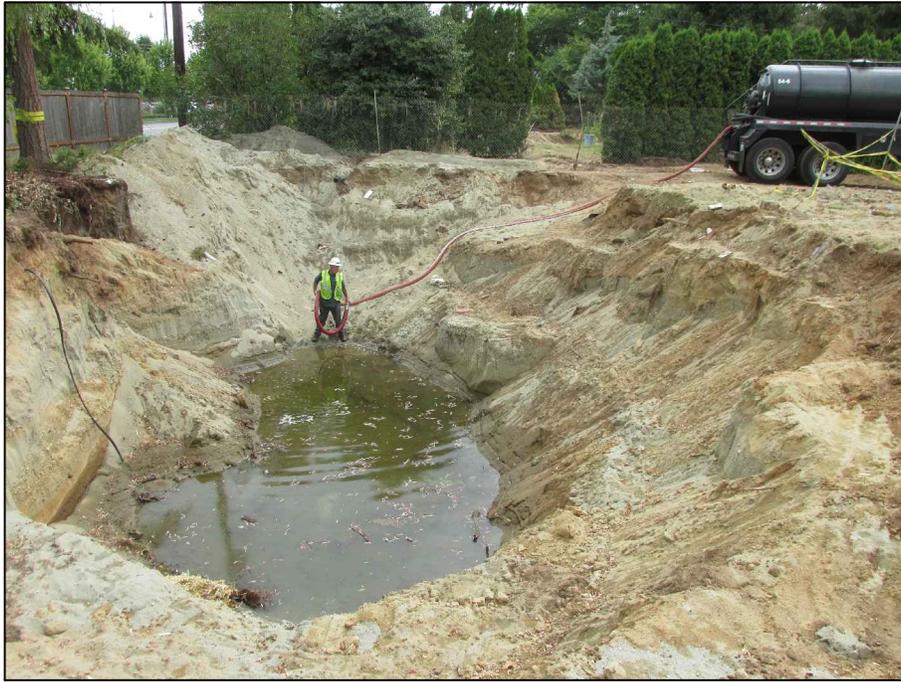
Photograph 11: View of remedial excavation just prior to excavation dewatering effort on August 2, 2016.

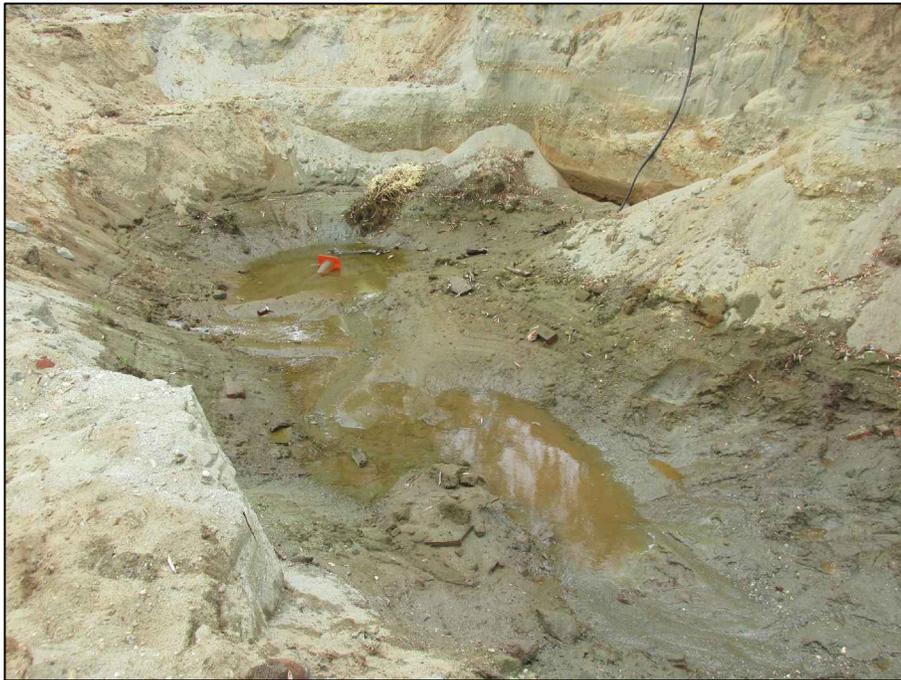
Photograph 12: View of remedial excavation following excavation dewatering effort on August 2, 2016.
