**FIRST SEMI-ANNUAL 2016  
GROUNDWATER MONITORING AND CAP  
INSPECTION REPORT**

**BNSF Glacier Park East  
Leavenworth, Washington**

TRC Project No. 230814

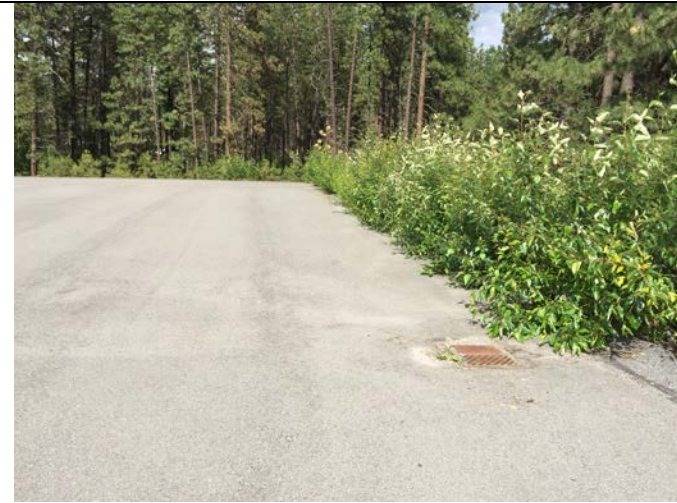
Photo 2: View looking east along southern edge of cap. Note vegetation growth along margin of asphalt cap.

The overall condition of the asphaltic concrete cap and associated drainage system is good. However, inspection of the cap identified several cracks on the north-northeast corner, north-northwest corner, and southern edge of the asphaltic concrete cap that are approximately 0.25 to 0.5 inches wide and range from 1.5 to 5.0 feet long. The cracks are caused by the roots of the vegetation growing at the edges of the cap. Significant vegetation growth was identified along the southeastern and eastern edges of the asphaltic concrete cap with minimal growth along the northern edge. To address the vegetation growth and mitigate the impacts that growth is having the condition of the asphalt cap, major brush clearing and vegetation removal activities were completed on August 11 and 12, 2016.

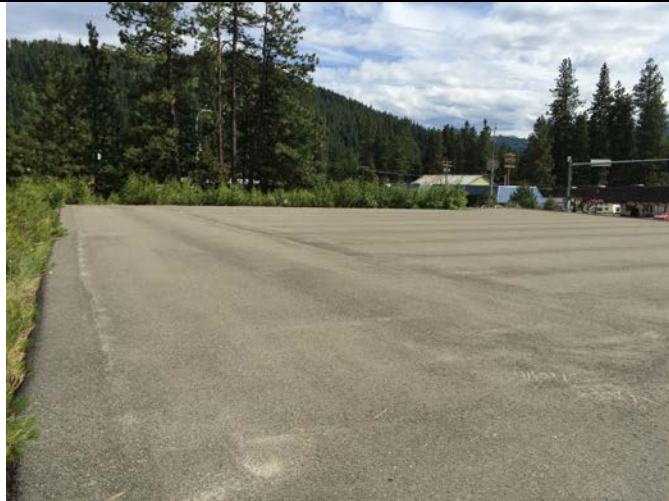
Photo 3: View looking south along eastern edge of cap. Note vegetation growth along margin of asphalt cap.

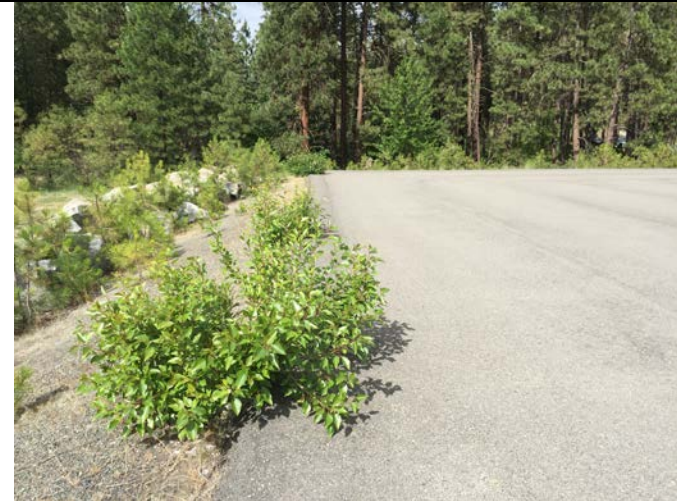
Photo 4: View looking east along northern edge of cap. Note vegetation growth along margin of asphalt cap.

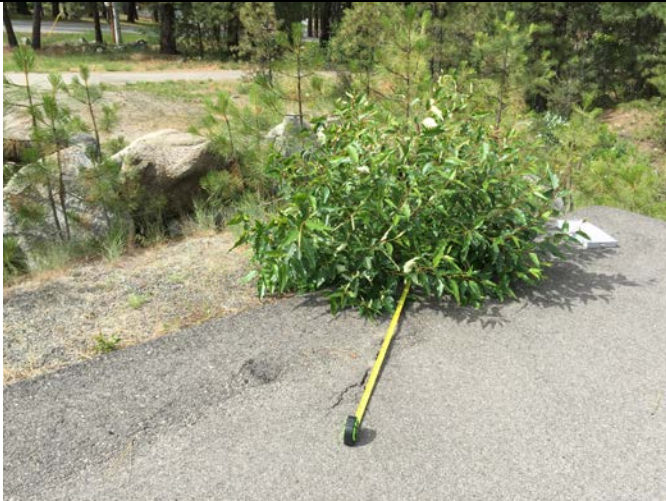
Inspection Area	Observations
<b>1. Asphalt Concrete Pavement</b>	
a. Presence of cracks greater than 1/8" wide	Cracks present on north-northeast corner of asphalt cap, approximately 0.5 inches wide. 0.5 inches deep, and up to 5 feet long (Photos #5 and #6). Cracks present on southern and southeast corner of asphalt cap, approximately 0.25 inches wide and up to 5 feet long (Photos #8 and #9).

Photo 5: Crack in northeastern corner of asphalt cap. Cracks developing and elongating as a result of root expansion.

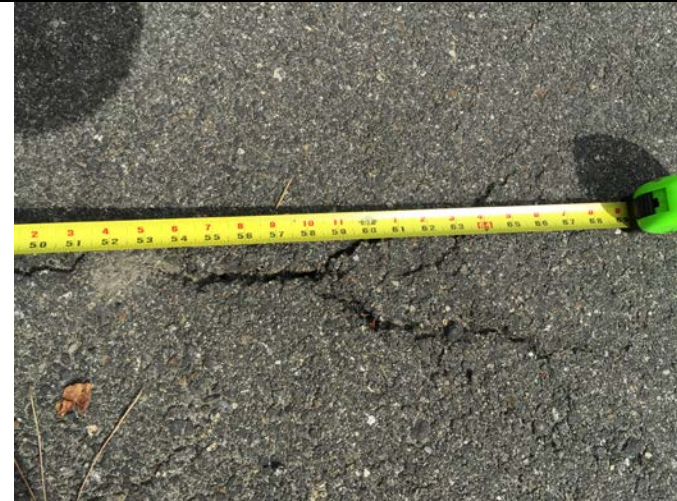
Photo 6: Close-up view of crack in northeastern corner of asphalt cap.

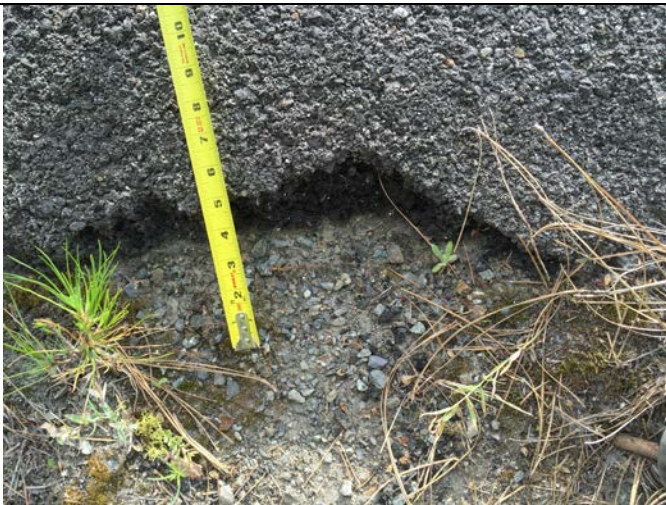
b. Sub-base material exposed	No.
c. Pavement edge deterioration	Yes. Pavement edge deteriorating along northern and southern edges where vegetation is growing and along the eastern edge at the location of the steps to MW-1 (Photo #7).

Photo 7: Close-up view of deteriorating eastern edge of asphalt cap at stairs down to MW-1.

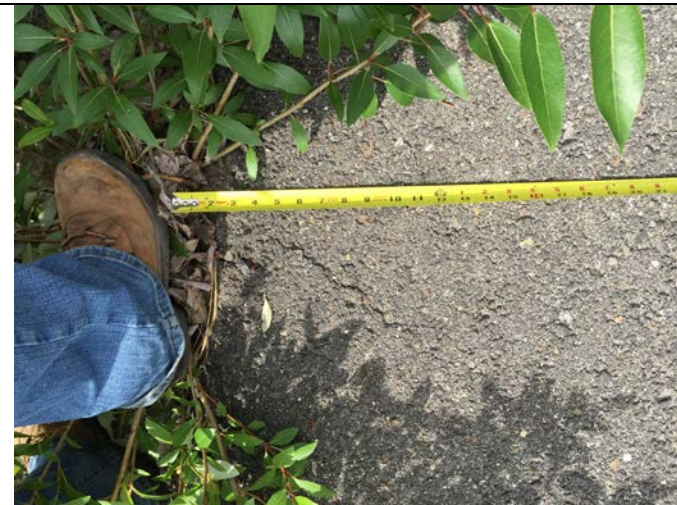
Photo 8: Crack developing in southeastern corner of asphalt cap.

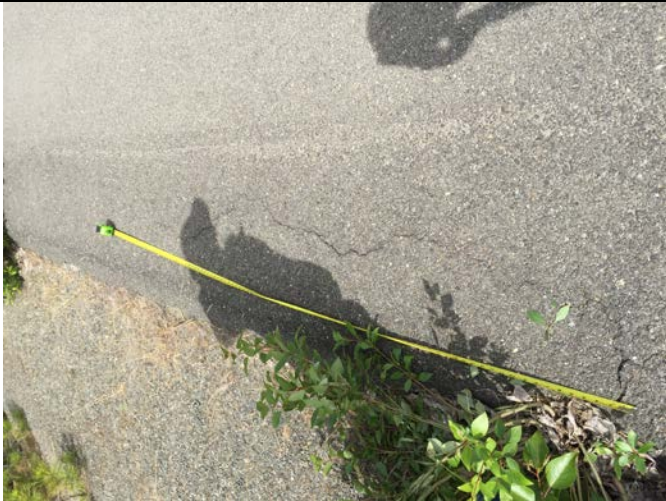
Photo 9: Crack parallel to northern edge of asphalt cap.

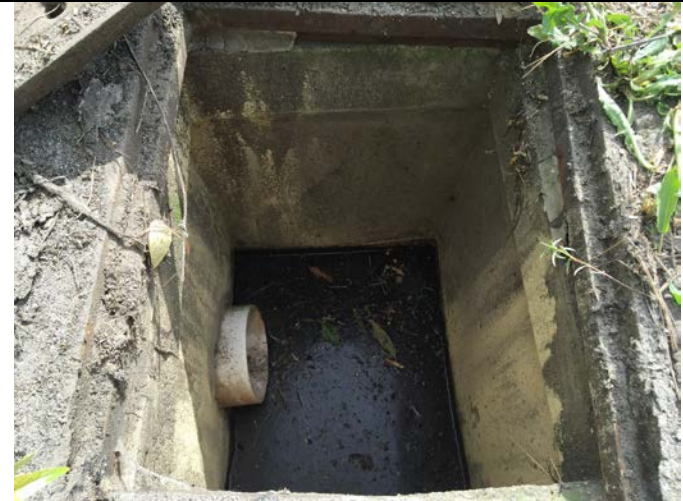
The catch basin had approximately 8 inches of standing water preventing observation of the sediment, the grit chamber had standing water to just below the access steps preventing observation of the sediment, and the vault had approximately 6 inches of sediment. The inspection log and photographic documentation are presented in Appendix C.

d. General appearance	Good.
<b>2. Catch Basin</b>	
a. Structural Condition/General Appearance	Good.
b. Sediment Accumulation, approximate	Water in vault, did not observe any sediment (Photo # 10).
<b>3. Grit Chamber</b>

Photo 10: View of inside catch basing located on asphalt cap. Approximately 8" of water in vault.

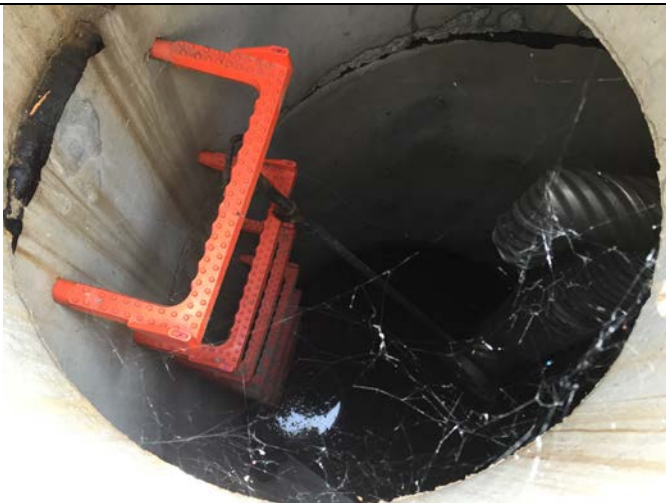
a. Structural Condition/General Appearance	Good.
b. Sediment Accumulation, approximate	Water in grit chamber. Did not observe any sediment (Photo #11).
<b>4. Vault</b>

Photo 11: View inside grit chamber at cap.

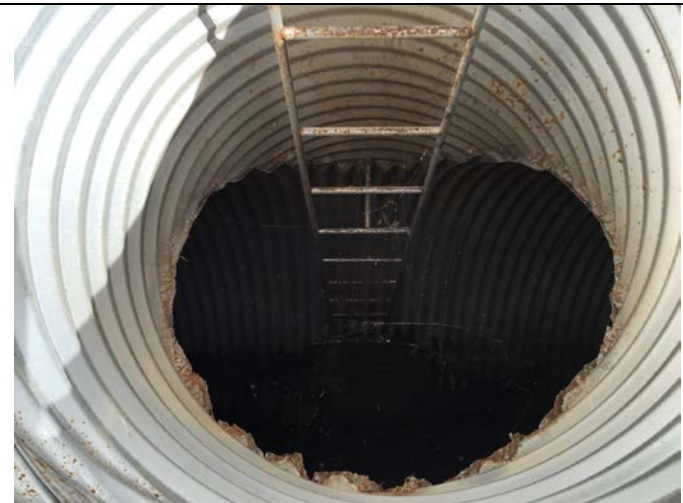
a. Structural Condition/General Appearance	Good. Minor rust on ladder.
b. Sediment Accumulation, approximate	Approximately 4" of sediment accumulation in vault (Photo #12).

Photo 12: View inside vault at cap.
