Phase I Environmental Site Assessment  
Yard Birds Shopping Center  
500 North Capitol Way  
Olympia, Washington 98501  
ATEC Project No. 93-00059

RE: Phase I Environmental Site Assessment  
**Yard Birds Shopping Center**  
500 North Capitol Way  
Olympia, Washington 98501  
ATEC Project No. 93-00059

PHASE I ENVIRONMENTAL SITE ASSESSMENT  
Yard Birds Shopping Center  
500 North Capitol Way  
Olympia, Washington 98501  
ATEC Project No. 93-00059

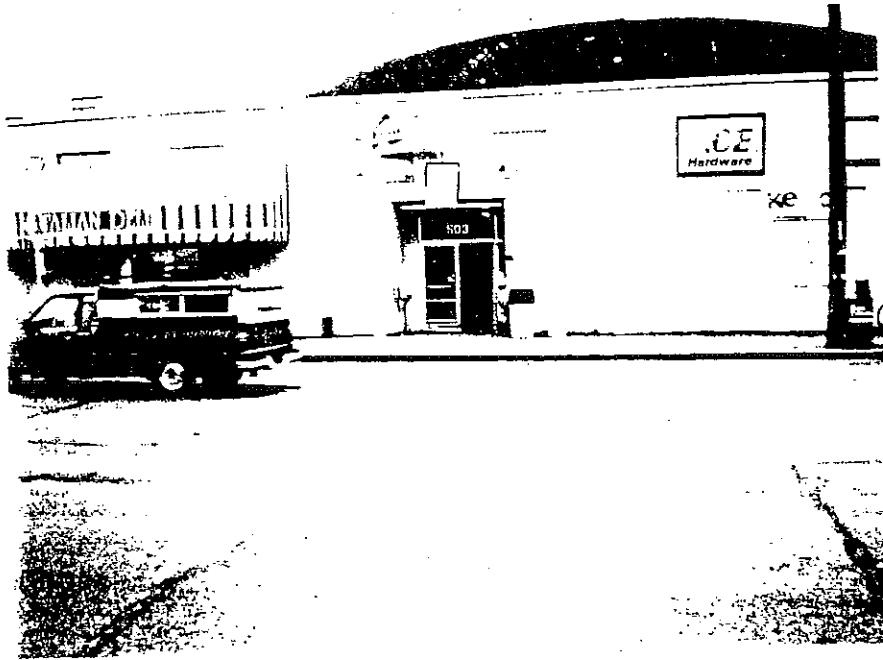
PHOTO 1: FACING WEST. ENTRANCE TO WEST BUILDING

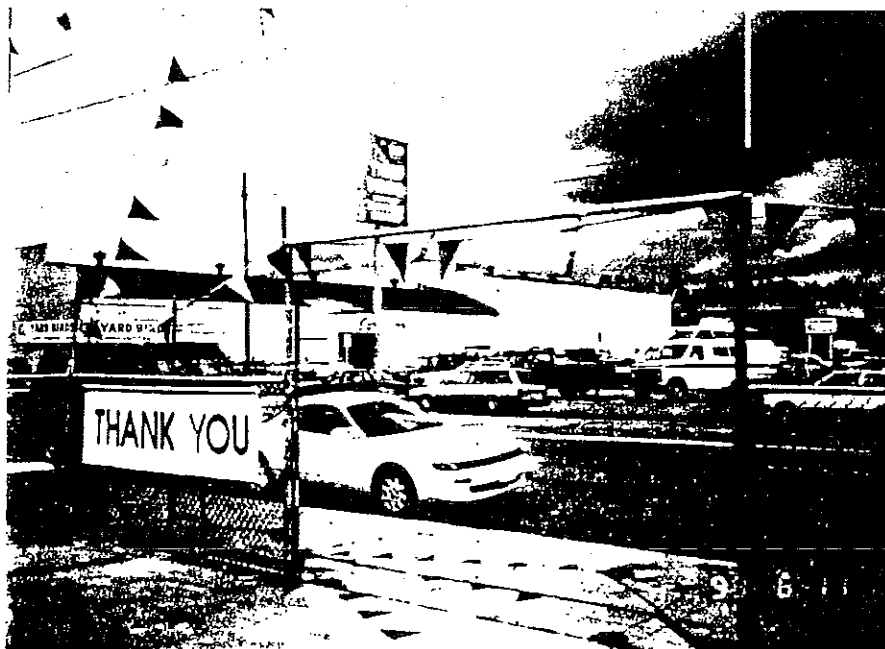
PHOTO 2: PARKING LOT ON RIGHT, YARD BIRDS STORE (EAST BLDG) OF RIGHT FACING NORTHEAST

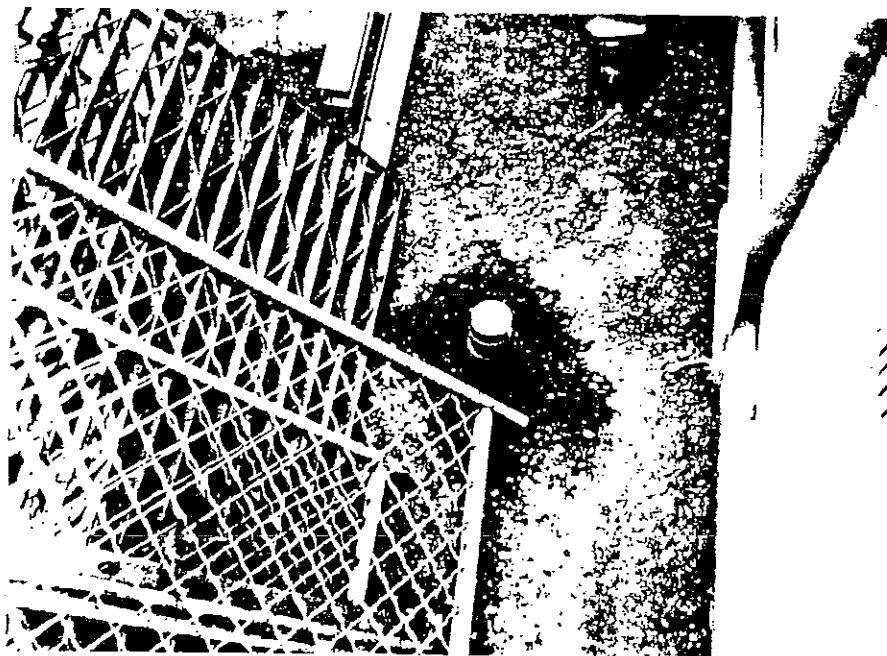
Mr. Terry Kamplin, manager of the Yard Birds facility was interviewed at the time of the site visit. He states that he is aware of two underground storage tanks (USTs) on the subject site. According to Mr. Kamplin, the former feed and grain store has an underground heating oil tank at the west end (Appendix A, photo 4). He is not aware of the tank size, but did have heating oil removed from it recently. He states that the tank has been out of service for many years. According to Mr. Kamplin, a second UST exists under the floor of a storeroom at the rear of the furniture outlet store (Appendix A, photo 3). The storeroom was not accessible at the time of our site visit. Mr. Kamplin is not aware of the size of the tank but states that he had it pumped out at the same time the heating oil tank was pumped out. This tank was last used to store gasoline which fueled the feed and grain business delivery trucks. When the tank was pumped out, reportedly the contents removed was water.

PHOTO 4: FILL PIPE TO HEATING OIL, UST, WEST END OF OLD FEED STORE

Based on this information, we recommend a limited bulk sampling asbestos program to confirm the presence or absence of asbestos. We also recommend the installation of six monitoring wells. Two wells should be installed near the out-of-service USTs. Two wells should be installed in the area shown in aerial photos as the former location of four (4) aboveground storage tanks. One well should be installed on the western boundary to identify potential migration of contaminants from the tank farm facility to the southwest. One well should be installed on the north side of the subject site to identify potential migration of contaminants from the former tank farm facility located to the north.
