EPMI**LETTER 8003.44**

Date: February 10, 2000
Project: Yard Birds
Subject: Update

***Results of Test Pit Explorations
and Monitoring Well Sampling at
Yard Birds Property
Olympia, Washington***

**RE: RESULTS OF TEST PIT EXPLORATIONS AND MONITORING WELL
SAMPLING AT YARD BIRDS PROPERTY, OLYMPIA, WASHINGTON**

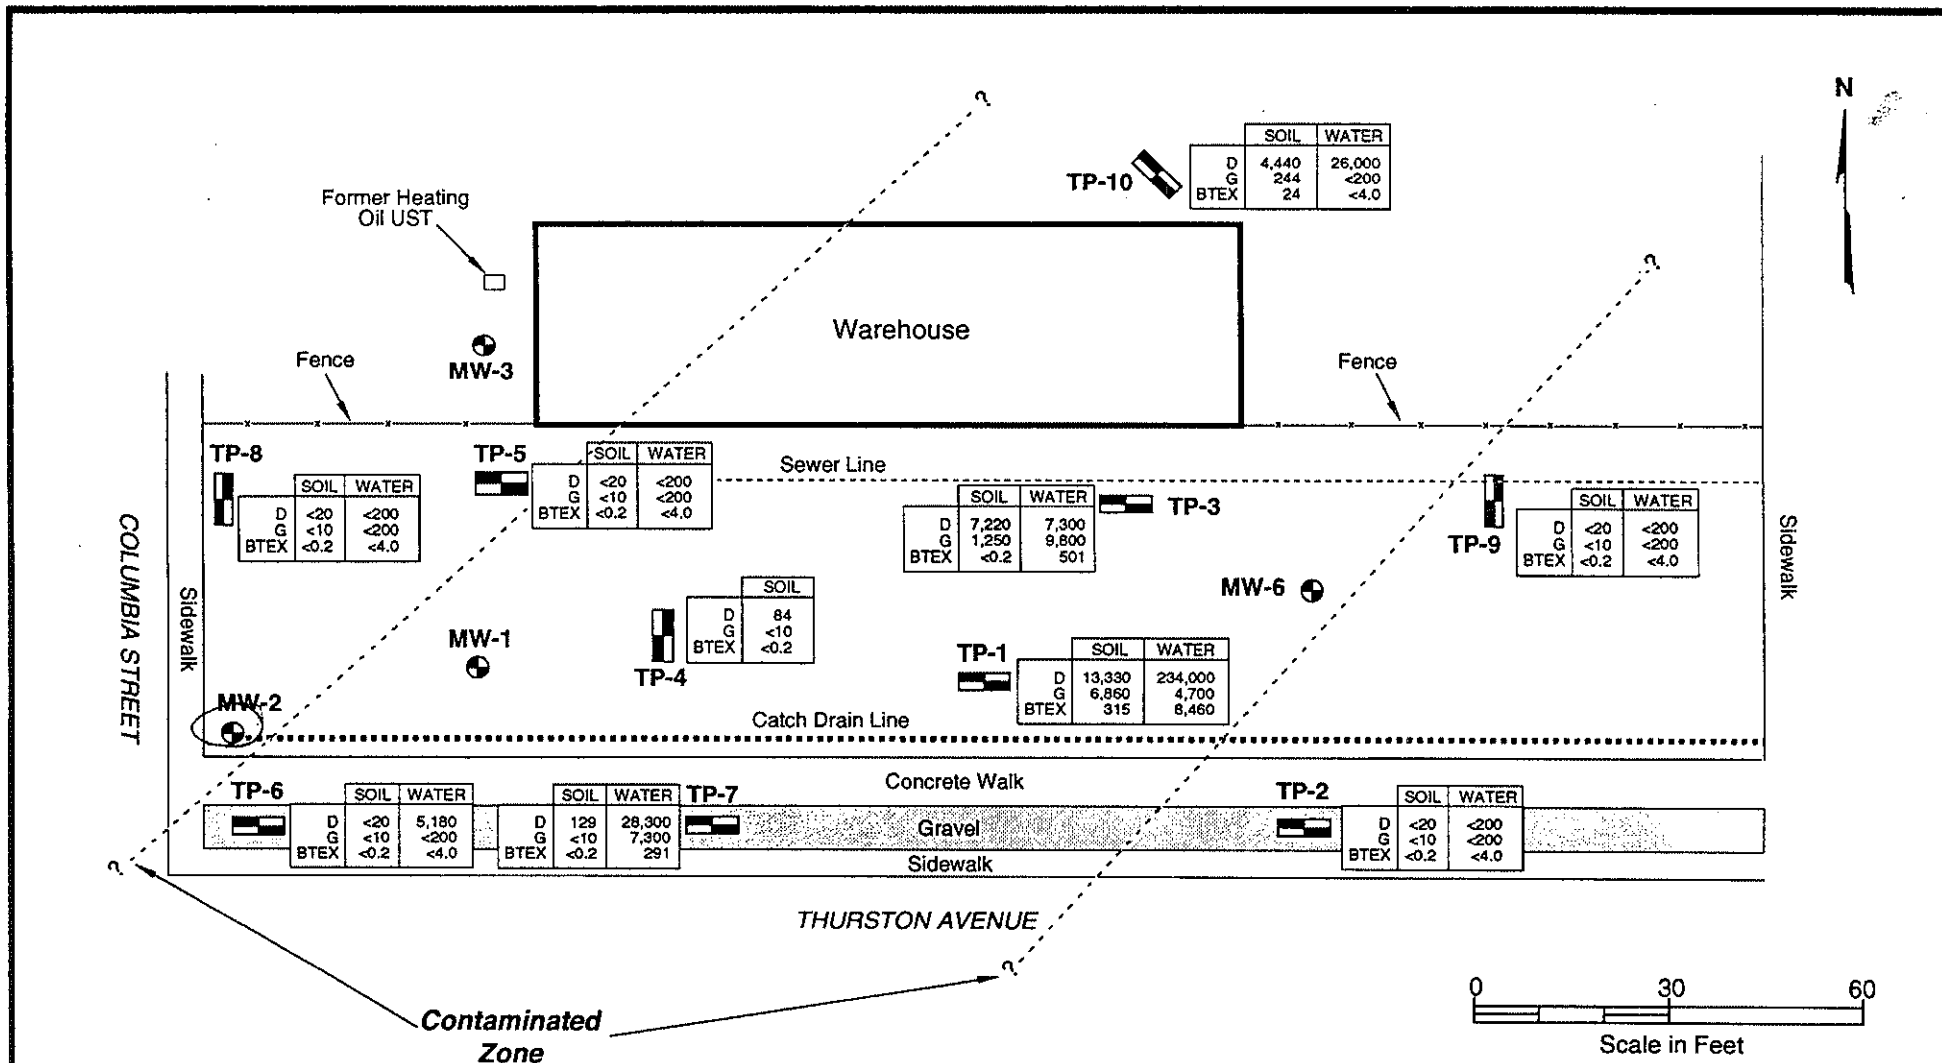
FIG. 2

Two underground storage tanks (USTs) (one 500-gallon heating oil tank and one 2,500-gallon gasoline tank) formerly existed on the Yard Birds property at the locations shown on

Figure 2. The heating oil UST was removed and the gasoline UST was closed-in-place in March 1994. In addition to the USTs, a bulk fuel storage facility was reported to be located at the south end of the Farmer's Market block (the block bounded by North Columbia Street, Thurston Avenue, North Capitol Way, and "A" Avenue). Two other bulk fuel storage facilities were reported to be located adjacent to the site: one on the block southwest of the subject block (Unocal) and one on the block immediately north of B Avenue.

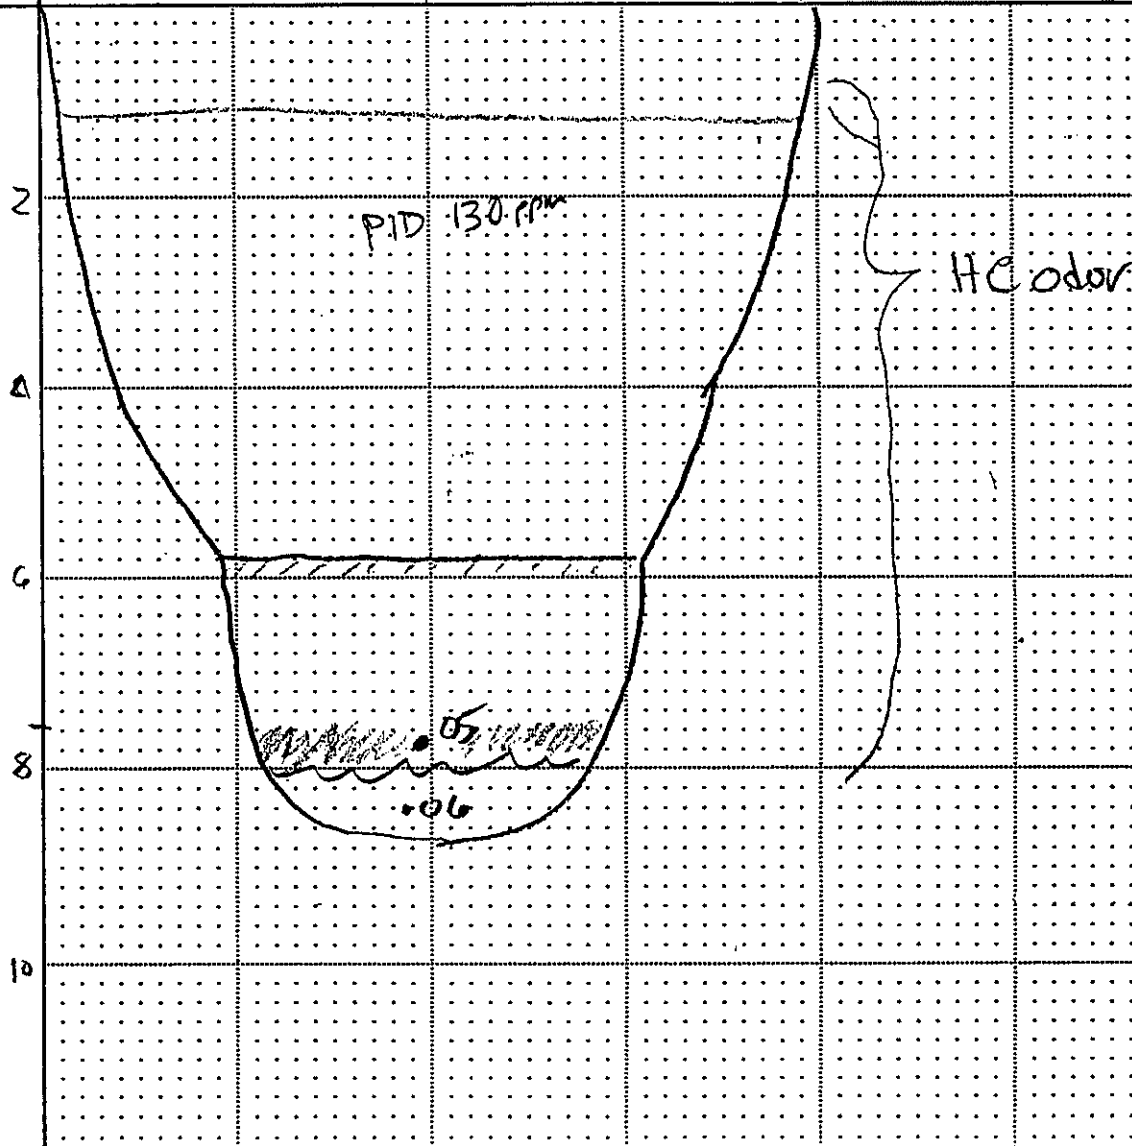
FIELD LOG OF TEST PIT

SOIL DESCRIPTION & REMARKS	GROUND WATER	SAMPLES	DEPTH IN FEET	SKETCH OF <u>N</u> PIT SIDE		SURFACE ELEVATION _____	
				HORIZONTAL DISTANCE IN FEET			
Gray beach sands w/ organic debris (wood & shells)			2	2	4	6	8
			4				
			6				
Brown HC stained sand		01	7				
Black/brown HC product on H ₂ O		02	8				
			10

Stained gray & brown (black) beach sands Heavy H₂O odor

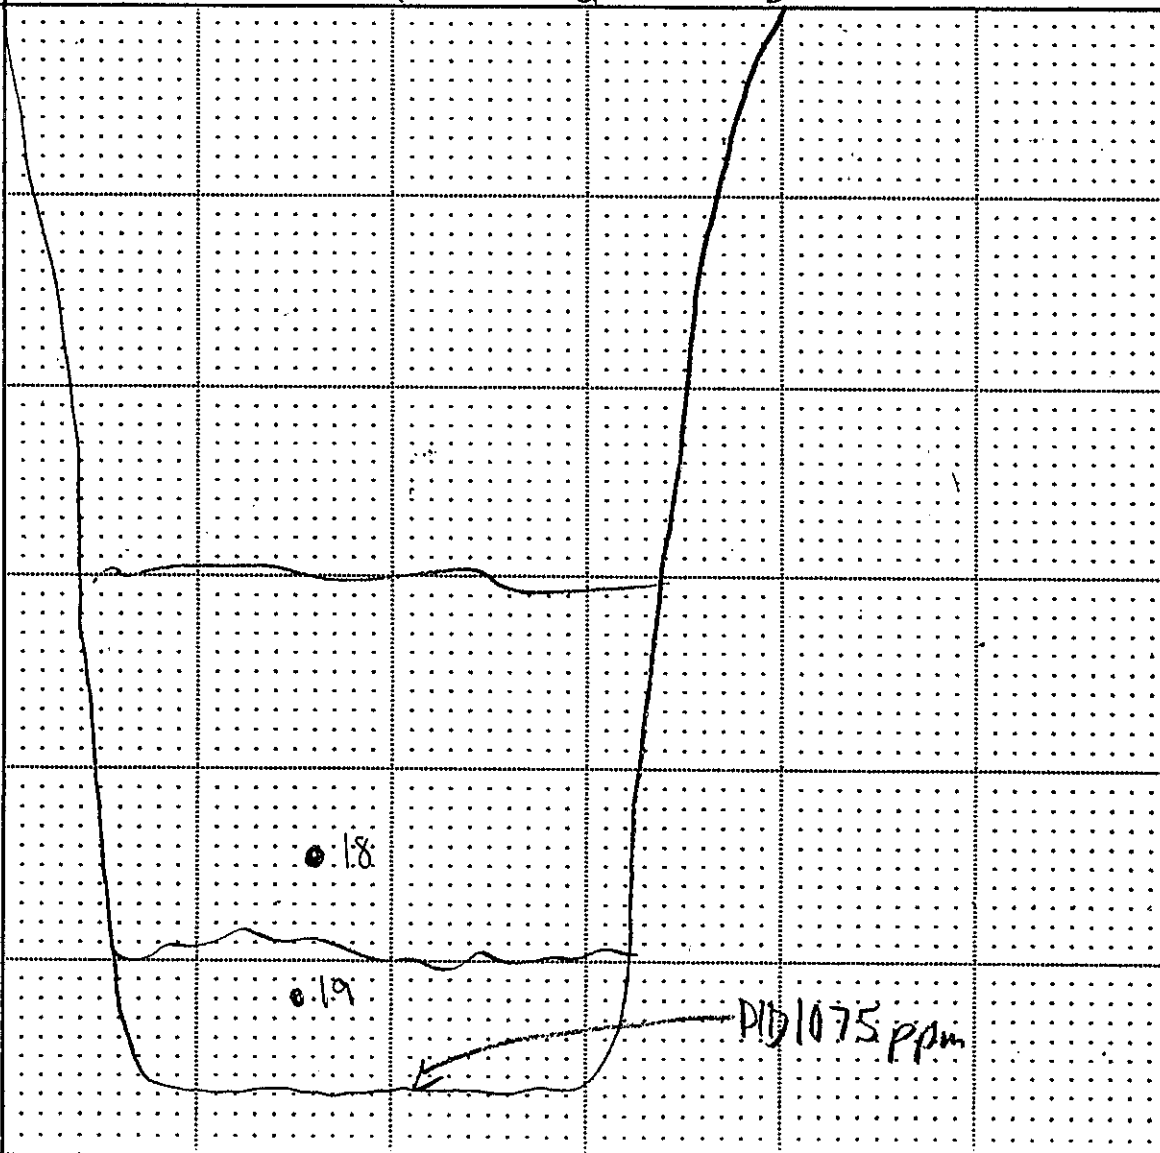
• 19

PID 1075 ppm

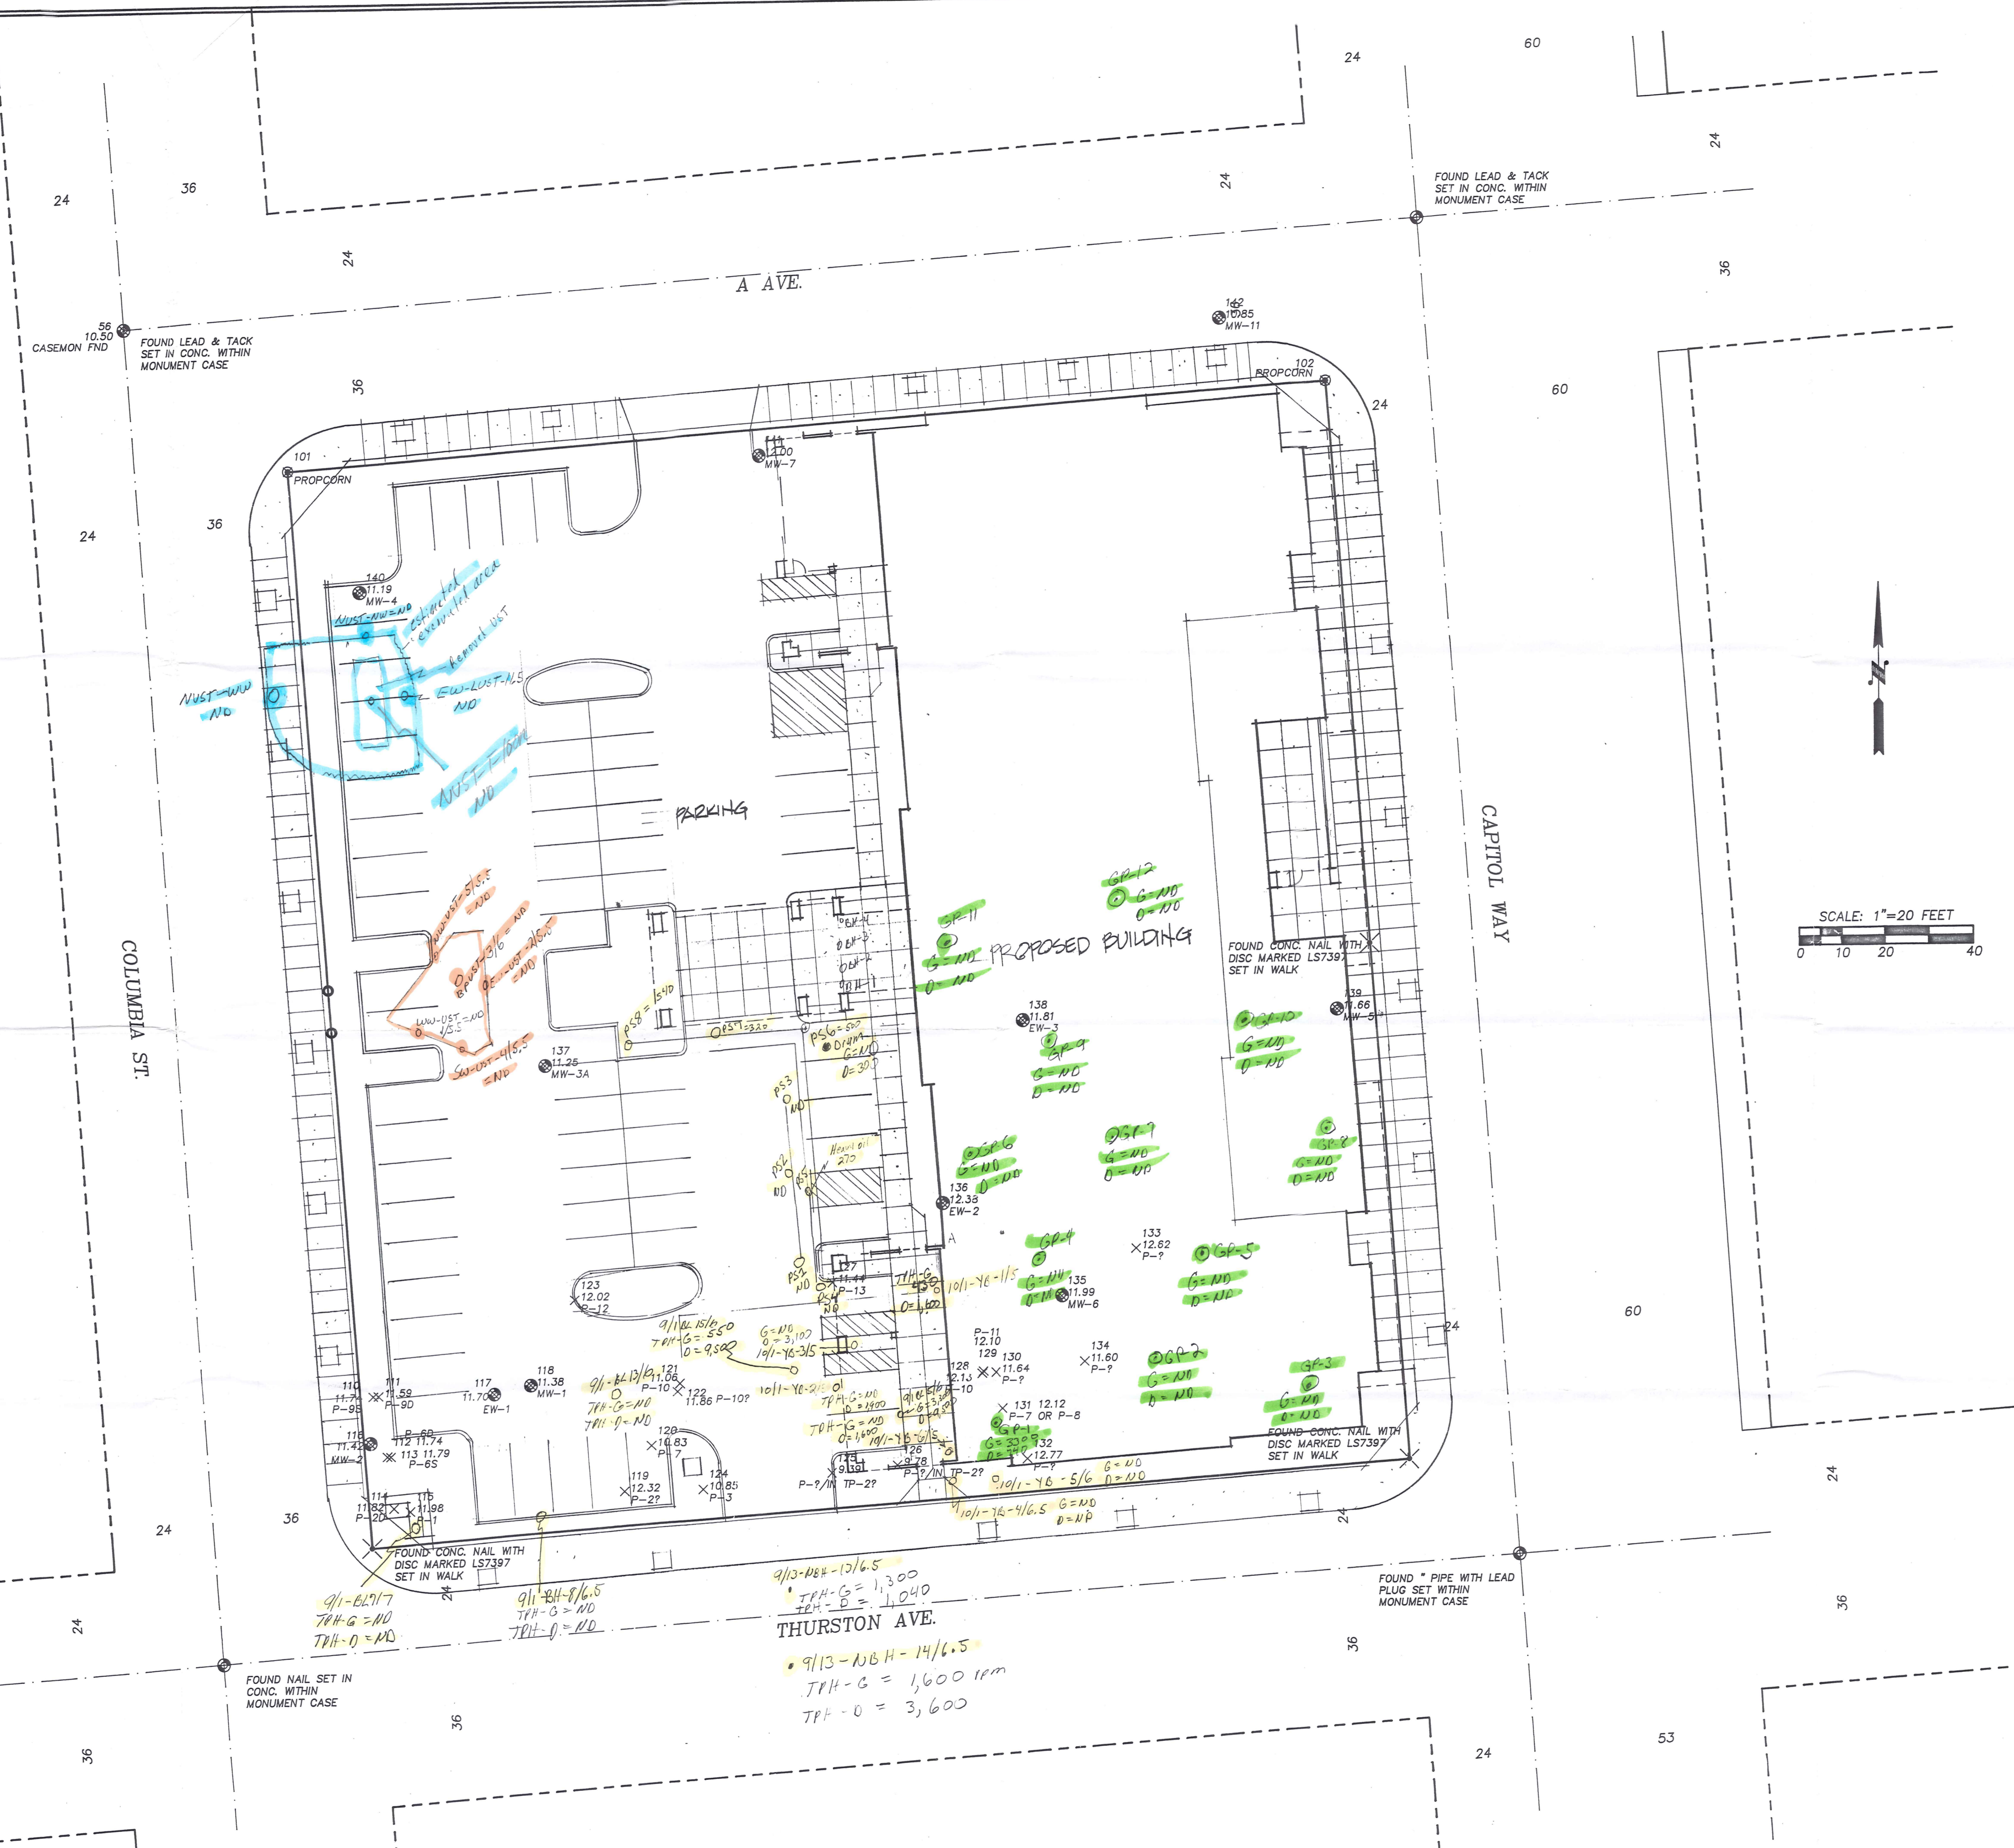
REMEDIATION EQUIPMENT LOCATION PHOENIX INN, OLYMPIA, WA

Geo Design Samples	Gas	Diesel
GP-1	3,300	740
GP-2	ND	ND
GP-3	ND	ND
GP-4	ND	ND
GP-5	ND	ND
GP-6	ND	ND
GP-7	ND	ND
GP-8	ND	ND
GP-9	ND	ND
GP-10	ND	ND
GP-11	ND	ND
GP-12	ND	ND

Thurston St. Samples	Gas	Diesel
9/15 NBH-13/6.5	1,300	1,040
9/13 NBH-14/6.5	1,600	3,600

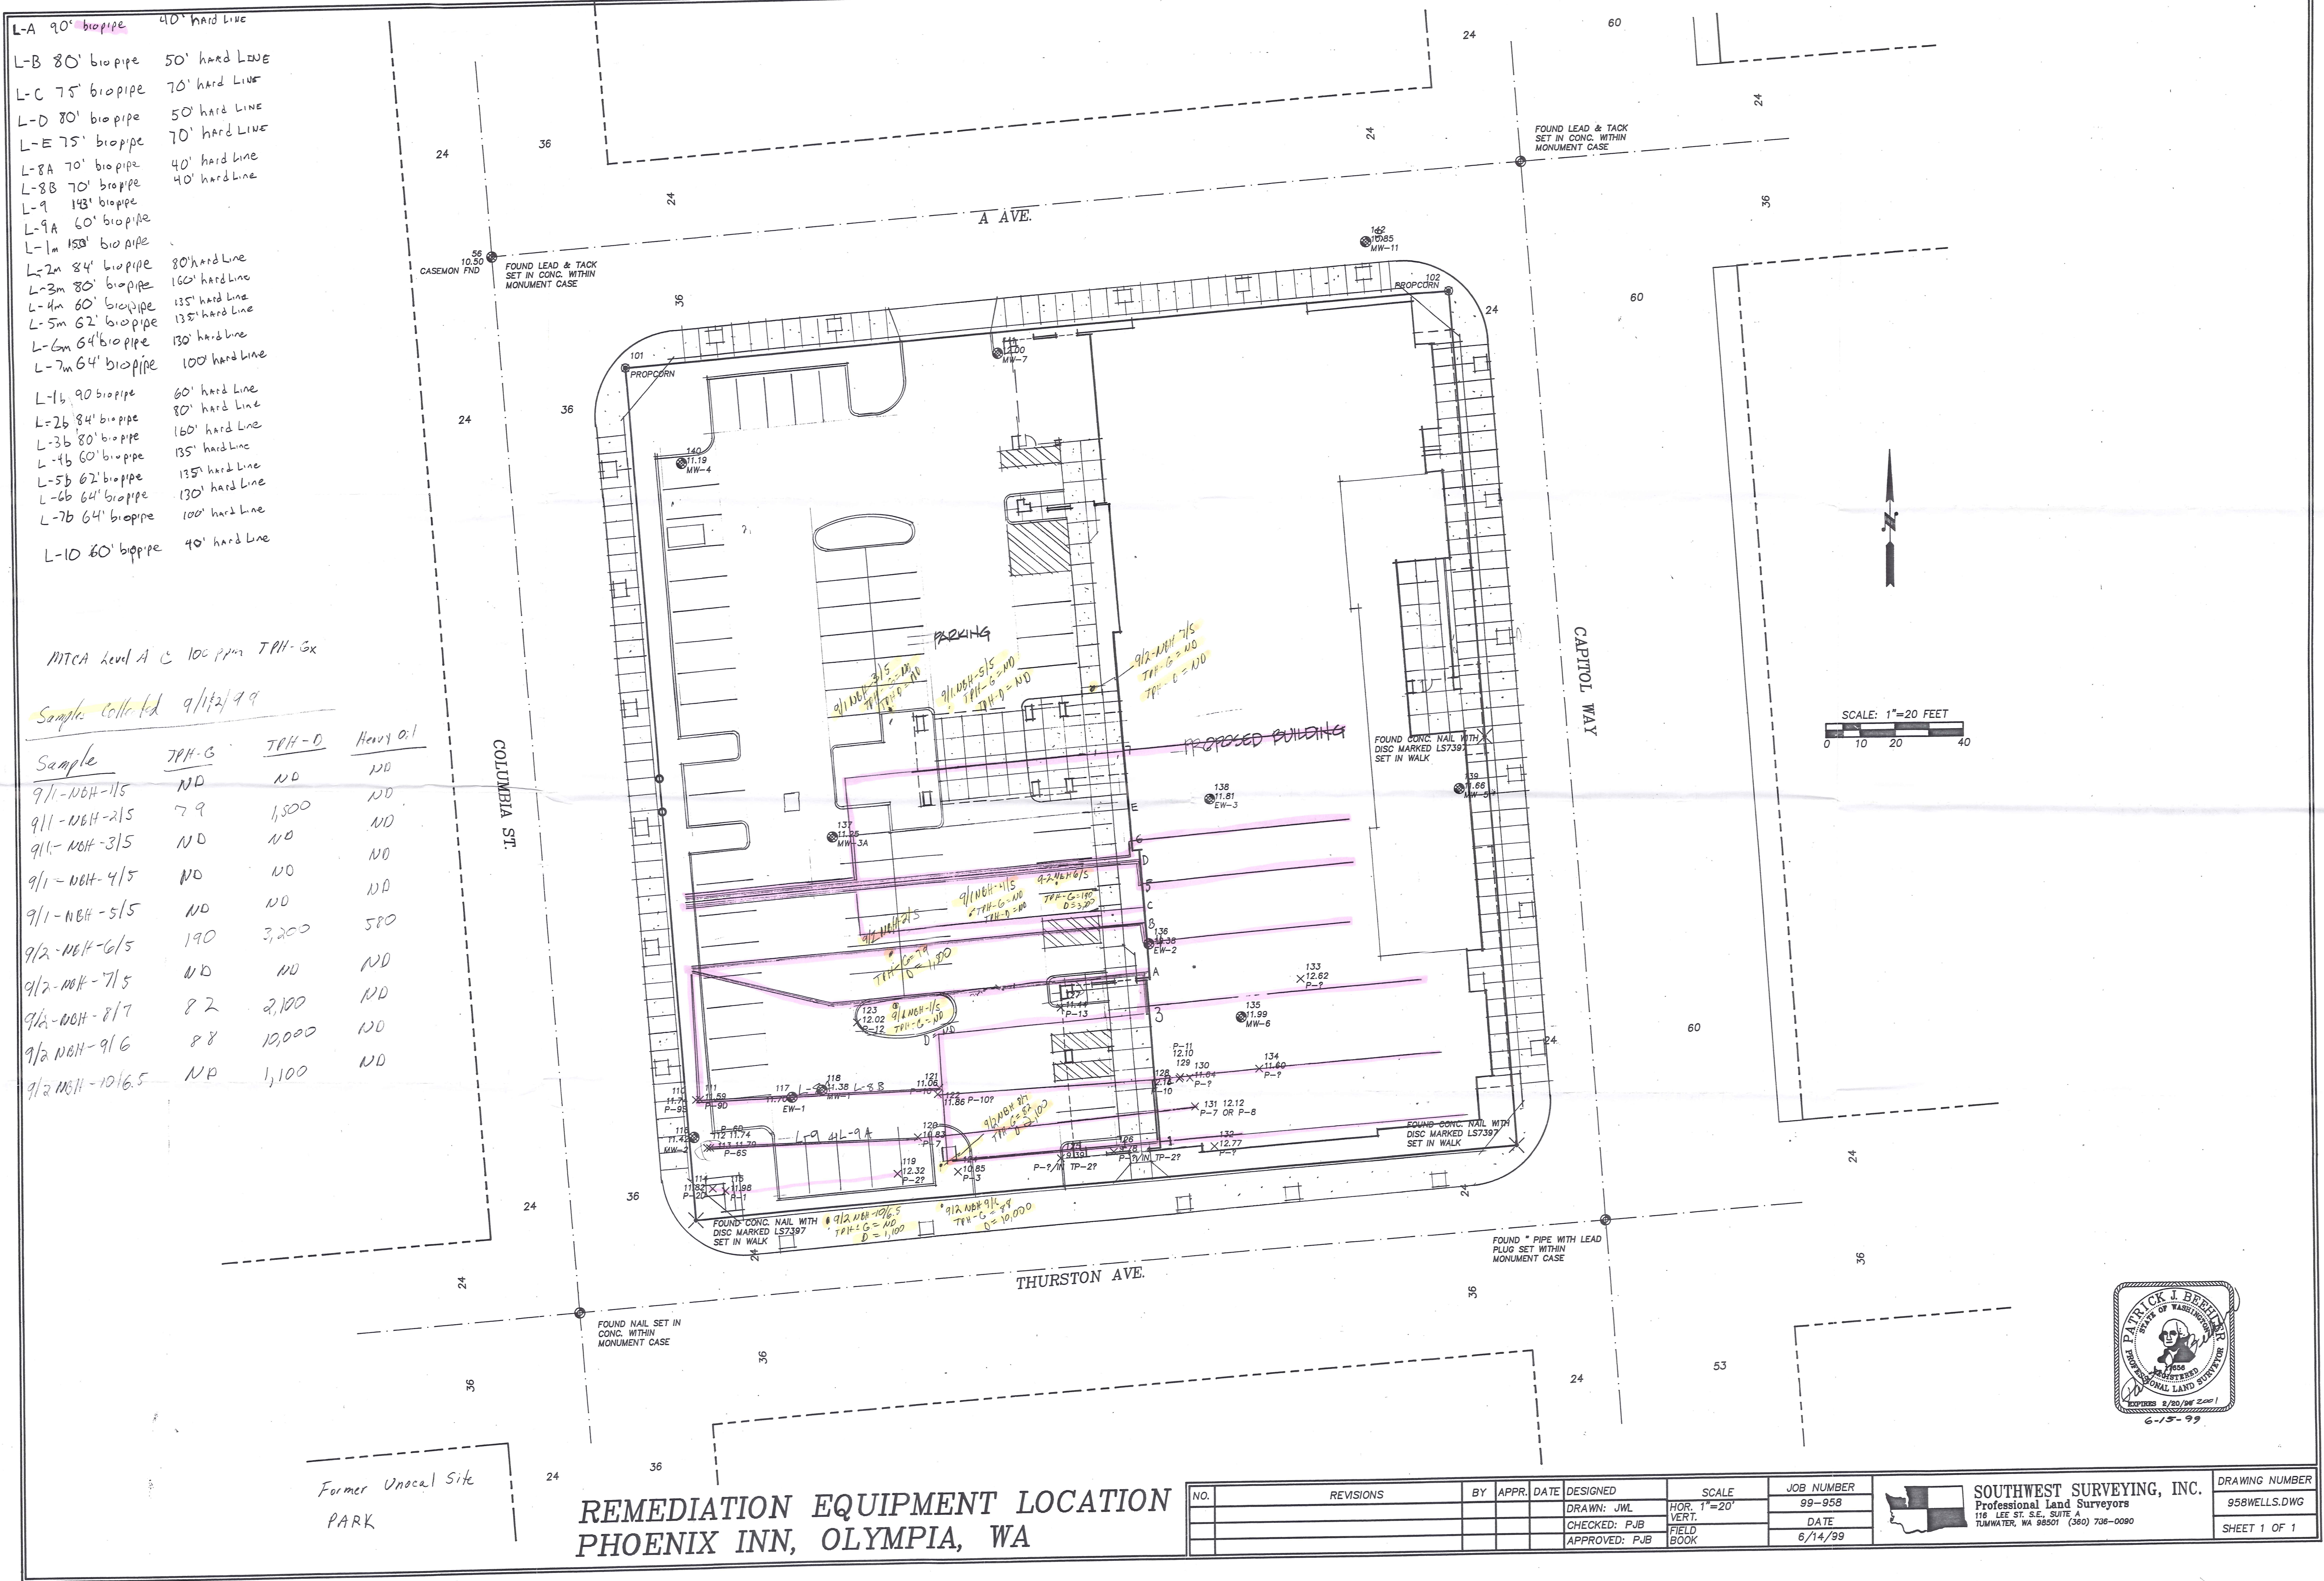
REMEDIATION EQUIPMENT LOCATION PHOENIX INN, OLYMPIA, WA

Sample	TPH-G	TPH-D	Heavy oil
9/1-NBH-1/5	ND	ND	ND
9/1-NBH-2/5	79	1,500	ND
9/1-NBH-3/5	ND	ND	ND
9/1-NBH-4/5	ND	ND	ND
9/1-NBH-5/5	ND	ND	580
9/2-NBH-6/5	190	3,200	ND
9/2-NBH-7/5	ND	ND	ND
9/2-NBH-8/7	82	2,100	ND
9/2-NBH-9/6	88	10,000	ND
9/2-NBH-10/6.5	ND	1,100	ND

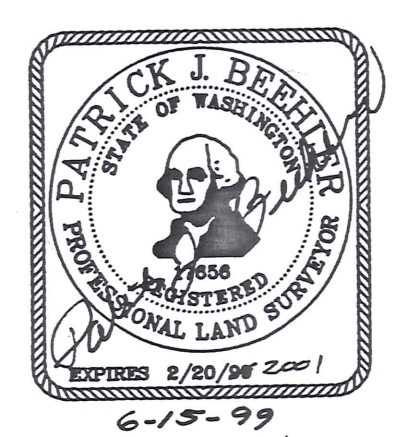
DRAWING NUMBER	958WELLS.DWG
SHEET 1 OF 1

- L-A 90' biopipe 40' hard line
- L-B 80' biopipe 50' hard line
- L-C 75' biopipe 70' hard line
- L-D 80' biopipe 50' hard line
- L-E 75' biopipe 70' hard line
- L-8A 70' biopipe 40' hard line
- L-8B 70' biopipe 40' hard line
- L-9 148' biopipe
- L-9A 60' biopipe
- L-1m 150' biopipe
- L-2m 84' biopipe 80' hard line
- L-3m 80' biopipe 160' hard line
- L-4m 60' biopipe 135' hard line
- L-5m 62' biopipe 135' hard line
- L-6m 64' biopipe 130' hard line
- L-7m 64' biopipe 100' hard line
- L-1b 90' biopipe 60' hard line
- L-2b 84' biopipe 80' hard line
- L-3b 80' biopipe 160' hard line
- L-4b 60' biopipe 135' hard line
- L-5b 62' biopipe 135' hard line
- L-6b 64' biopipe 130' hard line
- L-7b 64' biopipe 100' hard line
- L-10 80' biopipe 40' hard line

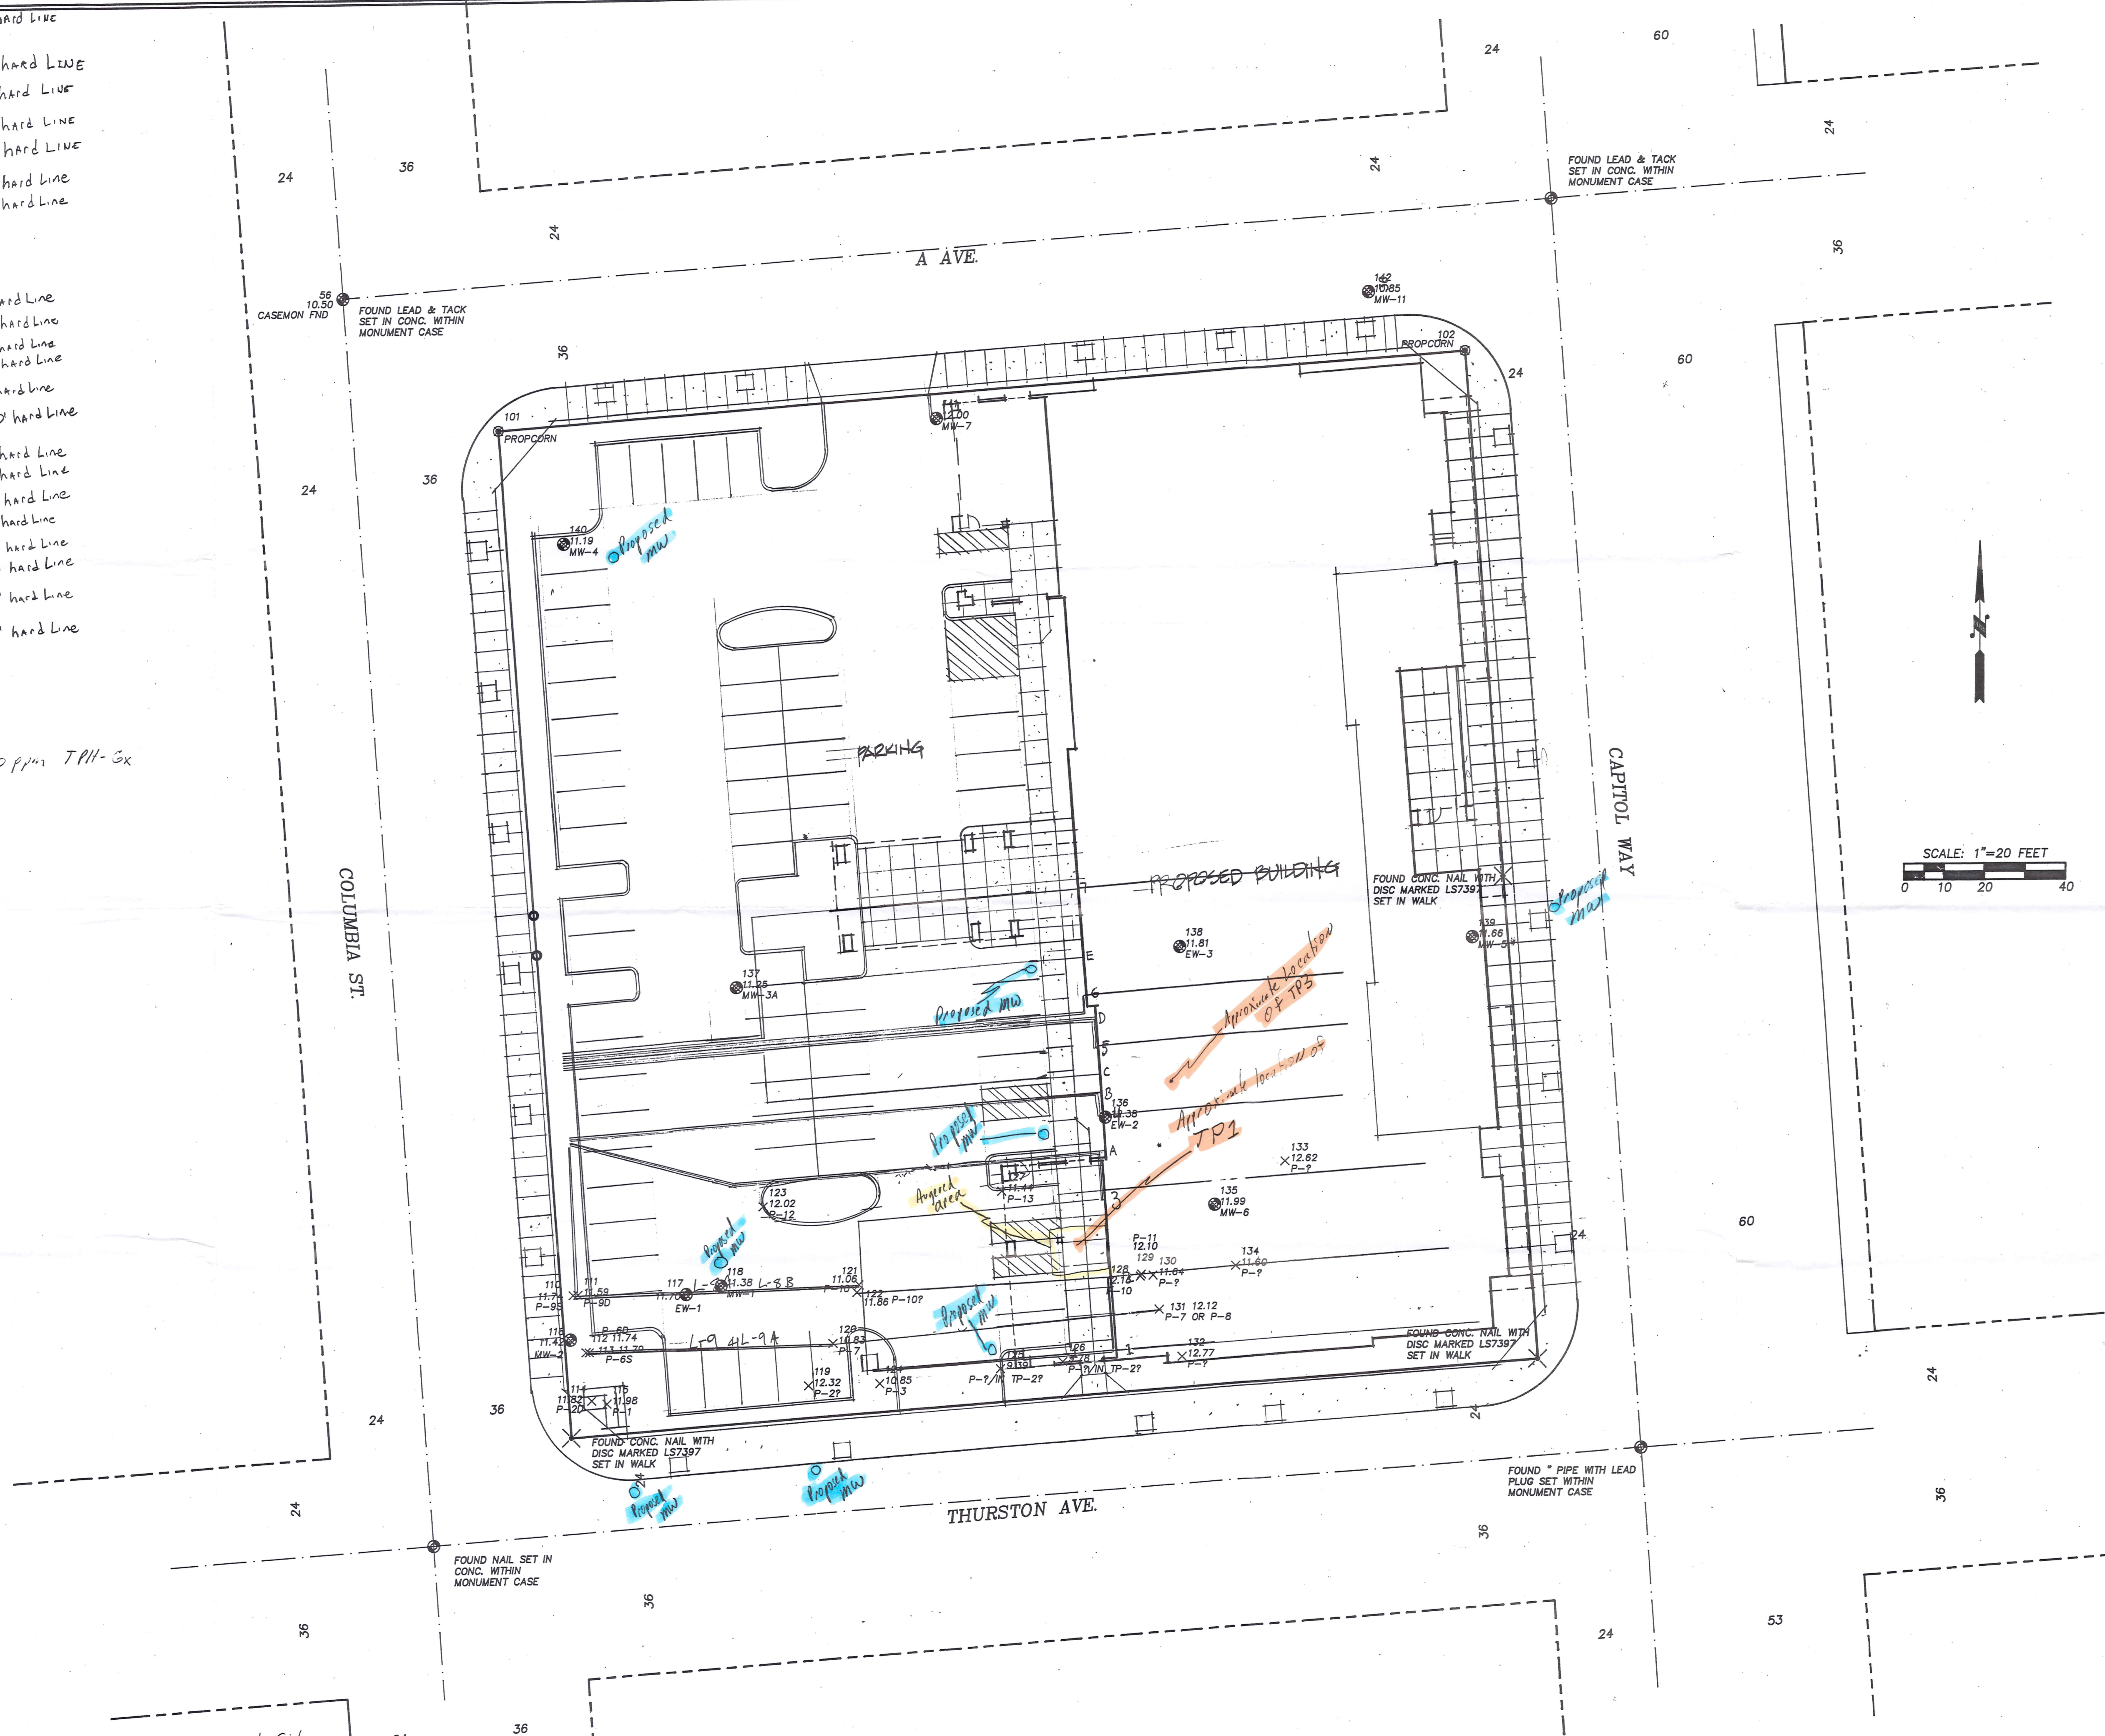
REMEDIATION EQUIPMENT LOCATION PHOENIX INN, OLYMPIA, WA

MTCA Level A C 100 p/m TPH-Gx
